## **Tailplane or main wing stall? LOC-I event due to suspected icing**

In January 2017, a business jet was being flown in Norway on a short repositioning flight with two pilots onboard, no passengers or cargo. Initially, the take-off proceeded as normal. As the landing gear was retracted the pilots observed that the airspeed was rapidly approaching the flap limiting speed of 200 kts. As the flaps were retracted at a height above ground level of approximately 2,000 ft, the crew experienced a violent nose-down pitch motion restrained by their seat belts, as the aircraft started banking sharply to the left. A full investigation was conducted by the Norwegian Safety Investigation Authority, supported by industry and academic partners ( ). It is likely that the commander (Pilot Flying) and first officer (Pilot Monitoring) experienced different levels of startle and/or surprise during the upset. Control was regained at a height of approximately 170 ft above ground level. Data from the Flight Data Recorder showed that the aircraft experienced -2.62 G during the pitch down upset and +5.99 G during the pull-out. A tailplane stall due to icing was suspected, however the flight data recorde

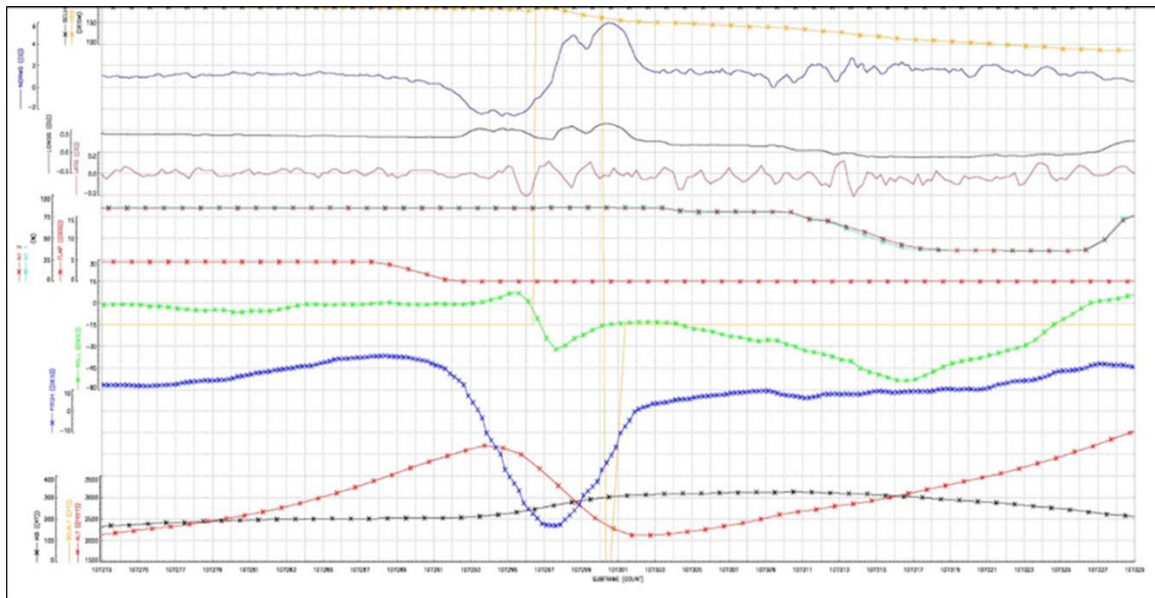
**Figure 2, Flight Data Recorder Output (1)**

Initially, the take-off proceeded as normal. Figure 2 shows a plot of the most important parameters retrieved from the Flight Data Recorder plotted over one common timeline (1). The landing gear was retracted and both pilots observed that the speed was rapidly approaching 200 kt, which is the maximum speed with flaps deployed. As the flaps were retracted, the crew experienced a violent nose-down movement and the pilots were "hanging by their seat belts", while the aircraft started sharply banking to the left. Following the accident, data from the Flight Data Recorder (FDR) showed that the aircraft at this moment experienced negative 2.62 G. The Commander did not trust the instruments while the First Officer, which was Pilot Monitoring (PM) had better situational awareness. The First Officer quickly took control and started a pull-out from the dive. The aircraft descended below the cloud base, and even though it was dark, the pilots could glimpse the ground. The control was regained, and the aircraft levelled off 170 ft above the ground. The aircraft was overstressed to 5.99 G during the pull-out. The crew called "MAYDAY" to the Air Traffic Control. The engines were left in take-off position during the entire pull-out and the speed increased to 325 kt. Once control was regained, the "MAYDAY" was cancelled, and the flight continued towards Torp where an approach and landing took place without further problems. The NSIA investigation has not revealed any technical malfunctions in the aircraft and its control systems.

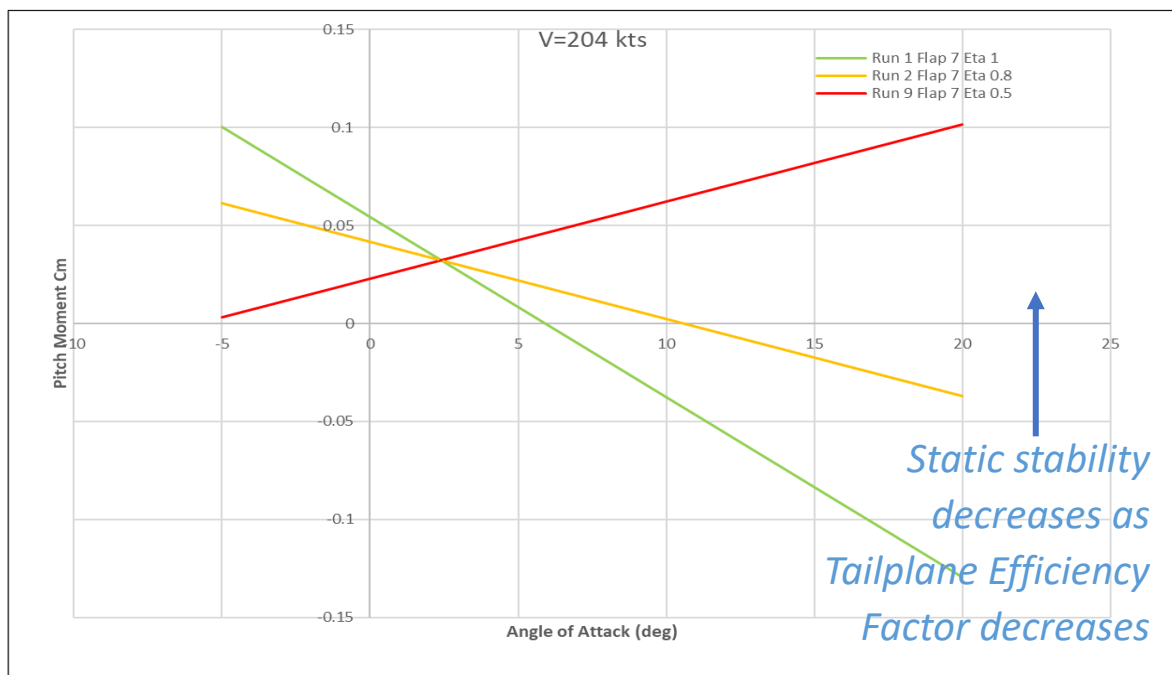
Figure 7, Pitch Stability - Pitching Moment vs Angle of Attack

For the 'generic business jet', using the given flight condition of  $V = 204$  KTAS,  $H = 4,000$  ft pressure height,  $T = 29F$ , aft CG/low MTOM with flap = 7 degrees, the variation of pitching moment with angle of attack was obtained for a range of horizontal tailplane efficiencies from 1.0 (100%) to 0.5 (50%) to simulate the effects of icing on the aircraft tailplane (Figure 7). The results show that the pitching moment versus angle of attack gradient decreases as the horizontal tailplane efficiency decreases, hence aircraft static stability also decreases as horizontal tailplane efficiency decreases.

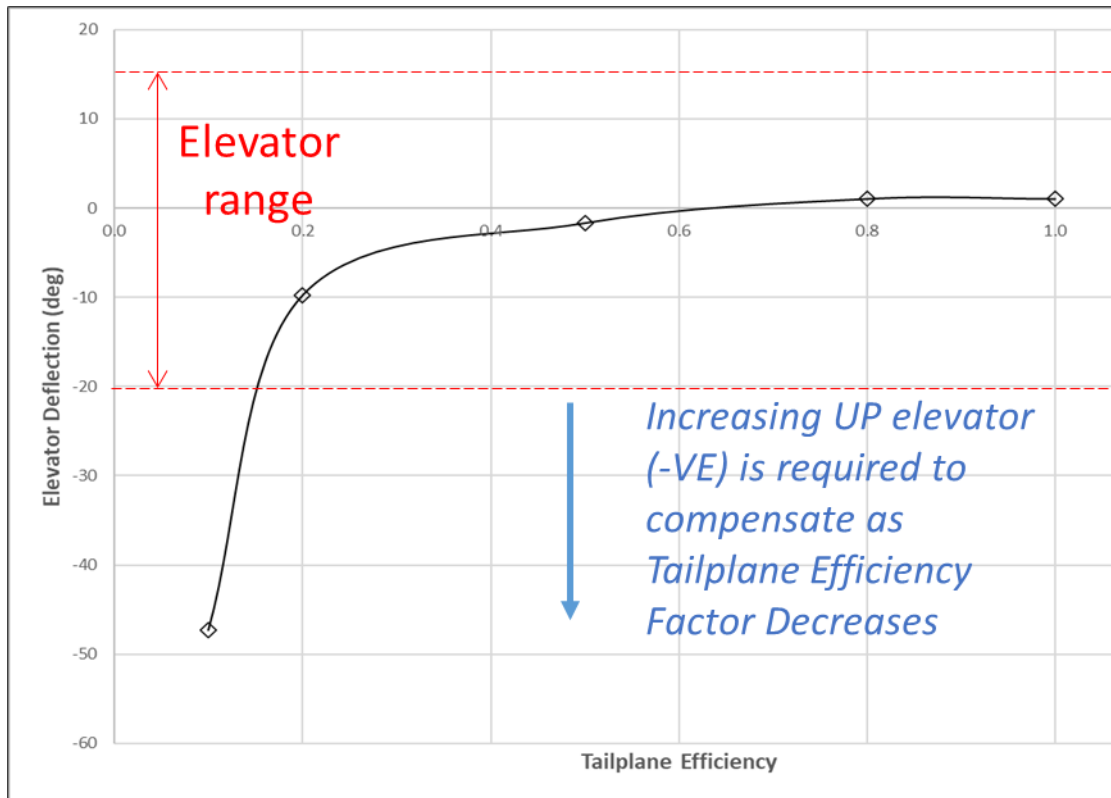
Figure 8, Elevator Deflection vs Tailplane Efficiency

The results also show that the angle of attack for trimmed flight conditions increases as tailplane efficiency decreases. Analysis of horizontal tailplane efficiency versus stick-fixed static margin suggests that static margin decreases as the horizontal tailplane efficiency decreases and that the aircraft is neutrally (statically) stable when the horizontal tailplane efficiency is approximately 0.68 for the 'generic business jet' model in given flight conditions (Figure 8).

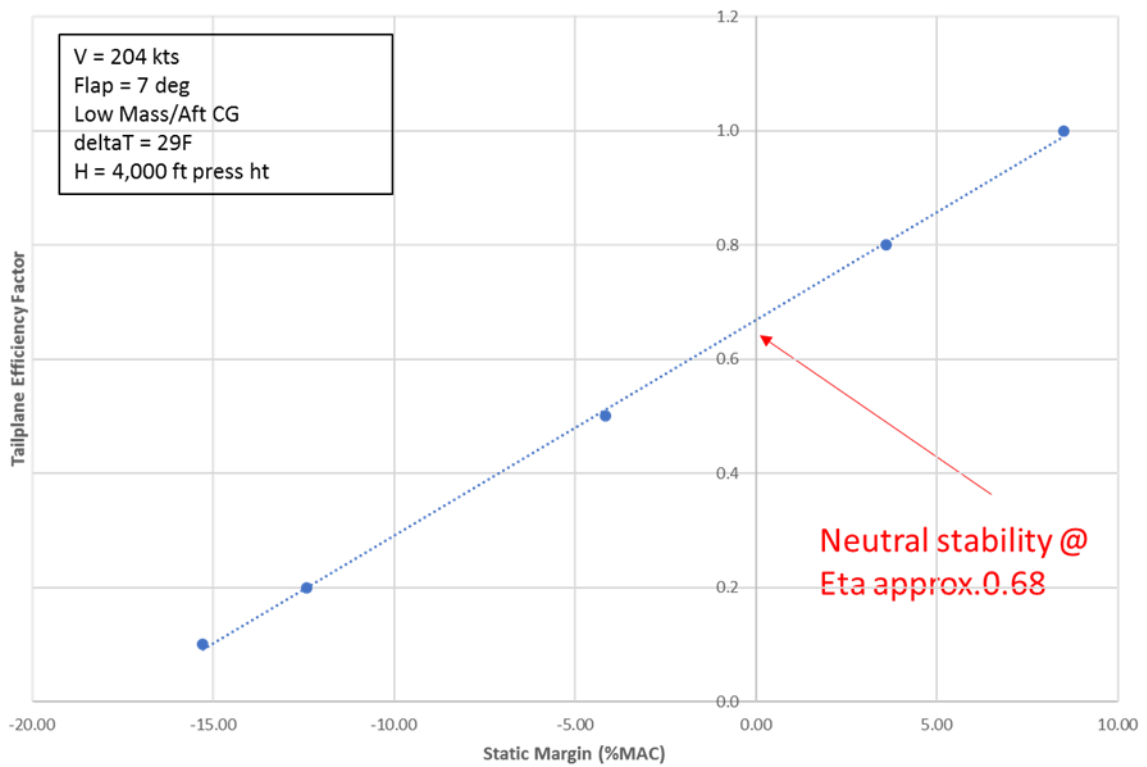
Figure 9, Tailplane Efficiency Factor vs Static Margin

Further analysis of elevator deflection versus horizontal tailplane efficiency (Figure 9) suggests that increasing UP elevator (-ve deflection) is required to maintain trimmed flight as the horizontal tailplane efficiency decreases. The range of elevator deflection for the 'generic business jet' model was 20 degrees UP and 15 degrees DOWN. The results suggest that as horizontal tailplane efficiency decreases below approximately 0.2 (20%), there is insufficient UP elevator to maintain trimmed flight.

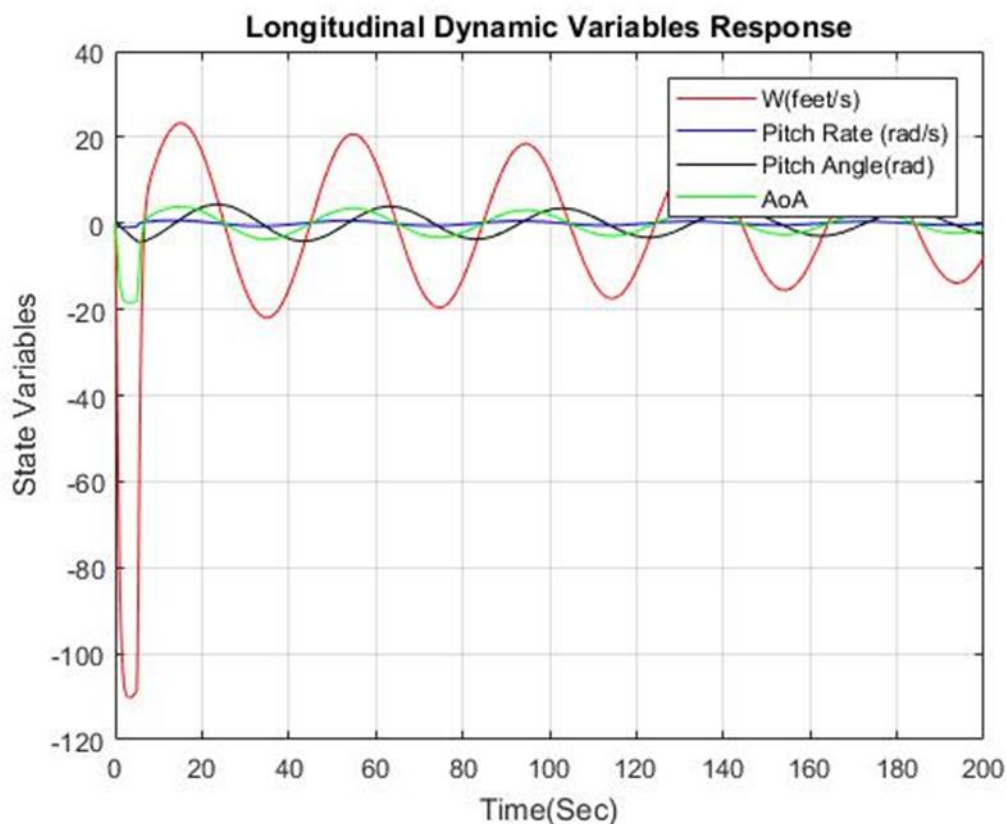
Figure 10, Long Period Oscillation (LPO) with 80% Horizontal Tailplane Efficiency

For model validation purposes, the longitudinal dynamics were analysed by excitation of the Short Period and Long Period modes using the eigenvectors (specific to modes) of Matrix A to specify initial conditions. The variables simulated were relative changes (variations with respect to a trim condition). The results show that for a horizontal tailplane efficiency of 100% the aircraft is statically and dynamically stable with heavy and moderate damping for the SPO and LPO respectively. In addition, the model was independently verified by comparing results to a reduced order model (**Error! Bookmark not defined.**). When the efficiency is reduced to 80%, the response for the LPO is also stable although with less damping of oscillations than the 100% efficiency case (Figure 10). The results of the dynamic stability are in agreement with those of the static stability analysis.

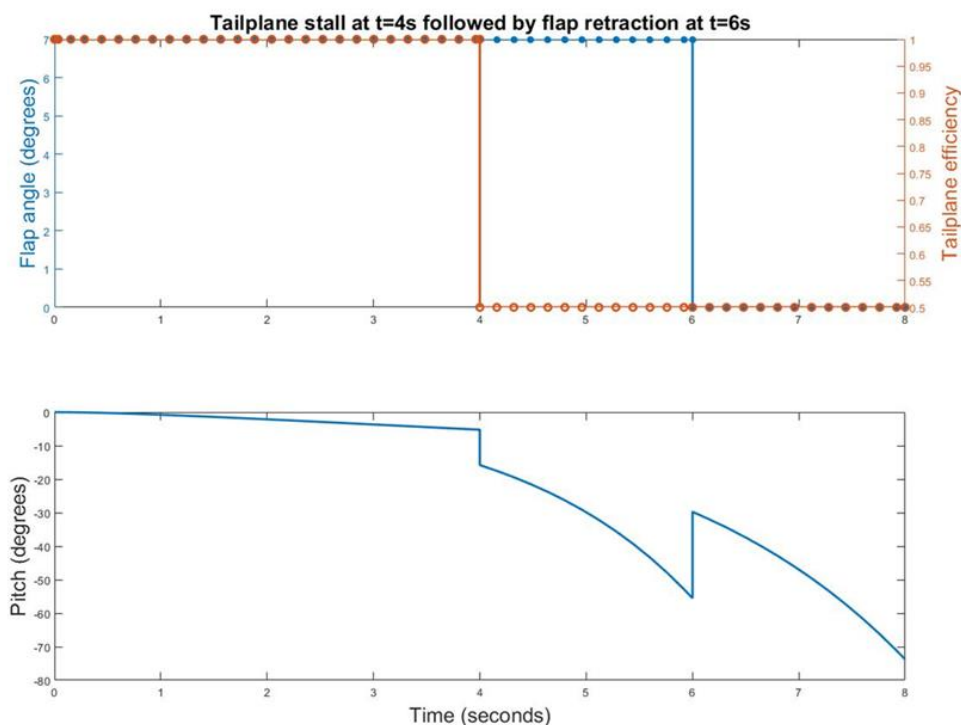
Figure 11, Tailplane Stall Followed by Flap Retraction

The results of a flap retraction following a simulated tailplane stall (Figure 11) were analysed with the tailplane efficiency of 100% and the flap deflection of 7 degrees. At  $t=4$  seconds, a tailplane stall was modelled by a step reduction of 50% to horizontal tailplane efficiency, which destabilises the system response. The aircraft pitches down (-30 degrees) within 2 seconds. At  $t=6$  seconds, the retraction of flaps from 7 degrees to 0 degrees initially helps, but not sufficiently to stabilise the response with 50% tailplane efficiency. The effect of tailplane efficiency on the initial response to a 1 second elevator impulse (Figure 13) shows that at 100% horizontal tailplane efficiency, a large 20deg elevator down during 1 second is needed to initiate a large magnitude but stable phugoid response, which is shown during the first 20 seconds for comparison purposes. At 50% efficiency, a 1 second 2-degree elevator down input destabilises the system with oscillations and at 20% efficiency, 1-degree elevator down is sufficient to produce very fast divergence without oscillations. Load factor changes with 1 second elevator down commands for varying horizontal tailplane efficiencies were also presented (Figure 11). With 100% efficiency, load factor remains very close to 1 with a small elevator command, as expected. With 50% tailplane efficiency, load factor is reduced but changes are small. Major changes to load factor are however obtained with 20% tailplane efficiency and negative G is quickly reached in this case. This is believed to be closer to the conditions experienced during the incident (1).
