TECHNICAL REPORT NO. 303

The Replacement of the Shaft Couplers in Las Campanas in 2008 March

Steven J. Hale

2008 April 23

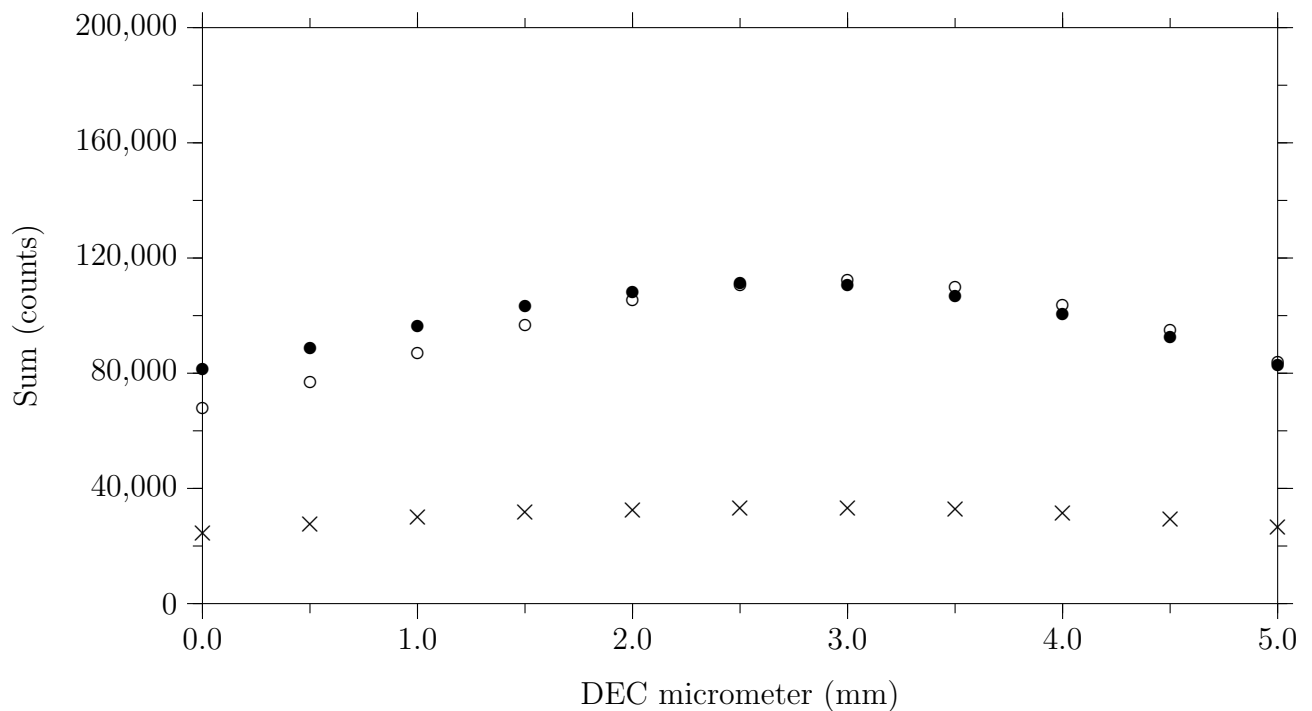
The results of the declination scan are shown in Figures 3 and 4. It looks like Hannibal wants the declination micrometer set to 2.5 mm while Ivan wants 1.5 mm. The best compromise here seems to be a setting of 2.0 mm. The initial setting was 2.25 mm and so a slight improvement was made.

Figure 3: DEC scan (Hannibal) - The guider was scanned declination. The plot shows how the starboard sum (●), port sum (○), and the transmission monitor (×) varied. This scan was done with the right ascension micrometer set at 4.0 mm and the cell hot.
