TECHNICAL REPORT NO. 357

Autoguider repairs in Las Campanas in 2012 March

Steven J. Hale

2012 April 5

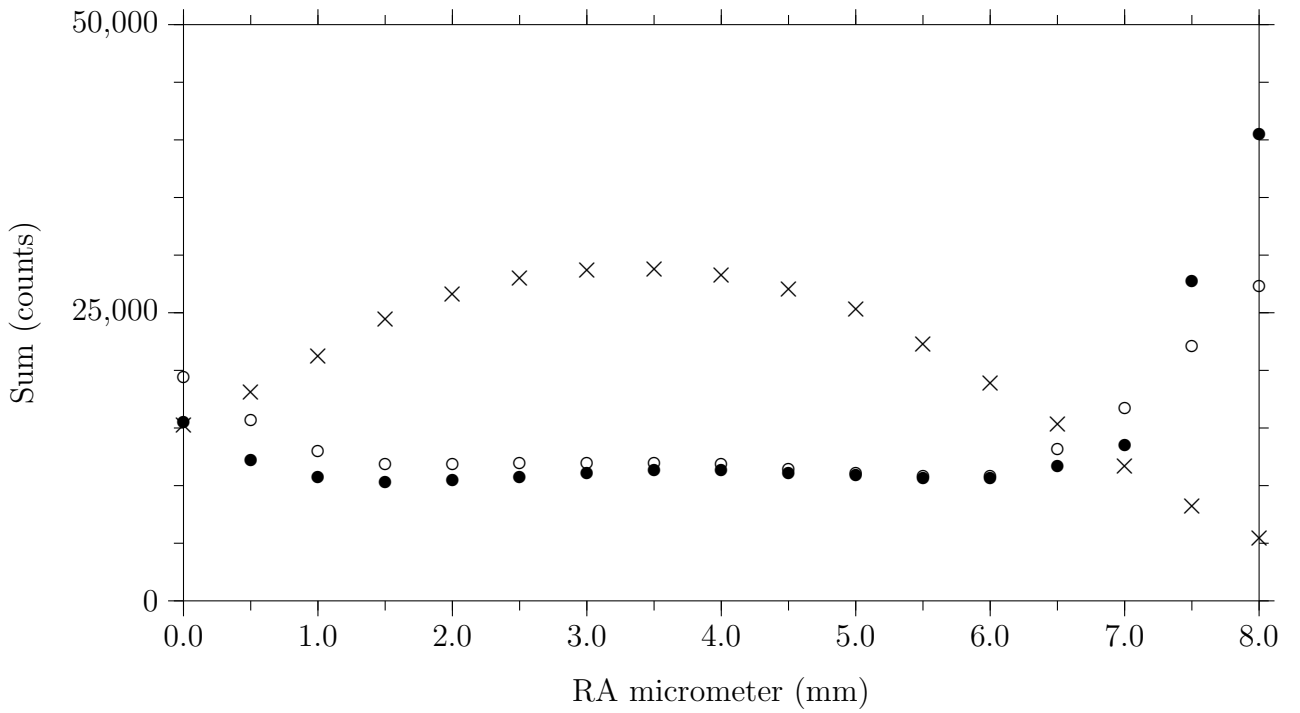
Figure 1: RA scan (Hannibal) - The guider was scanned right ascension. The plot shows how the starboard sum (●), port sum (○), and the transmission monitor (×) varied. This scan was done with the declination micrometer set at 2.00 mm and the cell cold.

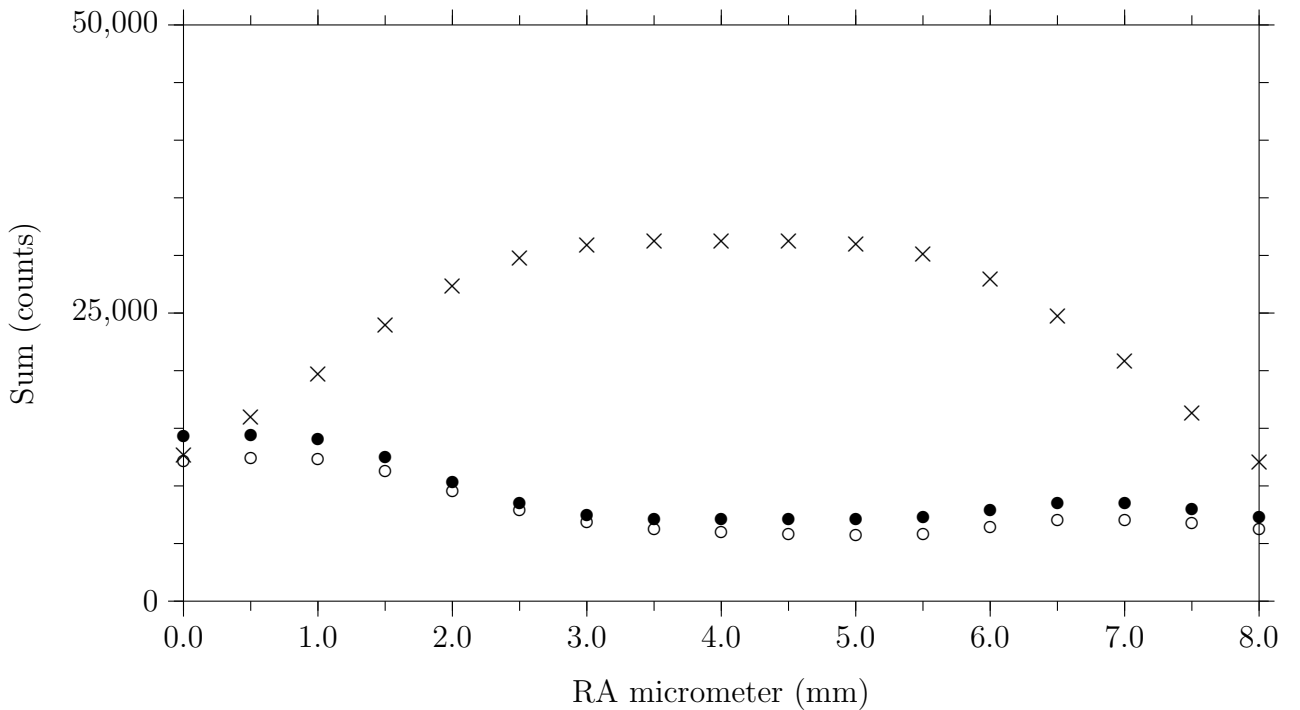
Figure 2: RA scan (Ivan) - The guider was scanned right ascension. The plot shows how the starboard sum (●), port sum (○), and the transmission monitor (×) varied. The transmission monitor data have been divided by ten. This scan was done with the declination micrometer set at 2.00 mm and the cell cold.

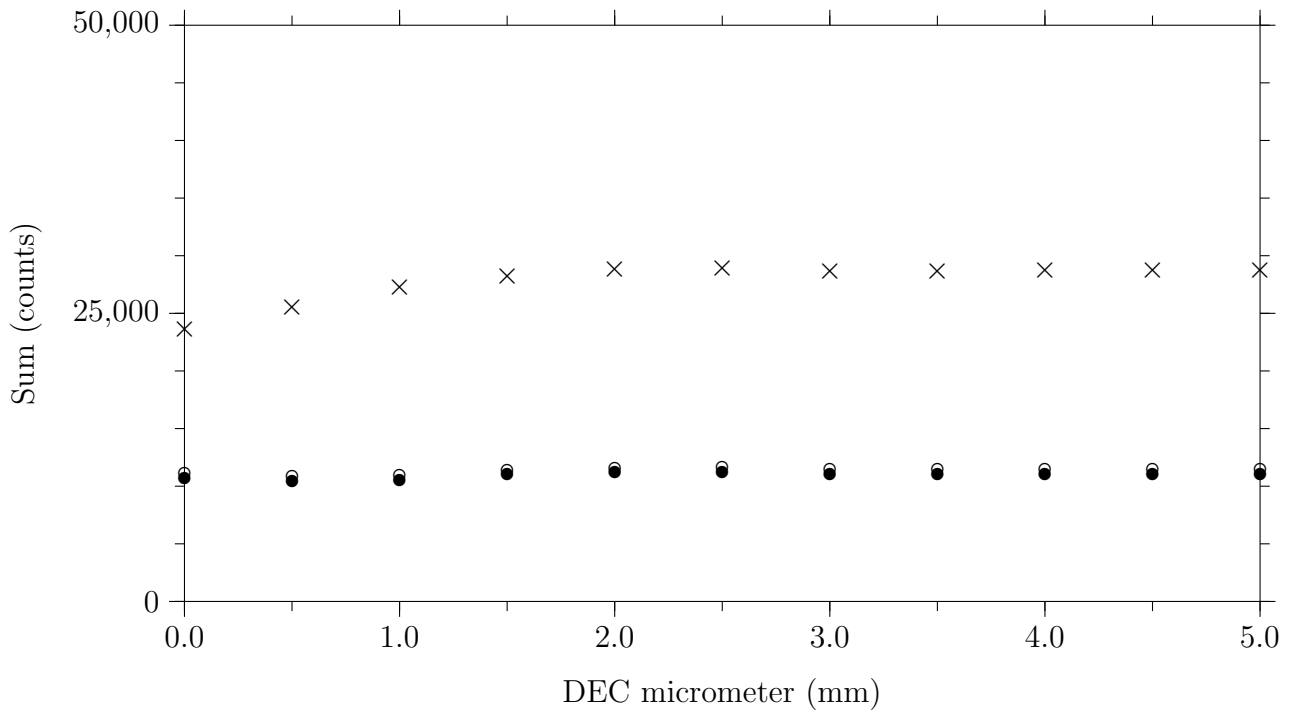
Figure 3: DEC scan (Hannibal) - The guider was scanned declination. The plot shows how the starboard sum (●), port sum (○), and the transmission monitor (×) varied. This scan was done with the right ascension micrometer set at 4.0 mm and the cell cold.

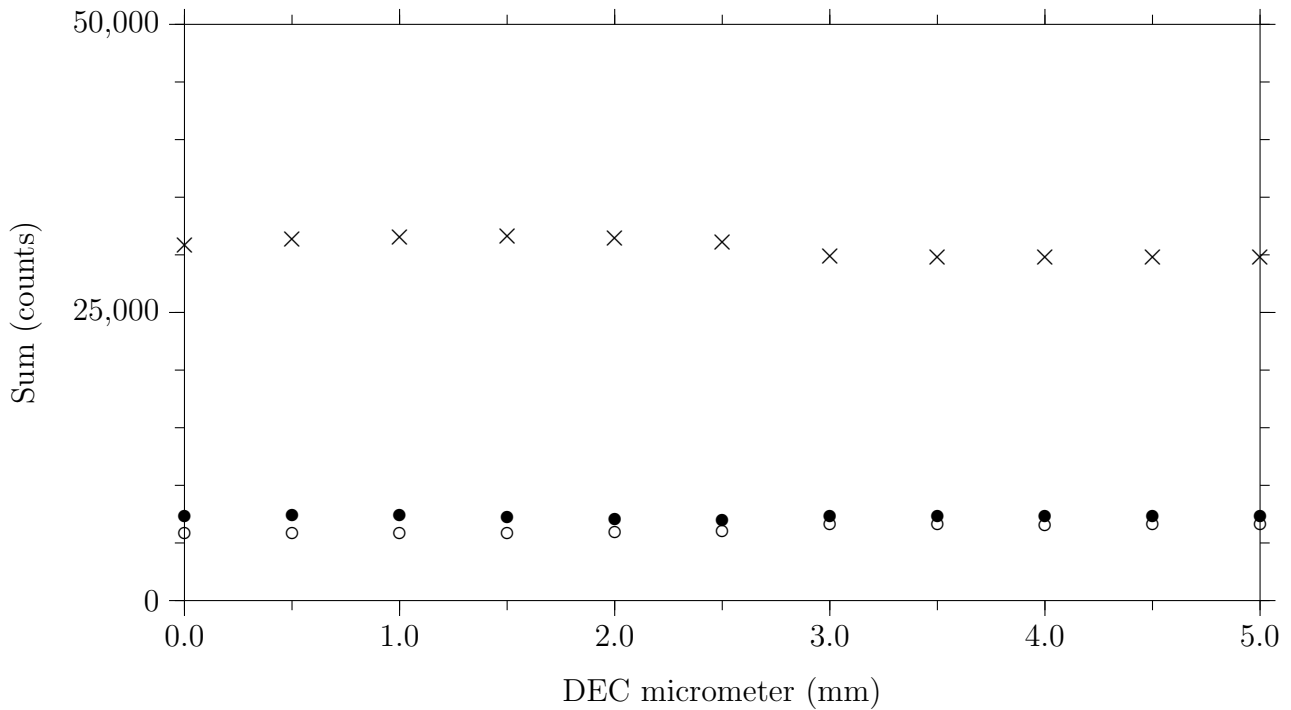
Figure 4: DEC scan (Ivan) - The guider was scanned declination. The plot shows how the starboard sum (●), port sum (○), and the transmission monitor (×) varied. The transmission monitor data have been divided by ten. This scan was done with the right ascension micrometer set at 4.0 mm and the cell cold.

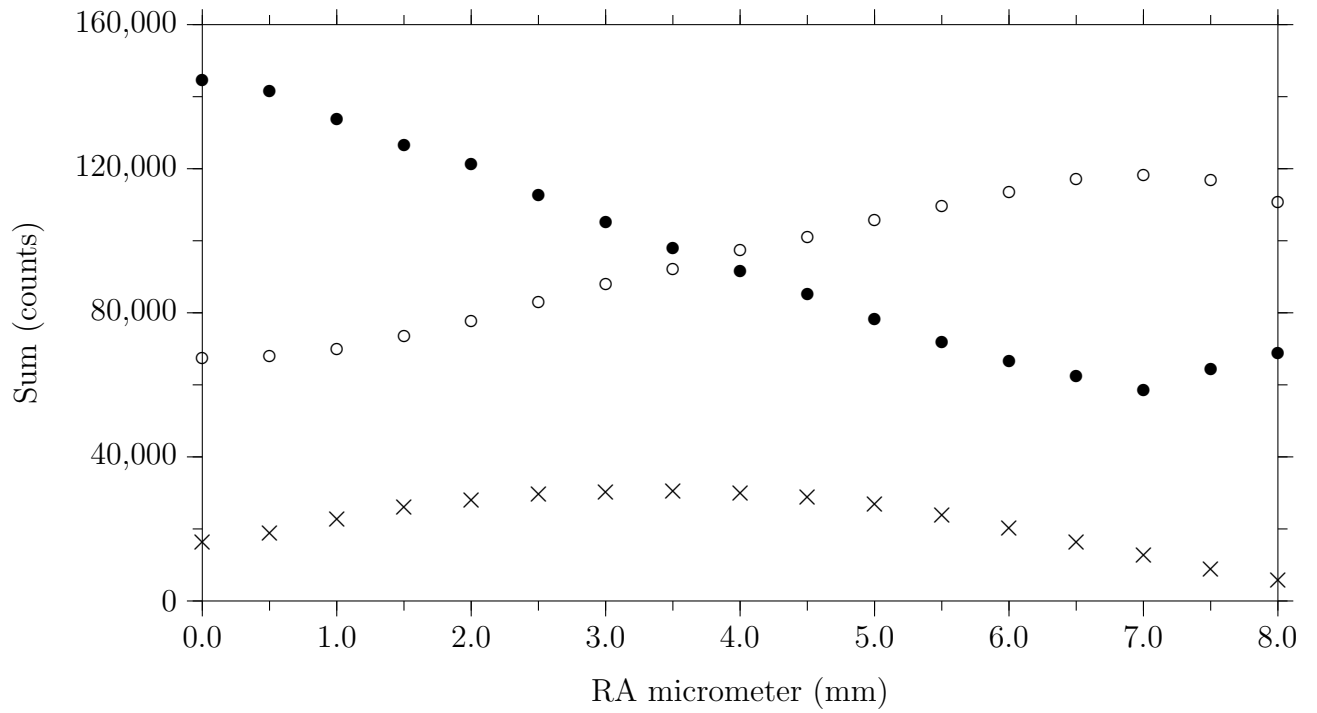
Figure 5: RA scan (Hannibal) - The guider was scanned right ascension. The plot shows how the starboard sum (●), port sum (○), and the transmission monitor (×) varied. This scan was done with the declination micrometer set at 2.00 mm and the cell hot.

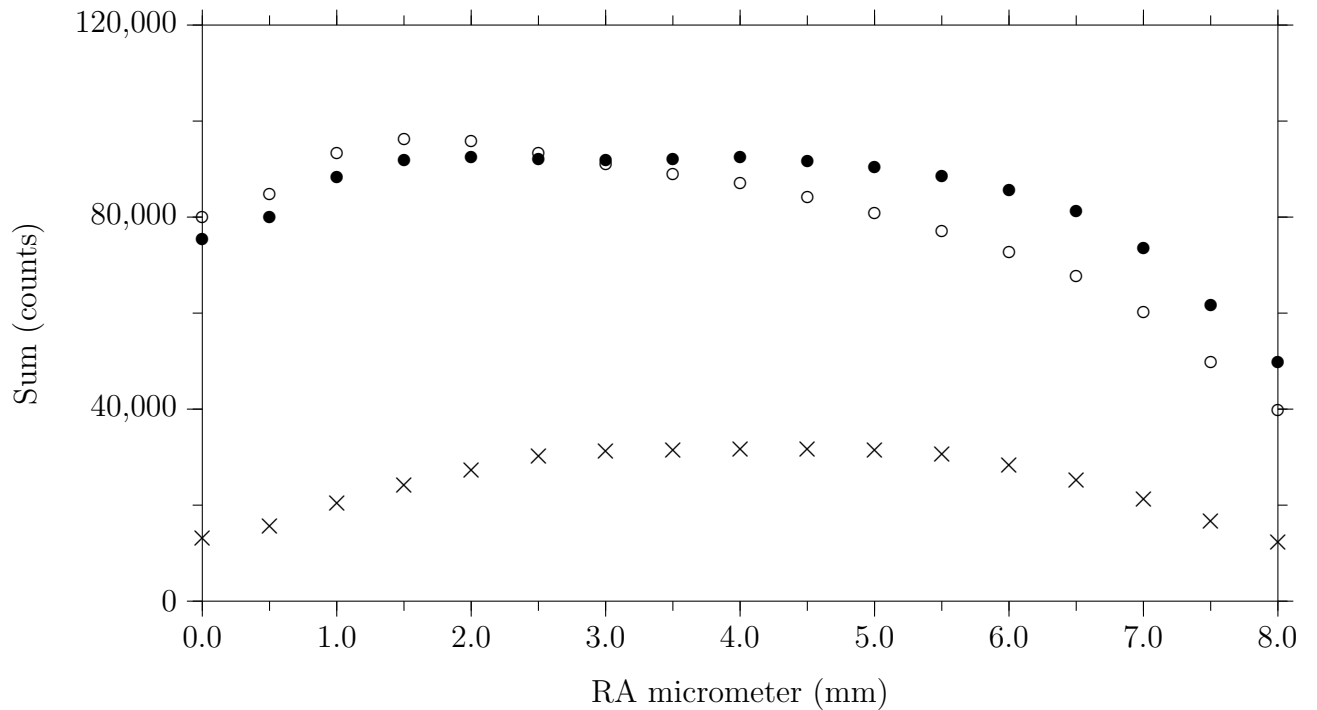
Figure 6: RA scan (Ivan) - The guider was scanned right ascension. The plot shows how the starboard sum (●), port sum (○), and the transmission monitor (×) varied. The transmission monitor data have been divided by ten. This scan was done with the declination micrometer set at 2.00 mm and the cell hot.

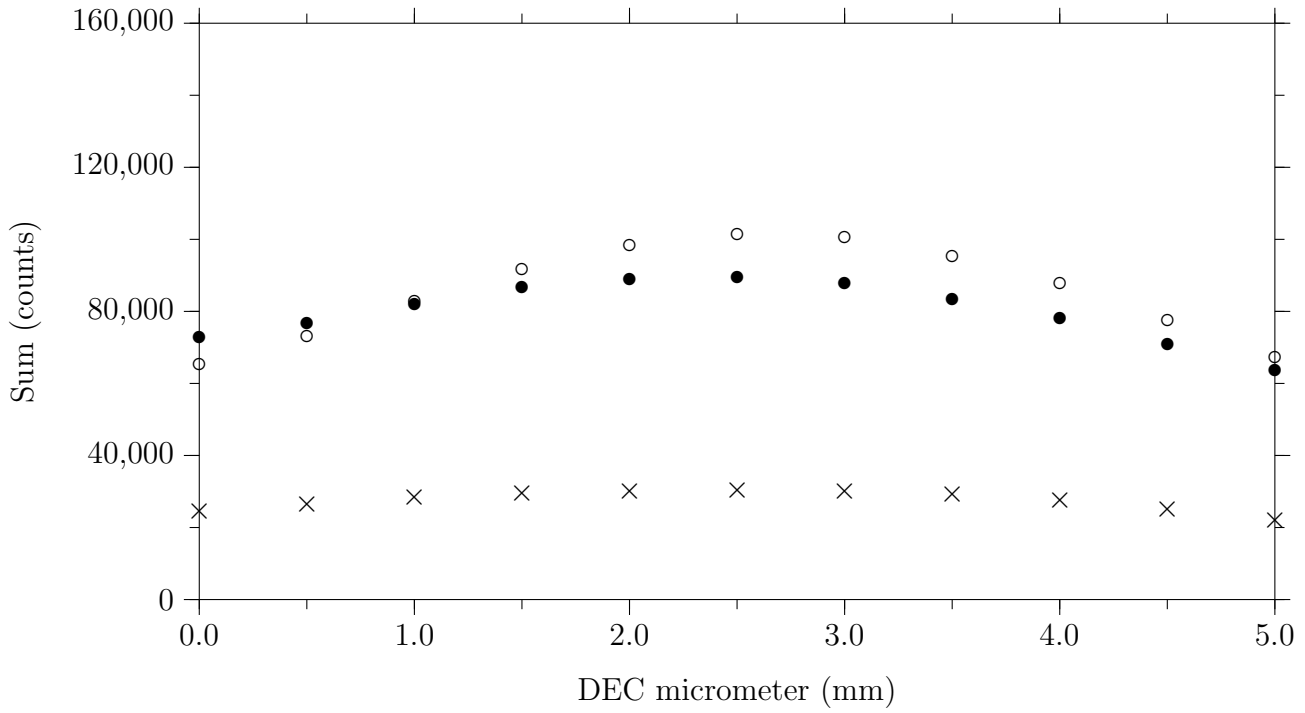
Figure 7: DEC scan (Hannibal) - The guider was scanned declination. The plot shows how the starboard sum (●), port sum (○), and the transmission monitor (×) varied. This scan was done with the right ascension micrometer set at 4.0 mm and the cell hot.

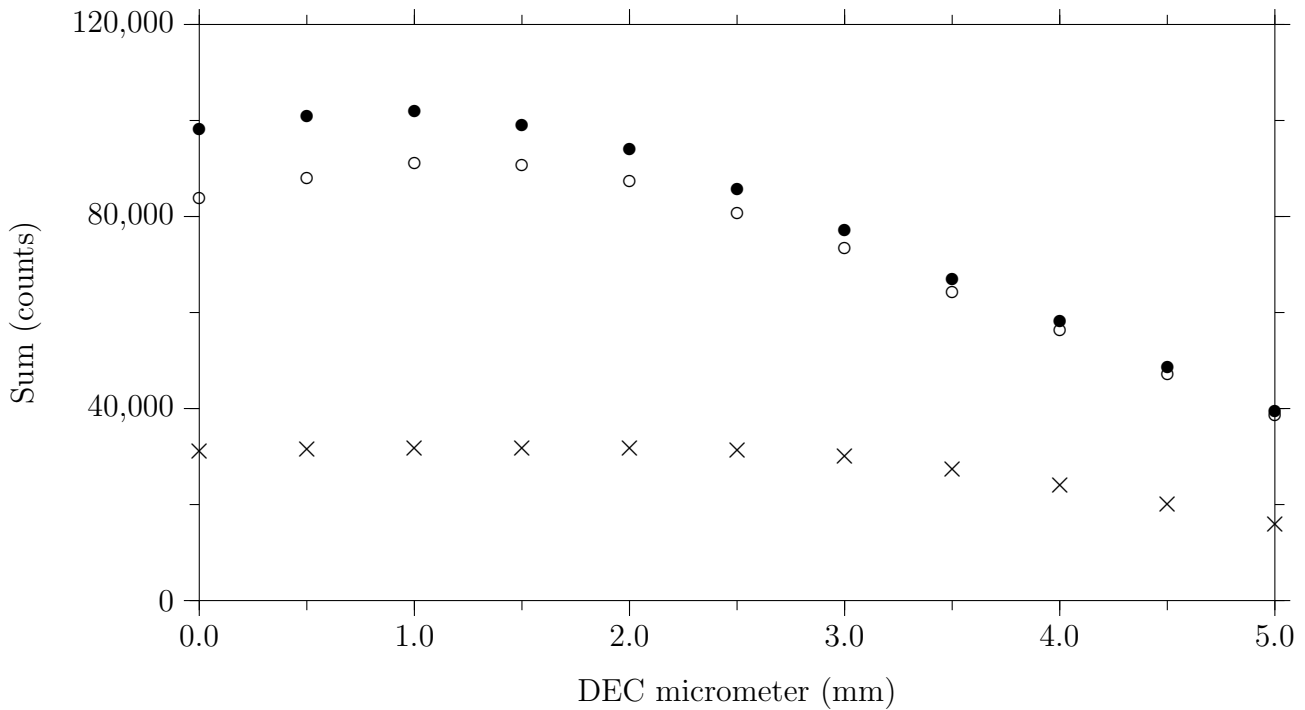
Figure 8: DEC scan (Ivan) - The guider was scanned declination. The plot shows how the starboard sum (●), port sum (○), and the transmission monitor (×) varied. The transmission monitor data have been divided by ten. This scan was done with the right ascension micrometer set at 4.0 mm and the cell hot.
