TECHNICAL REPORT NO. 358

2012 July 26

# Sutherland 2012 June Installation of Tiger Counters

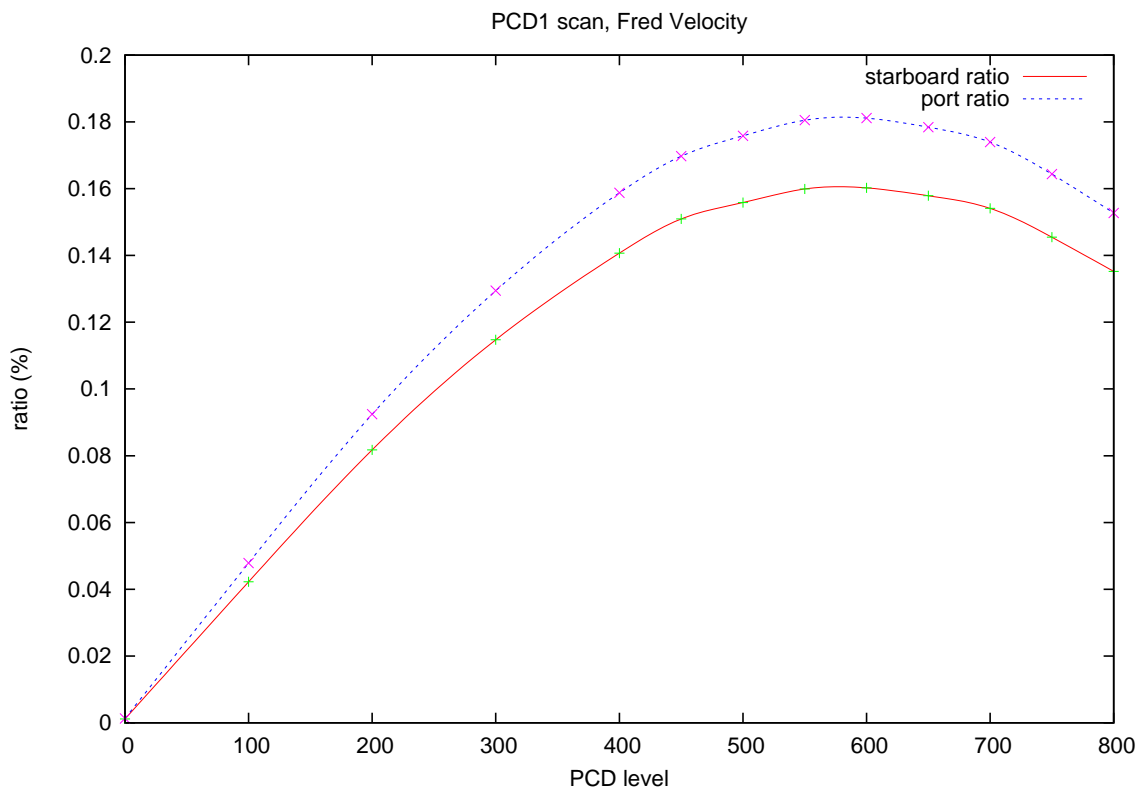
The delta-B was disconnected and the magnetic Pockels cell removed. The driver was scanned over the full range while looking at the velocity ratio output from the detectors. The results are in figure 1. The initial setting was “750”, the new scan suggests the best setting is “575” and so the velocity driver was adjusted to the new optimum.

Figure 1: Velocity PCD scan.

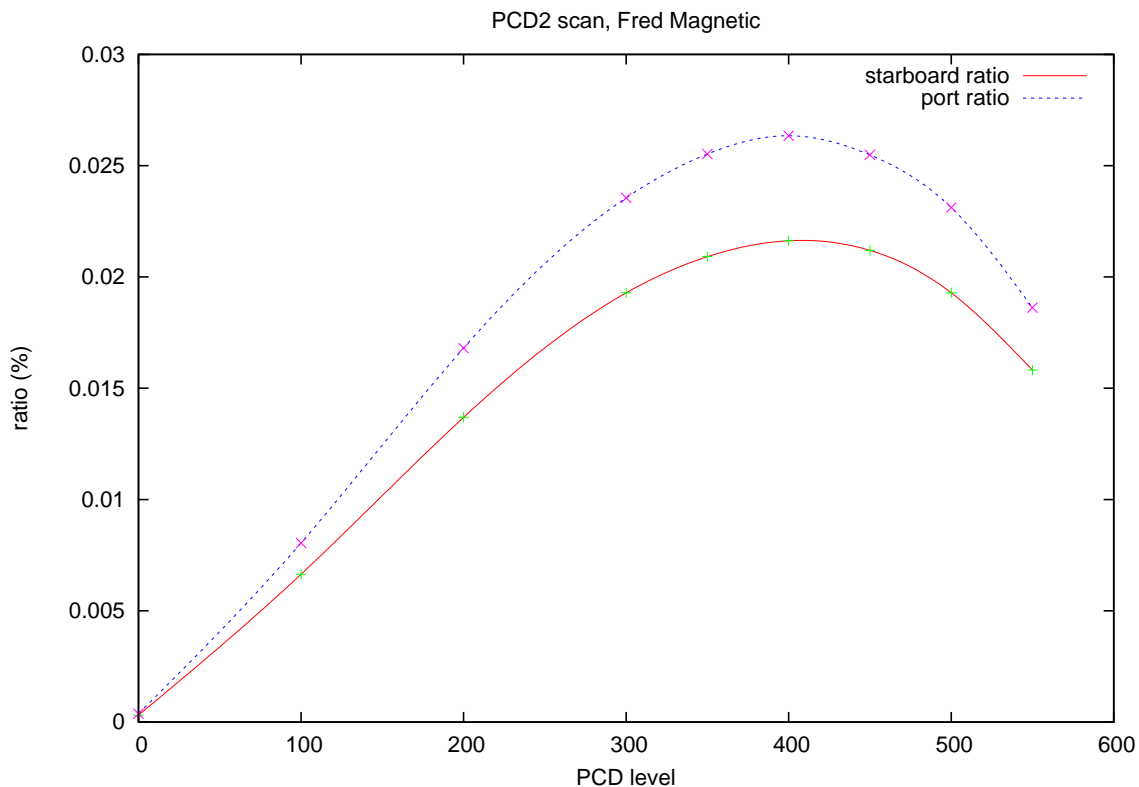
Calibrating the magnetic Pockels cell is slightly more tricky. The magnetic Pockels cell was replaced, and the velocity Pockels cell removed. The magnetic Pockels cell was then moved behind the polariser into the velocity position. The scan was then repeated using the magnetic cell and driver. The results are in figure 2. The initial setting was “375”, the new scan suggests the best setting is “400” and so the magnetic driver was adjusted to the new optimum.

**Figure 2:** Magnetic PCD scan.
