TECHNICAL REPORT NO. 367

**A check on Carnarvon in 2014 November following NBN
construction.**

2014 December 5

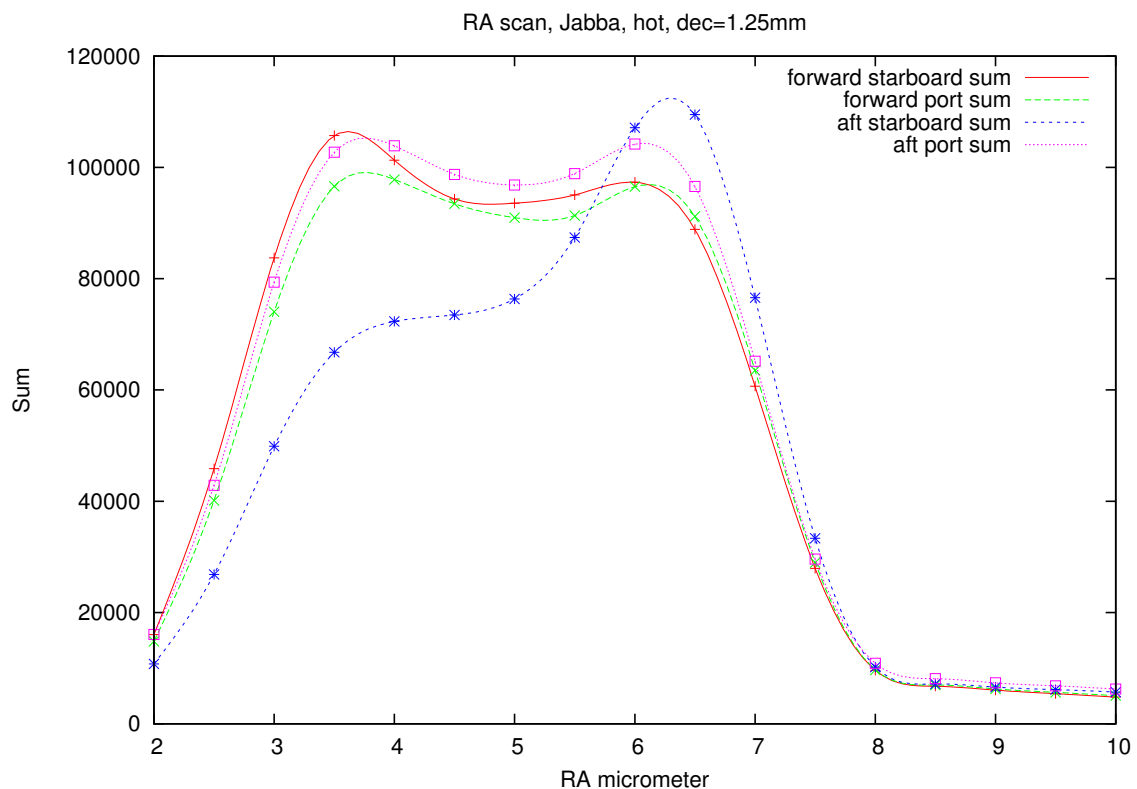
Figure 1: RA Hot Sum

The initial autoguider micrometer settings were 5.0 mm in RA and 1.25 mm in Declination, determined on the site visit in 2011 September [2]. A scan was performed in RA with the cell ovens hot. The results are shown in figures 1 and 2. The best alignment was determined to be at 5.0 mm in agreement with the initial setting. It would appear that no movement has taken place during the NBN works and so no further scans were performed.
