TECHNICAL REPORT NO. 365

Autoguider repairs at Mount Wilson in 2014 April

Steven J. Hale

2014 May 23

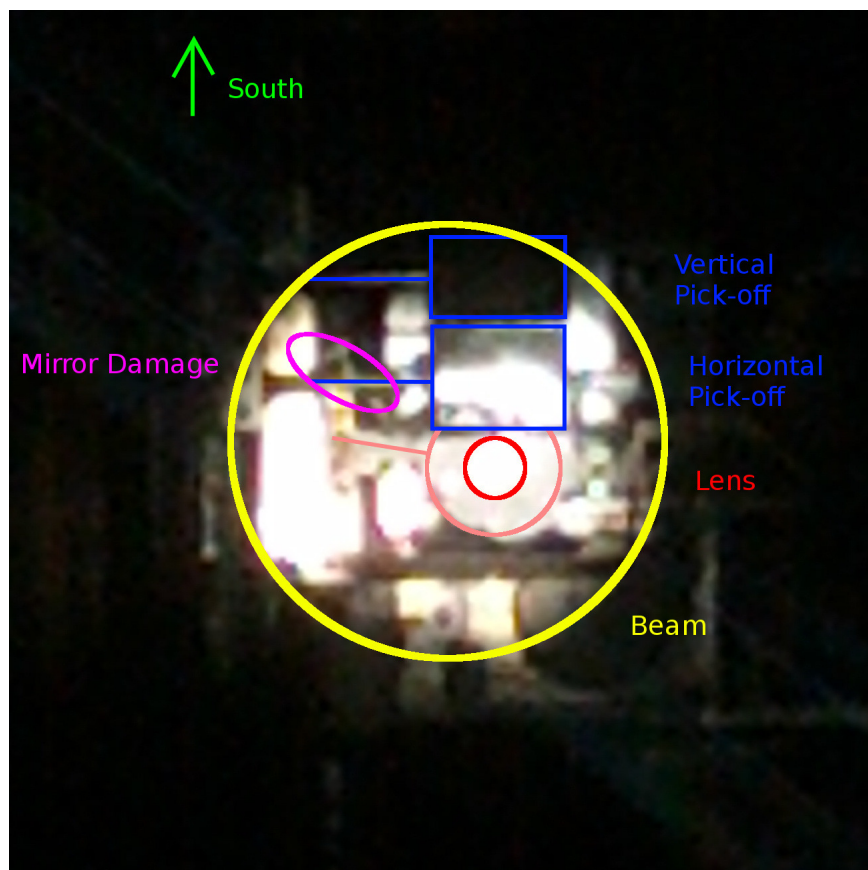
By looking down the tower from the top of the shaft, it is possible to see where the beam of light is falling at the bottom. The beam is currently not correctly centered on the objective lens, figure 1. It is biased to the south-east. The bias to the south is good because it means our pick-off mirrors are closer to the center of the beam. The bias to the east is not good, and the beam needs to be moved west to become more central. However, this can not be done because it would put the damaged part of the mirror directly over the area picked off by our mirrors.

In any case, it appears our pick-off mirrors are well illuminated. The beam would have to drift a long way for our spectrometer to experience vignetting. No adjustment to the guider-head position was made. This could be revisited once the first-flat has been repaired, and some improvement then made to the beam position.

Figure 1: Beam position, looking down the tower shaft.

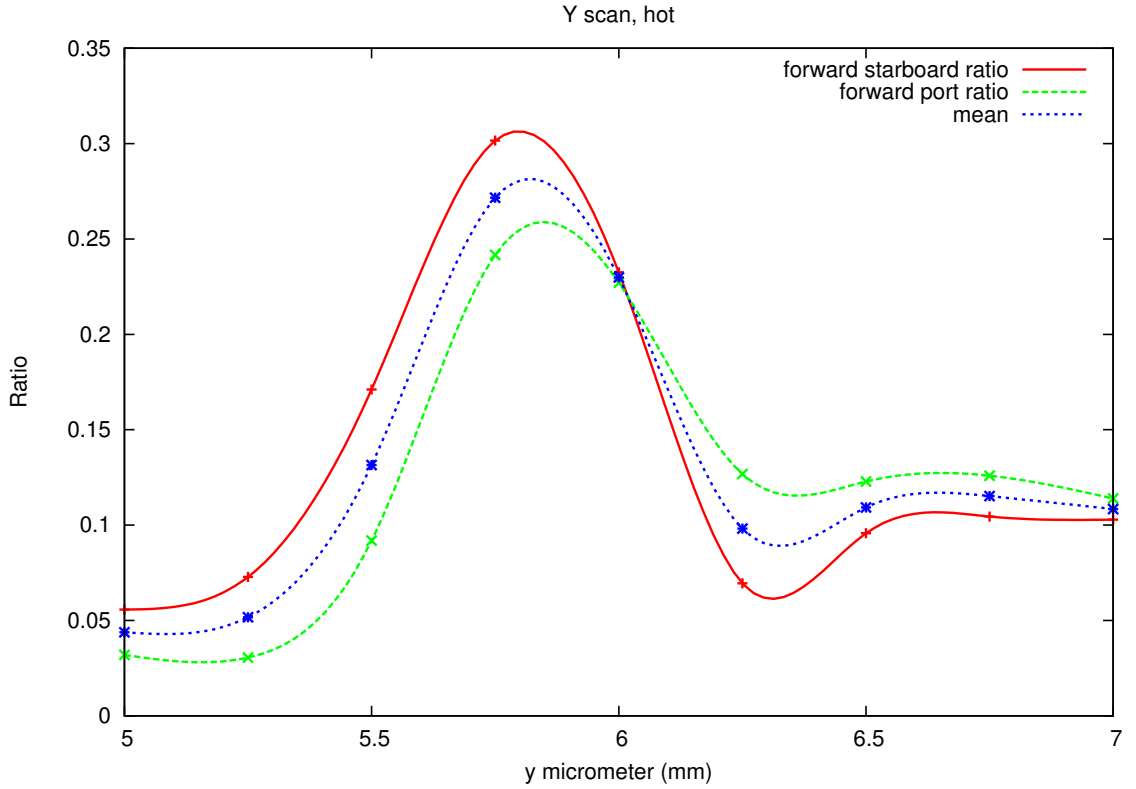
Later, a more quantitative alignment was performed by scanning the fifth-mirror in 0.25 mm increments and plotting the resulting data. These plots are shown in figures 2, 3, 4, and 5. These plots suggest that the basic alignment was almost perfect, with only a small change required on the x-micrometer.

The final settings were confirmed as 9.15 mm on the x-micrometer, and 5.85 mm on the y-micrometer. It is suggested that the basic visual alignment is sufficient for future trips.

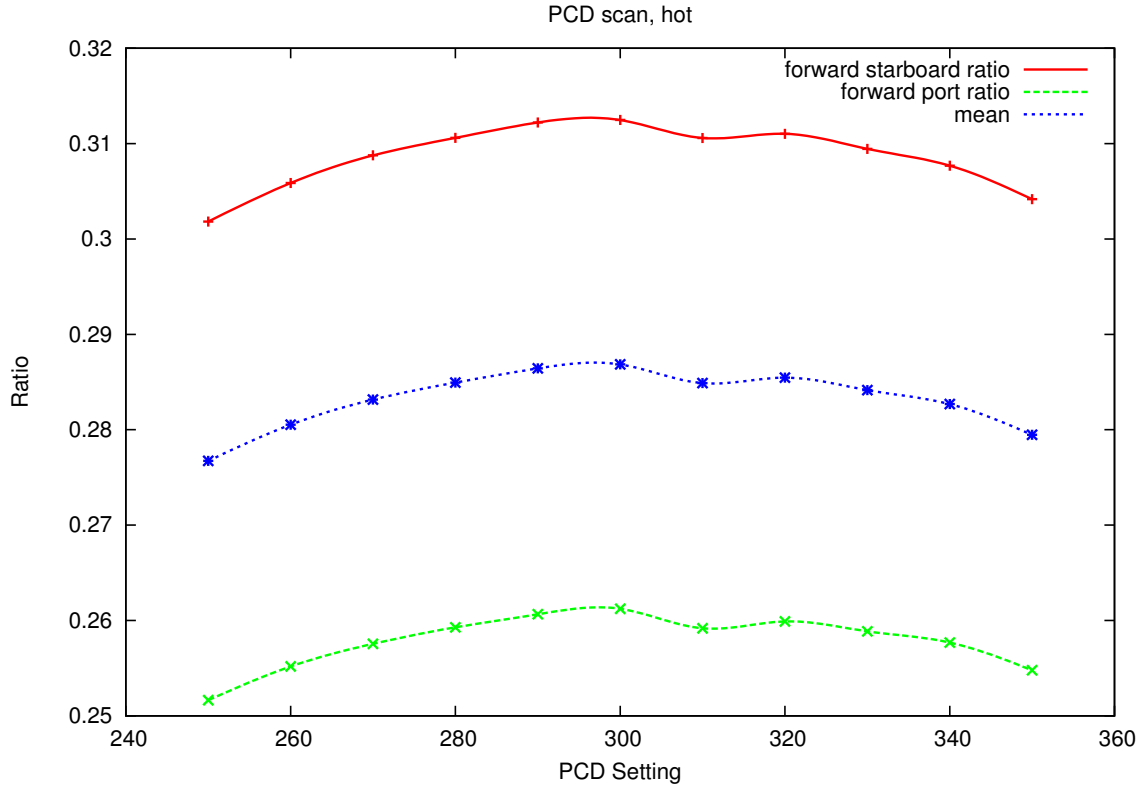
The initial dial setting was 330 units on the front of the PCD. This was swept in increments of 10 units and the ratio plotted against these values. The result is shown in figure 6.

There was unfortunately some brief intermittent cloud during this test, which explains the slight drop-out for the 310 unit value. Nevertheless, it is clear that the optimum ratio is found at the slightly reduced power setting of 300 units.

The final setting was confirmed as 300 units on the dial.

Figure 6: Pockels' Cell Driver Power Setting
