Autoguider repairs at Mount Wilson in 2014 April

TECHNICAL REPORT NO. 365

Steven J. Hale

2014 May 23

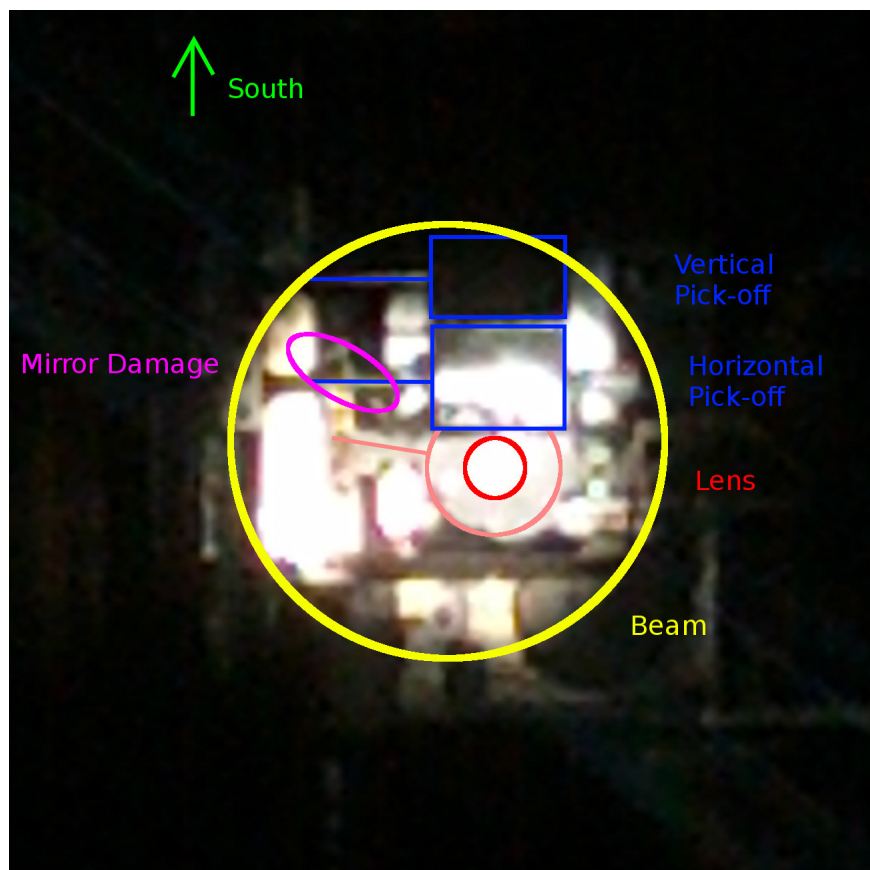
By looking down the tower from the top of the shaft, it is possible to see where the beam of light is falling at the bottom. The beam is currently not correctly centered on the objective lens, figure 1. It is biased to the south-east. The bias to the south is good because it means our pick-off mirrors are closer to the center of the beam. The bias to the east is not good, and the beam needs to be moved west to become more central. However, this can not be done because it would put the damaged part of the mirror directly over the area picked off by our mirrors.

In any case, it appears our pick-off mirrors are well illuminated. The beam would have to drift a long way for our spectrometer to experience vignetting. No adjustment to the guider-head position was made. This could be revisited once the first-flat has been repaired, and some improvement then made to the beam position.

Figure 1: Beam position, looking down the tower shaft.

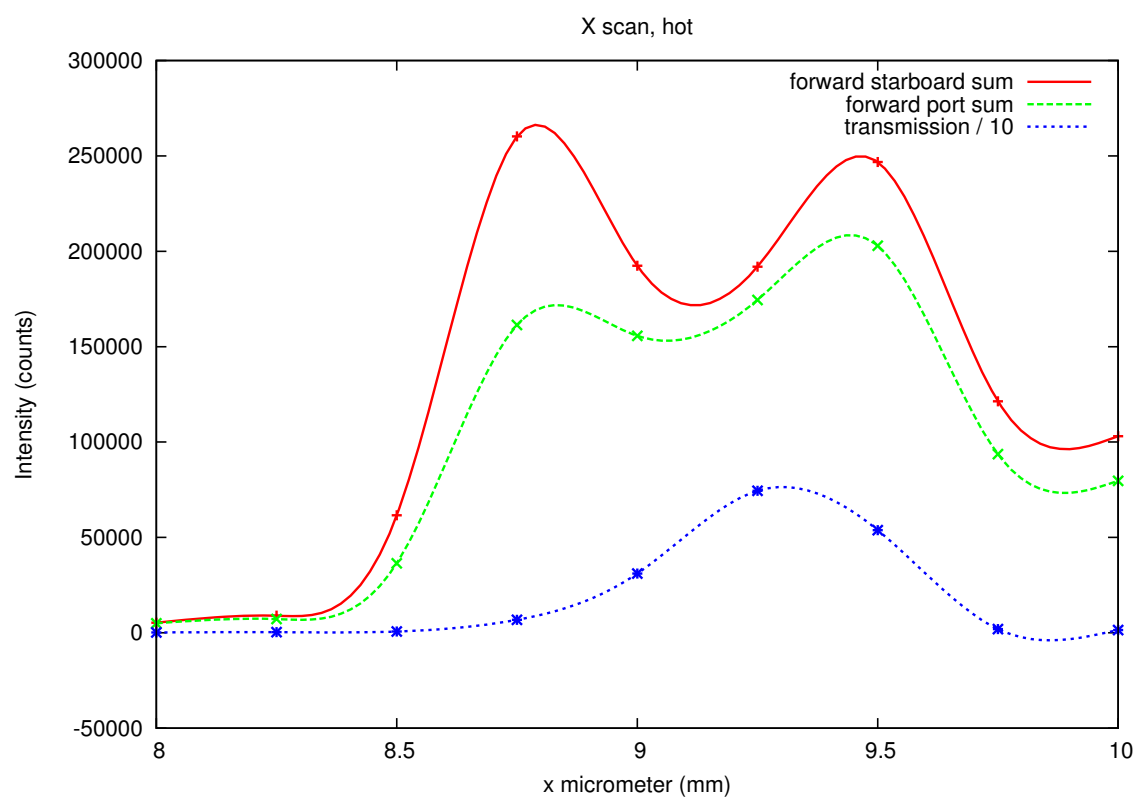
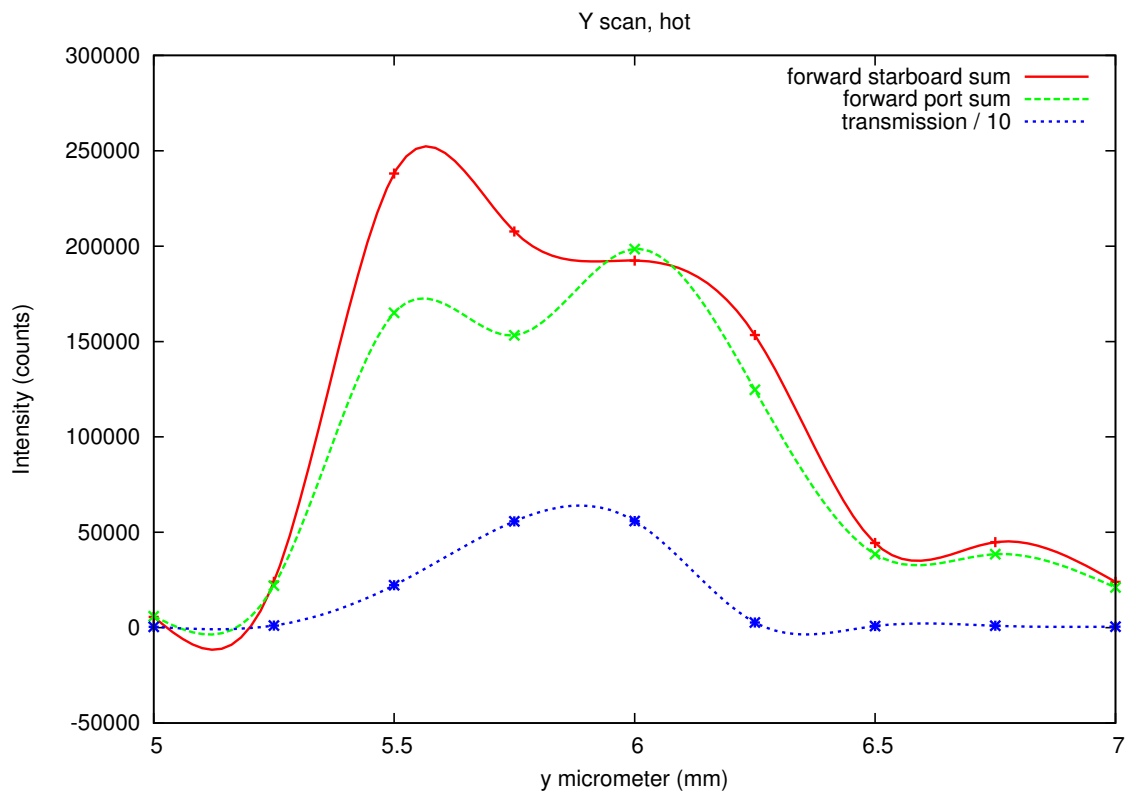
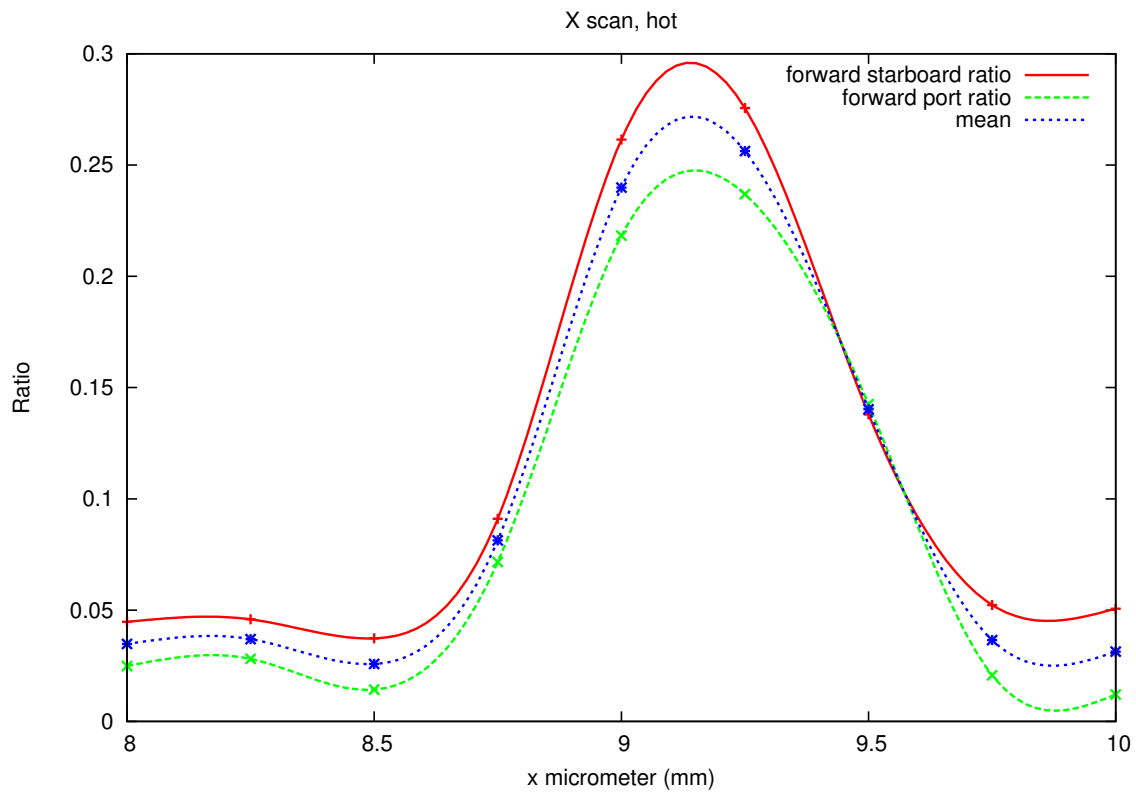
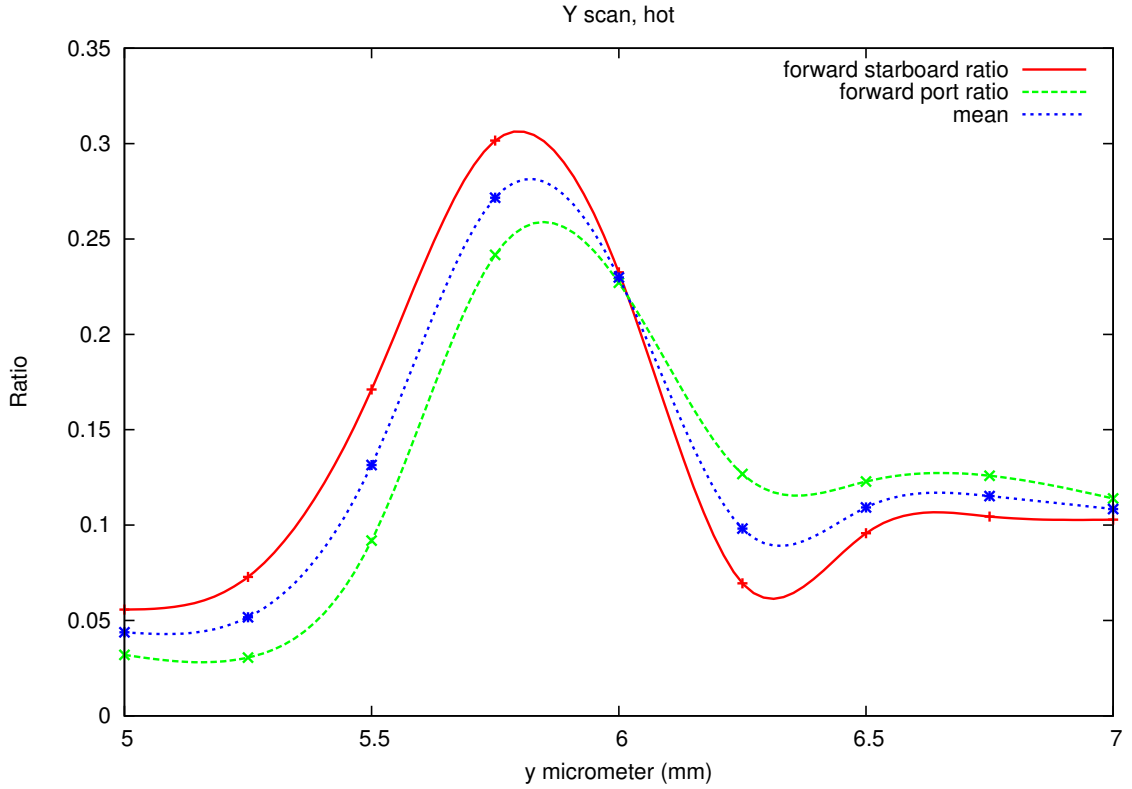
Later, a more quantitative alignment was performed by scanning the fifth-mirror in 0.25 mm increments and plotting the resulting data. These plots are shown in figures 2, 3, 4, and 5. These plots suggest that the basic alignment was almost perfect, with only a small change required on the x-micrometer.

The final settings were confirmed as 9.15 mm on the x-micrometer, and 5.85 mm on the y-micrometer. It is suggested that the basic visual alignment is sufficient for future trips.

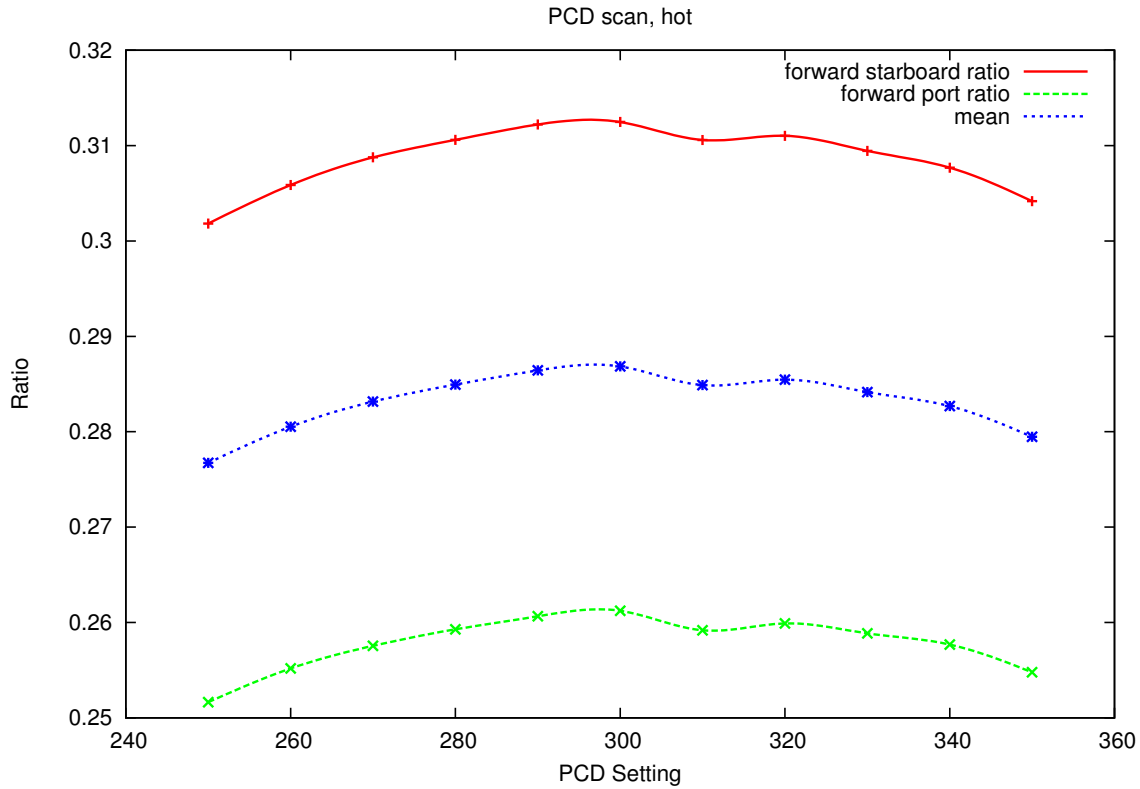
Figure 6: Pockels' Cell Driver Power Setting

The initial dial setting was 330 units on the front of the PCD. This was swept in increments of 10 units and the ratio plotted against these values. The result is shown in figure 6.

There was unfortunately some brief intermittent cloud during this test, which explains the slight drop-out for the 310 unit value. Nevertheless, it is clear that the optimum ratio is found at the slightly reduced power setting of 300 units.

The final setting was confirmed as 300 units on the dial.
