Framing Failures in Wood-Frame Hip Roofs under Extreme Wind Loads

Sarah A. Stevenson¹, Gregory A. Kopp^{1*} and Ayman M. El Ansary²

Wood-frame residential roof failures are among the most common and expensive types of wind damage. Hip roofs are commonly understood to be more resilient during extreme wind in relation to gable roofs. However, inspection of damage survey data from recent tornadoes has revealed a previously unstudied failure mode in which hip roofs suffer partial failure of the framing structure. In the current study, evidence of partial framing failures and statistics of their occurrence are explored and discussed, while the common roof design and construction practice are reviewed. Two-dimensional finite element models are developed to estimate the element-level load effects on hip roof trusses and stick-frame components. The likelihood of failure in each member is defined based on relative demand-to-capacity ratios. Trussed and stick-frame structures are compared to assess the relative performance of the two types of construction. The present analyses verify the common understanding that toenailed roof-to-wall connections are likely to be the most vulnerable eleme

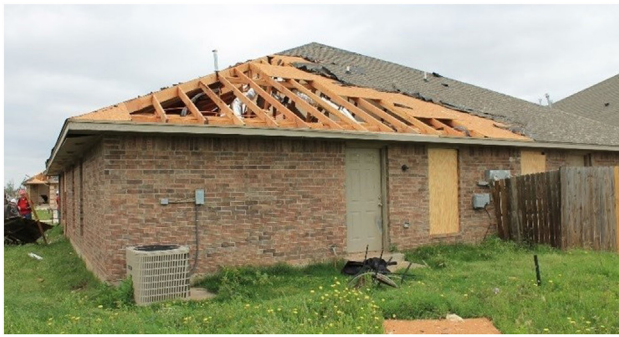
Figure 1 shows an example of typical sheathing failure, and **Figure 2** shows failure of the RTWC. As mentioned, most past research on roof damage focuses on these two failure modes. It is apparent that the wind speed estimates for roof damage in the EF-Scale are heavily based on these well-understood modes. Although DOD-6 encompasses all possible modes of major roof failures, a review of the available literature shows that the current understanding of DOD-6 is limited to research focused on RTWC failures. DOD-6 can occur at an expected wind speed of 122 mph (**Table 1**). This wind speed corresponds to relatively weak EF2 tornadoes (Wind Science and Engineering Centre, 2006). DOD-4 occurs at lower wind speeds. Gable roofs have been observed to

FIGURE 1 | Example of roof sheathing failure, corresponding to DOD-4 (image source: Dr. David Prevatt of University of Florida).

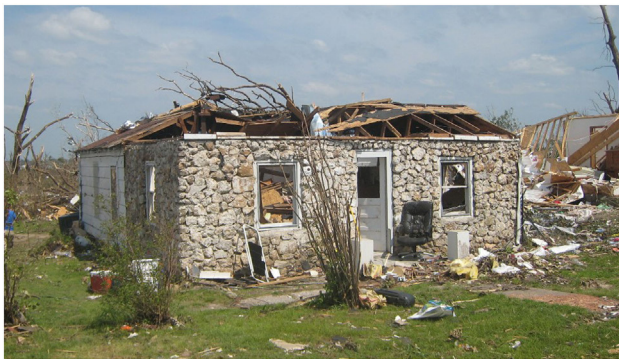
The shift in occurrence of certain failure modes between the two regions may be the result of several factors; however, it is noted that many of the houses in Region 2 appeared to be of older construction than those in Region 1 and had lower-sloping roofs. While this observation may suggest that roof slope contributes to the occurrence of framing failures, it is not apparent what other factors may have had an additional impact. For example, the lack of lateral restraint in older houses may have led to increased occurrence of wall collapse. In the example shown in **Figure 6**, partial roof-framing failure occurred. However, this failure may have occurred due to the tree debris visible on top of the failed roof. Other instances of partial failure in Region 2 are similarly

FIGURE 6 | Partial hip roof failure in Region 2 (image source: Dr. David Prevatt).

ambiguous, and because Region 2 was downwind of Region 1, debris likely played a larger role. In any case, in both regions, partial failures are found to occur at least as often as other modes of roof failure. More work is required to obtain a complete set of statistics on these failures and better define the regional conditions that may contribute to their occurrence.

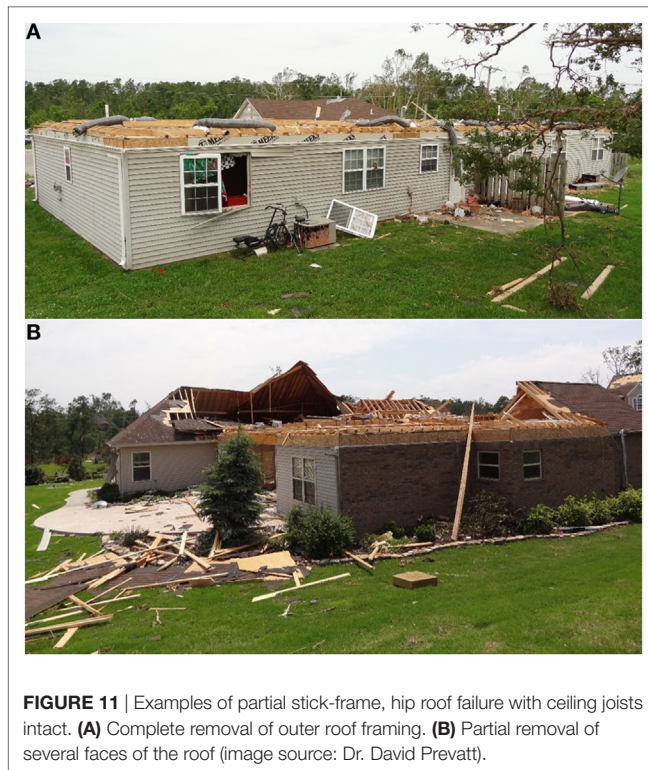
In Figure 11, partial framing failure and removal of large sections of the roof appears to have occurred. Upon closer inspection, however, it becomes apparent that the ceiling joists and the ceiling beneath them are intact. Only the external rafters and attached sheathing have been removed or damaged. Based on the results of the D/C analysis for the stick-frame case, this type of failure is unlikely, due to the relatively robust connection between the rafter and the ceiling joist. The RTWC and the connection along the ridge of the roof appear to be much more vulnerable in analysis, in comparison to the seven-nail joint previously mentioned. The pictured failures may have occurred due to improper or missing fasteners between the rafter and the joist at the wall top plate or initiated as failure of the upper rafter joint. Additionally, system effects may have led to progressive, cascading failure of adjacent

joints, resulting in removal of entire faces of the roof following initiation at a single point.

As mentioned, the D/C analysis for the stick-frame case did not predict that the rafter-to-wall connection would be vulnerable due to its relatively robust connection to the ceiling joist. According to the rafter capacity calculations, the rafter-to-top plate connection should have a capacity of 5,000 N, resulting in a D/C ratio of 0.2. Closer inspection of the photos suggests that there were nailed connections at the ends of the intact joists; however, it does not appear that there were more than a few nails. Keeping in mind that these houses were not designed to the same codes as the hypothetical roof in the present study, exploration of regional prescriptive design requirements in the US is required to determine whether these connections are meant to include more nails.

The failures shown in **Figure 11**, and many other similar failures, are interesting because they would be objectively classified within DOD-6 for residential roofs; however, this may be an inaccurate assumption. This is an important point for further exploration because it may influence refinements to the EF-Scale for different residential design methods, or even suggest a new DOD for stick-frame structures.
