Framing Failures in Wood-Frame Hip Roofs under Extreme Wind Loads

Sarah A. Stevenson¹, Gregory A. Kopp^{1*} and Ayman M. El Ansary²

Wood-frame residential roof failures are among the most common and expensive types of wind damage. Hip roofs are commonly understood to be more resilient during extreme wind in relation to gable roofs. However, inspection of damage survey data from recent tornadoes has revealed a previously unstudied failure mode in which hip roofs suffer partial failure of the framing structure. In the current study, evidence of partial framing failures and statistics of their occurrence are explored and discussed, while the common roof design and construction practice are reviewed. Two-dimensional finite element models are developed to estimate the element-level load effects on hip roof trusses and stick-frame components. The likelihood of failure in each member is defined based on relative demand-to-capacity ratios. Trussed and stick-frame structures are compared to assess the relative performance of the two types of construction. The present analyses verify the common understanding that toenailed roof-to-wall connections are likely to be the most vulnerable eleme

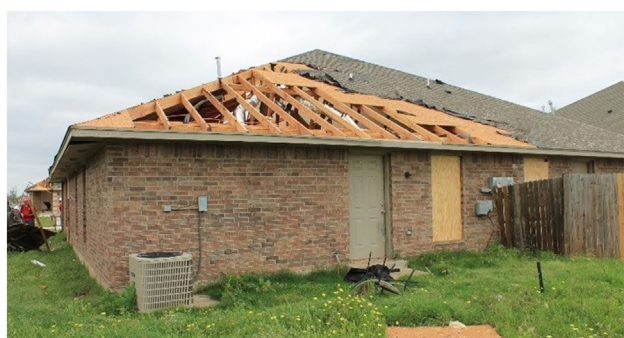
Figure 1 shows an example of typical sheathing failure, and **Figure 2** shows failure of the RTWC. As mentioned, most past research on roof damage focuses on these two failure modes. It is apparent that the wind speed estimates for roof damage in the EF-Scale are heavily based on these well-understood modes. Although DOD-6 encompasses all possible modes of major roof failures, a review of the available literature shows that the current understanding of DOD-6 is limited to research focused on RTWC failures. DOD-6 can occur at an expected wind speed of 122 mph (**Table 1**). This wind speed corresponds to relatively weak EF2 tornadoes (Wind Science and Engineering Centre, 2006). DOD-4 occurs at lower wind speeds. Gable roofs have been observed to

FIGURE 1 | Example of roof sheathing failure, corresponding to DOD-4 (image source: Dr. David Prevatt of University of Florida).

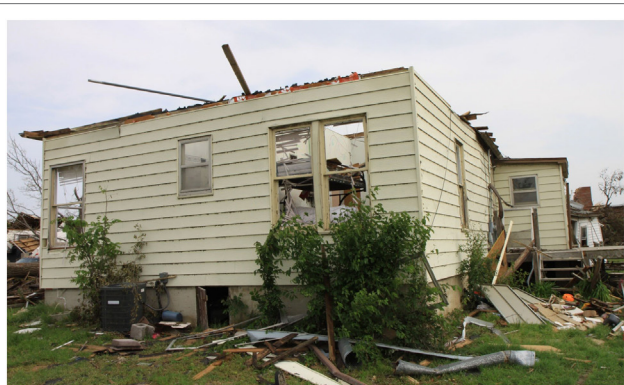
FIGURE 2 | Example of roof-to-wall-connection failure, corresponding to DOD-6 (image source: Dr. David Prevatt).

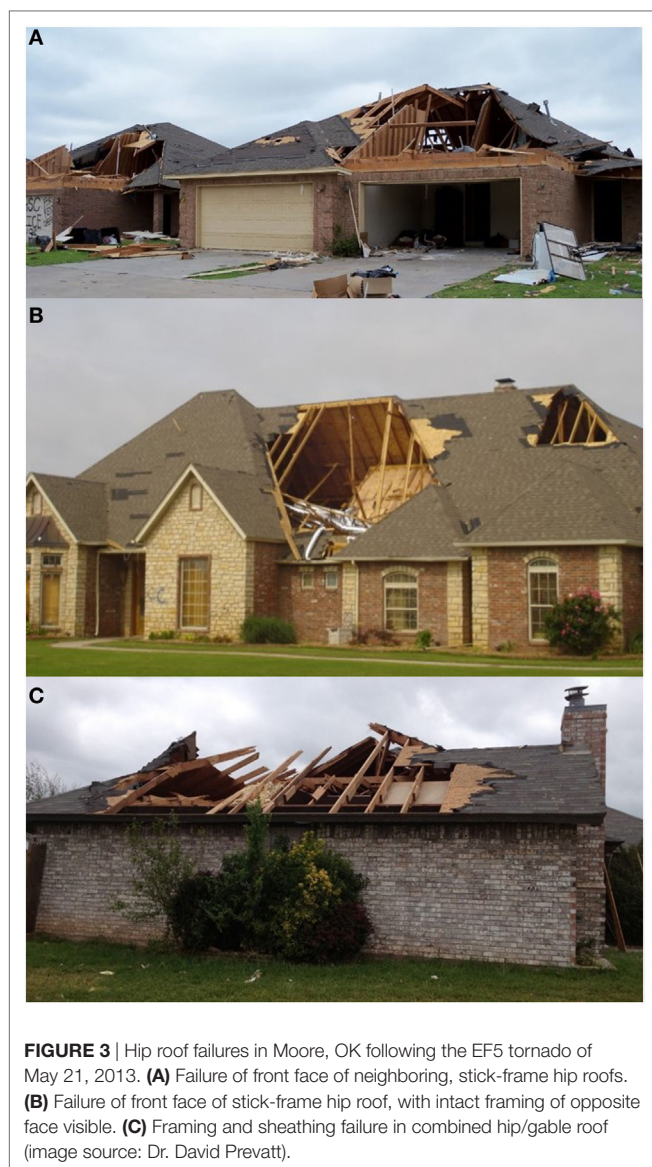
Figure 3A shows neighboring hip-roofed homes that exhibit similar failures of the front face of the roof. The RTWCs appear to be intact around the remaining perimeter of the roof and it is apparent that several members of the roof frame have failed or been removed, in addition to the sheathing covering this portion. At the right side of the photo, the remaining part of the roof is sagging, which further indicates that the underlying frame has failed. The houses shown in **Figure 3A** were located along Kyle Drive at the western edge of Moore, OK. Several houses along this short stretch had similar failures of hip roof framing and were built around 2006 (Graettinger et al., 2014). Inspection of the damage photos from this neighborhood indicate that, of houses experiencing DOD-4 or DOD-6 roof damage, 40% appeared to have failed through similar partial failures. In these cases, it appears that the frame failed at the nailed connections between the members, as no broken lumber is visible. The following section will present additional statistics and observations from two selected neighborhoods following the Joplin, MO tornado.

Figure 3B shows a failure similar to that in **Figure 3A**, but of a much steeper roof. The RTWCs appear to be intact, and a large open cavity is visible where both framing members and sheathing have been removed. Similar to **Figure 3A**, it is apparent that this roof did not exclusively suffer sheathing loss, although the smaller area of sheathing loss at the right side of the photo should be noted. The lack of visible internal members in the cavity, especially those supporting the intact opposite face of the roof, strongly suggest that this roof was built as a stick-frame structure as opposed to the one containing prefabricated trusses. Many of the failed hip roofs in the available data appear to have used stick framing.

Figure 3C shows a partial failure of a combined hip/gable roof. This failure is unique from those shown in **Figures 3A,B** because material failure of the wood members is apparent. The RTWCs appear to be intact, with the lower part of the

roof having lost only sheathing on the right side and framing members, in addition to sheathing, on the left. Near the peak of the roof, the frame has failed on both faces. This structure appears to contain either trusses or stick framing with robust connections. As indicated in the figure just above the RTWC, the members were connected or otherwise reinforced using nailed wooden plates.

Upon inspection of the failures shown in **Figure 3** and similar damage in the available photos, it becomes apparent that partial framing failures are possible, repetitive modes of failure occurring in hip roofs. When comparing these hip roof failures to nearby structures from the data, it was determined that framing failures may govern in some hip roofs at EF2 wind speeds, rather than RTWC failures or sheathing loss. It is also noted that the construction of the roof may be important. The observed stick-frame failures especially suggested that the performance of stick-frame roofs should be distinguished from that of trussed structures in analysis and design, as well as in the present research.

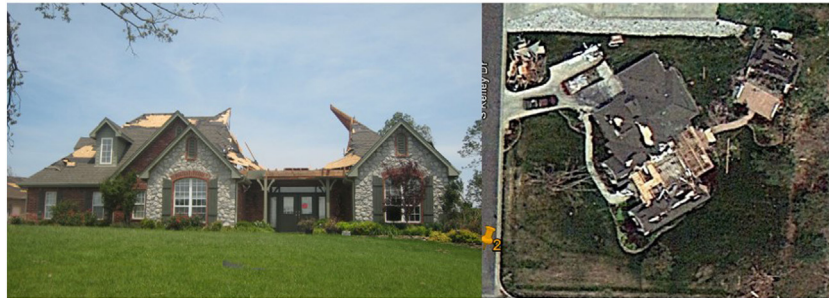
of failure of the RTWC. **Figure 5** shows an example of the steep-sloping hip roofs visible throughout this neighborhood, with an aerial image showing how the surface area of the roof was affected by the failure. In many instances, the largest surfaces of the roof were removed, while parts of the structure enclosing smaller spaces remained in place. Many of these structures also appeared to be of stick-frame construction.

FIGURE 5 | Example of typical hip roof failure in Region 1, including an aerial photo showing the footprint of the partial failure (image source: Dr. David Prevatt, Google Earth).

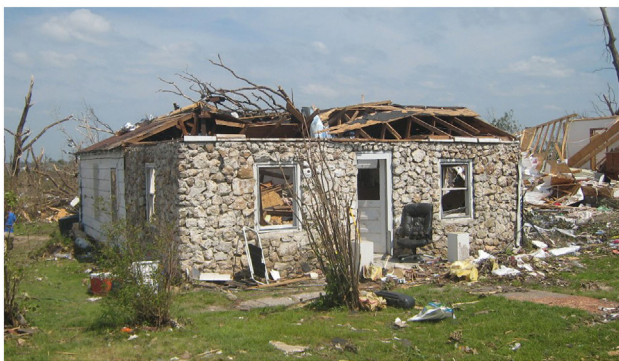
FIGURE 6 | Partial hip roof failure in Region 2 (image source: Dr. David Prevatt).

ambiguous, and because Region 2 was downwind of Region 1, debris likely played a larger role. In any case, in both regions, partial failures are found to occur at least as often as other modes of roof failure. More work is required to obtain a complete set of statistics on these failures and better define the regional conditions that may contribute to their occurrence.

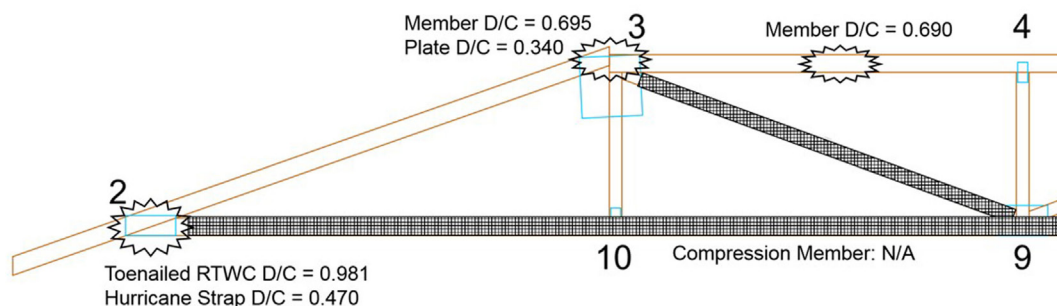
to the present finding. It is expected that toenailed RTWCs will almost always fail first in the plane truss case. However, this conclusion does not hold true in the case where hurricane straps are employed at the RTWC. In this case, the D/C ratio of the hurricane strap RTWC is 0.470, which is compared again to the 0.695 D/C in the top chord. Application of even the most basic hurricane strap could shift failure into the framing components of the truss.

FIGURE 10 | Schematic of failure locations in the truss, based on results of the demand-to-capacity (D/C) analysis.

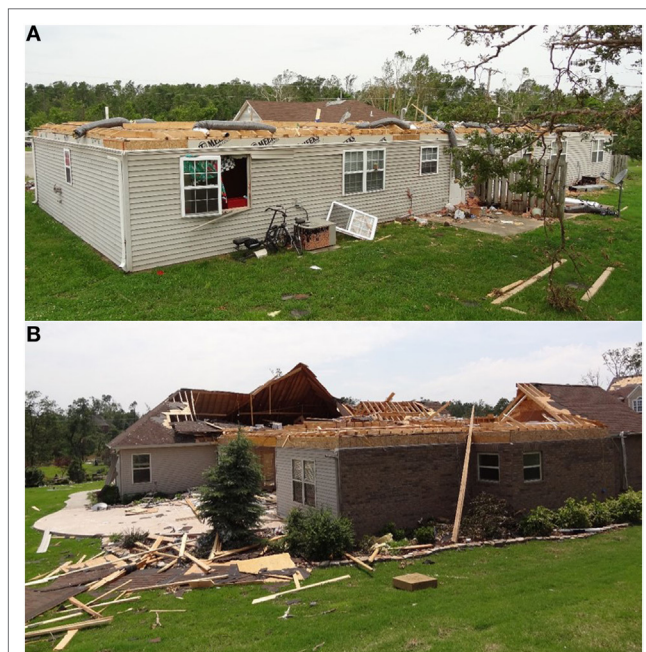
In Figure 11, partial framing failure and removal of large sections of the roof appears to have occurred. Upon closer inspection, however, it becomes apparent that the ceiling joists and the ceiling beneath them are intact. Only the external rafters and attached sheathing have been removed or damaged. Based on the results of the D/C analysis for the stick-frame case, this type of failure is unlikely, due to the relatively robust connection between the rafter and the ceiling joist. The RTWC and the connection along the ridge of the roof appear to be much more vulnerable in analysis, in comparison to the seven-nail joint previously mentioned. The pictured failures may have occurred due to improper or missing fasteners between the rafter and the joist at the wall top plate or initiated as failure of the upper rafter joint. Additionally, system effects may have led to progressive, cascading failure of adjacent

FIGURE 11 | Examples of partial stick-frame, hip roof failure with ceiling joists intact. **(A)** Complete removal of outer roof framing. **(B)** Partial removal of several faces of the roof (image source: Dr. David Prevatt).

joints, resulting in removal of entire faces of the roof following initiation at a single point.

The failures shown in **Figure 11**, and many other similar failures, are interesting because they would be objectively classified within DOD-6 for residential roofs; however, this may be an inaccurate assumption. This is an important point for further exploration because it may influence refinements to the EF-Scale for different residential design methods, or even suggest a new DOD for stick-frame structures.
