# The Installation of New Temperature Controllers at Narrabri in 2010 February

TECHNICAL REPORT NO. 332

2010 November 9

Details of the trip to Narrabri in 2010 February are presented.

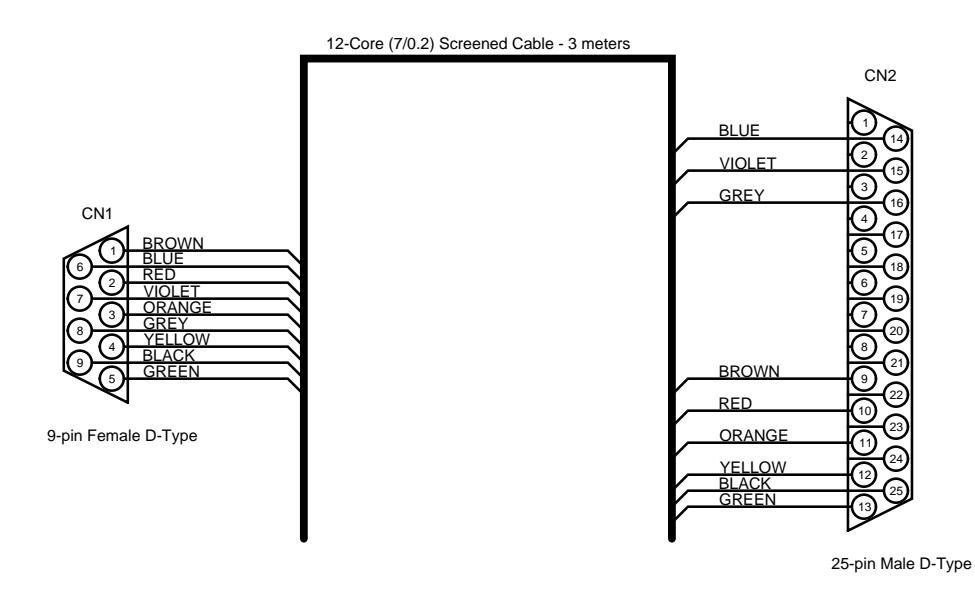
Figure 1: The Mains Controller Cable.

The Mains Controller Cable connects the Mains Controller to the DIO Splitter Card. Figure 1 shows the cable that is used in Narrabri.

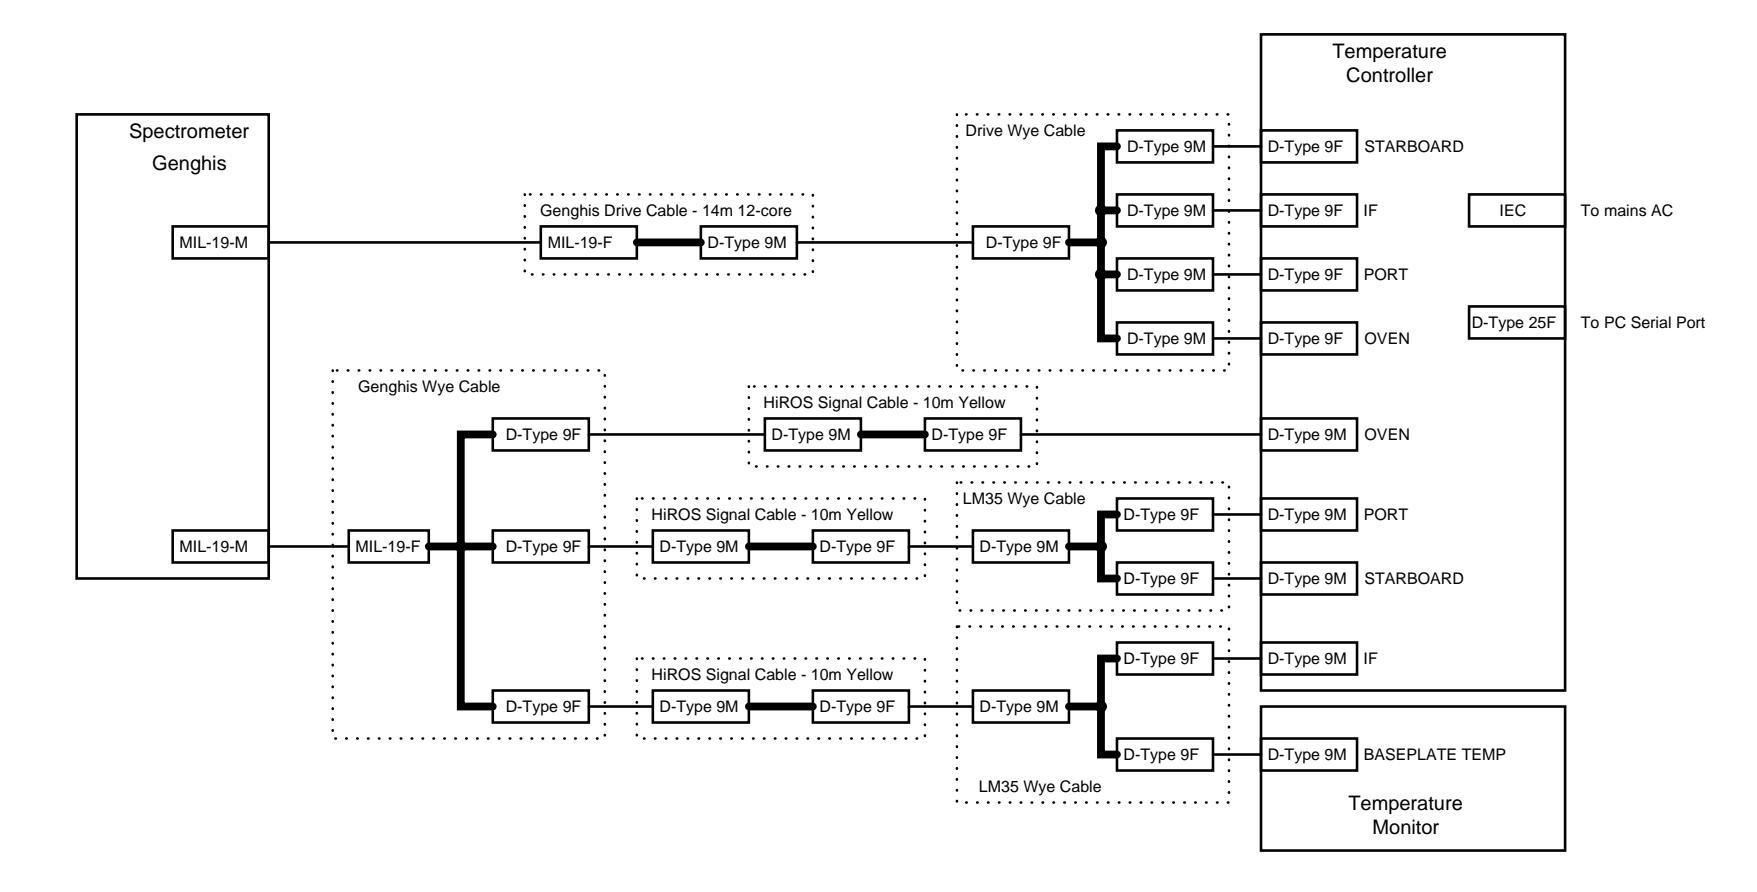
Figure 2: The Narrabri temperature controller system.

With the installation of the new temperature controllers there would also be changes necessary to the temperature monitor. The new temperature controller system is shown in Figure 2.

During the setup of the temperature controllers it was spotted that the power required to keep the port and starboard detectors at the required set-point of 20°C was very different. By switching off the temperature control and allowing the detection to settle at the ambient temperature, it was found that there was a 1.5°C offset between the two temperature sensors in the detectors. To match the powers required by both detectors, the set point of the port detector was increased to 21.5°C to compensate for the offset.

The power to maintain these setpoints was putting the Peltiers on maximum cool and so the detector temperatures were increased again to 23°C for starboard and 24.5°C for port.

It would be better to apply an offset to the temperature reading for the port detector to make it match the starboard detector, assuming that they are both actually at the same temperature. Unfortunately it is not simple since the temperature controller offset option is applied directly the ADC counts, and not after they have been scaled to temperature.

An offset of -210208 counts was applied to the port detector in *zoo.conf*, and the setpoint of both detectors reset to 23°C. The power required to maintain this temperature was now the same in both detectors.

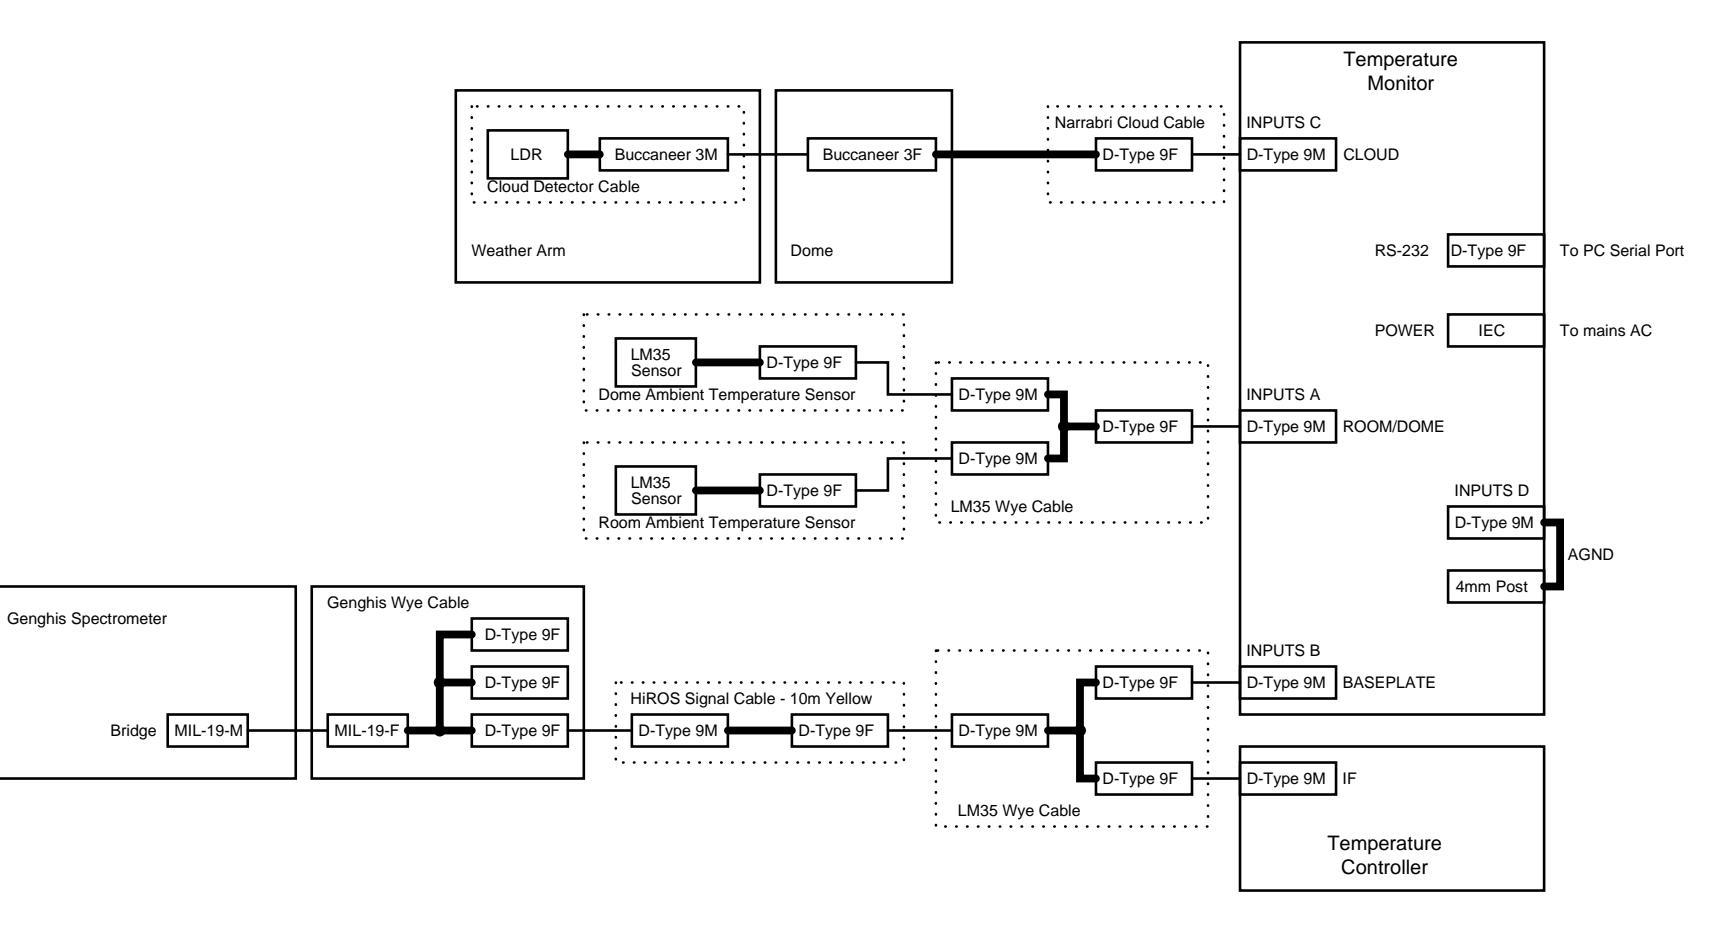
Figure 3: The Narrabri temperature monitor system.

The room and dome temperatures are measured using LM35 temperature sensor ICs on long cables. The spectrometer baseplate temperature comes from within the spectrometer down one of the cables going to the temperature controllers. The system diagram for the re-configured temperature monitor in Narrabri is shown in Figure 3.

Usually the output from the LM35 sensors is fed into an amplifier stage contained on an LM35 board within the temperature monitor main unit. Unfortunately the Narrabri unit does not have an LM35 board inside it and so the LM35s had to be connected directly to the ADC. This meant a loss of resolution but at least the temperatures could still be measured.

The temperature monitor hardware has undergone several hardware revisions since the Narrabri unit was built. Given the lack of the LM35 board and the fact that the cloud detector interface is on veroboard it is strongly recommended that the temperature monitor here gets replaced on the next visit.

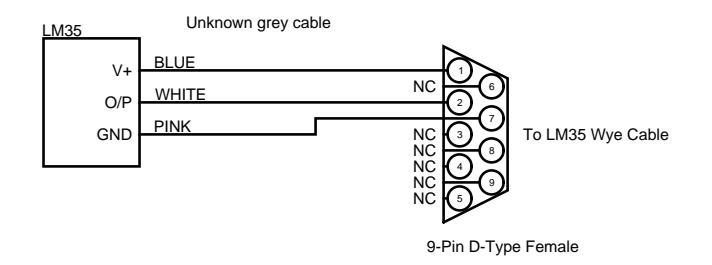
Figure 4: The Narrabri temperature probes.

Also the existing wiring for the LM35 temperature probes was found to be incorrect and used non-standard cable. The probes were re-wired and the wiring is shown in Figure 4.

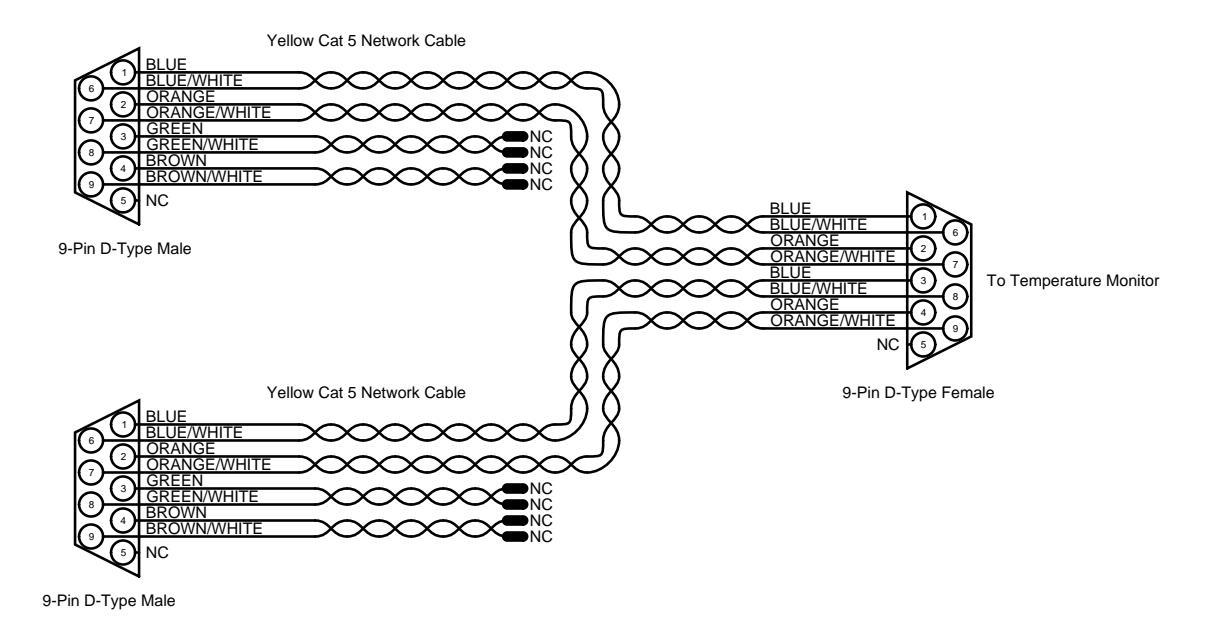
Figure 5: The LM35 wye cable.

In order to combine the room and dome temperatures to use a single connector on the rear of the temperature monitor an LM35-Wye cable was used. The LM35-Wye cable is shown in Figure 5.
