Wind Turbine Tower Collapse Cases: A Historical Overview

Y. Ma, P. Martinez-Vazquez, C. Baniotopoulos

School of Engineering, University of Birmingham, Edgbaston B15 2TT, Birmingham, United Kingdom

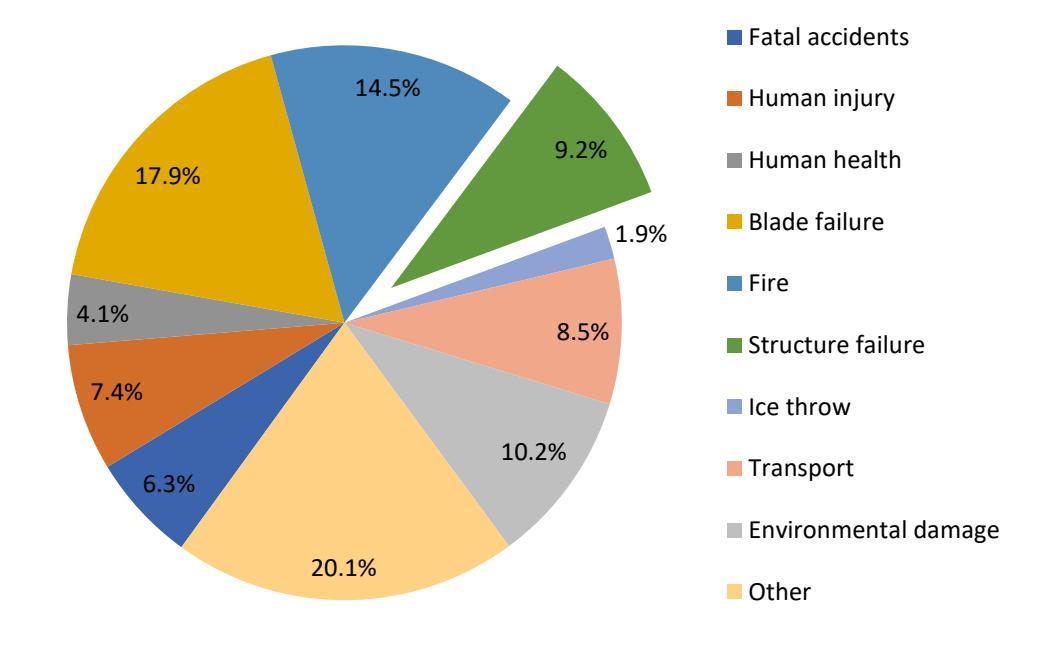
To date, a fair amount of wind turbine accidents are still recorded each year whilst the rate of occurrence over the last 20 years has increased. A report of Caithness Windfarm Information Forum (CWIF) revealed that in the past four decades and till 31 Dec 2016, there were 1,999 wind power plant accidents among which 126 were classified as fatal (CWIF, 2017). Fig. 1 shows that blade failure accumulates the largest number of incidents accounting for 17.9% of the total, followed by fire which accumulates 14.5%. Structural failure, including tower collapse and turbine damage, is the fourth largest type in the list accumulating 9.2% of the overall toll.

Fig. 1 shows that blade failure concentrates the maximum percentage of collapse cases, arguably due to the fact that this failure type often derives in chain reactions. Blades are made up of composite fibre having stable performance against aerodynamic forces although depending highly on the quality of their manufacturing. Blades may deform flapwise or be subject to significant lagged and torsional deformations, hence exhibiting ductile performance. Their connection components however tend to be exposed to large deformation occurring at high rates over time which makes them susceptible to fracture (Hau, 2013).
