Analysis of the failure of a PPS polymer cycling support:

Marsh, Joseph; Turner, Richard; Wang, Minshi; Jenkins, Michael

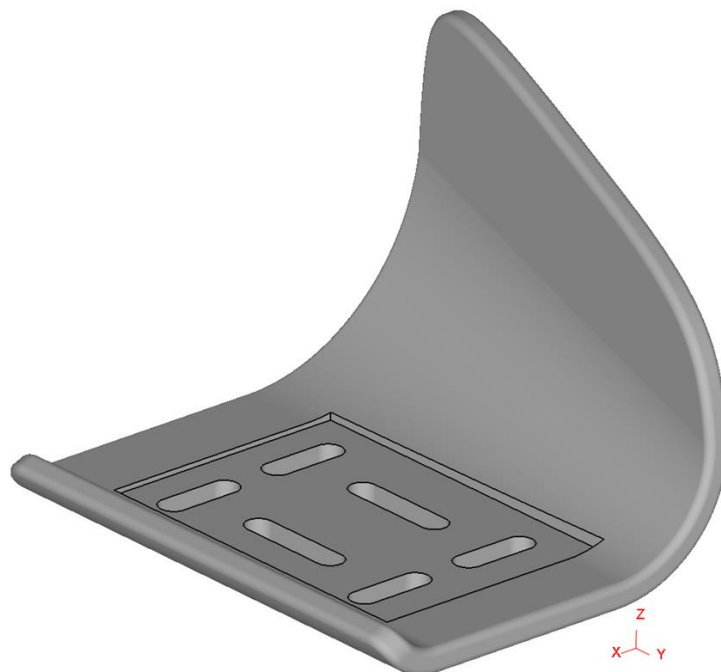
Figure 1: CAD imaged model of the arm rest component

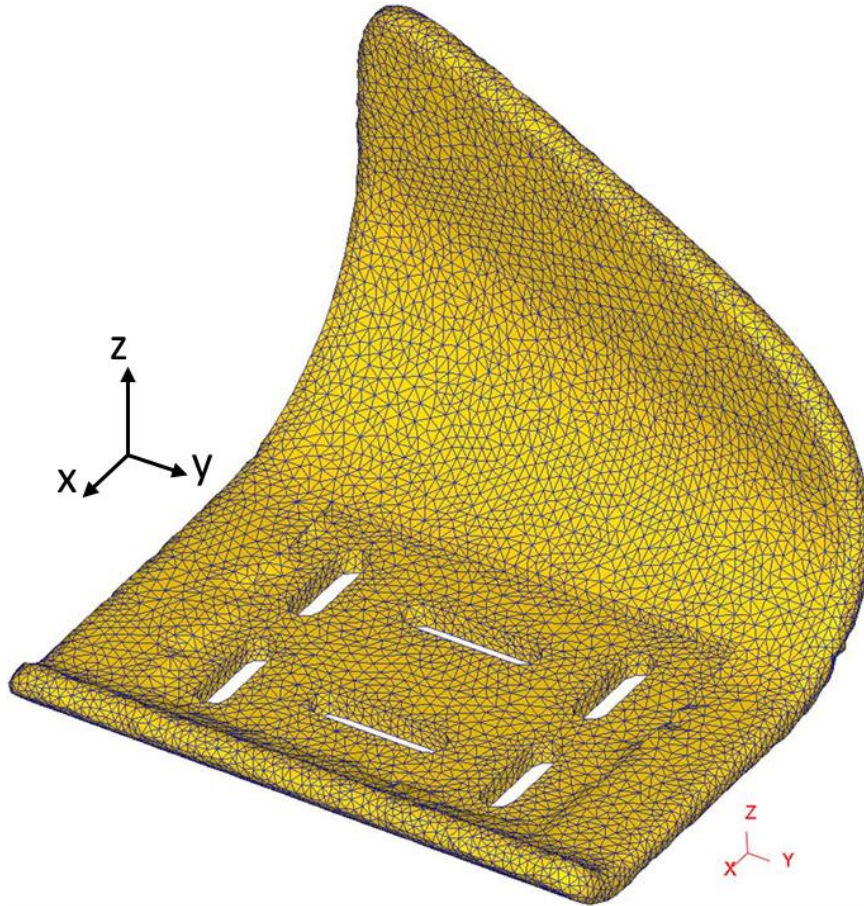
Figure 5: The cycling support arm-rest component, imported in to FE software Deform v11.1 and meshed with the automatic meshing tool

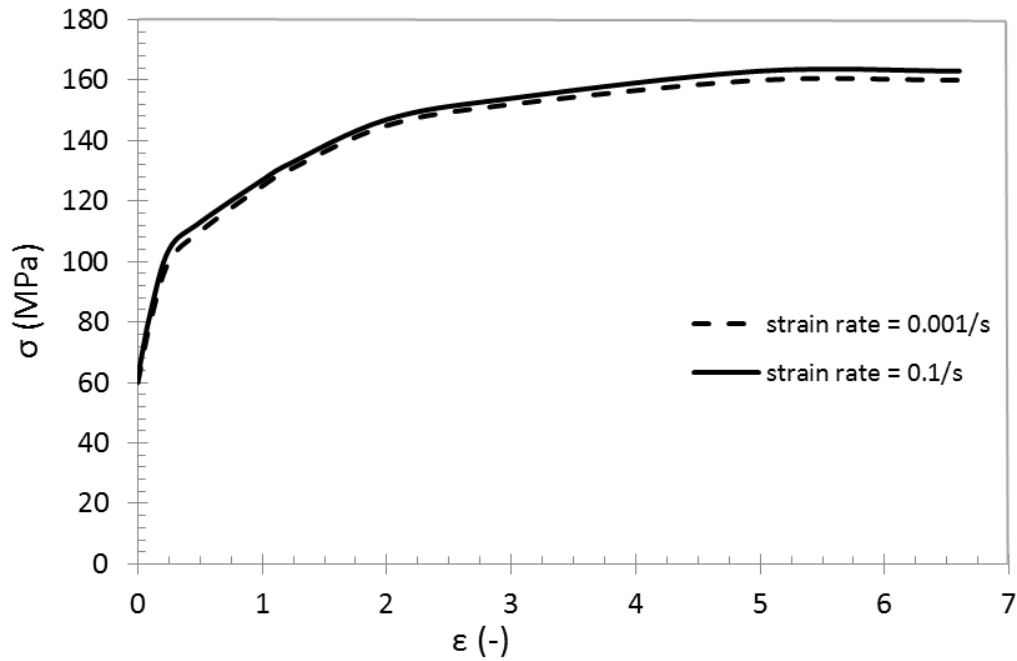
Figure 6: Stress-strain graph of PPS GF30 at a strain rate of 0.001 and 0.1/s
