1 **Experimental study on the effectiveness of strengthening over-** 2 **deformed segmental tunnel lining by steel plates**

9 **Abstract:** The method of using steel plates to strengthen existing tunnel linings has been widely
10 applied in many tunnel rehabilitation projects around the world. However, the effectiveness of the
11 strengthening resulting from this method is still unclear, especially for conditions when the
12 segmental linings are deformed to a relatively large extent. In this paper, a series of physical model
13 tests conducted in 1-g plane strain conditions were designed to study the strengthening
14 effectiveness of steel plates for over-deformed segmental tunnel linings. The results show that the
15 segmental tunnel linings affected by the ground surface surcharge will deform nonlinearly, as the
16 complex behaviour of the segment joints at different positions lead to a gradual degradation of the
17 tunnel overall performance. Once the deformed segmental tunnel linings were strengthened by
18 steel plates, the stiffness and capacity of the tunnel were improved by 190% and 69%, respectively,

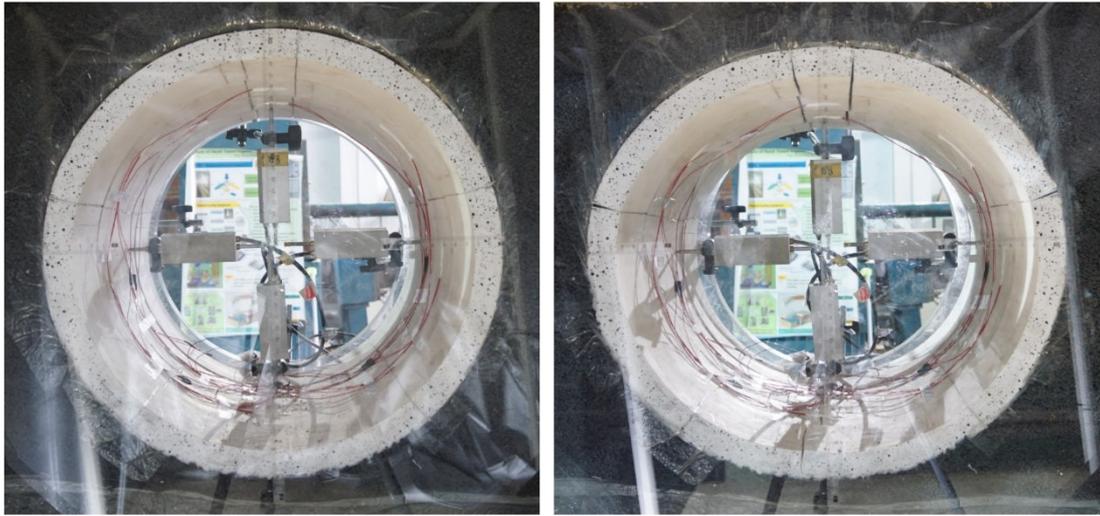
Figure 11 Photographs of the tunnel without strengthening (a) the initial tunnel profile; (b) the damaged tunnel profile

236 The test No. 1 was conducted on a tunnel without strengthening. The tunnel profiles before and
237 after loading are shown in Fig. 11 (a) and (b), where the overall shape of tunnel changed from a
238 circle to an oval as the applied load increased. It was observed that the tunnel crown went
239 downwards and the lining expanded horizontally at the spring-line. The relative deformation
240 increased at larger rate as the surcharge increased. Joint opening was observed during the test,
241 with the joints near the tunnel crown opening inwards, while the joints near the tunnel spring-line
242 opening outwards. A creak broke through the lining segment near the tunnel invert at end of the
243 test.

298 shown in Fig. 15 (b), where severe damage of tunnel lining and a significant debonding at tunnel-
299 steel interface can be observed. In contrast, the tunnel without steel plates deformed gradually
300 without a sudden failure as the surcharge load increased (as seen in Fig. 11).

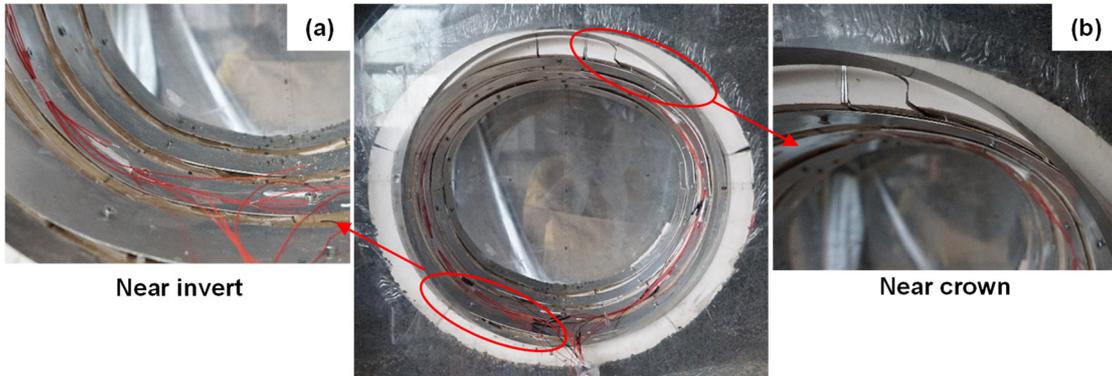
Figure 16 Detailed features of the debonding failure of the strengthened segmental linings, (a) the interface near the tunnel invert, (b) the interface near the tunnel crown

301 Some details of the strengthened tunnel after the occurrence of strengthening failure are shown in
302 Fig. 16. Debonding failure occurred at the interface between the tunnel lining and the steel plate in
303 the ranges $20\sim 50^\circ$ and $200\sim 230^\circ$ (clockwise from the tunnel crown), where a thin layer of gypsum
304 attached to aluminum plates was detached from the segment surface. A significant shear crack
305 throughout the segment was observed near tunnel crown where the debonding failure occurs, this
306 is because the sudden interface failure resulted in a sharp increase in the shear force within the
307 lining segment. It should be noted that, the interface conditions at the positions near the tunnel
308 spring-line were still well-bonded.
