2nd CIRP Conference on Surface Integrity (CSI)

The effect of cutting speed and feed rate on hole surface integrity in single-shot drilling of metallic-composite stacks

Experimental work was carried out to evaluate the influence of cutting speed (Ti/CFRP/Al: 30/120/120 and 36/144/144m/min) and feed rate (0.05, 0.08, 0.12 and 0.15mm/rev) on workpiece surface integrity following single-shot drilling of multilayer metallic-composite stacks (Ti-6Al-4V/CFRP/Al-7050) using CVD diamond coated tooling. When operating with the lower cutting speed set of 30/120/120m/min and a feed rate of 0.08mm/rev, average hole surface roughness (Ra) was ~ 0.60, 0.87 and 0.27µm in the Ti, CFRP and Al layers respectively after 30 holes. Roughness values in the stack increased to 0.84, 1.6 and 0.43µm Ra when employing the higher cutting speed of 36/144/144m/min, with the drill lasting only 20 holes. Microhardness depth profile evaluation of the machined surfaces showed no appreciable variation in both the Ti and Al material, irrespective of cutting conditions. Matrix cracking and burn were apparent in the CFRP layer as feed rate increased due to greater wear of the drill corner.

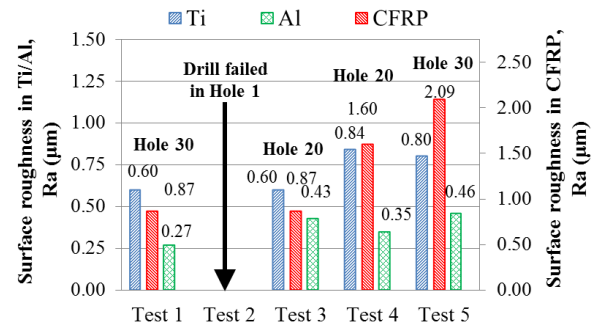
Fig. 2. Hole surface roughness in each material at last hole drilled

maximum flank wear criterion. Fig. 2 details surface roughness results measured at the last hole drilled for all tests. Under the low speed/intermediate feed rate regime (Test 1), average hole roughness in the Ti, CFRP and Al sections at test cessation was 0.60, 0.87 and 0.27 µm Ra respectively. Equivalent values for the Ti and CFRP layers were obtained in Test 3 after 20 holes, when operating at the higher cutting speed of 36/144/144 m/min and lower feed rate of 0.05mm/rev. The Ra in the Al section however was ~ 59% higher.

Increasing feed rate from 0.05 to 0.12mm/rev (at 36/144/144 m/min cutting speed) led to a ~ 140% rise in average hole surface roughness within the CFRP section, which was ~ 2.09µm Ra in Test 5 at hole 30. In terms of the Ti layer, roughness was 40% higher when operating at 0.08mm/rev compared to 0.05mm/rev, but remained approximately stable despite a further increase in feed rate to 0.12mm/rev. In contrast, no clear trend was apparent in the Al sections due to changes in feed rate, with the surface roughness varying between 0.35 and 0.46µm Ra.

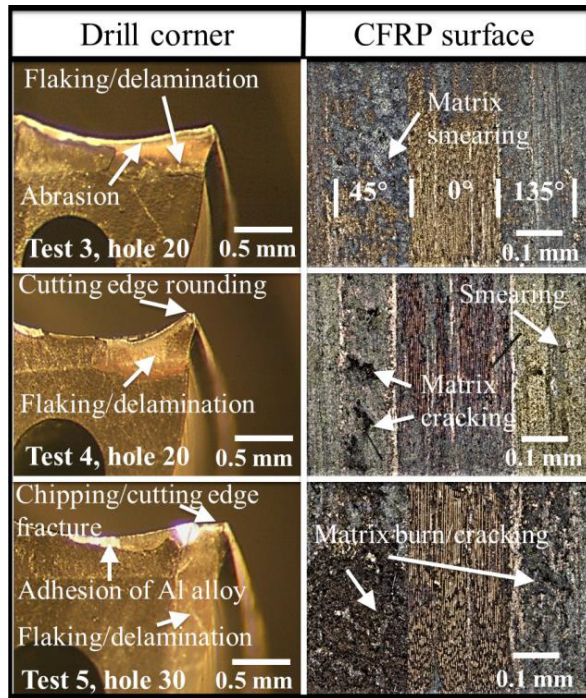
Fig. 3. Wear micrographs of drill corner and corresponding CFRP surface at last hole drilled in Tests 3, 4 and 5

The principal wear mode of the drills was flaking/delamination of the CVD diamond coating, irrespective of operating parameters. This was observed primarily on the tool flank face near the peripheral corners as well as at the chisel point. Micrographs of the worn CVD diamond coated drills for trials undertaken at the higher cutting speed level (Tests 3, 4, 5) together with corresponding hole surfaces in the CFRP section of the stack are shown in Fig. 3. Rapid abrasion of the exposed WC substrate was also prevalent in all tests, which increased cutting edge rounding and the corner radius of the drill. Wear was generally more severe at higher feed rates, with gross fracture of the chisel point occurring in Test 4 (0.08mm/rev) and chipping/fracture of the peripheral corner in Test 5 (0.12mm/rev). No significant wear/damage however was seen at the chisel section of the drill employed in Test 5 even after 30 holes, see Fig. 4, which was possibly due to the shorter tool-workpiece interaction time. Evidence of workpiece adhesion on the cutting edges was however visible.

Smearing of melted epoxy resin was the primary damage mode observed on the surface of the CFRP layer after 20 holes when drilling with the lowest feed rate of 0.05mm/rev, see Fig. 3. Greater deterioration of the workpiece surface occurred as feed rate increased, with matrix cracking and burning evident in the last holes drilled for Tests 4 and 5 respectively, which explains the surface roughness results detailed previously in Fig. 2. This was possibly due to the higher cutting temperatures generated from the increased feed rate and tool wear levels. No signs of grooves or significant material loss however were detected in any of the samples evaluated. In addition, defects were generally most severe in the 135° ply positions, as shown in the high resolution SEM micrograph and corresponding 3D topographic map (1.25 x 0.5mm scan area near the centre of the hole) of the machined surface (hole 30, Test 5) in Fig. 5.

Fig. 7(a) and 7(b) detail cross-sectional micrographs of the machined Ti and Al subsurface respectively from the last hole drilled in Test 5. No appreciable change in material microstructure was visible in both workpiece samples, despite chipping of the peripheral drill corner (Fig. 3). This was representative of results seen in the other trials.

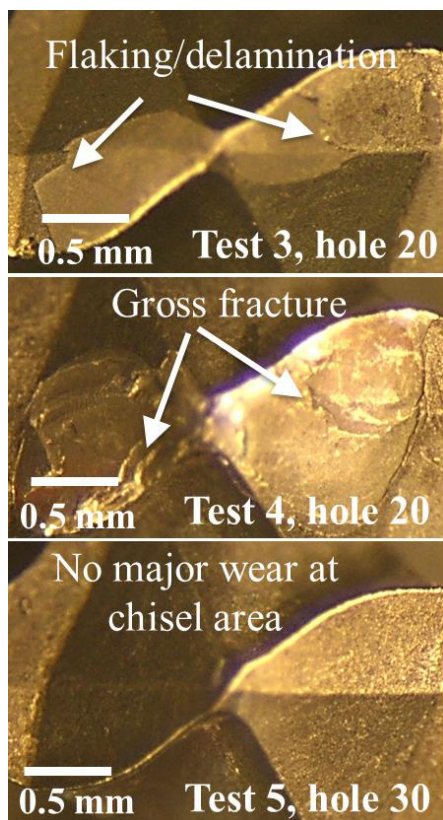
Fig. 4. Micrographs of worn drill chisel section in Tests 3, 4 and 5

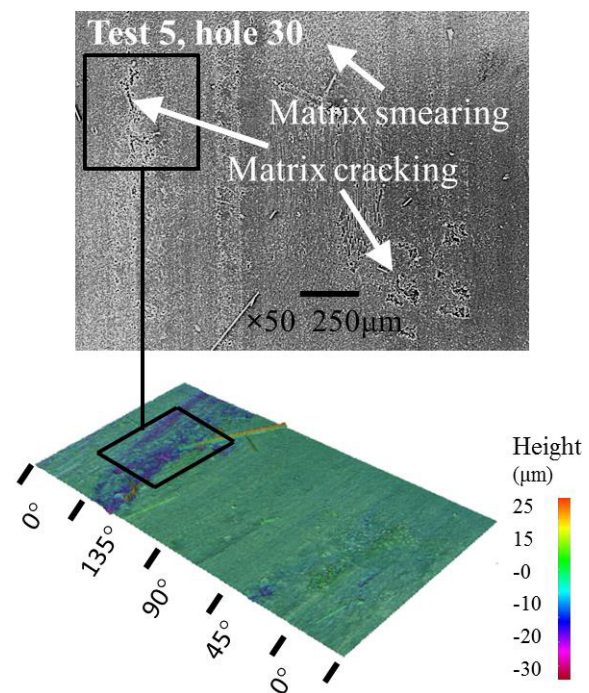
Fig. 5. SEM micrograph and 3D topographic map of CFRP hole surface in Test 5

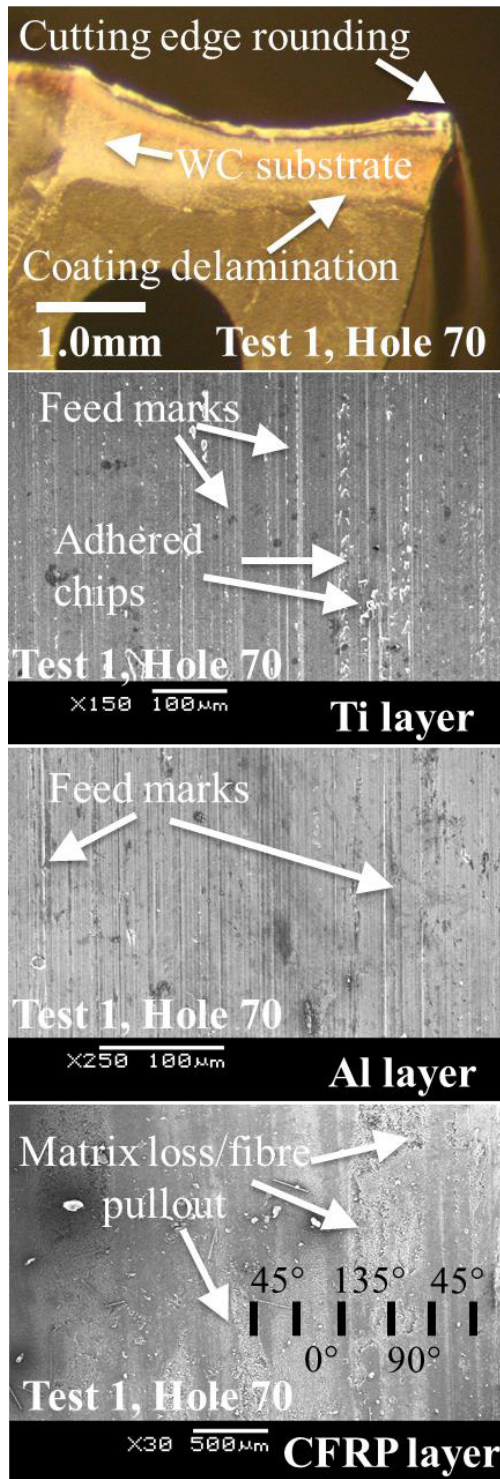
Fig. 6. Wear micrograph of the drill used in Test 1 and SEM images of the machined surfaces in each layer of the stack in hole 70

Test 1 was subsequently extended to 70 holes in order to investigate drill wear progression and its consequent influence on workpiece integrity. Fig 6 shows a micrograph of the drill after hole 70 together with associated SEM images of the machined surfaces in each material layer. Flank wear increased to ~1mm with near complete delamination of the coating from the cutting edge. Evidence of sporadic re-deposited chips was seen on the surface of the Ti layer while the Al section appeared to be relatively free of major flaws. In contrast, the highly worn drill caused substantial degradation of

the CFRP surface, with gross fibre loss and matrix pullout particularly at the 45°, 90° and 135° orientated plies.

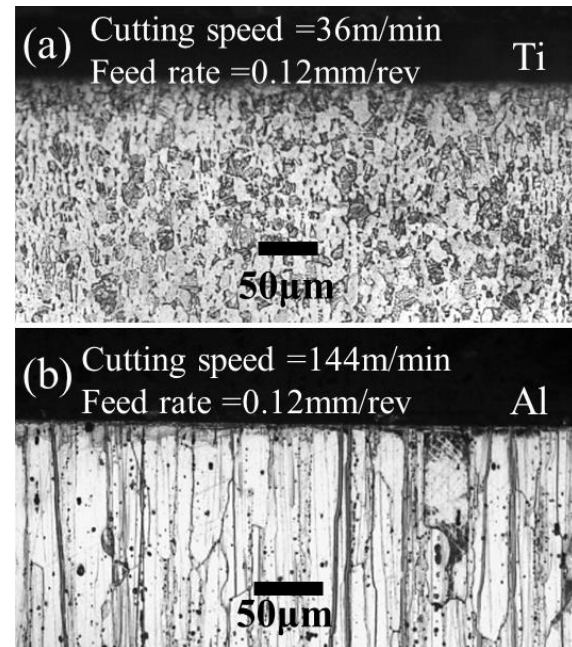
Fig. 7. Cross-sectional micrographs of the machined (a) Ti; (b) Al layers for last hole drilled in Test 5

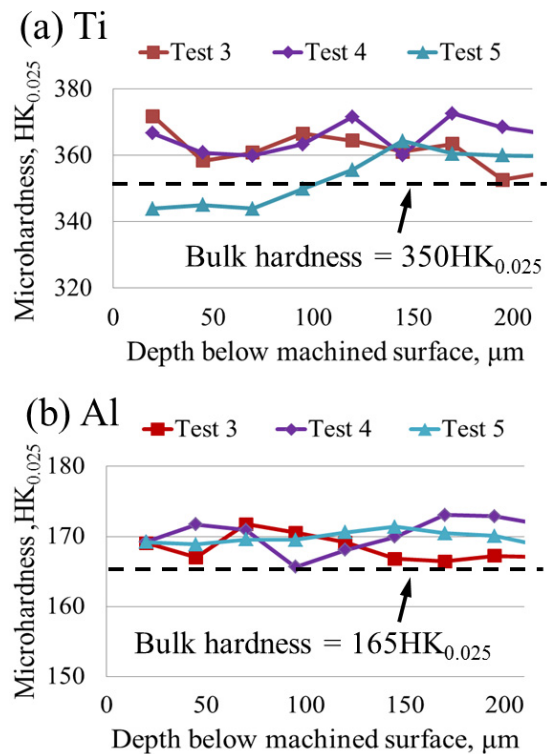
Fig. 8. Microhardness depth profile at test cessation when drilling at 36/144/144m/min cutting speed in (a) Ti; (b) Al layers

Fig. 8 details microhardness depth profiles of both the Ti and Al layers at the last hole drilled for Tests 3, 4 and 5 (cutting speed of 36/144/144m/min). No significant variation in microhardness was observed for the Ti layer in any of the trials evaluated; see Fig 8(a). This was despite measured thrust forces showing a rise of ~ 41% (~690 vs. 980N) as feed rate was increased from 0.05 to 0.12 mm/rev. Corresponding torque values ranged between ~2.3 and 3.6Nm at test cessation. Similarly, an analysis of the Al sections revealed no substantial changes in subsurface microhardness due to changes in feed rate; see Fig. 8(b). Here, thrust forces and torque for the last hole drilled varied from ~278 to 410N and ~0.75 to 1.3Nm respectively, as feed rate increased from 0.05 to 0.12mm/rev. The results suggest that neither strain hardening nor thermal softening played a major role.
