Cavitation erosion resistance and wear mechanisms of active screen low temperature plasma nitrided AISI 410 martensitic stainless steel

CAVITATION EROSION RESISTANCE AND WEAR MECHANISMS OF ACTIVE SCREEN LOW TEMPERATURE PLASMA NITRIDED AISI 410 MARTENSITIC STAINLESS STEEL

Quenched and tempered AISI 410 martensitic stainless steel specimens were active screen plasma nitrided in a mixture of 75 % of nitrogen and 25 % of hydrogen during 20 hours at 400 °C. The microstructure of the nitrided case was characterized by optical microscopy, scanning electron microscopy and microhardness measurements. The phases were identified by X-ray diffraction and the nitrogen content as a function of depth was measured using wavelength dispersive X-ray spectrometer coupled to SEM. Nanoindentation tests were carried out in order to assess hardness (H), Young modulus (E), H/E and H^3/E^2 ratios and the elastic recovery (W_e) of the nitrided layer. Cavitation erosion tests were carried out according to ASTM G32 standard during 20 hours, with periodical interruptions for registering the mass losses. Additional cavitation erosion tests were performed to identify the wear mechanisms in both specimens, thro

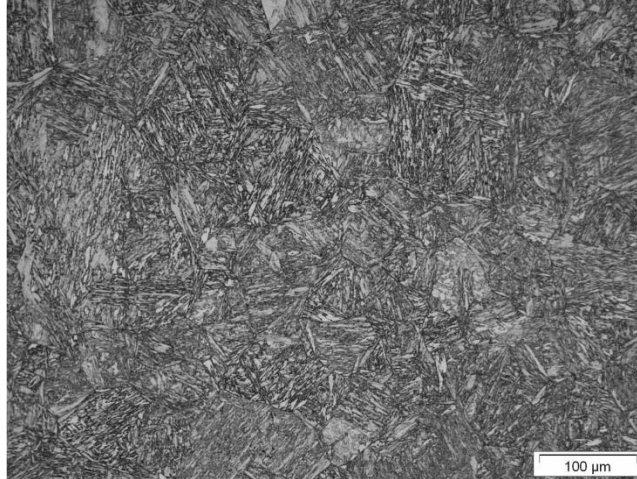
Figure 1 shows the microstructure of the quenched and tempered AISI 410, it can be seen that the microstructure is composed of tempered lath martensite as expected for the heat treatments conducted in this stainless steel. The average microhardness was 387 ± 7 HV0.01.

Figure 1 Quenched and tempered AISI 410 containing tempered lath martensite. OM image.

The active screen technique avoided crack formation and the massive precipitation of big iron nitrides observed in the first 5 μm deep region of the nitrided case obtained through conventional DC low temperature plasma nitriding of AISI 410, reported in a former work [5]. In addition, the microstructure of the nitrided case, shown in figure 3, remains almost the same in comparison with the original microstructure of the quenched and tempered AISI 410, shown in figure 1.

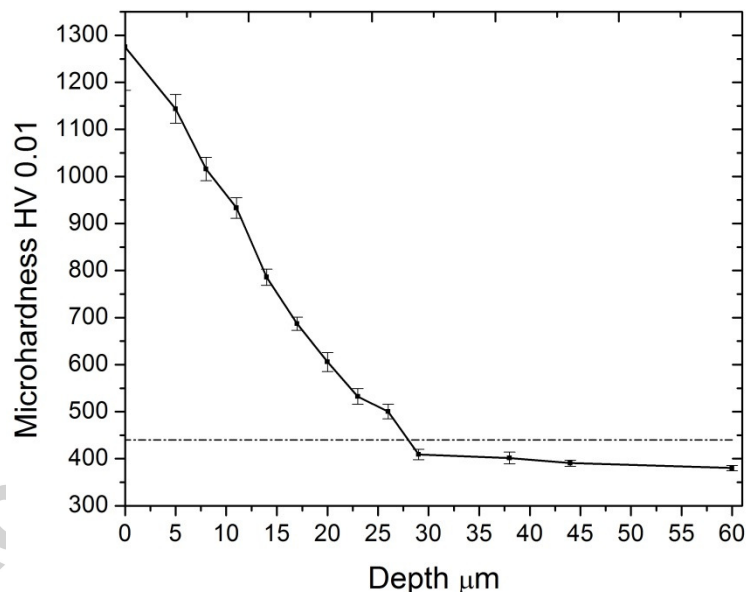
Figure 2 shows the microhardness variation as a function of depth for the nitrided specimen, together with the respective standard deviations.

Figure 2 Microhardness variation with depth of nitrided specimen.

The maximum hardness of 1275 ± 92 HV0.01 measured on the surface continuously decreases as a consequence of the reduction of nitrogen content with depth, till the hardness of the substrate is achieved. The microhardness gradient is very gentle throughout the nitrided case. According to the nitriding hardness depth – NHT criterion [19], the nitrided case is around $28 \mu\text{m}$ thick, as shown in figure 2.

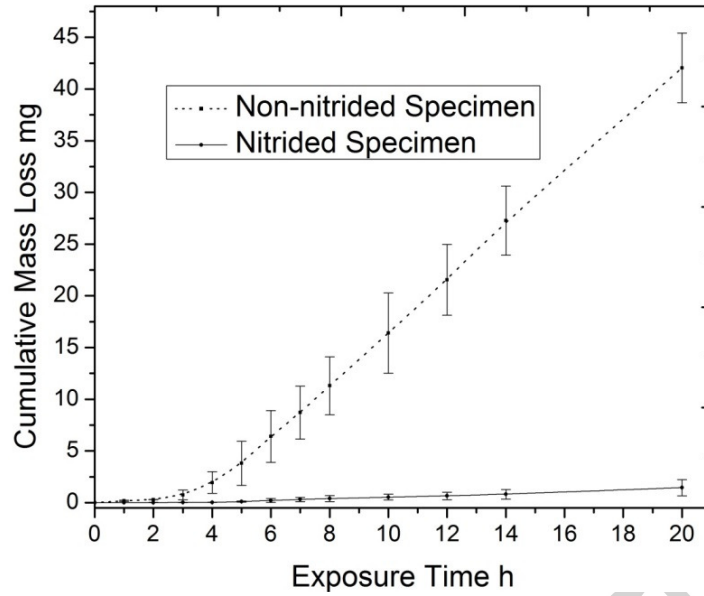
Cumulative mass losses variations as a function of exposure time are shown in figure 6. The scatter bars comprise one standard deviation.

After 20 hours of testing, the non-nitrided specimen lost ~42 mg and the nitrided specimen lost ~1.5 mg. The nitrogen addition decreased 27 times the mass loss of the quenched and tempered AISI 410. The erosion rates were calculated from the slope of the straight line plotted from the fifth hour on, as shown in figure 6, accordingly, the erosion rates were 0.085 mg/h and 2.56 mg/h for nitrided and non-nitrided specimens, respectively.

Figure 6 Cumulative mass losses variations as a function of exposure time for nitrided and non-nitrided specimens.

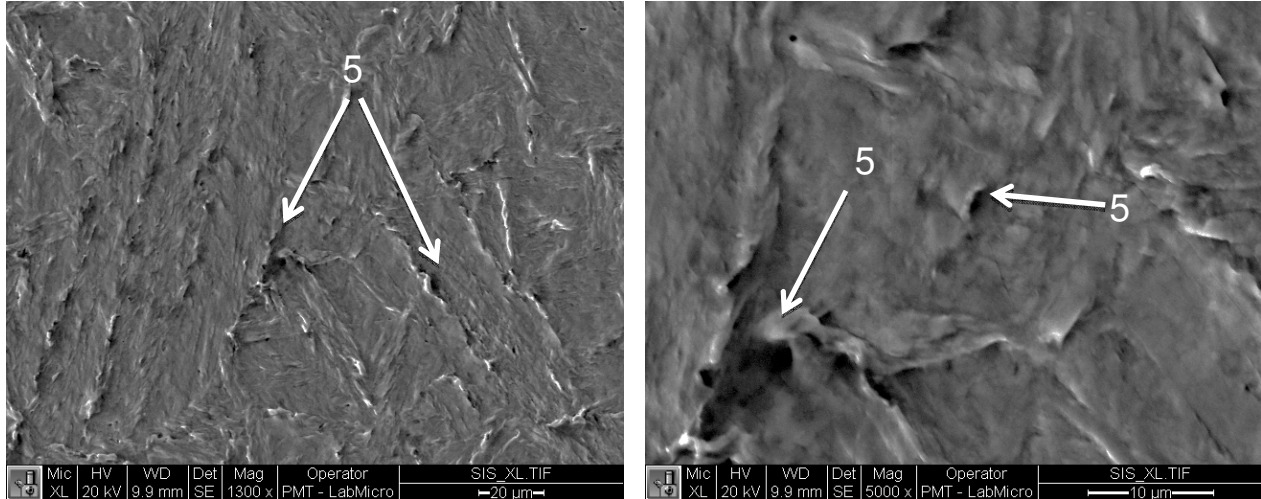
Plastic deformation increases and cavities (5) are formed along martensite lath boundaries and prior austenite grain boundaries. Furthermore, lath boundaries and grain boundaries act as barriers to material flow, causing an accumulation of strained-mass at these imperfections, creating protruding lips on the surface, shown in figure 8.

Figure 8 Cavities (5) and surface steps created due to mass accumulation at twins and grain boundaries after 120 minutes of testing. SEM images.

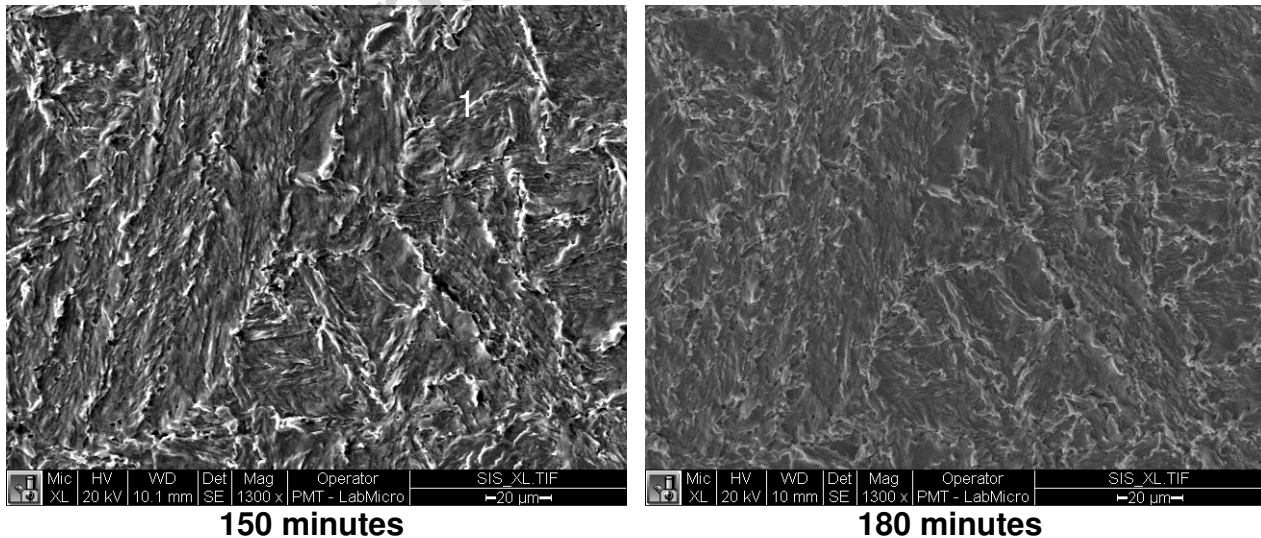
After 120 minutes of testing, the cumulative mass loss is around 0.30 mg indicating that some material was detaching from the protruding lips. Moreover, one can see that detachment of particles from these lips occurred mainly by a ductile mechanism, leaving very thin walls due to necking. In the interval between 150-180 minutes, the surface appearance strongly changed due to removal of the protruding lips, as shown in figure 9. Cavitation damage occurred by plastic deformation, possibly by fatigue and finally by ductile fracture mechanisms. The cumulative mass loss after 180 minutes of testing was ~0.75 mg.

Figure 9 Material detachment from the strained mass accumulated at protruding lips, due to a ductile fracture mechanism within 150 – 180 minutes of testing. SEM images.

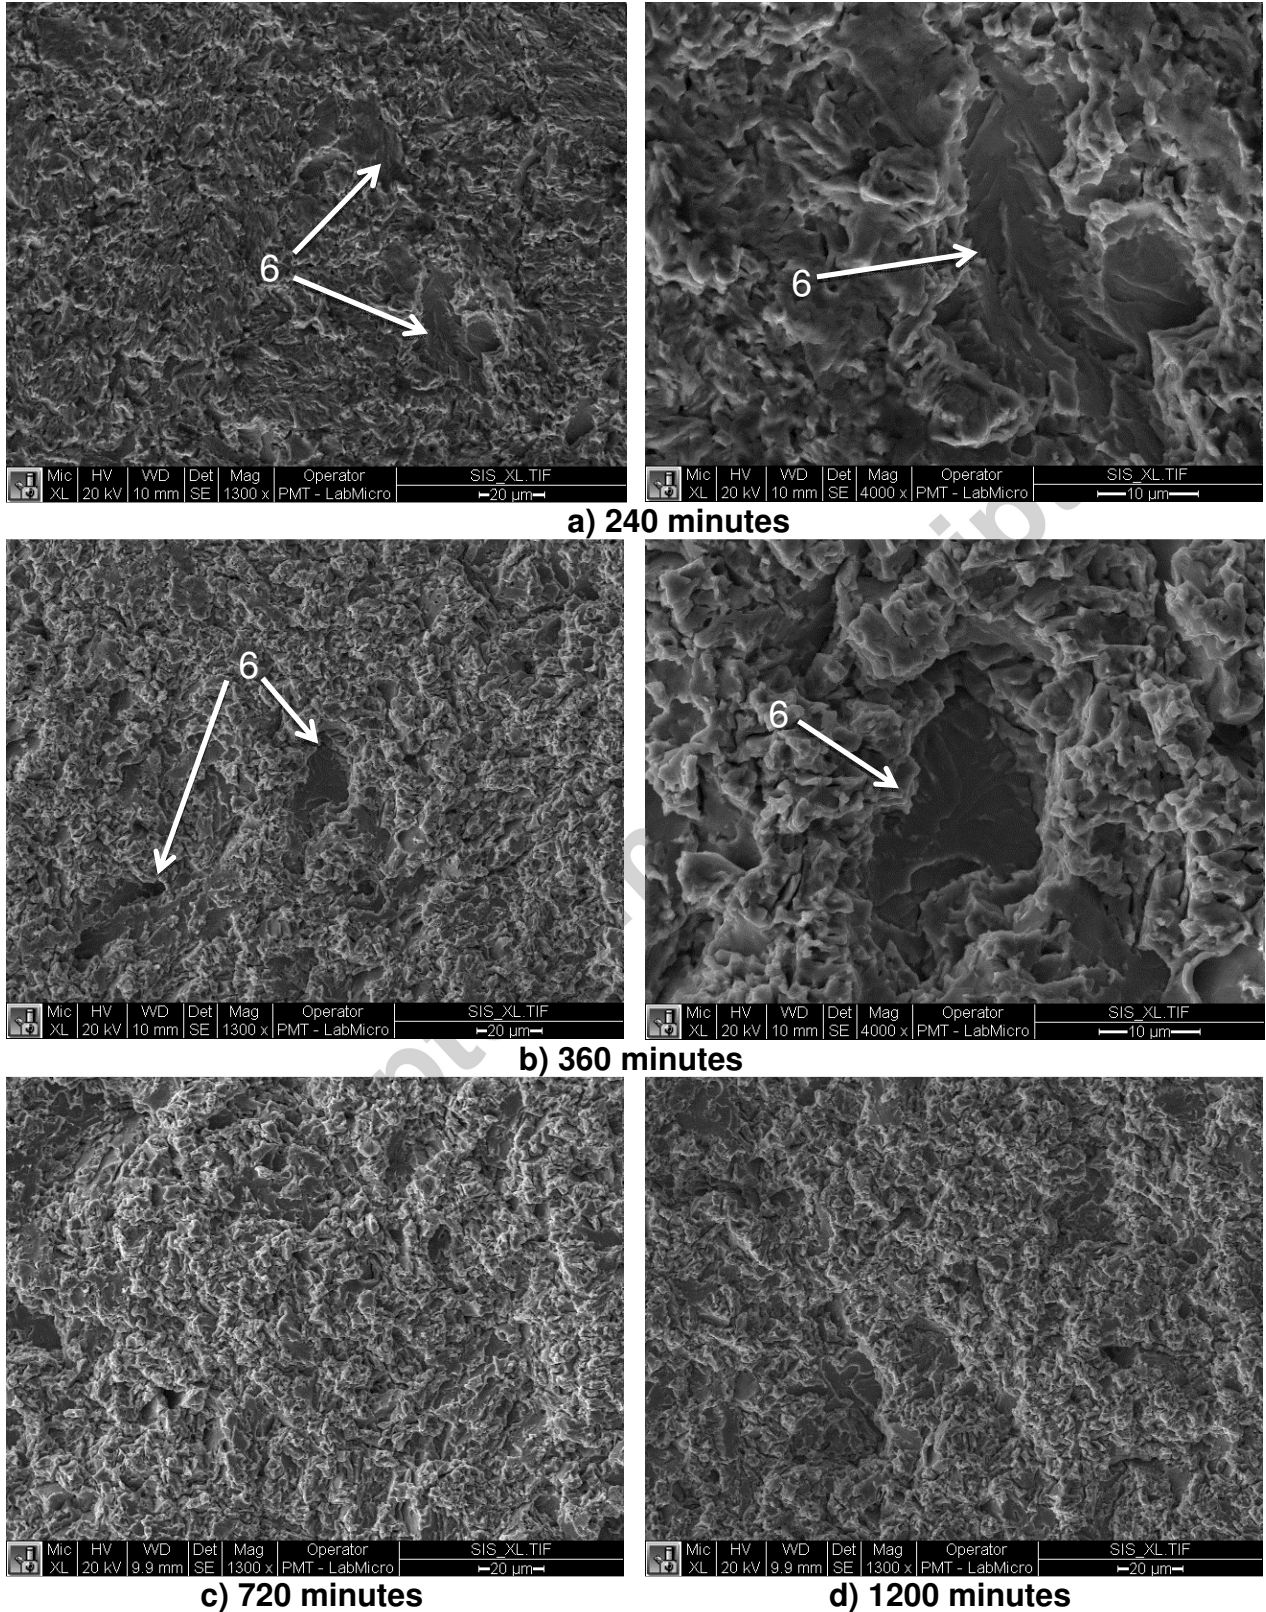
Figure 10 Material detachment due to cleavage from ~180 minutes of testing until the end of the test, a) 240 minutes of testing, b) 360 minutes of testing, c) 720 minutes of testing and d) 1200 minutes of testing. SEM images.

However, from 180 minutes of testing on, it seems that the non-nitrided specimen changed from ductile to brittle behavior. Most probably, due to the presence of small cavities on the surface, the shock waves induced more complex states of stresses, changing the mechanical behavior of the deformed surface from ductile to brittle. Consequently, cracks are able to propagate rapidly by cleavage (6) without significant plastic deformation. The non-nitrided specimen showed this brittle response until the end of the test, as shown in figure 10.

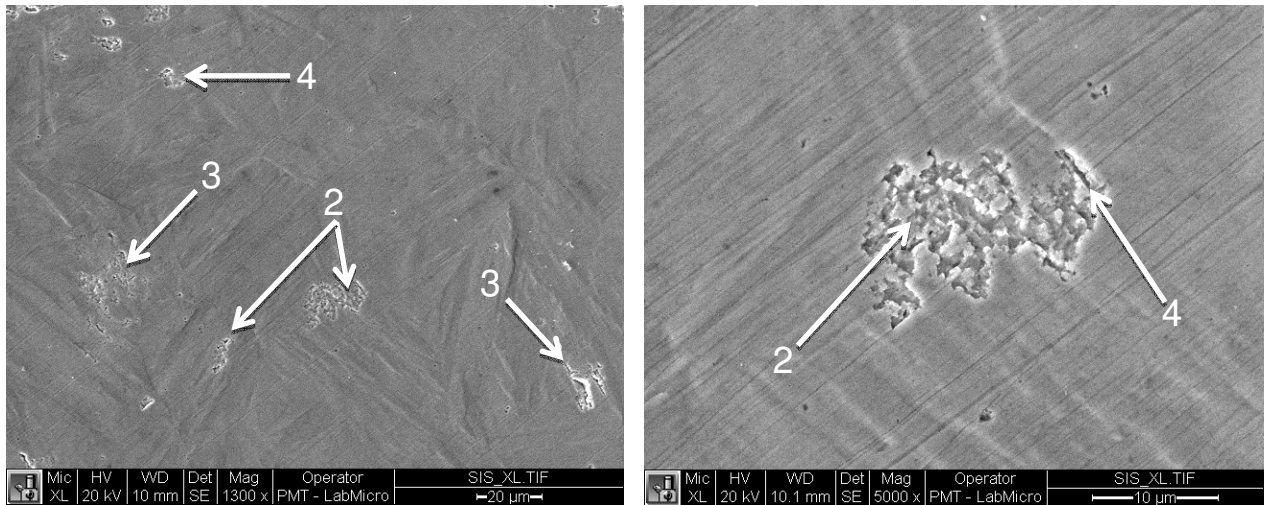
During the first 60 minutes of testing, some tiny pores (1) appeared inside some grains; but, generally speaking, the nitrided specimen surface did not show any significant change and most of the grains remained intact, supporting the fact that the expanded martensite elastically absorbed the shock-waves impact, without plastic deforming. After 105 minutes, the number of pores inside the grains was increased (2) and new pores were nucleated, not only in other grains (3) but also at grain boundaries (4), as can be seen in figure 12.

Furthermore, it can be seen in figure 12 that the damage inside the grain was nucleated at the martensite lath boundaries.

Figure 12 New pores nucleation in other grains (3) and at grain boundaries (4) after 105 minutes of testing. SEM images.

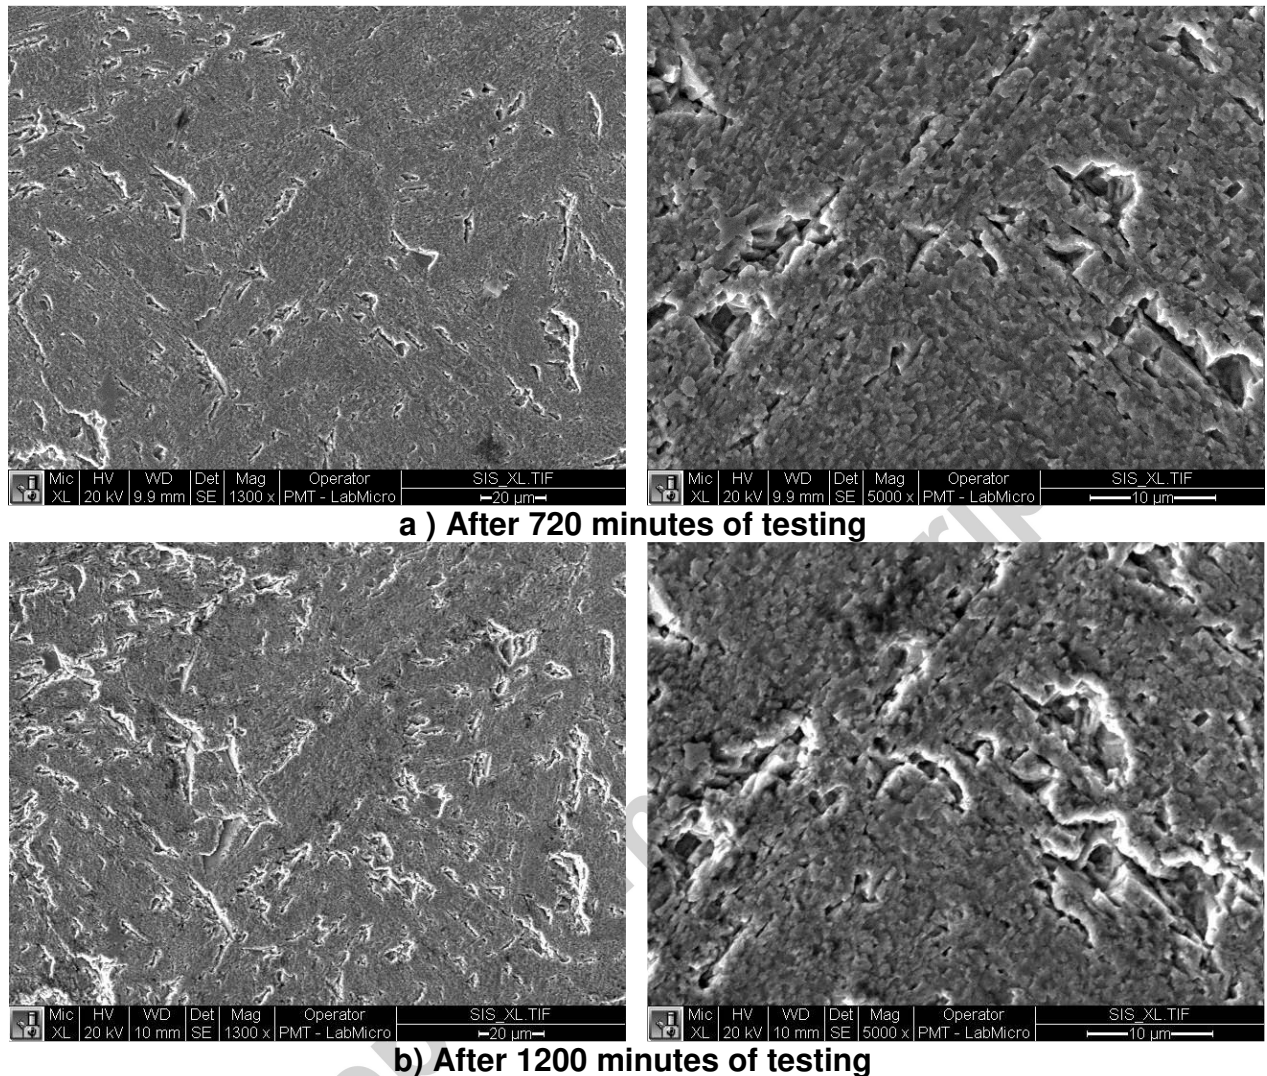
Figure 16 shows the evolution of the damage at 720 and 1,200 minutes of testing. The wear mechanism remained unchanged along the test. New craters were formed; the nitrided specimen continued losing mass from the craters and by debris detachment from the grains surfaces, due to brittle fracture, without evident plastic deformation.

Figure 16 Nitrided specimen surface, a) after 720 minutes of testing and b) after 1200 minutes of testing. SEM images.
