Wear mechanism and quantification of polycrystalline diamond milling cutter in high speed trimming of carbon fiber reinforced epoxy

Wear Mechanism and Quantification of Polycrystalline Diamond Milling Cutter in High Speed Trimming of Carbon Fiber Reinforced Epoxy

Farrukh Hafeez^{1,2}, Deviprakash Jyothishmathi Devan^{1,3}, Jamal Sheikh-Ahmad¹ and Fahad Almaskari⁴

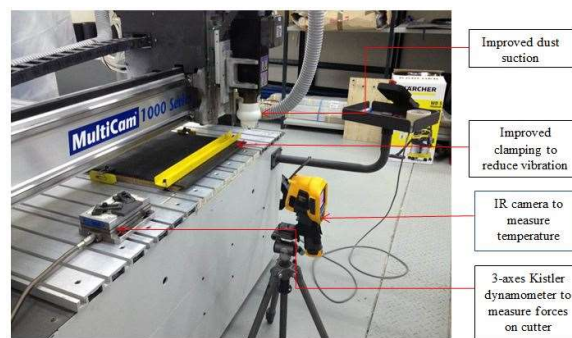
Figure 1- Cutting set up.

Edge trimming operation was performed on a three axis CNC router (MultiCam®, Texas, USA). A 500 mm long, 10 mm thick CFRP blank was clamped to the machine table so that the long side can be trimmed along the edge in a climb cutting configuration (Figure 1). The material was a plain-weave multidirectional CFRP laminate (Strata Manufacturing PJSC®, Al Ain, UAE) with a fiber orientation $[0/90^\circ]$. The radial depth of the cut was held at 10 mm. The router is CNC programmed to perform 40 repeated cuts on the plate to obtain 20 m of the cutting length.

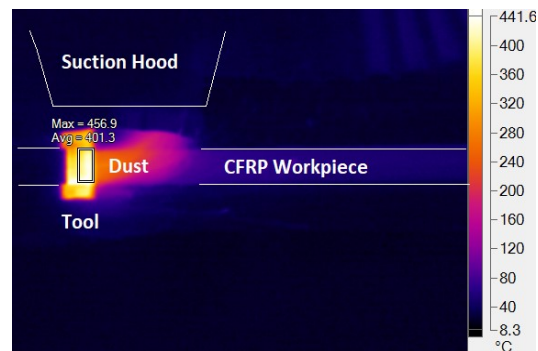
Figure 6- Infrared thermogram captured during the trimming operation.

The temperature on the tool is measured in every pass and is plotted against the number of passes. A typical infrared image captured during a pass is shown in Figure 6. Figure 7 and Figure 8 illustrate the average and maximum tool temperature readings with respect to the cutting length. Maximum temperature is the highest temperature value in the cutting zone in each of the images. Cutting zone is an approximate square area with the width of tool diameter and height of work piece thickness. Average temperature is the mean temperature value in the cutting zone.

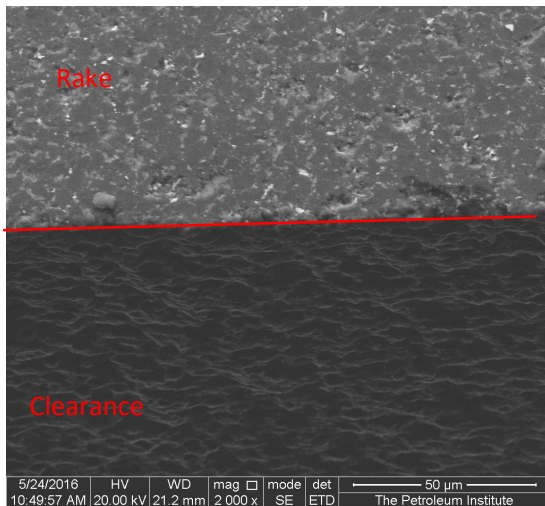
Figure 10- SEM images of the unworn PCD edge. Solid line across the image demarks rake and clearance face

Scanning electron microscopy has already been used for high resolution imaging of polycrystalline diamond wafers brazed to cutting tools. Unworn and worn cutting edges after 20 m of cutting are shown in Figure 10 and Figure 11 respectively. A clear sharp edge at the apex of clearance and rake edges is visible in unworn edge with little detail of grain boundaries on either of the faces. Due to wedge angle, it is challenging to observe both rake and clearance surfaces with the same amount of brightness. One face always tends to be darker than the other regardless of the orientation of the PCD wafer under the electron beam. Sharp image throughout the depth of the field is difficult to obtain due to the steep gradient along each surface, which makes most of the image blurry except the limited point of focus. Wear land can be seen on both rake and clearance face as a pitted surface in Figure 11.

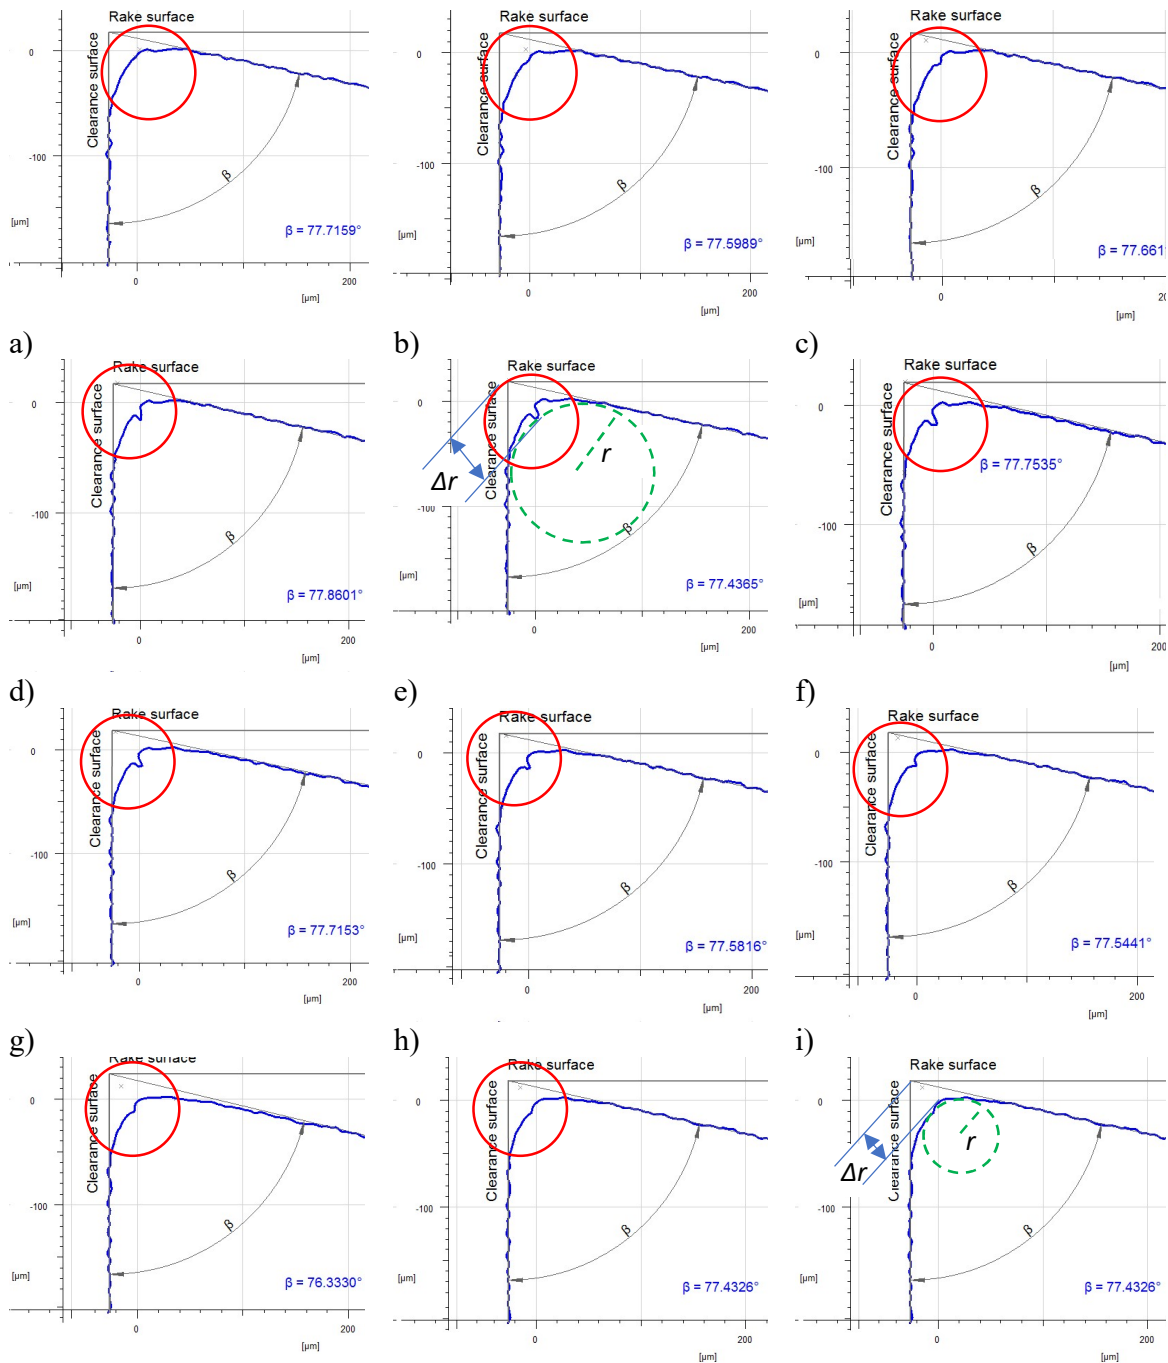
Figure 22- Consecutive cutting edge profiles at resolution of approximately every $4\mu\text{m}$ along the length of cutting edge. Encircled region in red shows the variation in profile depicting the loss of material around $40 \times 20\mu\text{m}$. This can be a single, a cluster of a few diamond crystals or piece of a continuous diamond skeleton. Comparison of green dotted line in Figure (e) and (l) shows effect of the localized cavity on the variation of edge recession Δr . All dimensions are in μm .

challenge that the reference point lies at the unworn edge lost during the cutting operation. Thus, edge width remains an easier candidate criterion for measuring wear in PCD tools through conventional as well as advanced measurement techniques. Edge recession Δr , edge width $W\Delta r$, and the shortest distance from apex to edge width r are all interrelated particularly for a typical PCD cutting edge used in the current study. Such relation can be explained using a set of images in Figure 22.

Each image is a cross section profile of the tool worn edge at $4\mu\text{m}$ intervals along the worn edge. Thus, the total length of $48\mu\text{m}$ is shown at regular intervals in 12 images. Close observation at the tip of the cutting edge shows the development of a crater which starts to appear in the first image Figure 22 (a) and vanishes in the final image Figure 22 (l). The depth of the crater is maximum in Figure 22 (e). A red circle is shown in every figure to highlight the crater. It is perhaps due to the loss of a cluster of diamond grains or edge of the diamond skeleton structure made of diamond precipitant during liquid phase sintering. It can be estimated that the volume of the cluster is around $45 \times 15 \times 10\mu\text{m}$ which is substantially higher than what an average single grain can occupy. Hence it can be assumed that this particular example is not due to the loss of a single grain. It is relevant to mention that dimensions of such cavity, in particular depth is difficult to estimate with SEM.

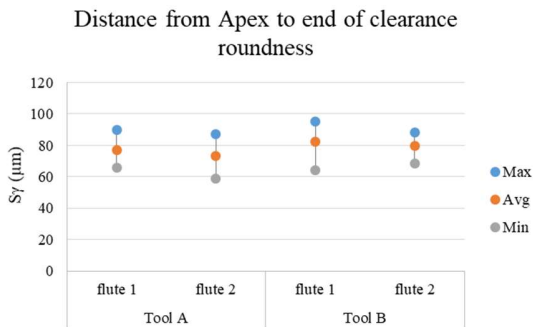
Figure 25- Maximum, average, and minimum values of distance from apex to the end of clearance roundness. Comparison between different flutes and tools. The overall average is about 80μm obtained by profile scanner (Alicona®)

On the other hand, distance from the apex to the end of clearance roundness (S_γ) exhibits relatively better repeatability as shown in Figure 25. The average values are within 10 μm variation. A further close insight is provided by presenting measured values of (S_γ) for the whole of scanned length at 4 μm resolution. The overall variation is within 20 μm around the mean and it is repeatable for both flutes of the same tool (Figure 27). The same conclusion can be made for this parameter when a comparison is made between different tools (Figure 28). Although there is a variation in

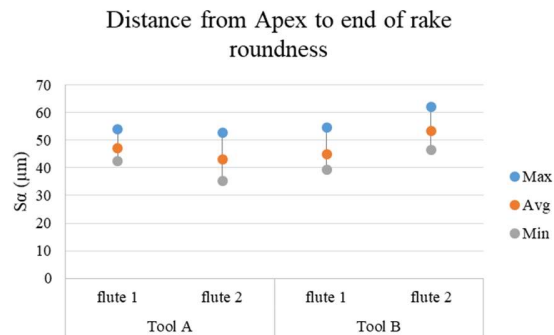
Figure 26- Maximum, average, and minimum values of distance from apex to the end of rake roundness. Comparison between different flutes and tools. The overall average is about 45 μm obtained by profile scanner (Alicona®)

S_a (distance from apex to rake roundness) exhibits the same behavior (Figure 26). However, it has a smaller magnitude compared to S_y in all scenarios. This can be attributed to the nature of the wear. Loss of diamond on the edge creating a cavity does not abruptly vary the distance of edge roundness from the apex, consequently causing gradual wear and consistently comparable worn edge. Hence it can be concluded that while measuring wear in PCD the distance from the apex to the end of the roundness proves itself as the best candidate for measuring wear.
