Flood characterization based on forensic analysis of bridge collapse using UAV reconnaissance and CFD simulations

Loli, Marianna; Mitoulis, Stergios; Tsatsis, Angelos; Manousakis, John ; Kourkoulis, Rallis; Zekkos, Dimitrios

1.2. The Bridge 9 failure

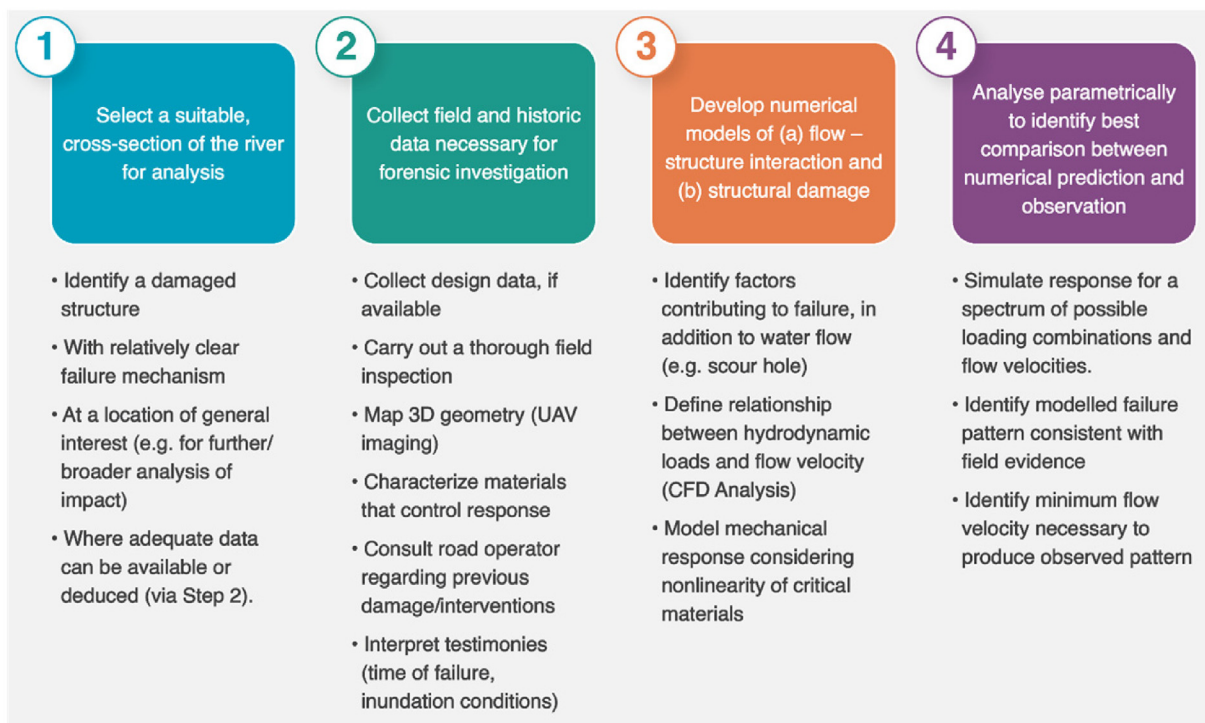
Fig. 1. A posteriori assessment of flood intensity: Method used to back-calculate flow velocity with respect to observed damage.
