Damage characterisation using Sentinel-1 images: Case study of bridges in Ukraine

Nadiia Kopiika, Jelena Ninic, Stergios-Aristoteles Mitoulis

University of Birmingham, UK

Abstract

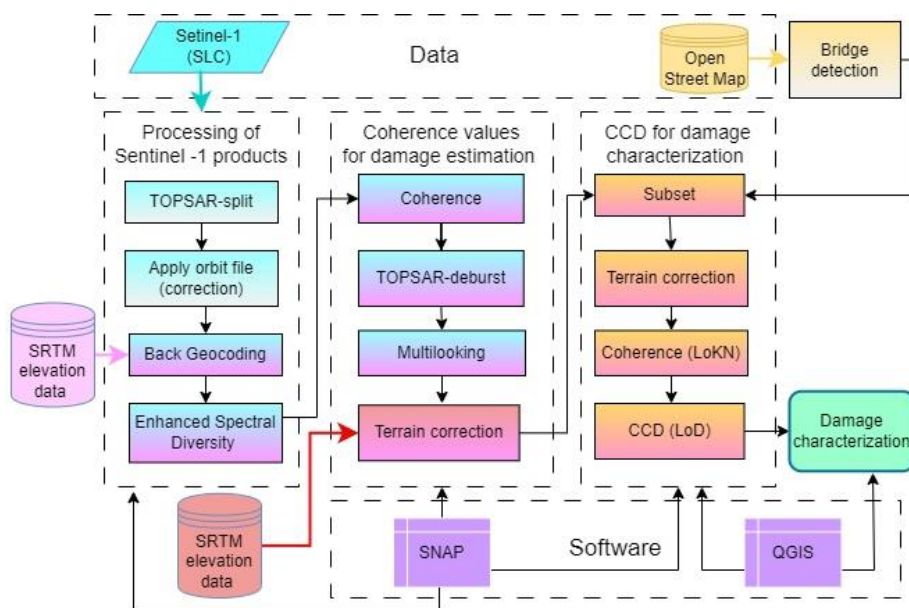
Figure 1. Workflow for damage characterization with the use of Sentinel-1 products

General stages of processing of Sentinel-1 products for characterization of damages are included in the workflow (see Figure 1).

As shown on Figure 1, further illustration of estimated indications of damages on examined assets is processed in QGIS environment (see Figure 7 for different LoD and High LoKn).

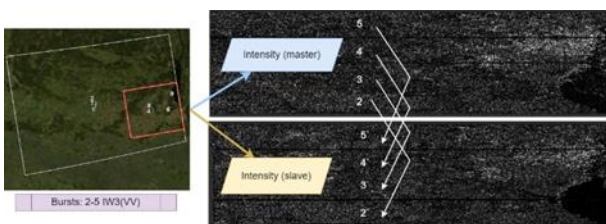
Processing of Sentinel-1 SAR SLC images was done with the use specialized software Sentinel Application Platform (SNAP)[10]. At the first stage the specific pre-processing operation was applied for two interferometric pairs before and after the invasion (19.01.2022 -12.02.2022 and 19.01.2022 - 01.04.2022). While each SAR pair requires its own processing workflow, in order to semi-automate the process and avoid saving interim products, the GraphBuilder tool was used. Thus, for IW mode 1 sub-swath and 3 bursts of Sentinel-1 products were used using the terrain observation with progressive scans SAR (TOPSAR) split method. Following, orbit file correction of products is applied in order to ensure best geo-positional accuracy using the 'SRTM 1Sec HGT' method. Subsequently, the Back-Geocoding operator is used for coregistration of the two products using the Digital Elevation Model of Shuttle Radar Topography Mission SRTM-1 arcsec. Coregistration in this case referred to the alignment of master and slave images, the pixels of the slave images corresponding to those of the master and representing an identical area (see Figure 2). Following, a constant range offset for each burst using a small block of data in the center of the burst and a constant azimuth offset are estimated (Enhanced Spectral Diversity operator) and bursts are averaged to get the final constant range and azimuth offset for the whole image [11],[12].

Figure 2. Coregistration of master and slave products (bursts 2-5).

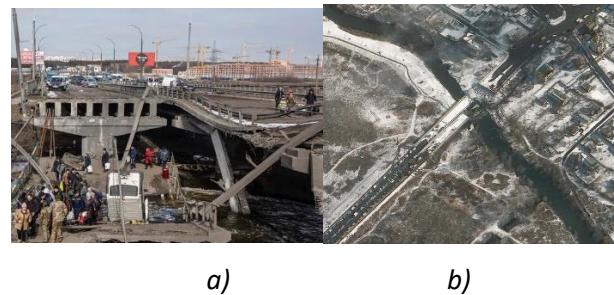
Figure 3. Evacuation routes for civilians in Kyiv region, targeting by Russian forces obtained from: a) social networking, b) satellite imagery.

Of equal importance, bridges served as crucial routes for facilitating the evacuation of civilian populations through humanitarian corridors. Regrettably, during this period, these critical conduits were subjected to targeting by Russian forces, as depicted in Figure 3 [16]. As a consequence of these circumstances, the pivotal role played by these bridges in the region, coupled with the considerable damage sustained, served as the primary motivation for the case study within the ambit of this research.

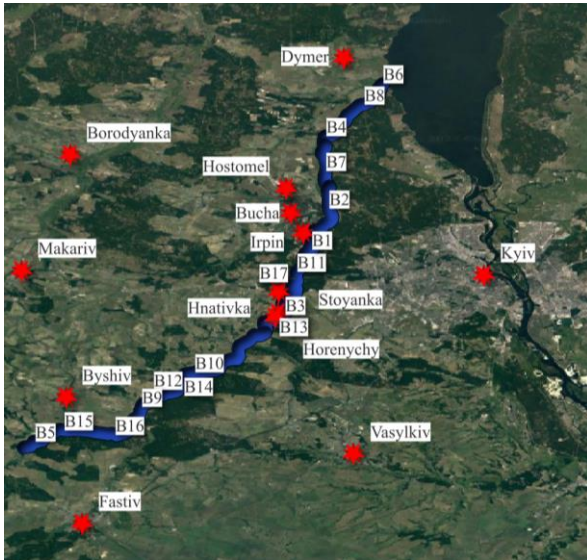
Figure 4. Bridges of the case study in AOI

identified with the use of OpenStreetMap geospatial data in the Area of Interest (AOI). Coordinates and parameters of examined bridges are presented in Figure 4 and Table 1.

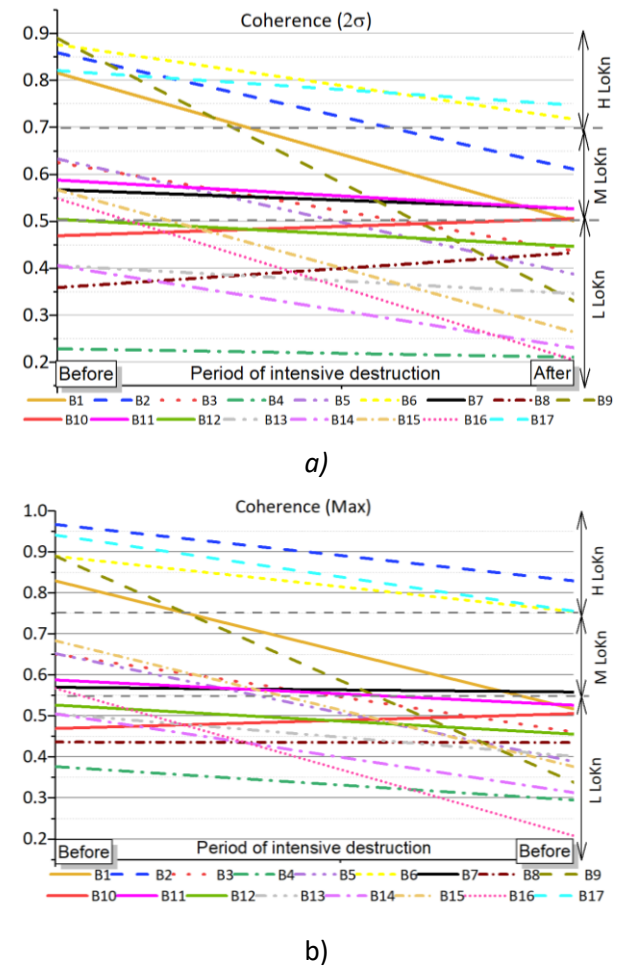
Figure 5. Coherent Change Detection (CCD) for examined bridges: a) 2σ-values, b) maximum values

Additional clarification of the LoKn and LoD indexes is given in Figure 5 and Figure 6.

Calculated values of coherence reveal a consistent overall pattern of decrease during the examined period of time, however to different degree (LoD). Nevertheless, results for different assets are associated with significantly different levels of uncertainty (LoKn), as shown by Table 2, Figure 5. For example, for bridges B1, B2, B9, B17 coherence between pre-event images exceed 0,7, which could serve as an indicator of sufficient reliability of data. However, for bridges B10-B14, estimated coherence values are lower than 0,5, which reveals low quality of initial products.

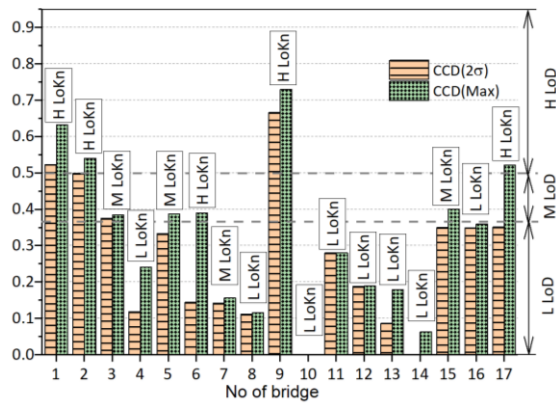
Figure 6. The level of reliability of damage characterization according to Coherent Change Detection (CCD)

Hence, it is important to take into account the level of certainty of damage detection results for their further implementation and decision making. Notwithstanding, the level of evidence concerning the quality and precision of these findings should be considered as they may not adequately represent damage characteristics of the bridge. Therefore, in order to eliminate the influence of low quality of results, classification from Table 3 is used and assets with Level of Knowledge (LoKn) that fall below a certain threshold are excluded from further consideration, as their reliability is insufficient to make any assumptions about the level of damage (LoD). Final results of coherence change for bridges with reliably estimated values are presented in Figure 6.

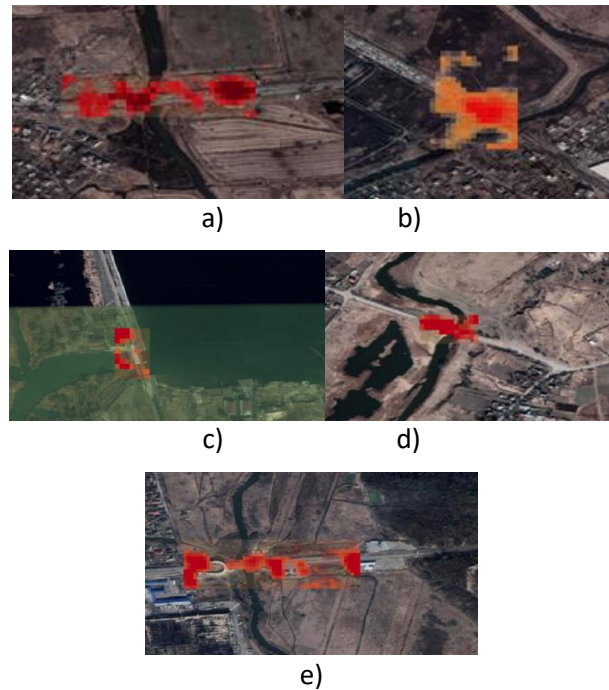
Figure 7. Damage characterisation according to CCD values at H LoKn: a) H LoD (B1); b) H LoD (B2); c) L LoD (B6); d) H LoD (B9); e) H LoD (B17)
