The role of oxidation damage in fatigue crack initiation of an advanced Ni-based superalloy

Cruchley, S, Li, H, Evans, H, Bowen, P, Child, D & Hardy, M 2015, 'The role of oxidation damage in fatigue crack initiation of an advanced Ni-based superalloy', *International Journal of Fatigue*, vol. 81, pp. 265-274. <https://doi.org/10.1016/j.ijfatigue.2015.08.016>

The Role of Oxidation Damage in Fatigue Crack Initiation of an Advanced Ni-based Superalloy

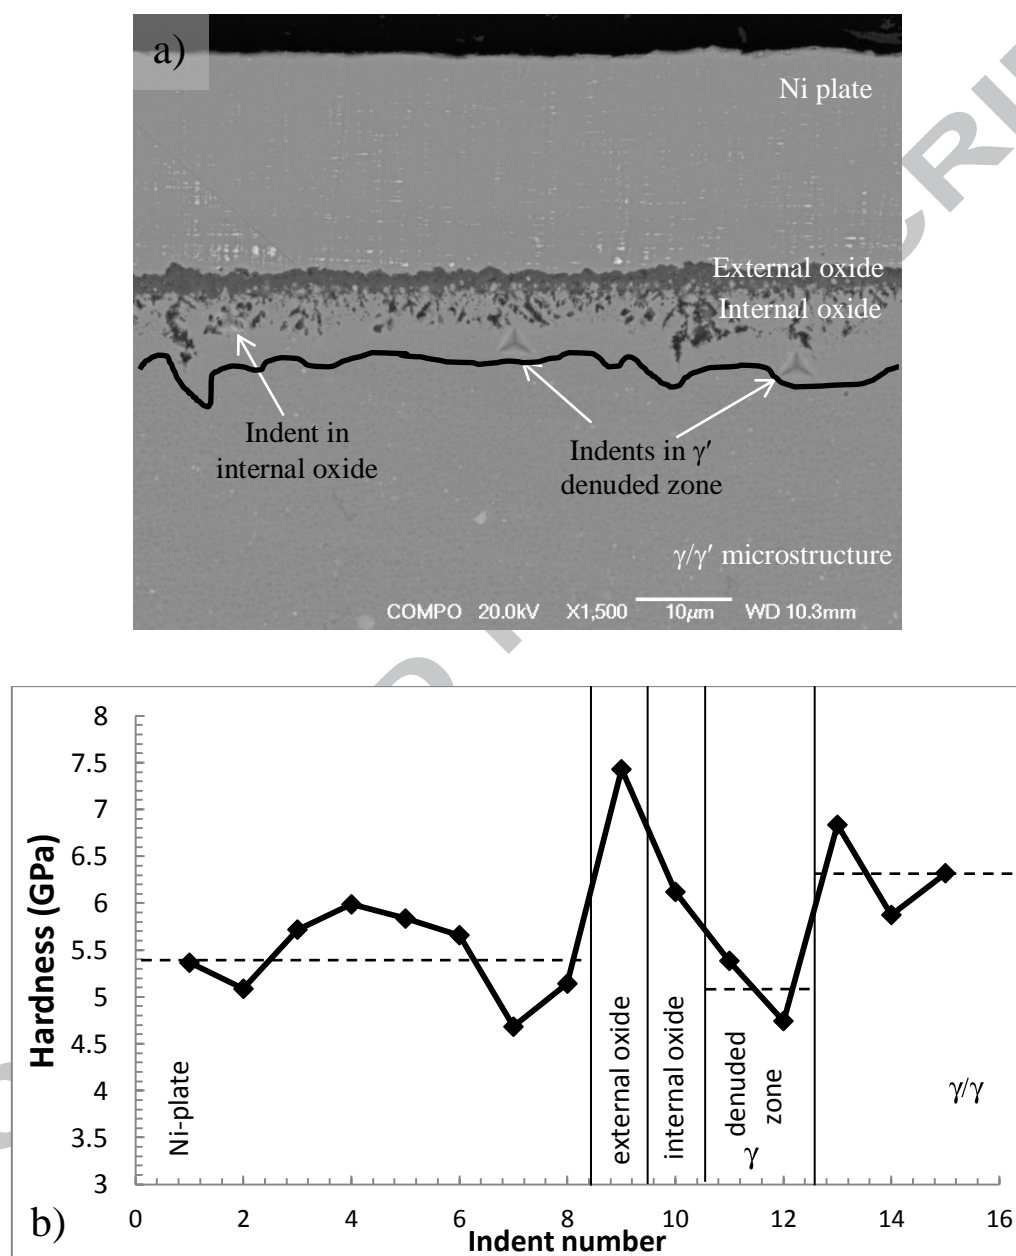
Nano-indentation was performed (with an applied load of 30 nN) in order to evaluate the variation of mechanical properties across the different zones affected by pre-oxidation. Figure 2 shows the results from a sample after oxidation at 800°C for 500 hours. The hardness value of the external oxide layer is 7.4 GPa but this gradually reduces through the zone of internal oxidation until a minimum is reached in the γ' denuded zone before increasing again into the matrix. Clearly a softer layer is sandwiched between the outer oxide shell and the matrix. It is reasonable to suggest that the reduction in yield stress in the γ' denuded zone is proportional to the reduction in hardness values. The yield stress of the matrix is about 1010 MPa, hence the yield stress in the γ' denuded zone can be estimated to be around 810 MPa (using the average hardness value in the γ' denuded zone and in the matrix). The formation of this weaker region has been reported previously [5, 9, 10].
