Online condition monitoring of rolling stock wheels and axle bearings

Abstract

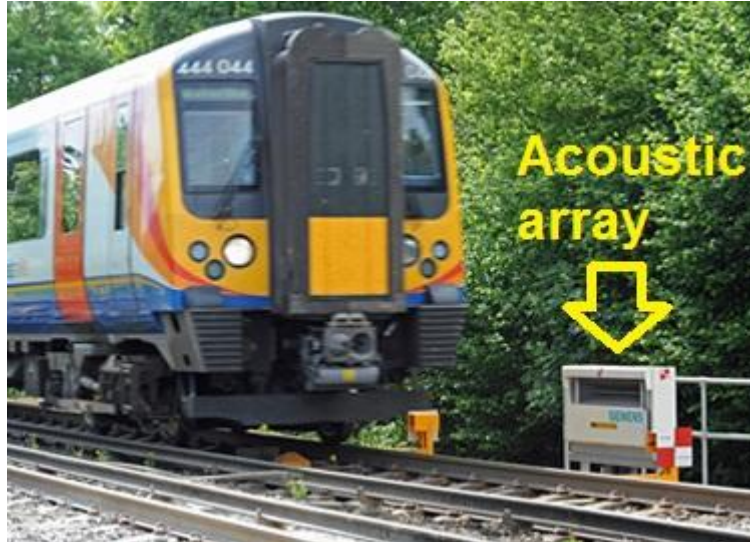
Figure 4: A RailBAM trackside acoustic array detector installed on the British rail network near London (the photograph is courtesy of SIEMENS).

Trackside Acoustic Array Detectors (TAADs) use arrays of microphone to record the noise produced by the bearing. An example of TAADs is shown in figure 4. TAADs are capable of detecting the acoustic signature of early bearing defects using spectral analysis and data trending [10]. The maximum operational frequency range of the microphones used in trackside acoustic arrays is normally 22-44 kHz. At this operating frequency range the microphones can be affected by surrounding environmental noises as well as noises from the measured train itself. Noises from the wheel-rail interface and the train engine can contaminate the signal acquired by the acoustic array possibly resulting in false alarms or missed faults.

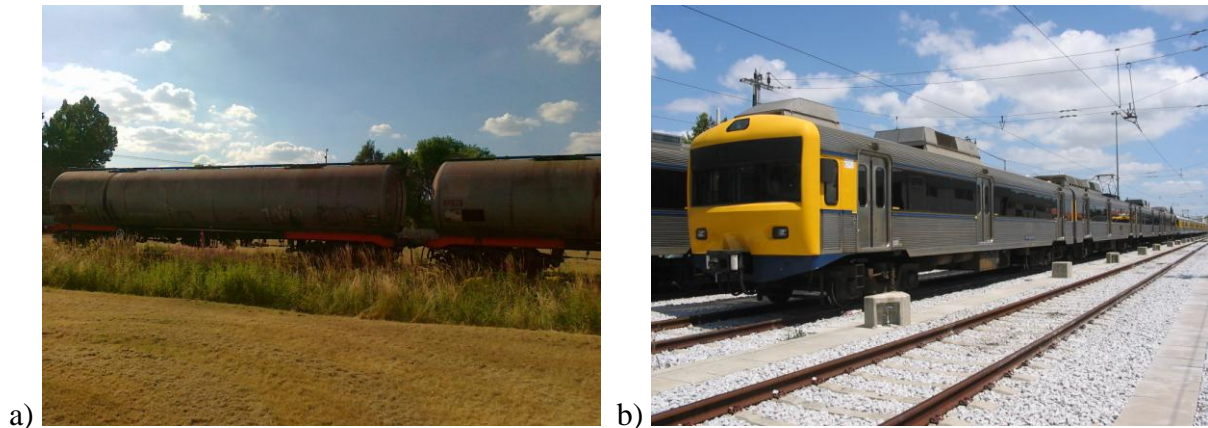
Figure 5: a) Tanker freight wagons with several axle bearings artificially damaged in the roller or race using a power tool, b) EMU with one defective wheel (tread shelling) used for experiments in Portugal.

The first set of experiments were carried out on tanker freight wagons with artificial damage induced on several axle bearings. The test wagons are shown in figure 5a. Testing took place in the Long Marston rail track, UK. From the acquired data and subsequent analysis it is evident that acoustic emission has the capability of detecting faulty axle bearings at various stages of evolution, well before they cause final failure of the bearing.

The second set of experiments were carried out on the Portuguese Rail Network managed by REFER on an Electric Multiple Unit (EMU) operated by Comboios de Portugal (CP) for suburban passenger services on the line between Lisbon City Centre and Cas-Cais. The test vehicle concerned in this paper is shown in figure 5b. It comprises of three carriages and operates at a maximum speed of 90 km/h. One of the wheels of the EMU considered in this study has developed shelling on the tread naturally during normal operation shown in figure 6. Vibration measurements carried out during a normal operational run from Cas-Cais to Lisbon showed that the tread defect could easily be detected and evaluated using appropriate signal processing.

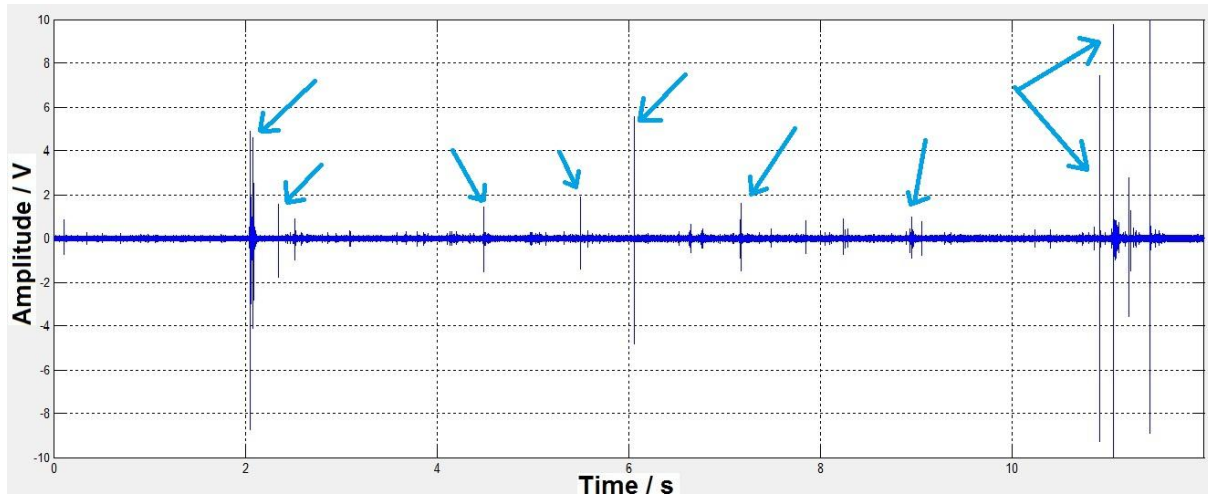
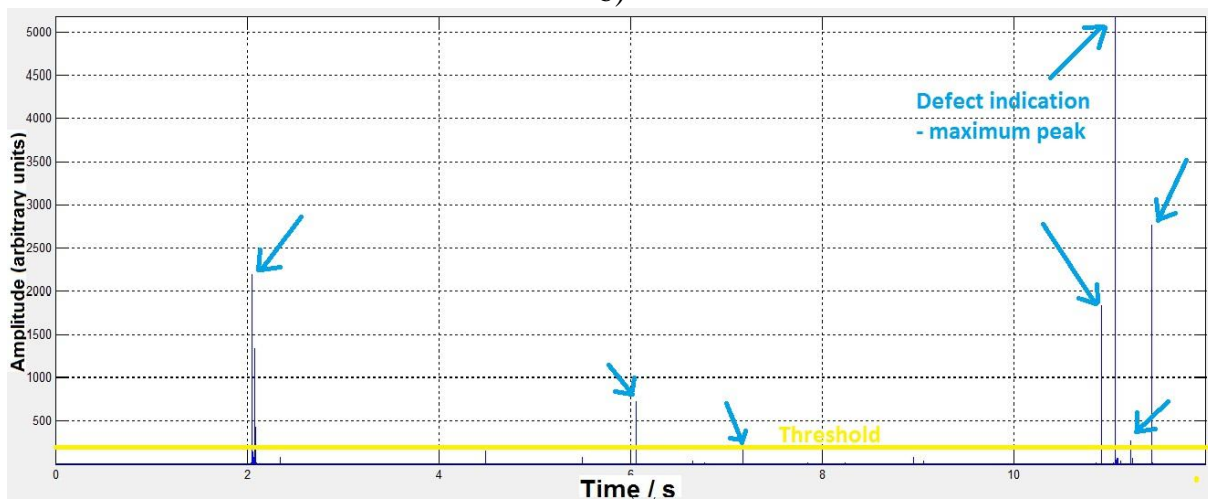
Figure 11: a) Raw AE data acquired from a bearing with a 8 mm roller defect and b) RMS processed results. Notice the amplitude of the strong RMS peaks which is much higher than the RMS for the 4mm roller.

Figure 11a presents the raw AE data and 11b the moving RMS from an 8mm roller defect. Note the increasing maximum peak amplitude (~5100 arbitrary units) of the RMS signal indicating the higher severity. However, the variability in each axle bearing rotation remains with some of the peaks falling even below the threshold limit despite the much higher amplitudes recorded in the raw signal. This is another indication that the amplitude is not sufficient indicator and the energy the signal carries need to be considered. Also in order to safely assess the severity of the signal we need to trend the maxima from several measurements in order to reach a reliable conclusion.

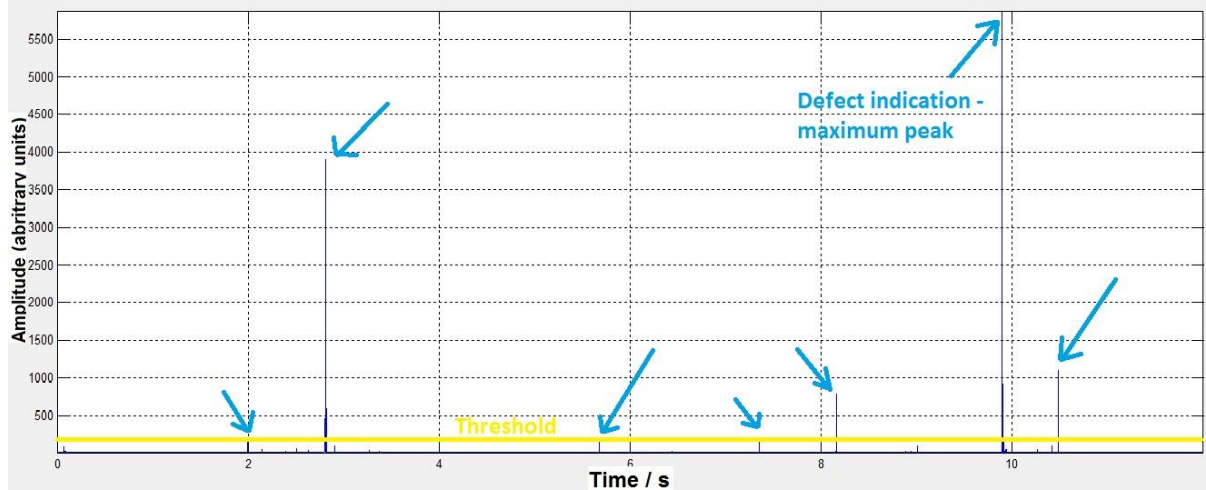
Figure 12: a) Raw data of 8 mm race defect and b) moving RMS processed results.

Figure 12a shows the raw AE data and 12b the moving RMS acquired from a bearing with an 8 mm race bearing defect. It is noticeable that the raw AE amplitude varies significantly from measurement to measurement but the moving RMS provides a consistent analysis method for evaluating the severity of the defects provided that the maxima are trended and compared.

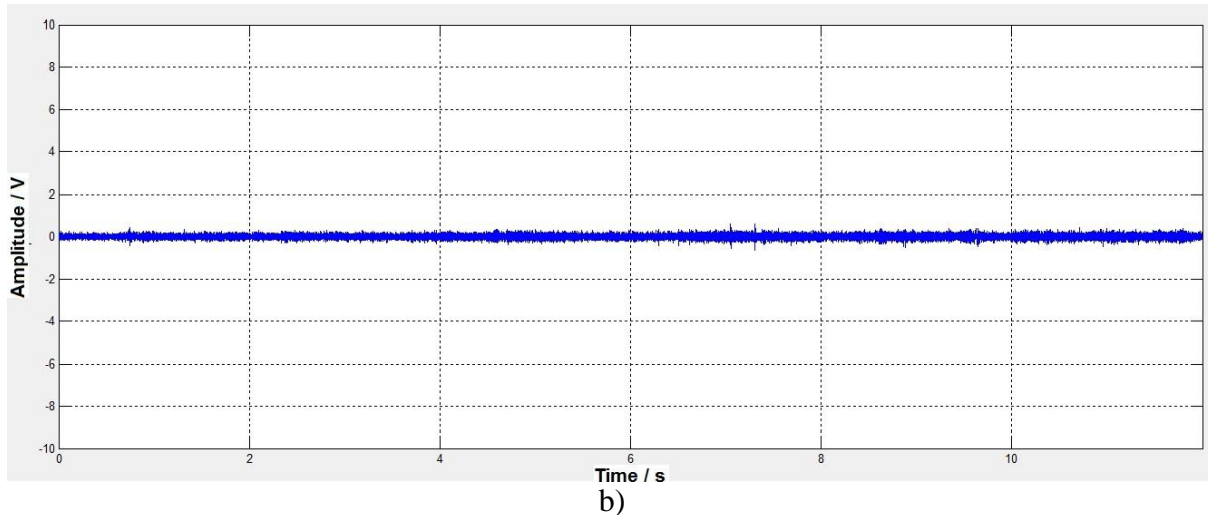
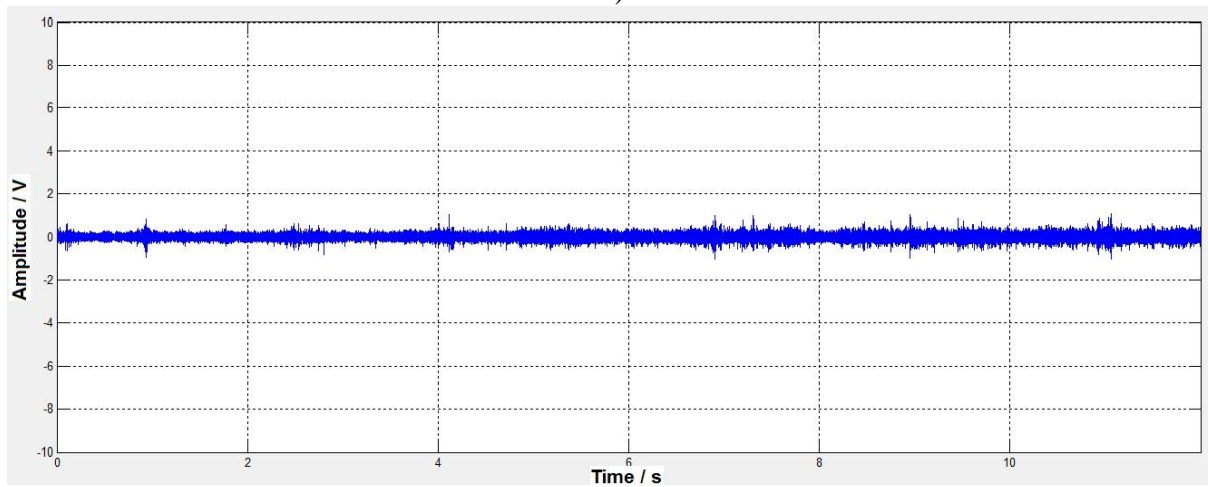
Figure 13: a) Raw acceleration for a healthy axle bearing and b) raw acceleration for an axle bearing containing a 2mm roller defect.

Figure 13a shows the raw vibration response for a healthy bearing and 13b for the axle bearing containing a 2 mm roller defect. The raw acceleration appears to be a bit more noisier for the defective axle bearing. However, it is not possible to arrive into safe conclusions by just looking into the raw measurements.

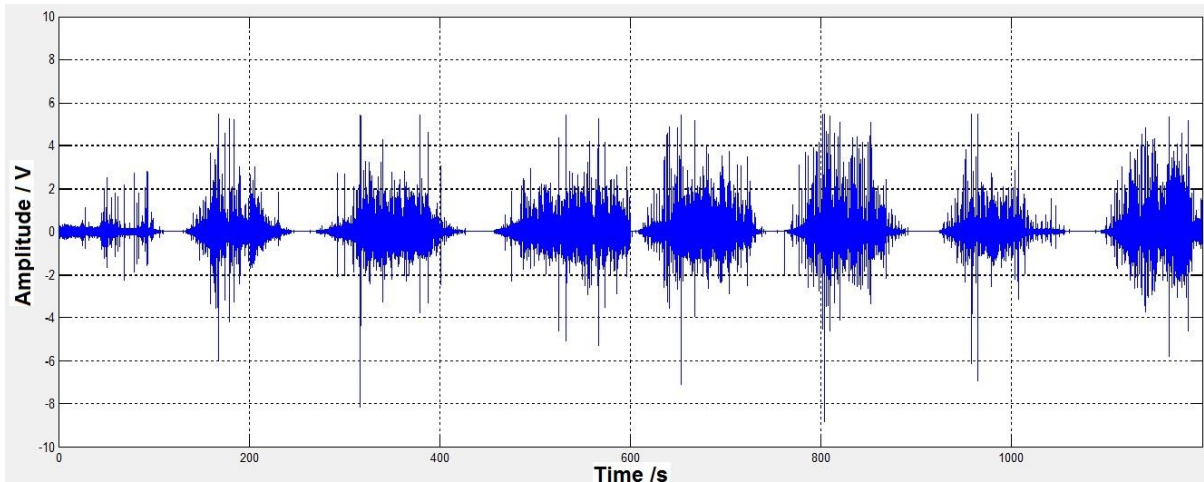
Figure 15: a) Raw vibration data for healthy wheel and b) raw vibration data for defective wheel.

During the EMU trials in Portugal, acceleration measurements were collected for a wheel free of defects and a defective wheel containing shelling on the tread surface. The average train speed during tests was 75 km/h or 20.70 m/sec. The plot in figure 15a shows the raw vibration signal for the healthy wheel and 15b for the wheel in the deteriorated condition. Although the raw vibration plots generally differ in each wheel condition, it is not sufficient to arrive in a safe conclusion since the vibration data will differ from wheel to wheel regardless of their actual condition. It is crucial to be able to identify from the vibration measurements the origin of the fault. A flat or spalling should give different pattern from a bearing defect. Approaches based on peak to peak levels alone should be considered more dependable on the measurement conditions as load, speed, wheel profile quality and rail track quality.

Thus it is impossible to assess the severity of the defects present on the damaged wheel based on the raw data alone. For this reason further analysis was carried out using moving RMS, spectral analysis (FFT) of the raw signal and spectral analysis of the demodulated signal (FFT of the envelope of the signal).
