# Onboard detection of railway axle bearing defects using envelope analysis of high frequency acoustic emission signals

### Case Studies in Nondestructive Testing and Evaluation

Birmingham Centre for Railway Research and Education, The University of Birmingham, Birmingham, B15 2TT, UK

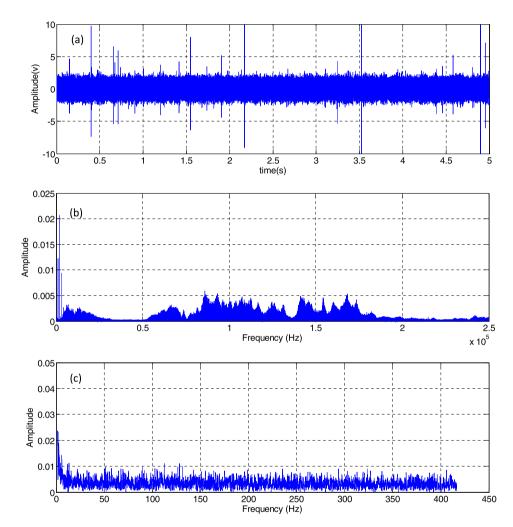
Fig. 3. Healthy bearing rig test: Raw data (a) - Power spectral analysis (b) - Envelope analysis (c).

Fig. 3 shows the AE signal envelope and power spectral analysis on a healthy bearing from the test rig. It is evident that no indication appears in the envelope analysis approach confirming that there is no defect present. If the severity of the defect is high (in stage 3 of the bearing failure), the fundamental frequency of the defect appears in lower frequency which can be simply detected by FFT analysis. However if the severity level is low, the fundamental frequency of the defect is only visible in the resonance frequency (demodulated signal) which can be revealed by the envelope analysis.

It should be noted that the optimum bandpass frequency used in the envelope analysis was evaluated based on the resonance frequency of the bearing. An impact test, also called excitation measurement, was used to determine this frequency. A central frequency of 6 kHz with a bandwidth of 2 kHz was applied for the envelope analysis.

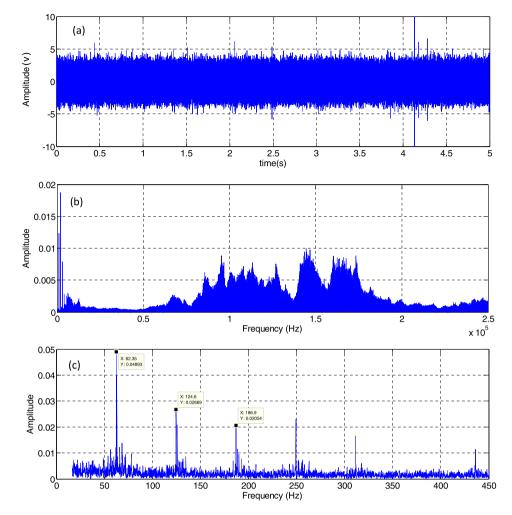
Fig. 4. Defective outer race bearing rig test: Raw data (a) - FFT analysis (b) Envelope analysis (c).

In the defective bearing, the fundamental frequency and its harmonics arising from the impulse caused by the impact of the bearing defect as it rotates have been excited in. The results for a sample bearing with an artificially induced roller

defect are shown in Fig. 4. From the envelope analysis carried out a peak at the characteristic frequency of 62 Hz is evident. The peak seen at the aforementioned characteristic frequency confirms the presence of the roller fault as it is in agreement with the fundamental frequency of the bearing at the rotating speed used during testing. There is a slight offset between the characteristic frequency given by the analysis and the table which is caused by a slight variation in the rotating speed during the test.

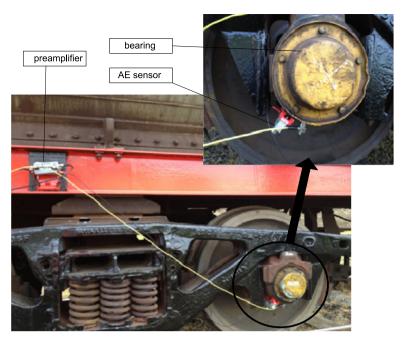
Fig. 5. Onboard mounting of the AE sensors on the bearing with 8 mm roller defect using a magnetic hold down.

Fig. 5 shows the onboard setup on the axle bearing casing of the test wagon employed. AE data were collected using the same  $R50\alpha$  AE sensor as for the laboratory tests. There were a number of artificially induced faults include wheel flat, lubricant contamination, outer race and inner race defects. The defect on the roller and race were in three different sizes of 2,4 and 8 mm. Tests were carried out at a speed of 30 MPH forward and 20 MPH backwards pulling the freight cars over a straight section of welded track for the first and second series and continues track for third and forth series of tests. The length of the track was about 200 metres. The sampling rate for acoustic emission signals was 500 kHz. The AE sensor was attached on the axle bearing casing using magnetic hold-downs. Ultrasonic coupling was achieved using Vaseline. The AE sensor should be installed as close as possible to the bearing, this is to provide a good transmission pathway between the possible damage source and the sensor. It should also be in the maximum load zone where the maximum stresses sustained by the bearing occur. The test wagons were equipped with Timken bearing model 99591-99100.

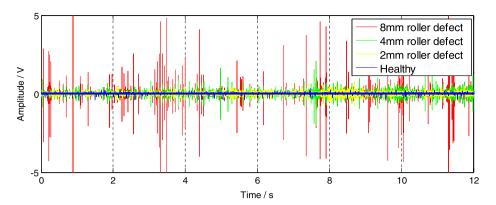
Fig. 6. AE data comparison of the bearings with different defect sizes.

The plots in Fig. 8 show the same analysis on a bearing with only a minor roller defect being present. The lower amplitude in raw data compared to the severely damaged bearing should be taken into account. It is evident that despite using envelope analysis, neither the fundamental frequency nor its harmonics are evident in the signal. This is due to the fact that the signal is affected by other sources of noise (such as wheel–rail interface and brake related noises) which make more difficult the evaluation of the type of the defect. Nonetheless, it is still possible to establish that the axle bearing measured is damaged. This is due to the fact that the defective bearings contain higher AE amplitude in the raw data. Fig. 6 shows the comparison of the bearings with different defect sizes.

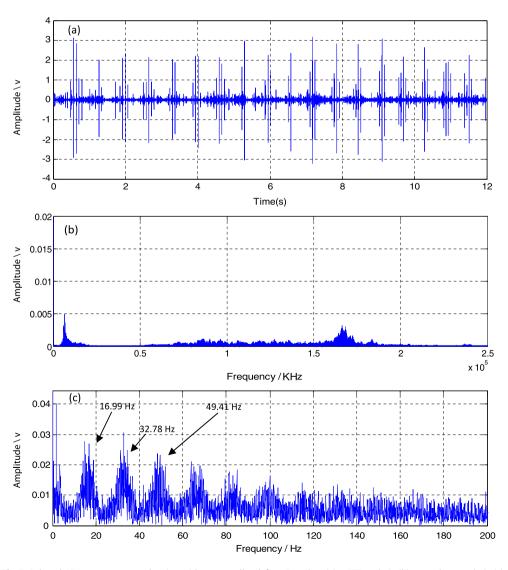
Fig. 7. Onboard AE measurement on bearing with severe roller defect: Raw data (a) - FFT analysis (b) - envelope analysis (c).

Fig. 7 demonstrates the AE data from onboard measurement carried out on a severely damaged axle bearing. Large peaks in raw data indicate the presence of a defect but not the type of defect. To find the type of the defect, data should be analysed in the frequency domain using envelope analysis. The characteristic frequencies do not appear in conventional FFT, however envelope analysis allow the detection of the fundamental frequency and its subsequent harmonics. The fundamental defect frequency obtained from the envelope analysis is 16.99 Hz followed by its harmonics, which are clearly correspond to the kinematics of the bearing provided by the manufacturer in the relevant technical data sheet. There is a slight offset between

the fundamental frequency calculated using manufacturer data sheet and the results due to the speed variation during the field test.

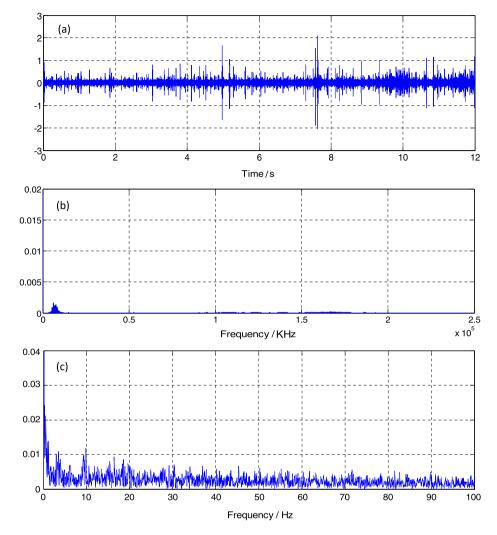
Fig. 8. Onboard AE measurement on bearing with minor defect: Raw data (a) FFT analysis (b) Envelope analysis (c).
