# Cutting resistance of metal-ceramic interpenetrating composites

Liu, Jing; Wu, Jinyu; Binner, Jon

Liu, J, Wu, J & Binner, J 2016, 'Cutting resistance of metal-ceramic interpenetrating composites', *Ceramics International*, vol. 43, pp. 2815-2823. <https://doi.org/10.1016/j.ceramint.2016.11.124>

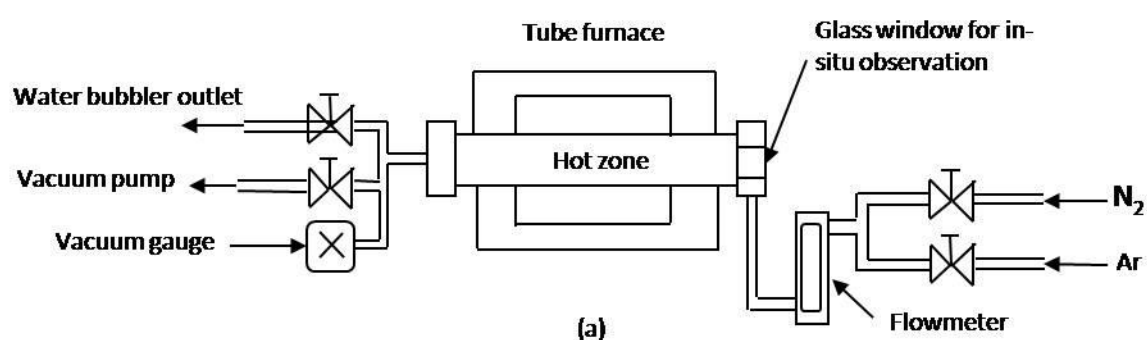
**Figure 1:** Schematic of (a) the furnace arrangement and (b) the arrangement of the metal/ceramic couples inside the tube furnace for the production of metal-ceramic interpenetrating composites (IPCs).

Each metal / ceramic foam couple was loaded into an alumina boat and positioned horizontally in the centre of a tube furnace, figure 1. Previous work had shown that it made no difference which was on top [6,9]. The couple was heated in flowing argon at  $5 \text{ cm}^3\text{min}^{-1}$  to a process temperature of  $915^\circ\text{C}$  when flowing nitrogen at  $20 \text{ cm}^3\text{min}^{-1}$  was substituted for the argon. This changed the wetting characteristics between the molten metal and ceramic foam, allowing the former to penetrate spontaneously through the latter's pores. A detailed study of the wetting process has been published elsewhere [8]. Once infiltration was complete, as observed through a window in the end of the tube furnace, argon was once again fed through as the resulting interpenetrating composite was cooled. Density of the samples was determined following ASTM C20-00[18]. The final products' densities were >99% of theoretical and any porosity was disconnected.

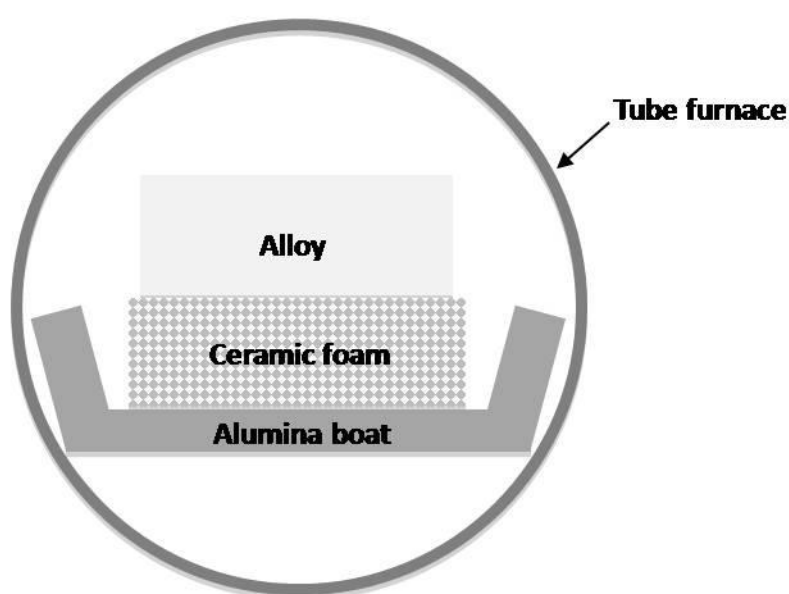
**Figure 2:** Schematic diagrams illustrating a) how the tip of each cut was analysed by SEM (the cut surfaces were also examined) and b) the location of the cross sections removed by DBFIB for imaging and EDS analysis, marked by the white line.

Field emission gun scanning electron microscopy, FEGSEM (LEO 1530VP, Carl Zeiss SMT, Oberkochen, Germany) was used to study the microstructures of the cut faces of the samples, the tip of each cut, figure 2a, and the debris created. To further characterise the microstructures at and beneath the cut tip surface, to enable an

understanding of the cutting mechanism to be developed, a layer of platinum was deposited on some of the samples and a dual-beam focused ion beam scanning electron microscope, DBFIB-SEM (Nova 600 Nanolab, FEI Company, Hillsboro OR, USA) used to obtain cross-sections, Figure 2b, for subsequent imaging and EDS mapping. The cutting edges of the diamond blades were also examined; an infinite focus microscope, IFM ( Alicona UK Ltd., Kent, UK) was used to determine their topography in the form of a 3-D height/roughness map. The morphology of the diamonds was investigated for both new and worn blades using scanning electron microscopy, SEM (Stereoscan 360, Cambridge Instruments/Carl Zeiss SMT, Cambridge, UK). For the worn blade, images were taken before and after thorough cleaning with acetone. All of the SEM images were taken with an accelerating voltage of 10 kV and an emission current of 20 mA. The duration of EDS was 40 seconds per spectrum for spot scans and 30 minutes per image for mapping, respectively. The FIB micrographs were taken with an accelerating voltage of 30 kV and an emission current of 30 pA.

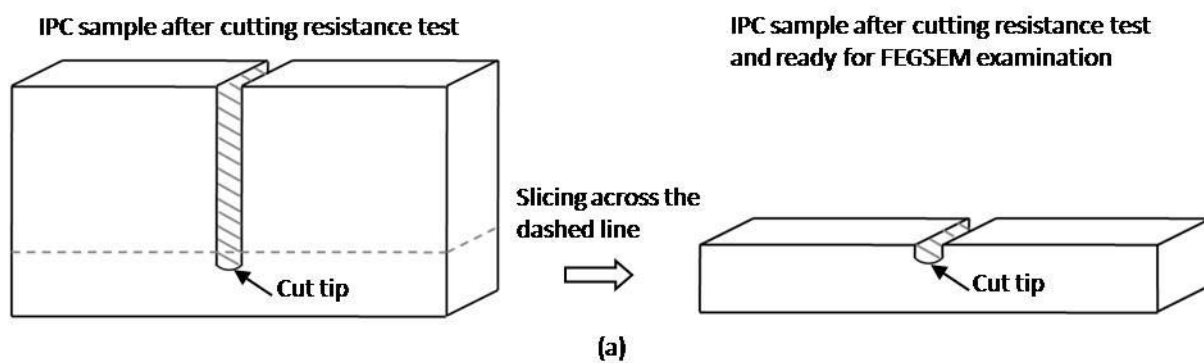
**Figure 3:** Cutting rates of all samples tested

The results of the cutting tests performed are shown in figure 3; obviously the lower the cutting rate, the higher the cutting resistance. As expected, the cutting resistance of either kind of IPC increases with increasing foam density, i.e. higher ceramic content leads to higher cutting resistance. The same result has been observed for

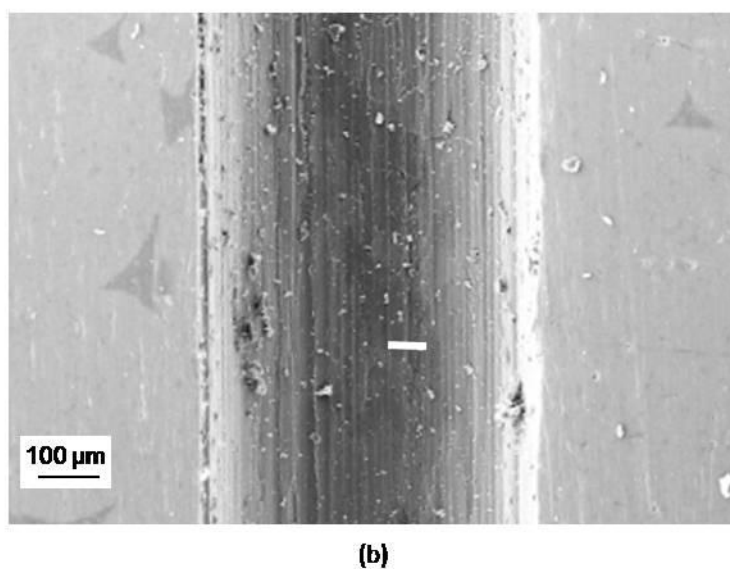
**Figure 4:** Relationship between hardness and cutting rate

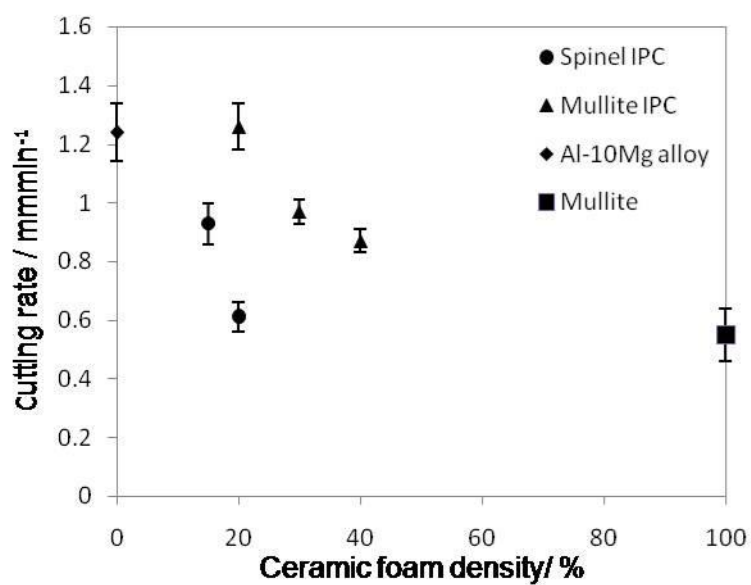
**Figure 5:** SEM micrographs of cut tips in the Al-10Mg/15% spinel-based IPC sample after (a) and (b) 0.5 minute's cutting; (c) and (d) 5 minutes' cutting.

it onto the blade and a simultaneous horizontal shear force arising from the sliding friction between the two sides of the cut sample and the blade. SEM micrographs of the cut tips for the Al-10Mg/15% spinel IPC samples after 0.5 and 5 minutes of cutting are shown in figure 5. Evidence of the two forces at work during cutting, in the form of both 'smearing' and brittle fracture of the metal phase, may be observed in figure 5(b). Severe brittle fracture of a hardened metal phase was also found by Ding et al. [21] at ridges formed in a SiC particle reinforced Al-MMC after cutting at  $50 \text{ mm min}^{-1}$ , with coolant, using a polycrystalline boron nitride (PCBN) cutting tool. Plastic deformation of the metal phase can also be found at the cut tip after longer cutting times, figure 5(c) & (d). The latter can help to absorb energy and improve strength when MMCs are damaged [22].

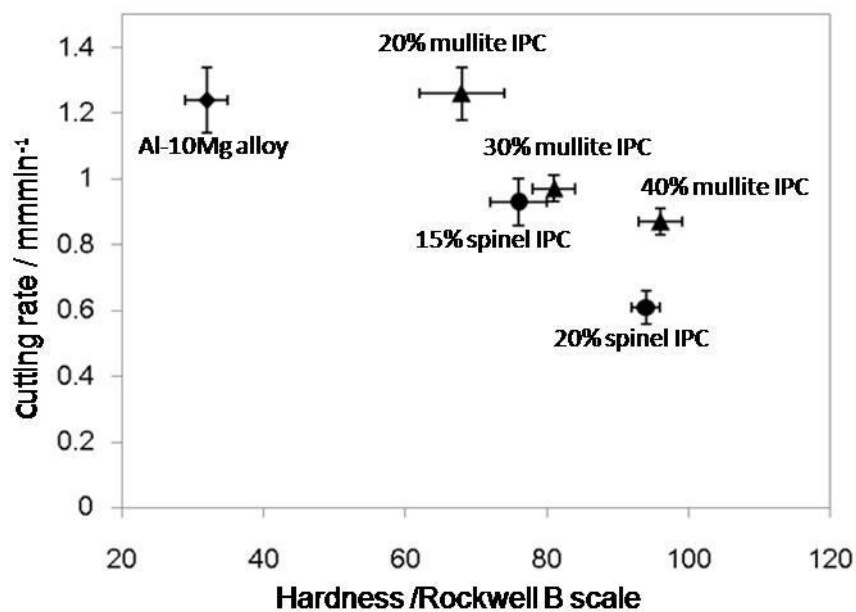
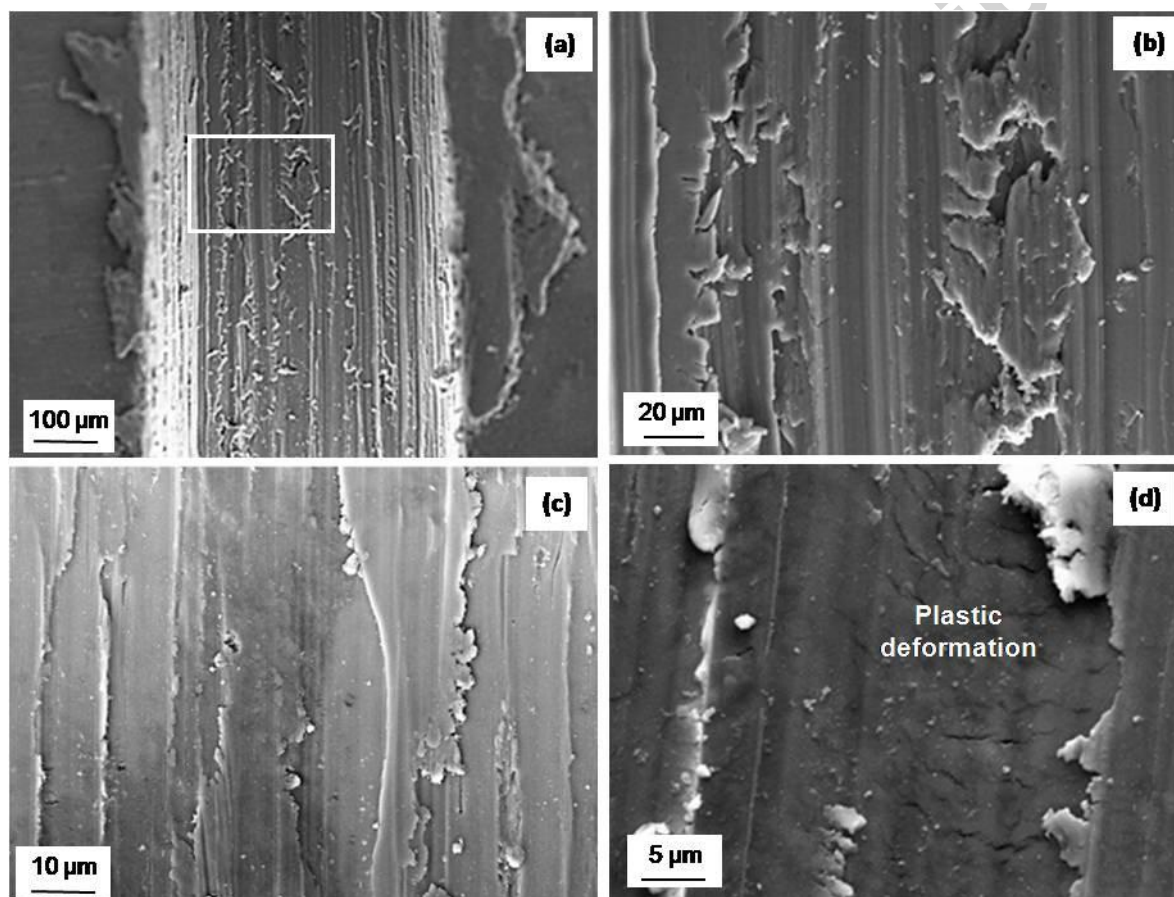
**Figure 6:** (a) Secondary electron and (b) back scattered SEM micrographs of a DBFIB cross section taken from beneath a 30 min cut tip in the 15% spinel IPC and corresponding EDS maps for (c) Al and (d) O. The crack shows evidence of metal bridging.

Since the ceramic phase was rarely observed at the cut tips of any of the IPCs, the 30 min cut tip for the 15% spinel-based IPC was cross-sectioned via DBFIB and the resultant microstructure is shown in figure 6. The ceramic phase appears brighter in the secondary electron image, figure 6(a), but darker in the backscattered electron micrograph, figure 6(b). A  $\sim 1 \mu\text{m}$  thick layer of metal can be observed spread across the surface in figure 6(b), just below the platinum layer deposited prior to FIBing. It is much more difficult to observe it in figure 6(a), though presumably it is also present. It is assumed that this layer was caused by the smearing of the metal phase from within the composite, although it might also have been generated by secondary adhesion of the metal debris that had originally adhered to the blade tip. Ding et al. [21] favoured

A crack can be clearly observed in figure 6; it is assumed that it was formed by the compressive forces present. As shown by the EDS maps for Al (indicating the location of the metal phase) and O (the ceramic phase) in figures 6(c) and (d), respectively, the crack tended to propagate along the ceramic grain boundaries and was bridged by the ductile metal phase. A second, smaller crack was observed beneath the surface metal layer, figure 7. This smoother crack looks as if it might indicate brittle fracture along a grain boundary in the (probably strain hardened) metal phase. According to previous microstructural characterisation of similar IPC samples, micropores in the metal can act as preferential cracking sites [11,23].

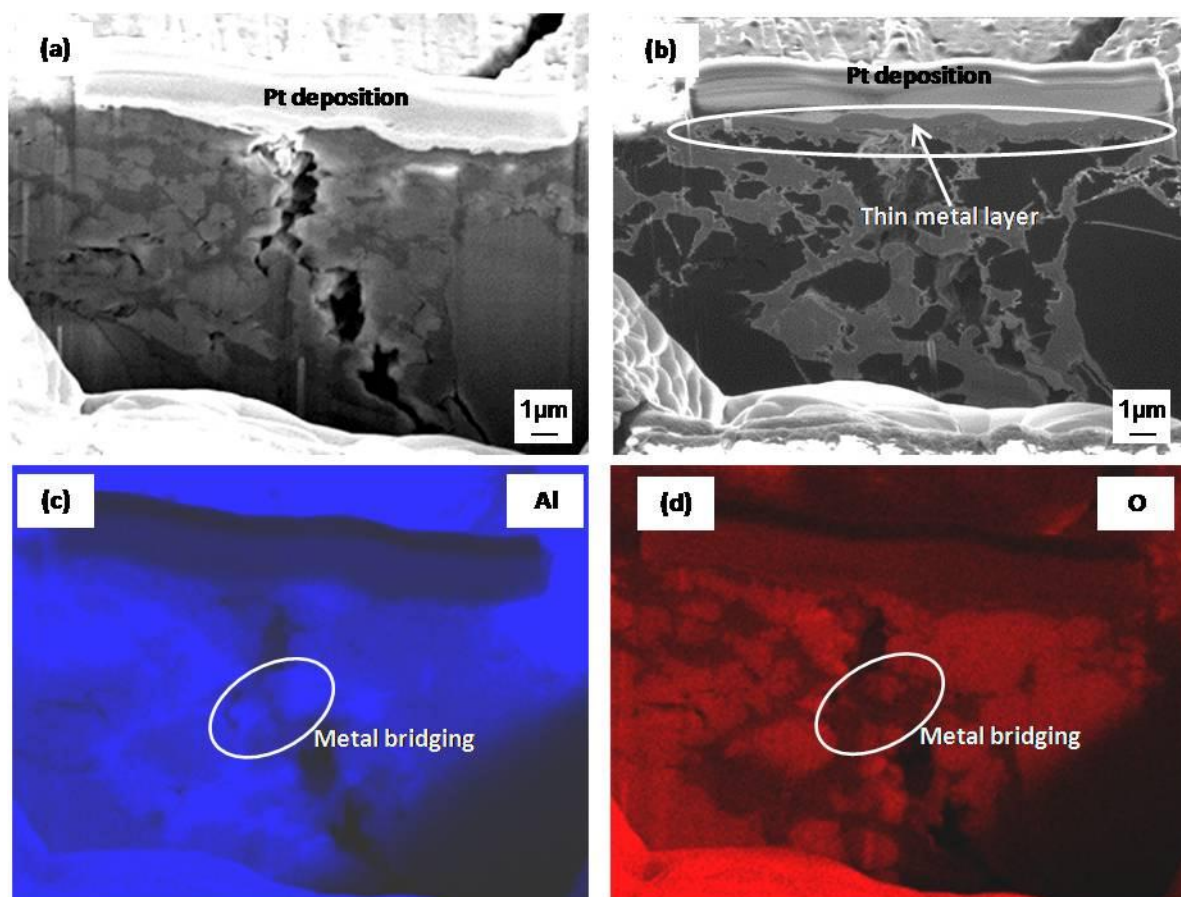
**Figure 7:** A backscattered SEM micrograph of a different crack found below the crack tip in a 15% spinel IPC sample after 30 min of cutting.

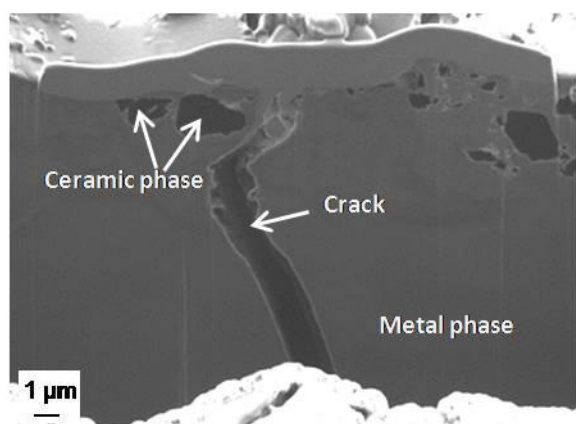
**Figure 8:** (a) An SEM photograph of cut debris from a 20% spinel IPC and (b) EDS analysis of two locations in the same flake showing the presence and absence of the O peak, which is indicative of the presence of the ceramic phase.

Amongst all of the IPC cut tips and cut sections investigated, ceramic-metal debonding was never observed indicating good interfacial bonding between the two phases. This was supported by the analysis of the debris, e.g. figure 8 from the cutting of a 20% spinel IPC sample, which again included both the ceramic and metal phases in each piece of debris.

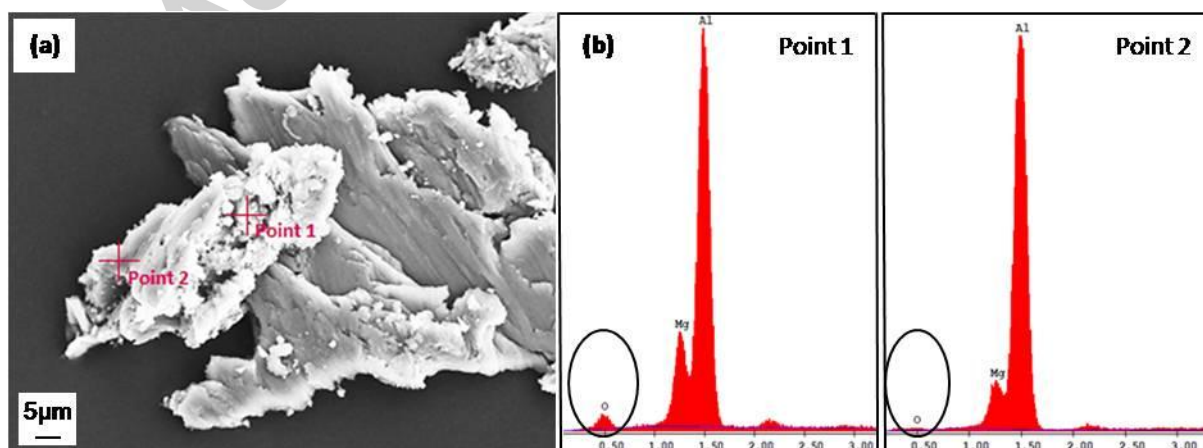
**Figure 9:** SEM images of (a) a diamond in the edge of the copper blade and (b) the void left behind after a diamond had been pulled-out of a blade after use.

The wear of the blade consisted primarily of the pull out of the diamonds, figure 9 (and some wear of the copper substrate). The extent of the damage can be seen from the infinite focus microscope, IFM, maps of new and used blades, figure 10. It is believed that the diamonds were pulled out mainly by the adhesion of the metal phase during cutting; figure 11 shows the diamond-studded edge of (a) a new blade and (b) a blade just after cutting, which shows a layer of ductile metal largely covering the diamonds. The metal layer can clearly be removed by cleaning, figure 11(c). A more detailed observation of the old blade just after cutting, showing severe debris built-up, is shown in figures 11(d) and (e). This 'built-up edge' (BUE) phenomenon has been reported several times in the literature for the cutting of MMCs [24-26]. Manna et al. [26] defined BUE as the repeated addition of debris to the blade edge under conditions of high friction, pressure and temperature. It is probable that as the adhering debris is removed during cleaning to expose the diamonds again, some of the latter are plucked out. Andrewes et al. [27] proposed the idea that in the initial stage of cutting Al/SiC composites, the flank wear of the polycrystalline diamond (PCD) tooling was mainly abrasive wear by the ceramic phase, but, as cutting progressed, both this and adhesive wear by the removal of the adhered metal phase occurred. Similar results were seen in the current work, as illustrated by figure 12, which shows the occurrence of cracking, chipping, surface spalling and diamond pullout at a used blade edge.

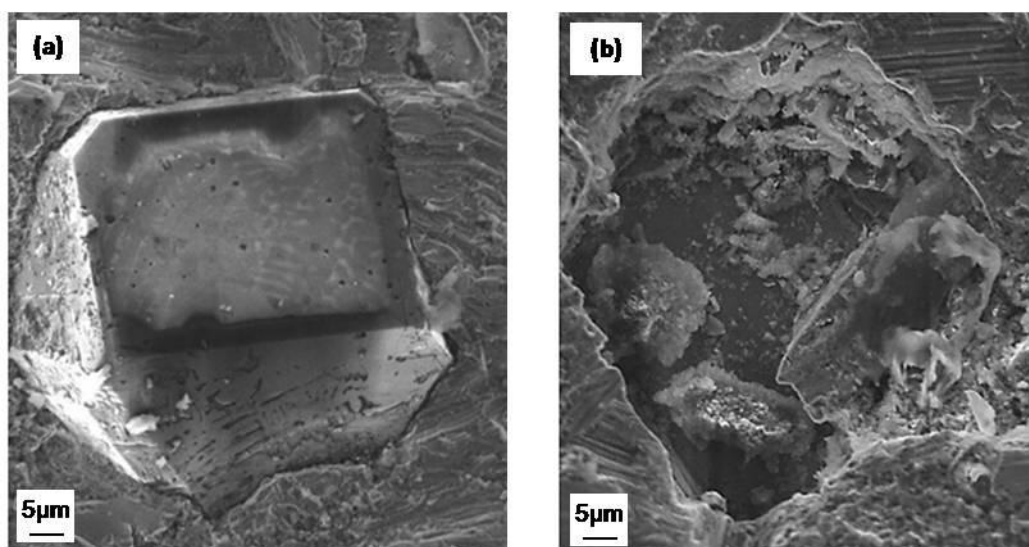
**Figure 10:** Infinite focus microscope, IFM, maps of the edges of (a) a new diamond cutting blade and (b) an old blade.

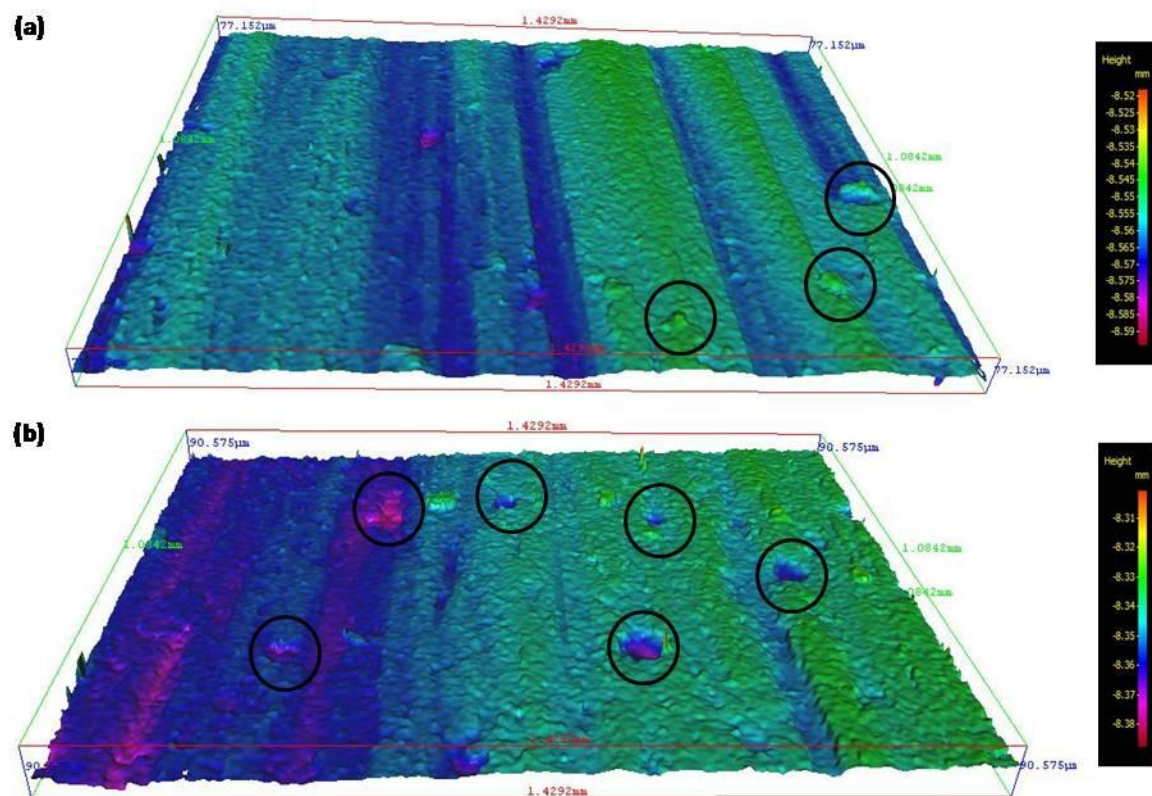
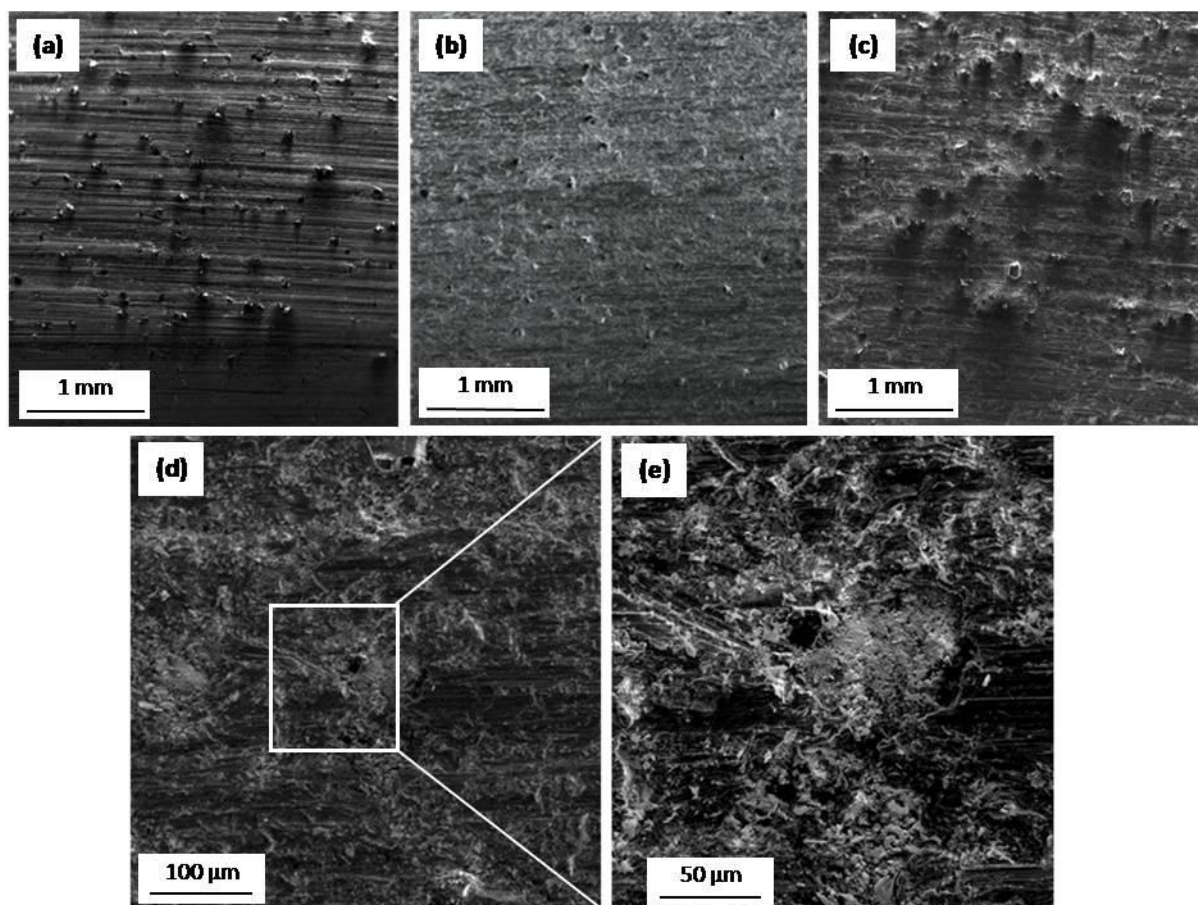
**Figure 11:** SEM micrographs of the diamond-studded edge of (a) a new blade, (b) a used blade just after cutting, (c) the same blade after cleaning. (d) and (e) show the debris build up during cutting at higher magnifications.

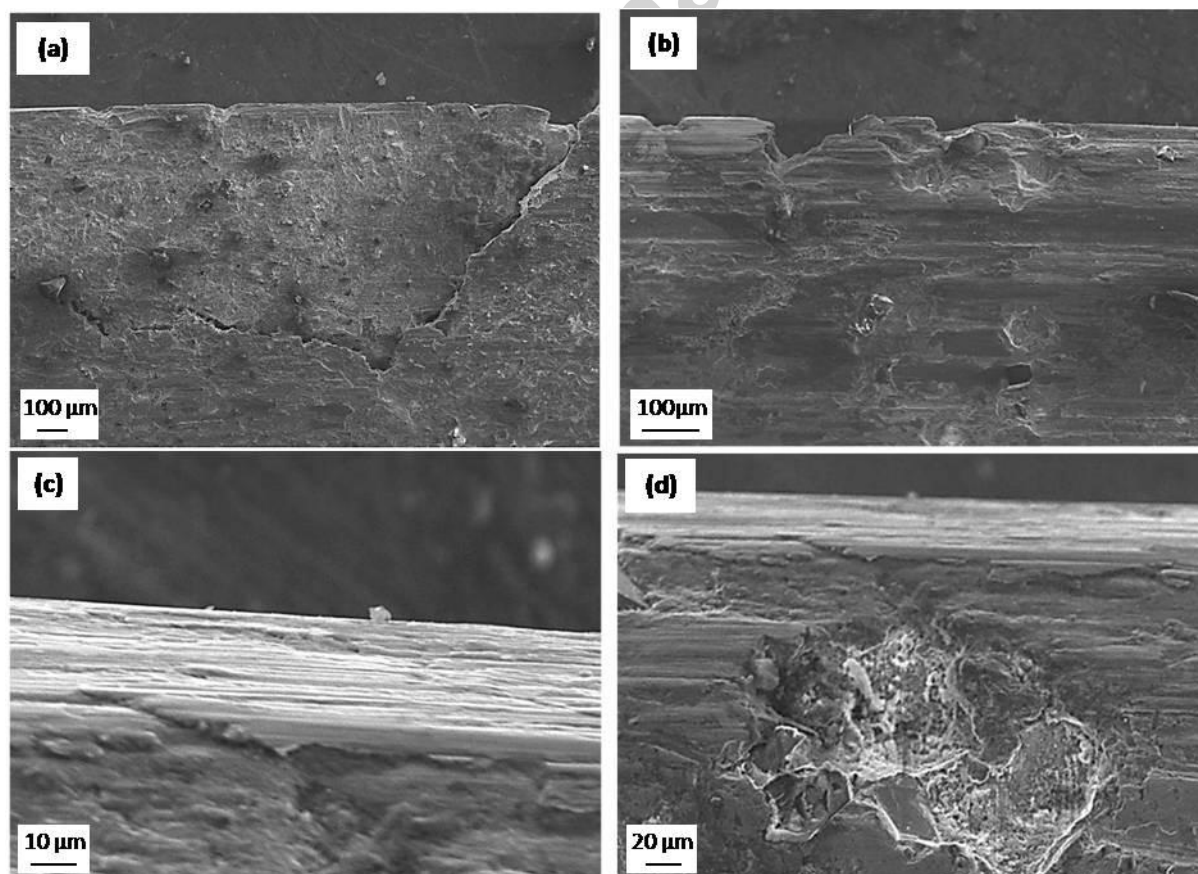
**Figure 12:** SEM photographs of (a) cracking, (b) chipping, (c) surface spalling and (d) diamond pullout at a used blade edge.

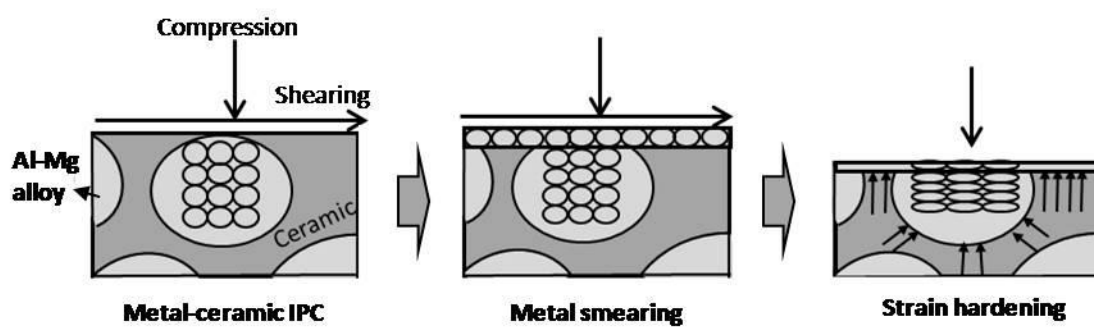
**Figure 13:** Proposed schematic of a metal-ceramic IPC under the twin actions of compression and shearing during cutting.

Whilst it is well-known that the high hardness of the continuous ceramic phase in ceramic reinforced IPCs is the primary contributing factor to their excellent cutting resistance, it is believed that the metal phase also contributes, figure 13. When a metal-ceramic IPC is compressed and sheared, some of the metal phase in the ceramic cells is extruded and smeared across the surface, forming, it is believed, a strain hardened thin metallic layer in a manner similar to the drawing of a metal [28]. As a consequence, it takes more stress to deform the metal phase after continuous cutting for a period of time. The significant effect of dislocation density on yield stress is shown in the equation below [28]:
