## Corrosion Fatigue Studies on a Bulk Glassy Zr-Based Alloy under Three-Point Bending

# Corrosion Fatigue Studies on a Bulk Glassy Zr-Based Alloy under Three-Point Bending

**Keywords:** bulk amorphous alloys, corrosion fatigue, mechanical characterization, fracture, shear bands

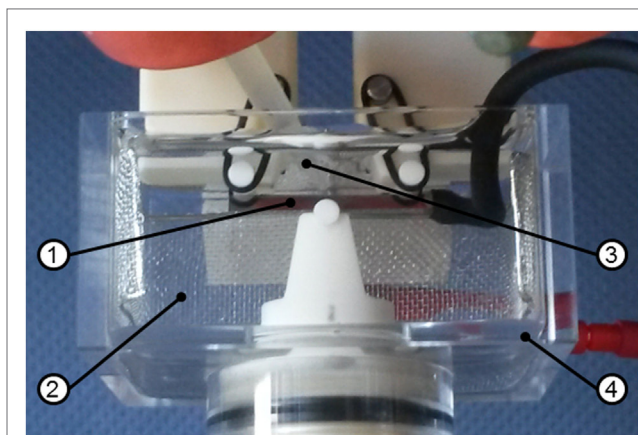
**FIGURE 1 |** Set-up of the electrochemical cell for corrosion fatigue experiments, including the sample (1) as working electrode, a fine platinum mesh (2) as counter electrode, an agar salt bridge (3) connected to the saturated calomel electrode reference electrode and an acrylic glass container (4) filled with 0.01 M Na<sub>2</sub>SO<sub>4</sub> + 0.01 M NaCl.

electrode and a [saturated calomel electrode (SCE),  $E = 0.241$  V vs. standard hydrogen electrode] as reference. All potential values in this work are referred to this reference electrode. The connection between the electrochemical cell and the reference electrode was achieved by an agar salt bridge-containing 1 M KCl solution for high charge transport.

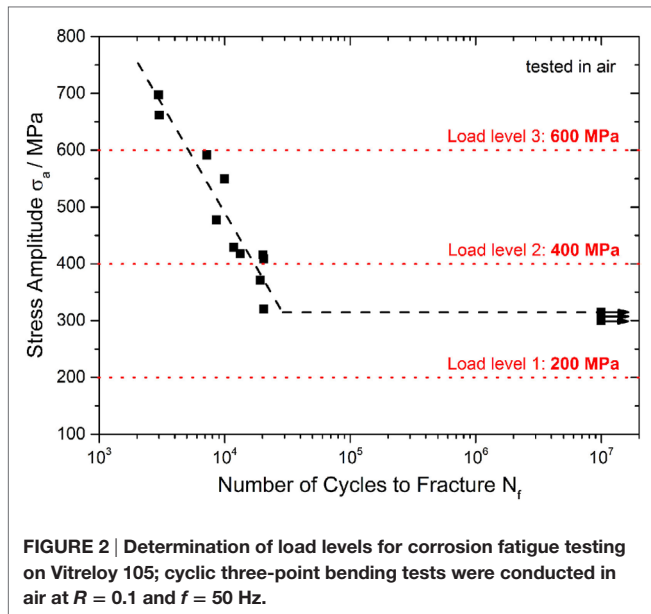
In order to select three load levels for CF tests, the S–N curve of the bulk glassy Zr<sub>52.5</sub>Cu<sub>17.9</sub>Al<sub>10</sub>Ni<sub>14.6</sub>Ti<sub>5</sub> alloy was determined in air (**Figure 2**). The black trend line characterizes the fatigue life of the tested Vitreloy 105 samples, and horizontal arrows denote runouts that endured more than  $10^7$  load cycles. It should be noted that the real fatigue strength of Vitreloy 105 was determined at  $\sigma_a = 315$  MPa. When assuming an ultimate tensile strength

of  $\sigma_{UTS} = 1,700$  MPa [only determined for Vitreloy 105 under four-point bending conditions (Morrison et al., 2007b)], there is a normalized fatigue limit of  $\sigma_a/\sigma_{UTS} = 0.19$ . The load levels for later CF tests were chosen in order to cover an interval of number of cycles to fracture as wide as possible.

of Vitreloy 105 and should be discussed in correlation with the fatigue behavior in air (see S–N curve in **Figure 2**). Although all three selected potentials are located in the anodic regime enabling pitting corrosion [all three potentials are higher than the repassivation potential, i.e., mean value  $-99$  mV vs. SCE, SD 28 mV (Gostin et al., 2015a)], there seems to be a lifetime extending effect of the most negative potential, i.e.,  $-50$  mV vs. SCE, and an obviously degrading effect of  $0$  mV vs. SCE and  $+50$  mV vs. SCE, which are closer to the critical pitting potential  $E_p$  (Gostin et al., 2015a) compared to the results of the samples tested in air. The fine grading of the chosen potentials offers a much more explicit view on the electrochemical influence of fatigue life than the research of Morrison et al. (2007a) who distinguished only between anodic polarization at  $100$  mV vs. SCE and cathodic polarization at  $-900$  mV vs. SCE in aqueous  $0.6$  M NaCl solution. Their research also detected an environmental degradation mechanism only at anodic potentials and concluded that anodic dissolution is responsible for the negative effect. That assumption is in good accordance with the results of our recent CF reference tests in halide-free  $0.01$  M  $\text{Na}_2\text{SO}_4$  solution, where no negative effect on fatigue life could be detected. So, we consider the increased pitting propensity in presence of chloride ions to be the driving force during crack propagation.

1. The S–N curve was determined under cyclic three-point bending conditions at  $R = 0.1$  in air, and the highest fatigue endurable stress amplitude is  $\sigma_a = 315$  MPa;

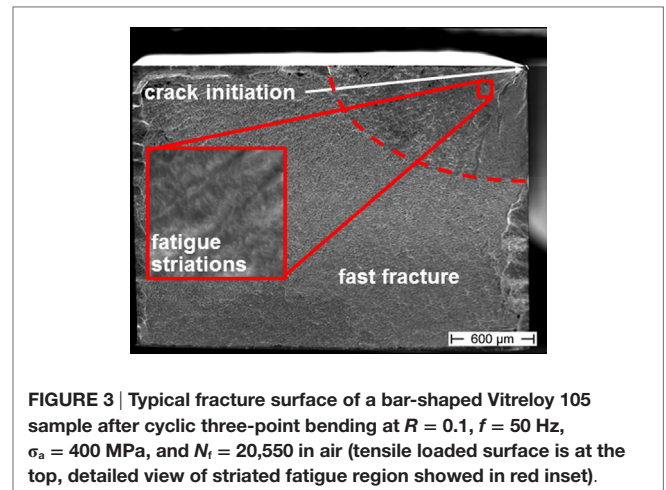
Fractographic analysis of samples fractured in air revealed characteristic features of Zr-based BMG fracture surfaces as also detected in Hess et al. (2006) and Morrison et al. (2007b). **Figure 3** shows a representative fracture surface of the three-point bending fatigue samples. Cracks were found to initiate at the tensile stressed surface, especially at sample edges starting from small surface defects or sometimes at near-surface micropores that act as supplementary stress concentrators (not shown here). Stable crack growth occurred in the quarter-elliptical fatigue region that is characterized by fine striations (see red inset in **Figure 3**) that result from stepwise crack propagation along small shear bands arising in the plastic zone in front of the crack tip. However, crack propagation could not be correlated directly to striation spacing, which suggests that there is an accumulation of damage over several loading cycles as also reported by Liu et al. (2015). The area of fatigue crack growth covered between 6 and 35% of the whole fracture surface in the present study. After passing a sharp transition region, the crack propagates much faster until final fracture occurs. The resulting fast fracture region has a characteristic vein-like morphology, which is commonly observed in BMGs.

The large scatter in fatigue lifetimes during cyclic bending tests in air, mainly visible around the  $\sigma_a = 400$  MPa load level, is

explained by a varying sample quality. Fracture can be influenced by micropores with sizes up to  $50 \mu\text{m}$  as well as by other material imperfections (e.g., unmolten particles). The formation of such defects during the suction casting process could not be avoided completely. Both features led to a shifting of the crack initiation site from the tensile-stressed surface to inner regions in some cases, and this could also be detected on the fracture surface.

Besides the bending fatigue samples tested in air, which showed the characteristic features on their fracture surfaces (see **Figure 3**), the polarized samples have also been investigated by SEM. The observed fractographic characteristics are presented exemplarily in **Figure 7** on a CF sample tested at  $\sigma_a = 388$  MPa and an anodic potential of  $0$  mV vs. SCE.

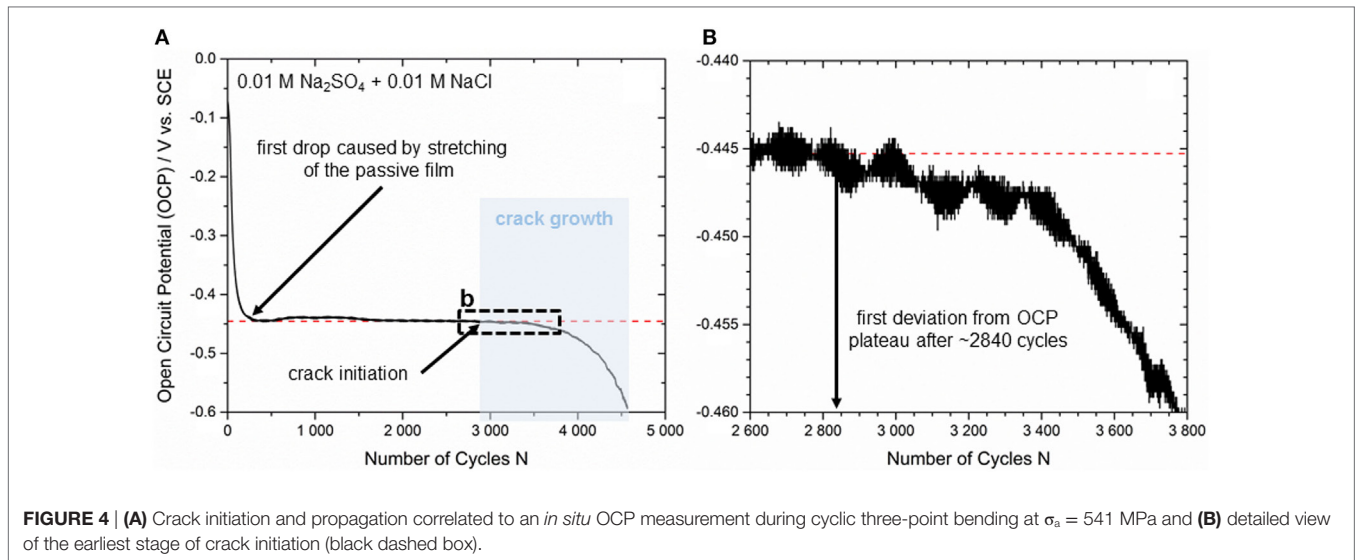
Before mechanical testing was started, the bending samples have been immersed in  $0.01 \text{ M Na}_2\text{SO}_4 + 0.01 \text{ M NaCl}$  solution for 45–60 min until the changes in OCP were less than  $2 \text{ mV}/5 \text{ min}$ . According to that, OCP was in a steady state (mean value from all tests  $\sim 165 \text{ mV}$  vs. SCE) when the first loading cycle was applied. Since the mechanical pre-load to ensure exact positioning of the samples in the three-point mounting was set to only  $\sim 50\%$  of the maximum stress prior to cyclic loading, there was a significant drop in OCP from  $-74 \pm 5 \text{ mV}$  vs. SCE to  $-445 \pm 5 \text{ mV}$  vs. SCE when the test started, and the maximum load was achieved for the first time. This effect is caused by a sudden stretching of the passive

layer as a consequence of extended flexure on the tensile loaded surface. Subsequently, repassivation started and there is a slight but steady increase visible in the OCP curve. Because of the high sensitivity of the electrochemical set-up and as a result of small vibrations in the corrosion cell during cyclic loading, there is a little deviation in OCP until a significant plateau at  $-450 \pm 10$  mV is reached (see red dotted line in **Figure 4A**). Our results are also in good agreement with the observations of Morrison et al. (2007a) as the plateau levels are supposed to depend on the loading level. Cyclic testing at  $\sigma_a = 400$  MPa led to a steady OCP value of  $-300 \pm 10$  mV vs. SCE, while testing at  $\sigma_a = 650$  MPa generated an OCP value of  $-500 \pm 10$  mV vs. SCE. However, the first deviation from the stable plateau in terms of a smooth drop of the OCP is detected after  $2,840 \pm 10$  loading cycles (see **Figure 4B**) for the presented sample. This drop indicates the earliest stage of crack initiation at the tensile-stressed sample surface. It can be assumed that the OCP changes immediately since in the crack region the bare metal surface is exposed to the electrolyte. A continuous decrease in OCP characterizes the following stable crack growth section (**Figure 4A**, marked in blue), which can be correlated to stable fatigue crack propagation detected by fine striations on the fracture surface. Further small drops in OCP are supposed to be related to locally increased crack growth velocity before crack tip blunting delays crack propagation. The OCP signal decreases until sample fracture after  $4,530 \pm 10$  cycles, and therefore, the section of stable crack growth is suggested to be  $(4,530 - 2,840) / 4,530 \approx 37 \pm 1\%$  of the whole fatigue life. An additional analysis of the equivalent fracture surface (not shown here) reveals a fatigue crack region of  $0.53 \text{ mm}^2$  delivering a fraction of only  $11 \pm 1\%$  with respect to the total cross section of  $4.76 \text{ mm}^2$ . Furthermore, the rate of decrease (or the slope) of the OCP curve increases uniformly as expected in accordance with increasing crack growth velocity. As the stable crack growth regime determined by the OCP analysis is significantly larger than the fatigue fraction at the fracture surface, we suppose that the highly sensitive electrochemical response also considers early

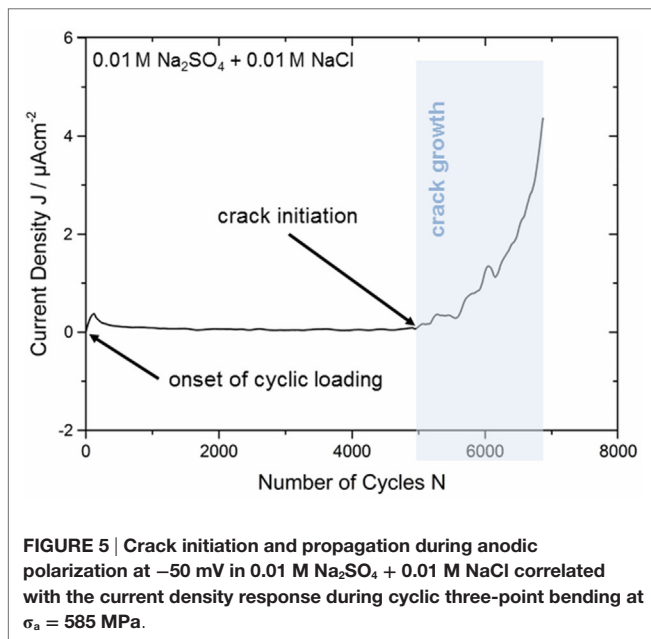
When applying a potential of  $-50$  mV vs. SCE, the current density establishes at a nearly constant value slightly above  $0 \text{ } \mu\text{Acm}^{-2}$  due to almost equal cathodic and anodic currents as expected in a regime so close to the corrosion potential. This steady state was achieved after  $\sim 200$  s, and mechanical loading was started subsequently. Due to the onset of cyclic loading, the current density shows a sharp peak (see **Figure 5**) and this is attributed to the stretching of the passive layer as described for the OCP measurements in Section “Crack Growth Analysis by OCP Measurement” above. This is followed by a continuous decrease until a second plateau is attained at  $\sim 0.2 \text{ } \mu\text{A cm}^{-2}$ . The current density remains at a nearly constant level, which is

slightly above the value in the mechanically unloaded regime because the passive film is constantly altered by the cyclic stress. Since the scatter in the current density curve is very small, the point of passive film breakdown can be detected quite exactly after  $4,880 \pm 10$  loading cycles. Thereby, the fatigue crack initiates at the tensile stressed sample surface and breaks the passive layer locally. Then, the current response starts to increase steadily as a result of stable crack propagation and related local metal dissolution. Several sudden current drops occur and these phenomena may be related to variations in the crack growth rate and short-term delay of crack propagation. Shear banding processes in the plastic zone in front of the crack tip are expected to cause crack tip blunting, and multiple shear bands can lead to changes of the crack path until the sample finally failed after  $6,885 \pm 10$  loading cycles. Such a delayed crack growth was also detected for bainitic and martensitic steels by Suresh et al. (1981). They observed the generation of oxide films within the crack during mechanical testing at low loading ratios ( $R = 0.05$ ) in moist atmospheres. In case of small crack tip opening displacements that are present especially at early fatigue fracture stages, these oxide layers lead to an earlier contact between both crack surfaces. As a consequence, the authors suggested a raise in the critical stress intensity factor  $K_c$  and a reduced effective  $\Delta K$  in the crack tip region. Due to comparable testing conditions, a similar mechanism could be supposed in our current investigation on Zr-based bulk metallic glass. However, oxidization processes within the propagating crack as a result of repassivation events should be clearly detectable by drops in the current response (see stable crack growth regime in **Figure 5**). The fraction of stable fatigue crack propagation related to the number of cycles to failure is  $29 \pm 1\%$  and thus  $\sim 21.6\%$  lower than the fraction determined at comparable stresses by *in situ* OCP analysis in Section “Crack Growth Analysis by OCP Measurement.” However, it should be noted that fatigue life could be extended by more than 50% due to anodic

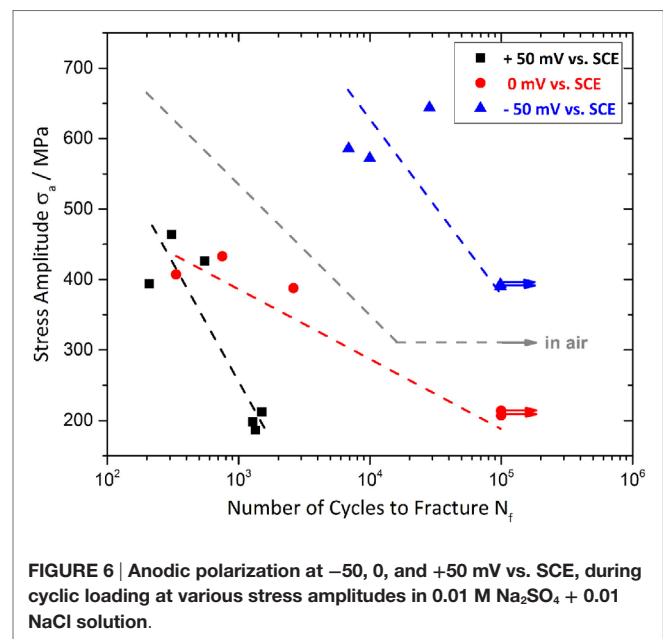
Further tests at anodic potentials of  $0$  mV vs. SCE and  $+50$  mV vs. SCE were conducted under cyclic three-point bending conditions, i.e., at higher potentials that are still in the  $E_p$ – $E_R$  regime (Gostin et al., 2015a). In that context, the present research focusses on the interaction between mechanically and electrochemically induced fractures. **Figure 6** exhibits the results of CF testing in  $0.01$  M  $\text{Na}_2\text{SO}_4$  +  $0.01$  M  $\text{NaCl}$ . Thereby, three comparable tests were conducted for every anodic potential and stress amplitude in case of sample fracture or until two runouts (marked by horizontal arrows) were achieved. The dotted lines characterize only the trend of fatigue lives for the different testing conditions and are not very representative because of the restricted number of specimens and the low runout limit of  $10^5$  loading cycles.

The results in **Figure 6** reveal a distinct influence of the stress level as well as of the applied anodic potential on the fatigue life

Our results reveal a mean number of cycles to failure of  $18,290 \pm 10$  in air,  $375 \pm 10$  cycles at  $+50$  mV vs. SCE,  $1,234 \pm 10$  cycles at  $0$  mV vs. SCE, and two runouts for  $-50$  mV vs. SCE (all tests around  $\sigma_a = 400$  MPa). Therefore, a superimposed effect of both anodic dissolution and repassivation processes at the crack tip is suggested to influence CF behavior of Vitreloy 105 essentially with the predominant effect depending on the selected anodic potential. Consequently,  $-50$  mV vs. SCE is slightly more noble than the repassivation potential  $E_R = -99$  mV vs. SCE meaning a lower tendency to anodic dissolution and increased repassivation tendency preventing the sample from fracture within  $10^5$  loading cycles. The fact that even longer fatigue lifetimes than in air were detected at  $-50$  mV vs. SCE could be explained by an oxide-induced crack closure, which was already described above (Suresh et al., 1981). Whereas, anodic polarization at  $+50$  mV vs. SCE is passing closer to the pitting potential of  $E_p = 297$  mV vs. SCE and reinforces the creation of corrosion pits and anodic dissolution. An anodic potential of  $0$  mV vs. SCE seems to have

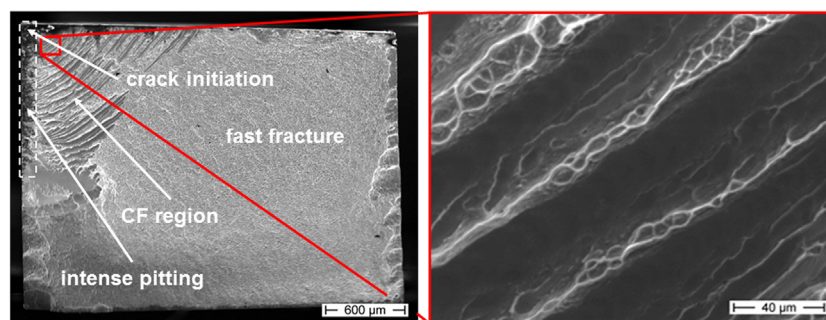
The main features are comparable to those observed for the non-polarized samples indicating a clear crack initiation site, a presumably quarter-elliptic (corrosion) fatigue region, and a large fast fracture area with significant cleavage near the left and right sample edges. Especially the tensile stressed surface areas in the upper left of **Figure 7** exhibit intense pitting corrosion in terms of dark areas near the sample surface (marked by white dotted box). The pits which are detected as dark areas can reach up to  $\sim 150$   $\mu\text{m}$  into the sample. While the fast fracture region is characterized by the typical vein-like morphology (not shown here in higher magnification), the CF striations appear much broader than the striations generated under open circuit conditions or in air. The red inset in **Figure 7** gives a representative and more detailed image of typical CF striations. Alternating smooth

**FIGURE 7 |** Fracture surface of a corrosion fatigue (CF) sample tested at an anodic potential of  $0$  mV,  $\sigma_a = 388$  MPa, and  $N_f = 2,616$ , in  $0.01$  M  $\text{Na}_2\text{SO}_4 + 0.01$  M NaCl (tensile loaded surface is at the top, detailed view of striated corrosion fatigue region showed in red inset).

dark regions and brighter areas with vein-like structures offer interesting information about the related CF fracture mechanisms. The striation spacing increases from the crack initiation site to the fast fracture transition area. In consequence of these observations, there are two possible mechanisms suggested that are interfering with each other during anodic polarization and simultaneous cyclic loading. The smooth areas of the broad striated CF region may result from anodic dissolution and related cleavage along shear bands while the vein-like morphology might be caused by abrupt fast fracture. Besides the samples tested at 0 mV vs. SCE also those tested at +50 mV vs. SCE revealed those broader striations than in air consisting of alternating smooth and vein-like areas. In contrast, an anodic polarization at -50 mV vs. SCE led to fracture surfaces comparable to those in air with a lack of these broad striations. A subsequent investigation of the elemental distribution could contribute to the clarification of the involved processes (later in the text).

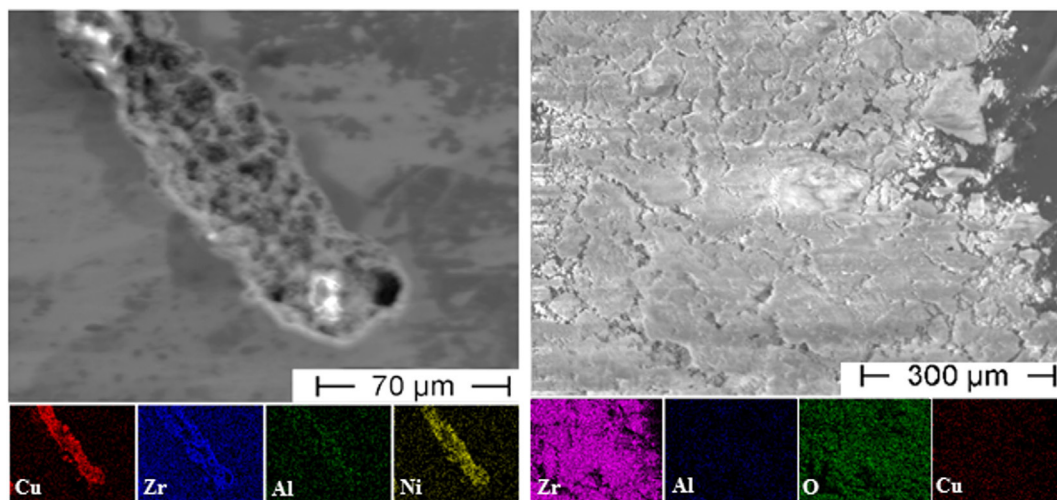
The onset of anodic dissolution could be determined easily during CF testing under potentiostatic control. Characteristic corrosion products developed at the crack tip and spread out quickly. After the experiment, it was possible to gather the dissolved material in form of fine powder at the bottom of the electrochemical cell and to extract it from the residual electrolyte. This powder was investigated by EDX as well, and the results are shown in **Figure 8** (right). As expected, it consists basically of Zr and O while only traces of Cu could be detected. However, the fraction of Al seems to be smaller than expected due to the results from the corrosion pit, but this element could be detected poorly overall.

**FIGURE 8 |** Energy dispersive X-ray analysis of a corrosion pit at the side surface of the bending sample (left) and of the dissolved material extracted from the electrolyte as powder after testing (right).
