Corrosion Fatigue Studies on a Bulk Glassy Zr-Based Alloy under Three-Point Bending

Corrosion fatigue (CF) tests were carried out on bulk glassy $Zr_{52.5}Cu_{17.9}Al_{10}Ni_{14.6}Ti_5$ (Vitreloy 105) samples under load-controlled three-point bending conditions with a load ratio of $R = 0.1$ in 0.01 M $Na_2SO_4 + 0.01$ M $NaCl$ electrolyte. During cyclic testing, the bar-shaped specimens were polarized *in situ* at constant potentials and the current was monitored. Three different anodic potentials within the interval between the pitting potential E_P and the repassivation potential E_R and three different load amplitudes were applied. In some cases, *in situ* microscopic observations revealed the formation of black corrosion products in the vicinity of the crack tip during anodic polarization. Fractographic analysis revealed a clear distinction between two modes of crack growth characterized by smooth dissolution induced regions on the one hand and slim fast fracture areas on the other hand. Both alternating features contributed to a broad-striated CF fracture surface. Moreover, further fatigue tests were carried out under free corrosion conditions yielding additional information

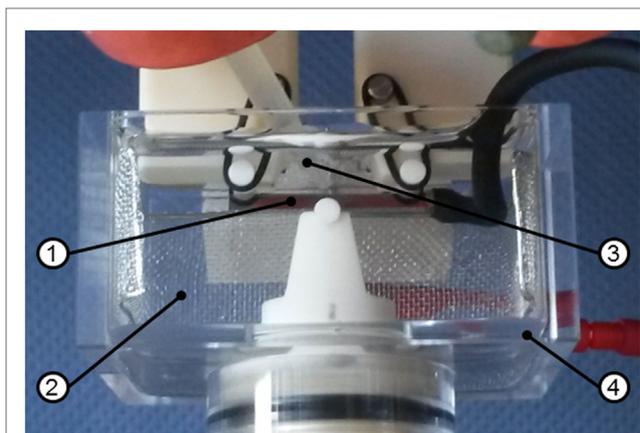
FIGURE 1 | Set-up of the electrochemical cell for corrosion fatigue experiments, including the sample (1) as working electrode, a fine platinum mesh (2) as counter electrode, an agar salt bridge (3) connected to the saturated calomel electrode reference electrode and an acrylic glass container (4) filled with 0.01 M Na₂SO₄ + 0.01 M NaCl.

electrode and a [saturated calomel electrode (SCE), $E = 0.241$ V vs. standard hydrogen electrode] as reference. All potential values in this work are referred to this reference electrode. The connection between the electrochemical cell and the reference electrode was achieved by an agar salt bridge-containing 1 M KCl solution for high charge transport.

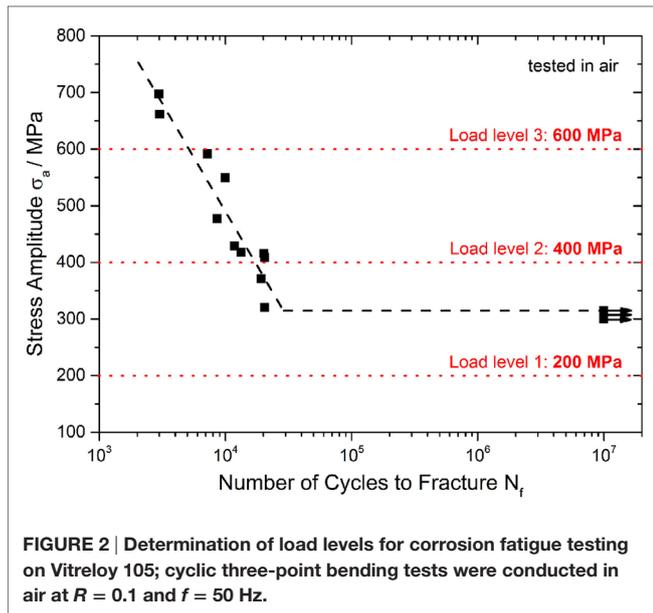
In order to select three load levels for CF tests, the S–N curve of the bulk glassy Zr_{52.5}Cu_{17.9}Al₁₀Ni_{14.6}Ti₅ alloy was determined in air (**Figure 2**). The black trend line characterizes the fatigue life of the tested Vitreloy 105 samples, and horizontal arrows denote runouts that endured more than 10^7 load cycles. It should be noted that the real fatigue strength of Vitreloy 105 was determined at $\sigma_a = 315$ MPa. When assuming an ultimate tensile strength

of $\sigma_{UTS} = 1,700$ MPa [only determined for Vitreloy 105 under four-point bending conditions (Morrison et al., 2007b)], there is a normalized fatigue limit of $\sigma_a/\sigma_{UTS} = 0.19$. The load levels for later CF tests were chosen in order to cover an interval of number of cycles to fracture as wide as possible.

of Vitreloy 105 and should be discussed in correlation with the fatigue behavior in air (see S–N curve in **Figure 2**). Although all three selected potentials are located in the anodic regime enabling pitting corrosion [all three potentials are higher than the repassivation potential, i.e., mean value -99 mV vs. SCE, SD 28 mV (Gostin et al., 2015a)], there seems to be a lifetime extending effect of the most negative potential, i.e., -50 mV vs. SCE, and an obviously degrading effect of 0 mV vs. SCE and $+50$ mV vs. SCE, which are closer to the critical pitting potential E_p (Gostin et al., 2015a) compared to the results of the samples tested in air. The fine grading of the chosen potentials offers a much more explicit view on the electrochemical influence of fatigue life than the research of Morrison et al. (2007a) who distinguished only between anodic polarization at 100 mV vs. SCE and cathodic polarization at -900 mV vs. SCE in aqueous 0.6 M NaCl solution. Their research also detected an environmental degradation mechanism only at anodic potentials and concluded that anodic dissolution is responsible for the negative effect. That assumption is in good accordance with the results of our recent CF reference tests in halide-free 0.01 M Na_2SO_4 solution, where no negative effect on fatigue life could be detected. So, we consider the increased pitting propensity in presence of chloride ions to be the driving force during crack propagation.

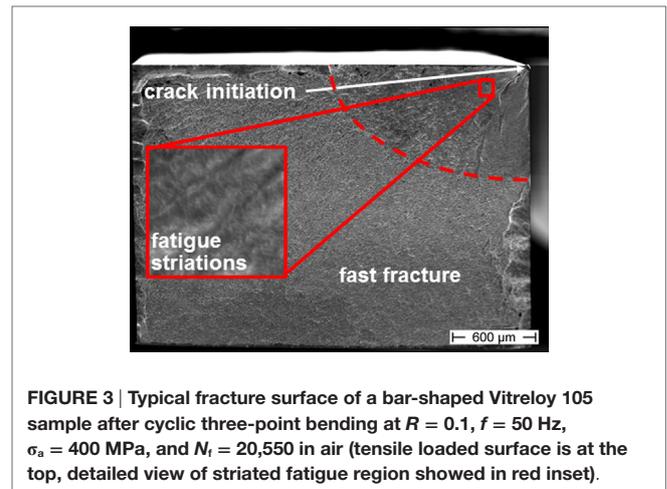
Fractographic analysis of samples fractured in air revealed characteristic features of Zr-based BMG fracture surfaces as also detected in Hess et al. (2006) and Morrison et al. (2007b). **Figure 3** shows a representative fracture surface of the three-point bending fatigue samples. Cracks were found to initiate at the tensile stressed surface, especially at sample edges starting from small surface defects or sometimes at near-surface micropores that act as supplementary stress concentrators (not shown here). Stable crack growth occurred in the quarter-elliptical fatigue region that is characterized by fine striations (see red inset in **Figure 3**) that result from stepwise crack propagation along small shear bands arising in the plastic zone in front of the crack tip. However, crack propagation could not be correlated directly to striation spacing, which suggests that there is an accumulation of damage over several loading cycles as also reported by Liu et al. (2015). The area of fatigue crack growth covered between 6 and 35% of the whole fracture surface in the present study. After passing a sharp transition region, the crack propagates much faster until final fracture occurs. The resulting fast fracture region has a characteristic vein-like morphology, which is commonly observed in BMGs.

explained by a varying sample quality. Fracture can be influenced by micropores with sizes up to $50 \mu\text{m}$ as well as by other material imperfections (e.g., unmolten particles). The formation of such defects during the suction casting process could not be avoided completely. Both features led to a shifting of the crack initiation site from the tensile-stressed surface to inner regions in some cases, and this could also be detected on the fracture surface.

Besides the bending fatigue samples tested in air, which showed the characteristic features on their fracture surfaces (see **Figure 3**), the polarized samples have also been investigated by SEM. The observed fractographic characteristics are presented exemplarily in **Figure 7** on a CF sample tested at $\sigma_a = 388$ MPa and an anodic potential of 0 mV vs. SCE.

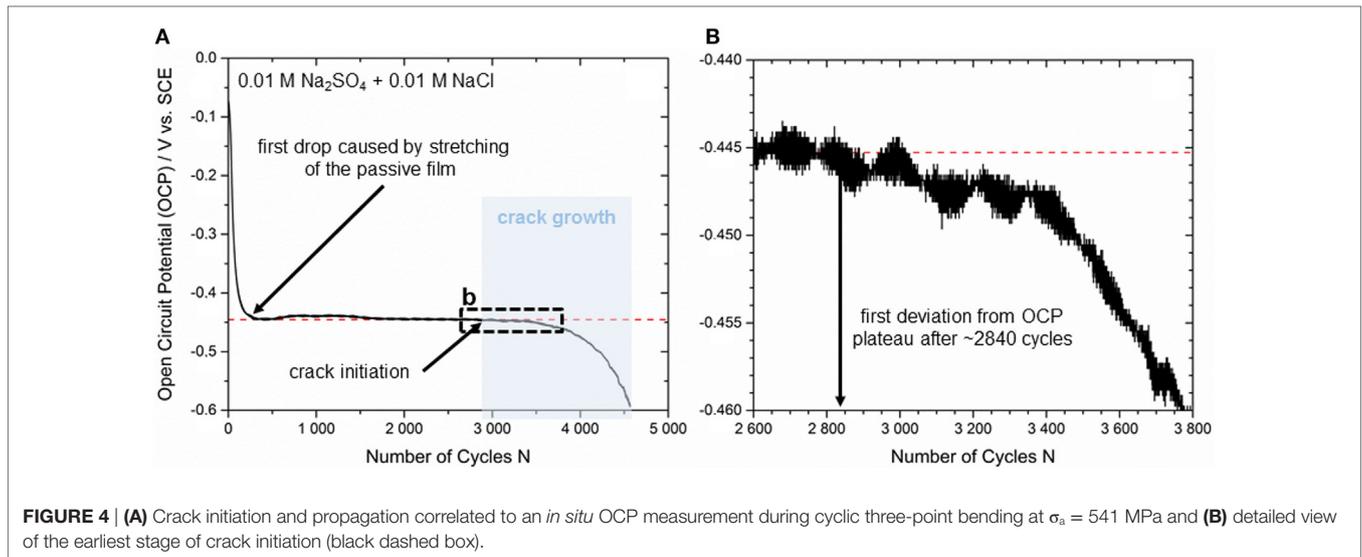
Before mechanical testing was started, the bending samples have been immersed in $0.01 \text{ M Na}_2\text{SO}_4 + 0.01 \text{ M NaCl}$ solution for 45–60 min until the changes in OCP were less than $2 \text{ mV}/5 \text{ min}$. According to that, OCP was in a steady state (mean value from all tests $\sim 165 \text{ mV}$ vs. SCE) when the first loading cycle was applied. Since the mechanical pre-load to ensure exact positioning of the samples in the three-point mounting was set to only $\sim 50\%$ of the maximum stress prior to cyclic loading, there was a significant drop in OCP from $-74 \pm 5 \text{ mV}$ vs. SCE to $-445 \pm 5 \text{ mV}$ vs. SCE when the test started, and the maximum load was achieved for the first time. This effect is caused by a sudden stretching of the passive

layer as a consequence of extended flexure on the tensile loaded surface. Subsequently, repassivation started and there is a slight but steady increase visible in the OCP curve. Because of the high sensitivity of the electrochemical set-up and as a result of small vibrations in the corrosion cell during cyclic loading, there is a little deviation in OCP until a significant plateau at -450 ± 10 mV is reached (see red dotted line in **Figure 4A**). Our results are also in good agreement with the observations of Morrison et al. (2007a) as the plateau levels are supposed to depend on the loading level. Cyclic testing at $\sigma_a = 400$ MPa led to a steady OCP value of -300 ± 10 mV vs. SCE, while testing at $\sigma_a = 650$ MPa generated an OCP value of -500 ± 10 mV vs. SCE. However, the first deviation from the stable plateau in terms of a smooth drop of the OCP is detected after $2,840 \pm 10$ loading cycles (see **Figure 4B**) for the presented sample. This drop indicates the earliest stage of crack initiation at the tensile-stressed sample surface. It can be assumed that the OCP changes immediately since in the crack region the bare metal surface is exposed to the electrolyte. A continuous decrease in OCP characterizes the following stable crack growth section (**Figure 4A**, marked in blue), which can be correlated to stable fatigue crack propagation detected by fine striations on the fracture surface. Further small drops in OCP are supposed to be related to locally increased crack growth velocity before crack tip blunting delays crack propagation. The OCP signal decreases until sample fracture after $4,530 \pm 10$ cycles, and therefore, the section of stable crack growth is suggested to be $(4,530 - 2,840) / 4,530 \approx 37 \pm 1\%$ of the whole fatigue life. An additional analysis of the equivalent fracture surface (not shown here) reveals a fatigue crack region of 0.53 mm^2 delivering a fraction of only $11 \pm 1\%$ with respect to the total cross section of 4.76 mm^2 . Furthermore, the rate of decrease (or the slope) of the OCP curve increases uniformly as expected in accordance with increasing crack growth velocity. As the stable crack growth regime determined by the OCP analysis is significantly larger than the fatigue fraction at the fracture surface, we suppose that the highly sensitive electrochemical response also considers early

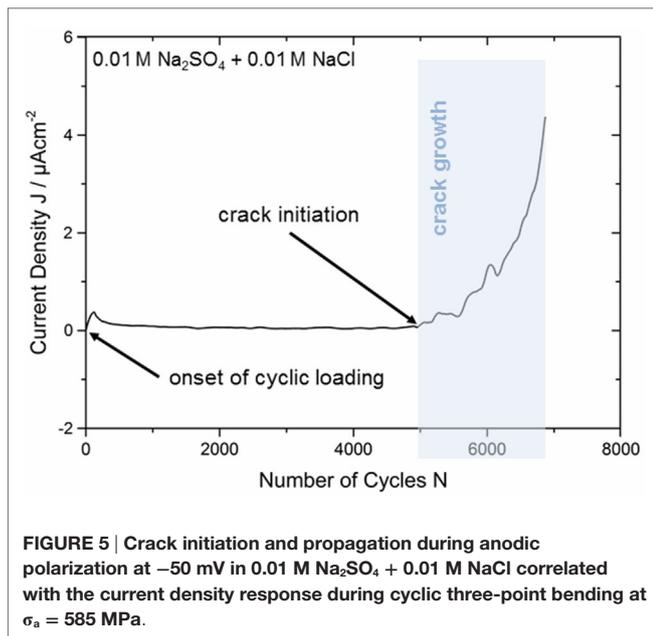
When applying a potential of -50 mV vs. SCE, the current density establishes at a nearly constant value slightly above $0 \text{ } \mu\text{Acm}^{-2}$ due to almost equal cathodic and anodic currents as expected in a regime so close to the corrosion potential. This steady state was achieved after ~ 200 s, and mechanical loading was started subsequently. Due to the onset of cyclic loading, the current density shows a sharp peak (see **Figure 5**) and this is attributed to the stretching of the passive layer as described for the OCP measurements in Section “Crack Growth Analysis by OCP Measurement” above. This is followed by a continuous decrease until a second plateau is attained at $\sim 0.2 \text{ } \mu\text{A cm}^{-2}$. The current density remains at a nearly constant level, which is

slightly above the value in the mechanically unloaded regime because the passive film is constantly altered by the cyclic stress. Since the scatter in the current density curve is very small, the point of passive film breakdown can be detected quite exactly after $4,880 \pm 10$ loading cycles. Thereby, the fatigue crack initiates at the tensile stressed sample surface and breaks the passive layer locally. Then, the current response starts to increase steadily as a result of stable crack propagation and related local metal dissolution. Several sudden current drops occur and these phenomena may be related to variations in the crack growth rate and short-term delay of crack propagation. Shear banding processes in the plastic zone in front of the crack tip are expected to cause crack tip blunting, and multiple shear bands can lead to changes of the crack path until the sample finally failed after $6,885 \pm 10$ loading cycles. Such a delayed crack growth was also detected for bainitic and martensitic steels by Suresh et al. (1981). They observed the generation of oxide films within the crack during mechanical testing at low loading ratios ($R = 0.05$) in moist atmospheres. In case of small crack tip opening displacements that are present especially at early fatigue fracture stages, these oxide layers lead to an earlier contact between both crack surfaces. As a consequence, the authors suggested a raise in the critical stress intensity factor K_c and a reduced effective ΔK in the crack tip region. Due to comparable testing conditions, a similar mechanism could be supposed in our current investigation on Zr-based bulk metallic glass. However, oxidization processes within the propagating crack as a result of repassivation events should be clearly detectable by drops in the current response (see stable crack growth regime in **Figure 5**). The fraction of stable fatigue crack propagation related to the number of cycles to failure is $29 \pm 1\%$ and thus $\sim 21.6\%$ lower than the fraction determined at comparable stresses by *in situ* OCP analysis in Section “Crack Growth Analysis by OCP Measurement.” However, it should be noted that fatigue life could be extended by more than 50% due to anodic

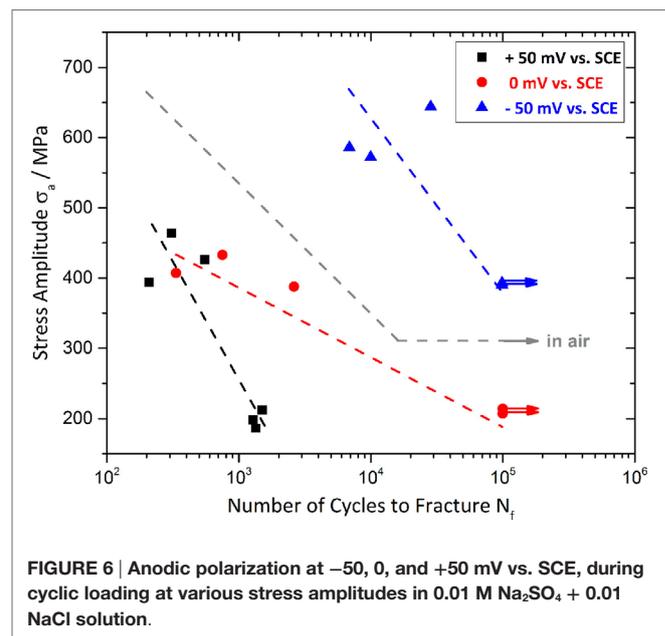
The results in **Figure 6** reveal a distinct influence of the stress level as well as of the applied anodic potential on the fatigue life

Our results reveal a mean number of cycles to failure of $18,290 \pm 10$ in air, 375 ± 10 cycles at $+50$ mV vs. SCE, $1,234 \pm 10$ cycles at 0 mV vs. SCE, and two runouts for -50 mV vs. SCE (all tests around $\sigma_a = 400$ MPa). Therefore, a superimposed effect of both anodic dissolution and repassivation processes at the crack tip is suggested to influence CF behavior of Vitreloy 105 essentially with the predominant effect depending on the selected anodic potential. Consequently, -50 mV vs. SCE is slightly more noble than the repassivation potential $E_R = -99$ mV vs. SCE meaning a lower tendency to anodic dissolution and increased repassivation tendency preventing the sample from fracture within 10^5 loading cycles. The fact that even longer fatigue lifetimes than in air were detected at -50 mV vs. SCE could be explained by an oxide-induced crack closure, which was already described above (Suresh et al., 1981). Whereas, anodic polarization at $+50$ mV vs. SCE is passing closer to the pitting potential of $E_p = 297$ mV vs. SCE and reinforces the creation of corrosion pits and anodic dissolution. An anodic potential of 0 mV vs. SCE seems to have

also a degrading effect on the fatigue life at $\sigma_a = 400$ MPa as it reduces the number of cycles to failure to 6.7% compared to samples tested in air. The E_R and E_p values are adopted from our previous paper on SCC of Vitreloy 105 in the same chloride-containing electrolyte (Gostin et al., 2015a). At an elevated load level of $\sigma_a = 600$ MPa for the -50 mV vs. SCE polarized samples, the fatigue lifetime is $15,110 \pm 10$ cycles (average value), which is five times longer than in air. However, the mean fatigue lifetime in non-halide 0.01 Na_2SO_4 solution under open circuit conditions is $2,560 \pm 10$ cycles and, therefore, slightly below the fatigue life in air. Consequently, the applied potential of -50 mV vs. SCE seems to have a further beneficial effect on the forming of the presumed oxide layer within the crack. At $\sigma_a = 200$ MPa, all non-polarized samples passed the limit of 10^5 cycles while anodic polarization at $+50$ mV vs. SCE caused failure after $1,380 \pm 10$ cycles due to intense anodic dissolution processes. The damage-provoking mechanisms are suspected to be mechanically as well as corrosion driven. This should be clarified by a comprehensive SEM analysis with additional EDX in the following part of the manuscript.

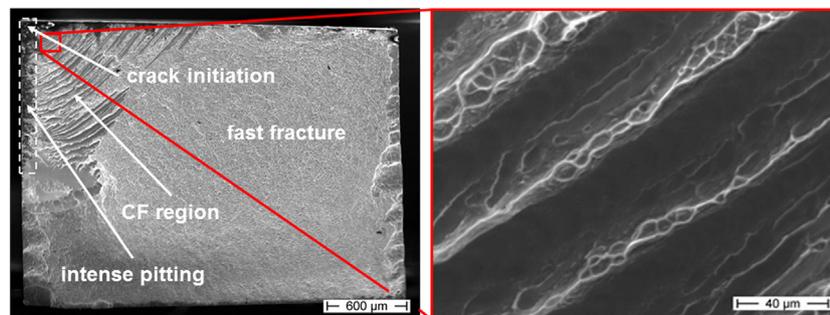
FIGURE 7 | Fracture surface of a corrosion fatigue (CF) sample tested at an anodic potential of 0 mV, $\sigma_a = 388$ MPa, and $N_f = 2,616$, in 0.01 M $\text{Na}_2\text{SO}_4 + 0.01$ M NaCl (tensile loaded surface is at the top, detailed view of striated corrosion fatigue region showed in red inset).

The main features are comparable to those observed for the non-polarized samples indicating a clear crack initiation site, a presumably quarter-elliptic (corrosion) fatigue region, and a large fast fracture area with significant cleavage near to the left and right sample edges. Especially the tensile stressed surface areas in the upper left of **Figure 7** exhibit intense pitting corrosion in terms of dark areas near the sample surface (marked by white dotted box). The pits which are detected as dark areas can reach up to ~ 150 μm into the sample. While the fast fracture region is characterized by the typical vein-like morphology (not shown here in higher magnification), the CF striations appear much broader than the striations generated under open circuit conditions or in air. The red inset in **Figure 7** gives a representative and more detailed image of typical CF striations. Alternating smooth

dark regions and brighter areas with vein-like structures offer interesting information about the related CF fracture mechanisms. The striation spacing increases from the crack initiation site to the fast fracture transition area. In consequence of these observations, there are two possible mechanisms suggested that are interfering with each other during anodic polarization and simultaneous cyclic loading. The smooth areas of the broad striated CF region may result from anodic dissolution and related cleavage along shear bands while the vein-like morphology might be caused by abrupt fast fracture. Besides the samples tested at 0 mV vs. SCE also those tested at +50 mV vs. SCE revealed those broader striations than in air consisting of alternating smooth and vein-like areas. In contrast, an anodic polarization at -50 mV vs. SCE led to fracture surfaces comparable to those in air with a lack of these broad striations. A subsequent investigation of the elemental distribution could contribute to the clarification of the involved processes (later in the text).

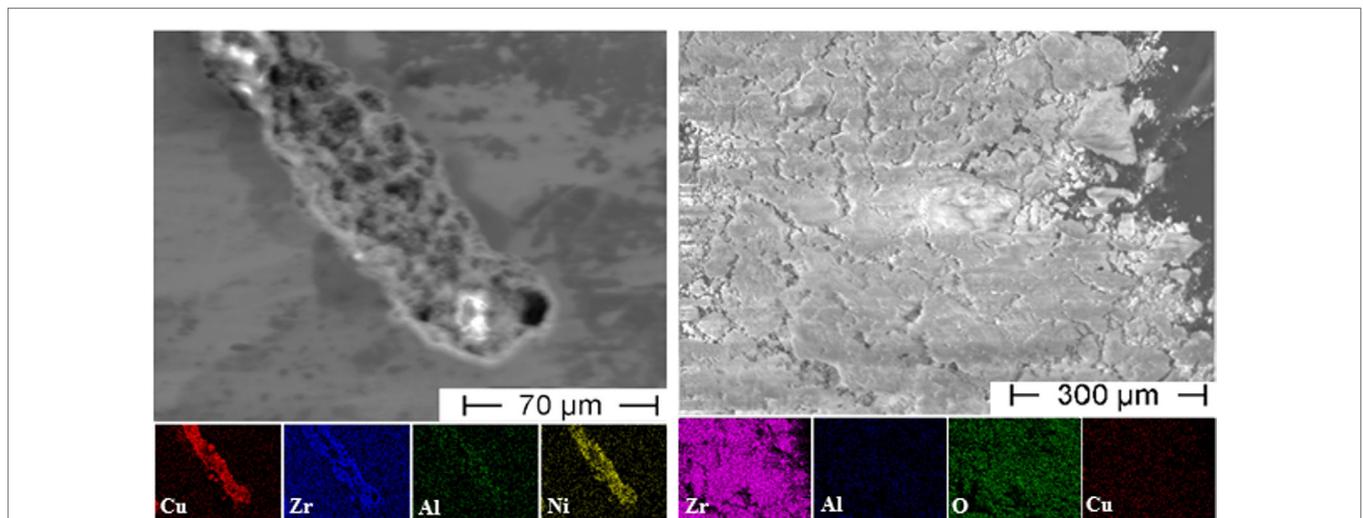
FIGURE 8 | Energy dispersive X-ray analysis of a corrosion pit at the side surface of the bending sample (left) and of the dissolved material extracted from the electrolyte as powder after testing (right).

The onset of anodic dissolution could be determined easily during CF testing under potentiostatic control. Characteristic corrosion products developed at the crack tip and spread out quickly. After the experiment, it was possible to gather the dissolved material in form of fine powder at the bottom of the electrochemical cell and to extract it from the residual electrolyte. This powder was investigated by EDX as well, and the results are shown in **Figure 8** (right). As expected, it consists basically of Zr and O while only traces of Cu could be detected. However, the fraction of Al seems to be smaller than expected due to the results from the corrosion pit, but this element could be detected poorly overall.
