4th CIRP Conference on Surface Integrity (CSI 2018)

Study on tool wear and workpiece surface integrity following drilling of CFRP laminates with variable feed rate strategy

Keywords: CFRP laminate; Drilling; Surface integrity

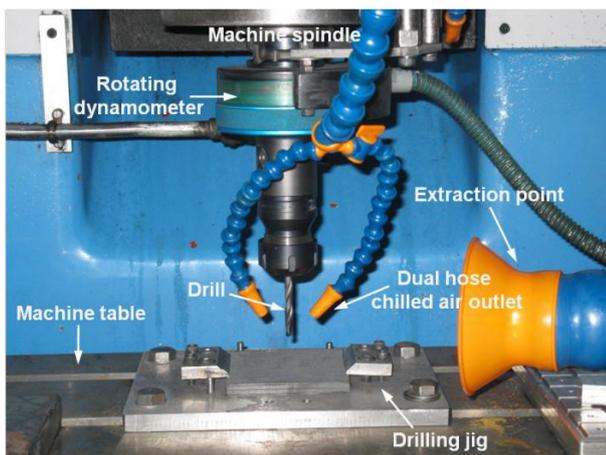
Fig. 2. Experimental drilling setup in Matsuura FX-5.

Trials were carried out on a Matsuura FX-5 vertical high speed machining centre with a maximum spindle rotational speed of 20,000 rpm rated at 15 kW. The machining centre was fitted with a Renishaw probe and tool length setter as well as a dust extraction system capable of removing particles down to 0.3 µm. Fig. 2 shows the experimental setup on the Matsuura FX-5. Chilled air (~8°C) was generated and delivered by a Nex-Flow vortex tube at a pressure of 0.4 bar. Thrust force and torque were measured using a Kistler 9123B 4-component piezoelectric rotating dynamometer mounted on the machine spindle via a quick change toolholder. The force signals were relayed to a PC installed with Dynoware software for analysis via a Kistler type 5221A stator and type

5223A multichannel signal conditioner. Drill flank/chisel wear was evaluated using a WILD M3Z toolmakers microscope integrated with a X-Y digital micrometer platform having a resolution of 1 μm . Optical images of workpiece delamination/damage at hole entry/exit locations for the first and last holes drilled in each test, were captured using a digital camera mounted on the toolmakers microscope. Corresponding delamination factor, F_d (ratio of maximum damaged diameter to nominal drilled hole diameter) was then calculated, with the respective diameters measured from the micrographs using Autodesk software.

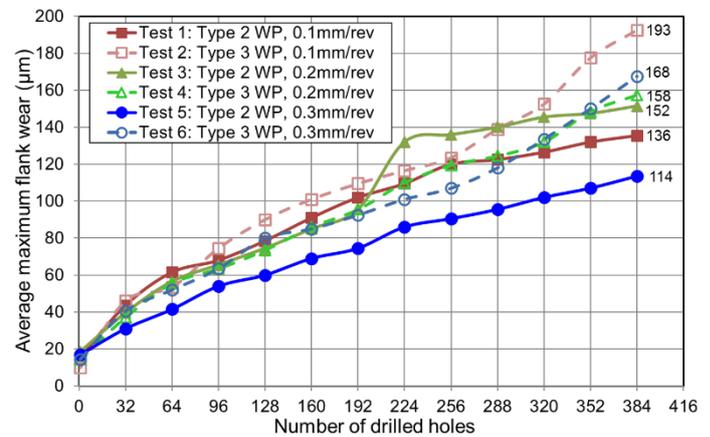
Fig. 3. Flank wear curves for all tests against number of drilled holes.

Fig. 3 details the evolution of tool flank wear against number of holes drilled for all tests. All of the drills produced 384 holes, with flank wear ranging between 114 μm (Test 5) and 193 μm (Test 2). Tool wear at test cessation was typically lower by up to ~41% when drilling the Type 2 laminates and operating at higher feed rates. This was due in part to the larger thickness of the Type 3 workpieces as well as the shorter tool-workpiece contact time. It was observed that abrasion (prior to removal of coating layer) and delamination of the CVD-diamond coating were the principal tool wear modes, as shown in the wear scar micrographs from Tests 2 and 5 in Fig. 4.

Analysis of variance (ANOVA) of the data revealed that none of the main factors were statistical significant with respect to tool wear, although this was possibly due to the fact

that the majority of tool-workpiece contact time (~70-88%) was confined to the final 2 mm of the hole when feed rate was reduced to 0.01 mm/rev. This may also have contributed to the relatively high residual level (~75%), with workpiece material having a percentage contribution ratio (PCR) of 24.54% while the corresponding PCR for primary feed rate was negligible.

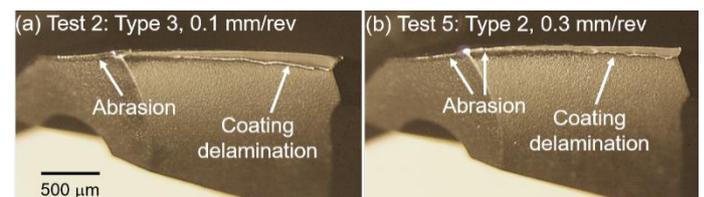
Fig. 4. Tool wear scar at test cessation in (a) Test 2 and (b) Test 5.

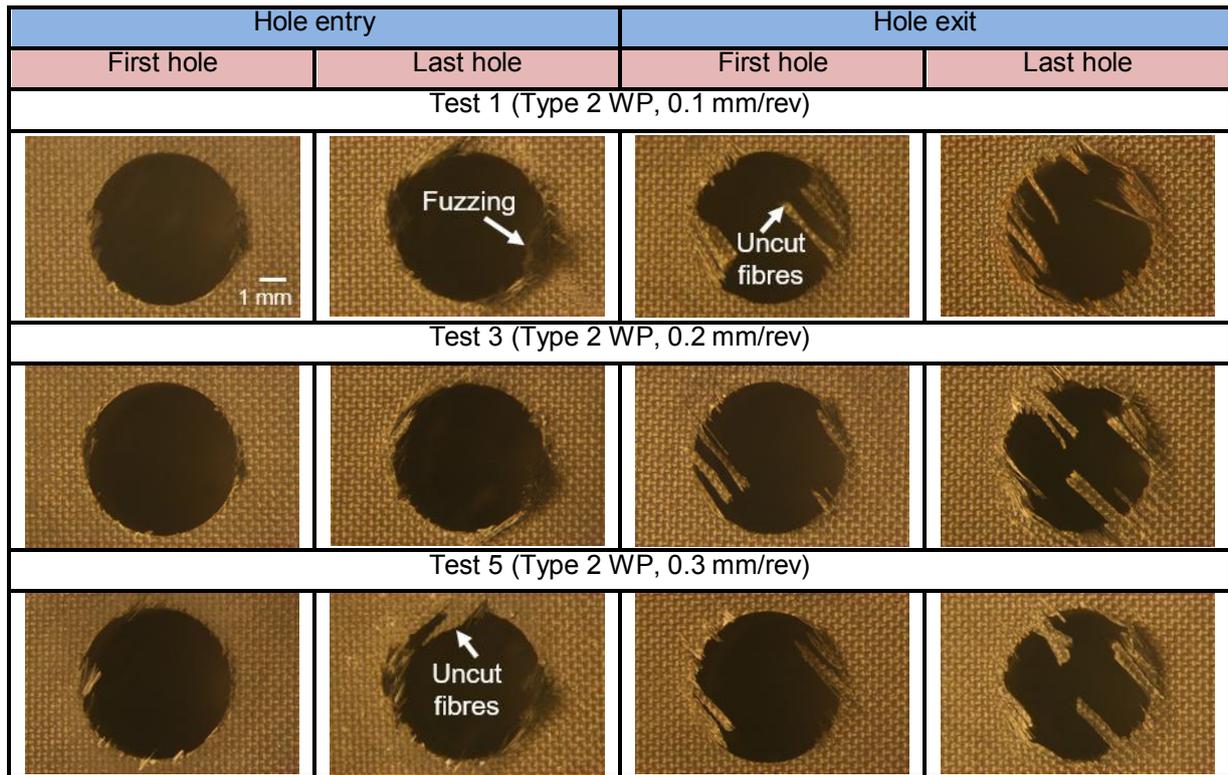
Fig. 5. Hole entry and exit quality of the first and last holes in tests involving Type 2 workpiece material.

Fig. 5 shows micrographs of hole entry and exit for the first and last holes drilled in trials involving the Type 2 workpiece materials (Tests 1, 3 and 5). In terms of hole entry quality, minor damage in the form of fuzzing and limited uncut fibres was observed in the first holes drilled, while greater levels of fuzzing, uncut fibres and delamination were apparent for the last holes drilled, irrespective of primary feed rate and workpiece type. Despite application of the decreased feed rate (0.01 mm/rev) strategy for the final 2 mm of the workpiece, the damage at hole exit was generally similar or more pronounced than the corresponding entry location, see Fig. 5. However, a reduction in exit damage was evident when compared to holes drilled at a constant feed rate of 0.1 mm/rev [14].

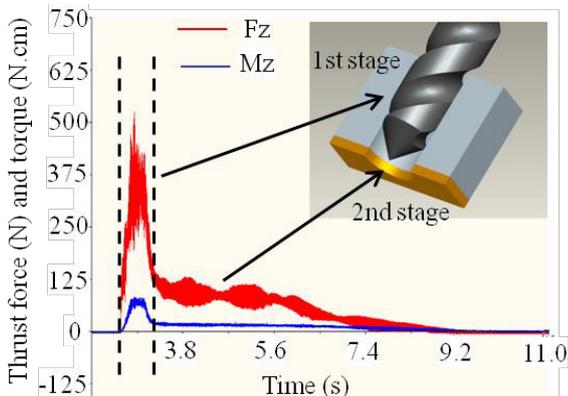
Fig. 6. Typical force and torque profile at the last hole (hole 384) drilled.

Fig. 6 shows the typical thrust force and torque profiles obtained when drilling the last hole in each test. Both parameters increased rapidly during the first stage of drilling (primary feed rates of 0.1-0.3 mm/rev), with thrust force and torque peaking at 591 N and 111 N.cm respectively in Test 6, but subsequently dropped by up to ~80% in the second stage of operation where feed rate was considerably reduced (0.01 mm/rev). Thrust force increased by ~98-155% over the test duration when drilling the Type 3 composite while the corresponding rise was limited to ~56-67% in trials involving the Type 2 material.

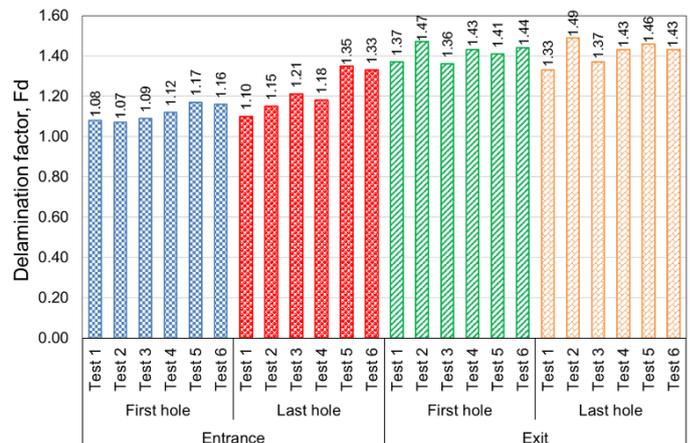
Fig. 7. Delamination factor at hole entry and exit for first and last holes drilled in all trials.

The calculated delamination factors at hole entry and exit positions for the first and last hole drilled in each test are detailed in Fig. 7. In general, F_d was found to be greater (by up to 0.18) at test cessation compared with the first hole drilled for both entrance and exit locations. Delamination factor values at hole entrance generally increased with feed rate with a maximum of 1.35 observed in Test 5 (Type 2, 0.3 mm/rev). For the exit delamination factor, Type 2 workpiece normally produced lower values (up to 0.16 lower) than the Type 3 material, except for the last hole drilled when operating at 0.3 mm/rev (Test 5). Understandably, the influence of varying primary feed rate on exit delamination factor exhibited no apparent trend. According to the associated ANOVA, feed rate was found to be a statistically significant factor (at the 5% level) affecting the entrance F_d of the first hole drilled with a PCR of 87.9%, which was in agreement with the observations of other researchers [7].

There was limited discrepancy between exit F_d values of the first and last holes drilled, which suggests that the lower feed rate used had a more dominant effect than tool wear level on hole exit damage.

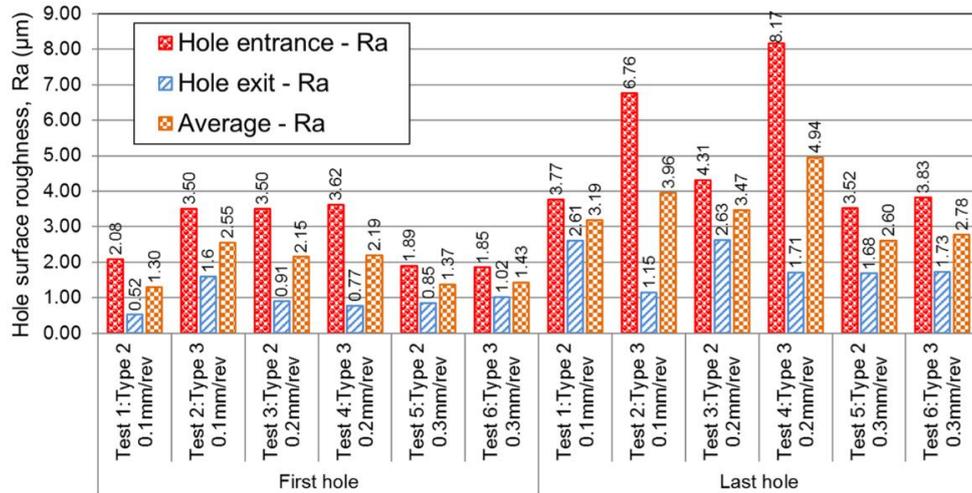
Fig. 8. Surface roughness (Ra) of hole entry and exit section of the first and last holes drilled in all tests.

Fig. 8 outlines the hole surface roughness (R_a) values measured at the entry and exit positions of both the first and last holes drilled in all tests. In general, the roughness values were typically higher in Type 3 workpieces (Tests 2, 4 and 6) compared to the Type 2 configuration machined at equivalent feed rate levels. This was due to the larger number of plies orientated at 135° in the former (14).

Increasing feed rate from 0.1 to 0.3 mm/rev led to lower surface roughness (by ~44% in terms of average Ra) in all of the first holes drilled in Type 3 laminates, which was attributed to the decrease in tool wear when operating at higher feed rates, as a result of the shorter drill-workpiece interaction period. Conversely, there was no apparent correlation between the hole surface roughness and feed rate for the last holes drilled, possibly due to the comparatively high levels of tool wear at test cessation. Furthermore, the roughness measured in the vicinity of the hole exit location was consistently lower (by up to ~80%) than the entrance section, probably due to a ‘ploughing’/‘polishing’ effect when operating at the extremely low feed rate of 0.01 mm/rev.

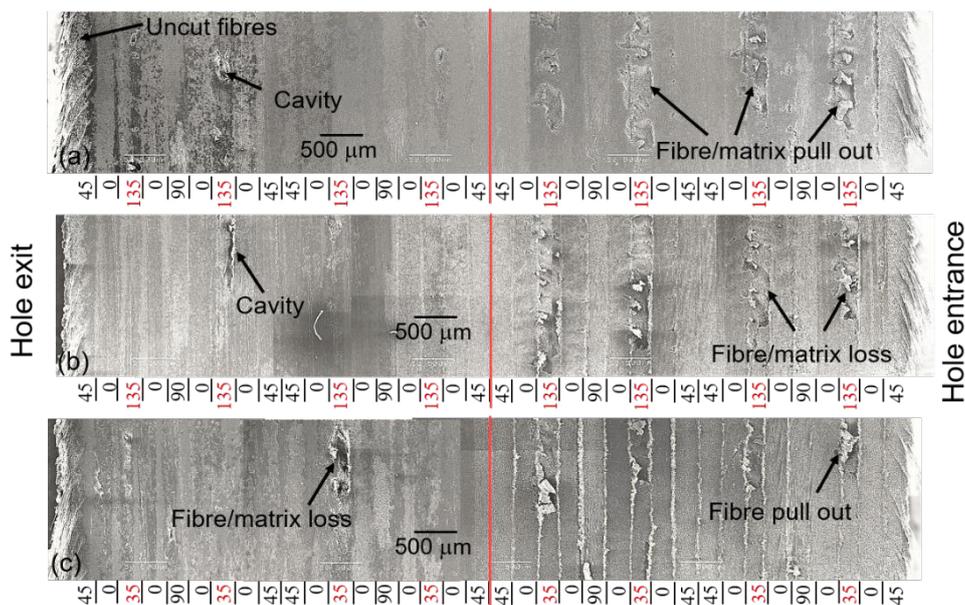
Fig. 9. SEM micrographs of hole surfaces for the first hole in (a) Test 1 (0.1 mm/rev), (b) Test 3 (0.2 mm/rev) and (c) Test 5 (0.3 mm/rev).

Fig. 9 shows SEM micrographs of the machined surfaces for the first holes drilled in Tests 1, 3 and 5 involving the Type 2 workpieces. Defects in the form of fibre and matrix

loss/void formation were evident particularly in the 135° direction plies around the vicinity of the hole entry regardless of the primary feed rate level (0.1-0.3 mm/rev) and despite the drills being in the new condition. Several other researchers have also reported that damage was typically severe in plies orientated at 135° due to the cutting mechanism being dominated by shearing, leading to macro fracture of the fibres [15-16]. In contrast, surfaces with limited flaws were observed near the hole exit due to the lower feed rate (0.01 mm/rev) employed over the final 2 mm of drilling. Considerable deterioration in surface quality over the entire hole however was visible at test cessation; see Fig. 10. Here, reducing feed rate to 0.01 mm/rev near the hole exit provided no appreciable benefits, which suggests that tool condition had a more prominent influence than feed rate during the latter stages of a test. Surprisingly, increasing the primary feed rate to 0.3 mm/rev did not appear to exacerbate the level of damage compared to results when drilling at 0.1 mm/rev. Similar results and trends were seen with the Type 3 lay-up.

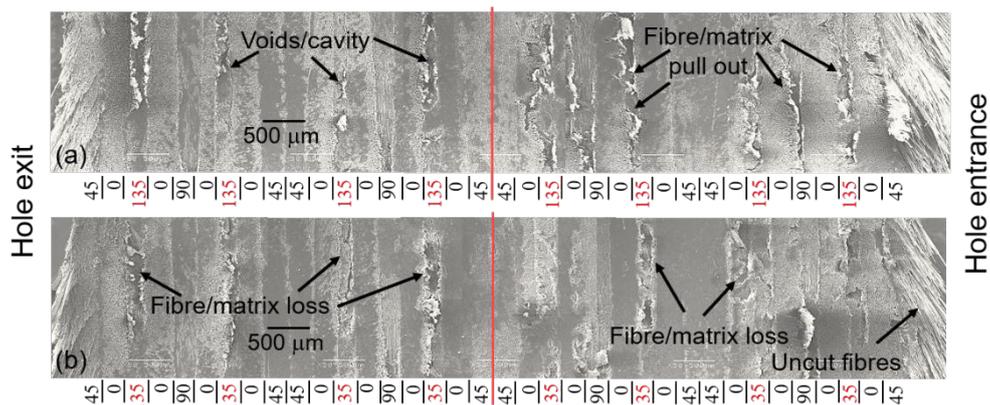
Fig. 10. SEM micrographs of hole surfaces for the last hole in (a) Test 3 (0.2 mm/rev) and (b) Test 5 (0.3 mm/rev).
