Experimental investigations into SGP laminated glass under low velocity impact

Wang, Xing-er; Yang, Jian; Liu, Qiang; Zhao, Chenjun

Wang, X, Yang, J, Liu, Q & Zhao, C 2018, 'Experimental investigations into SGP laminated glass under low velocity impact', *International Journal of Impact Engineering*. <https://doi.org/10.1016/j.ijimpeng.2018.06.010>

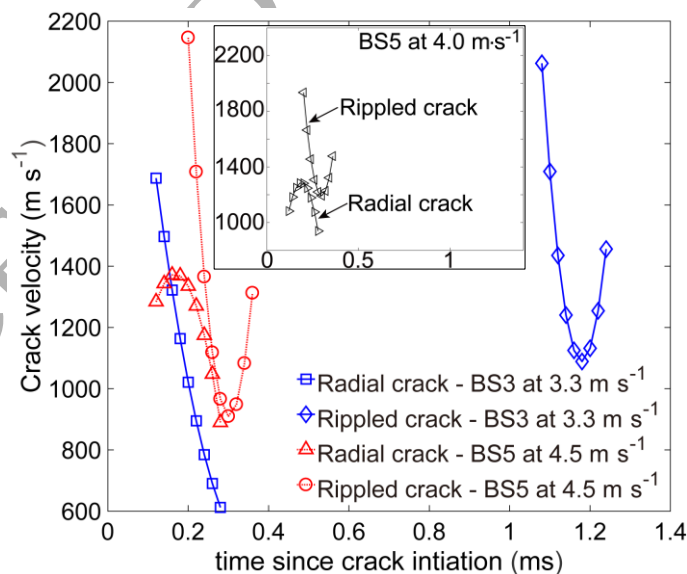
The crack propagation speed obtained for the specimens in **Fig. 3** is summarised and shown in **Fig. 4**. It can be seen that the propagation speed of rippled cracks in both cases show the same

trend, i.e. deceleration first and then acceleration. The peak speed of rippled cracks in the BS5 case (around $2146 \text{ m}\cdot\text{s}^{-1}$) is slightly greater than that in the BS3 case (around $2063 \text{ m}\cdot\text{s}^{-1}$). **Figure 4** also shows that the propagation speed of the radial cracks is evidently lower than that of the rippled cracks, with a peak speed of approximately $1688 \text{ m}\cdot\text{s}^{-1}$ in BS3 and $1335 \text{ m}\cdot\text{s}^{-1}$ in BS5. The propagation speed of radial cracks in BS3 experiences a monotonic decline, the crack tip propagation decelerates to nearly $600 \text{ m}\cdot\text{s}^{-1}$ when it reaches the edge. In comparison to the monotonic trend in BS3, the radial crack tip in BS5 first accelerates to $1335 \text{ m}\cdot\text{s}^{-1}$ and then decelerates to $890 \text{ m}\cdot\text{s}^{-1}$ afterwards. A similar observation on the propagation of the radial cracks can be found [28], where its trend and peak can be traced within 0.04 ms after the crack initiation. Therefore, one can anticipate that the propagation speed of radial cracks up to 0.08 ms in BS3 may also show the same trend but there is no evidence to support this argument due to an absence of high speed photos.

Fig. 4. Crack propagation speed of specimens No. 1 (BS3) and No. 5 (BS5)

In addition, **Figure 4** shows an inset figure that presents the crack propagation speed in BS5 when impact velocity decreases to $4.0 \text{ m}\cdot\text{s}^{-1}$. It should be noted that the case in BS3 with a

different breakage velocity from $3.3 \text{ m}\cdot\text{s}^{-1}$ cannot be found in the same glass make-up and is hence not included in **Fig. 4**. Compared with the results at the impact velocity of $4.5 \text{ m}\cdot\text{s}^{-1}$, the peak propagation speeds of both radial (around $1933 \text{ m}\cdot\text{s}^{-1}$) and rippled cracks (around $1280 \text{ m}\cdot\text{s}^{-1}$) at the impact velocity of $4.0 \text{ m}\cdot\text{s}^{-1}$ have an evident decrease. However, both cases show a similar variation pattern. Such observation supports the conclusion that the peak propagation speed is expected to decline when impact velocity decreases. As the crack propagation is driven by the stress component normal to the crack front [32], which can be significantly reduced by decreasing impact velocity.

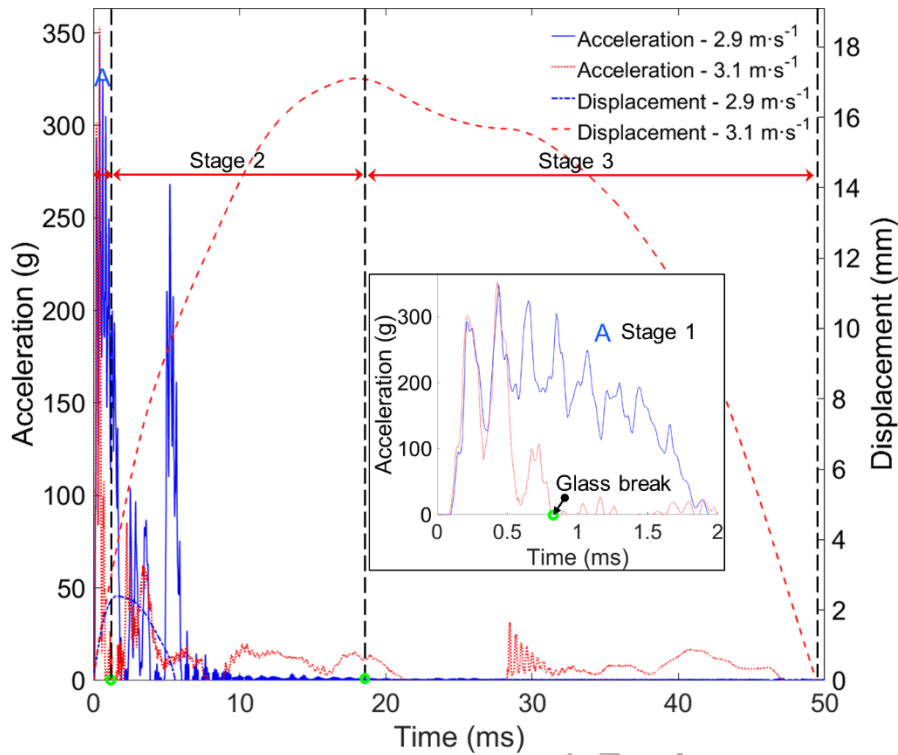
Fig. 6. Typical impactor motion at various impact velocities.

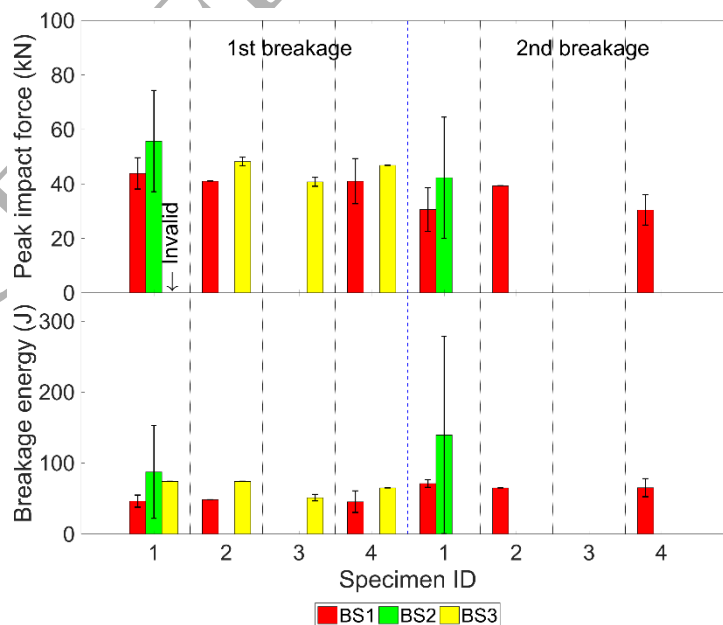
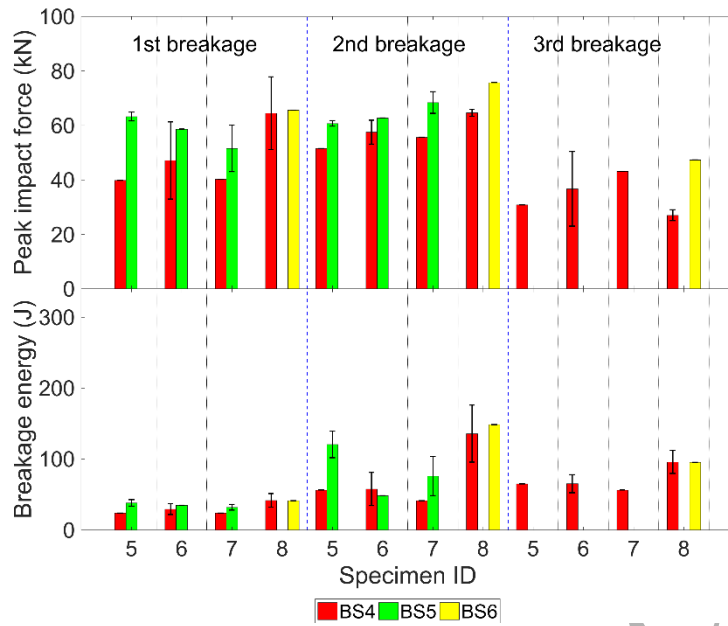
As **Fig. 7 (b)** shows, a significant increase in breakage energy can be seen in the post-breakage stage of the No. 5 group in BS5 compared with the specimens with HS glass layers, i.e., the No. 6 and No. 7 groups. It can be seen that the No. 5 group with three FT glass layers presents the highest breakage energy, followed by the No. 7 group with two FT glass layers, while that of the No. 6 group with only one FT glass layer ranks the lowest. Such results can satisfactorily confirm the prediction that the glass type will dominate the post-breakage energy in BS5.

From **Fig. 7 (a)**, a similar conclusion can be made when comparing the first breakage energy of the No. 1 and 3 groups in BS3. Specimen No. 1, with two FT glass layers, requires more impact energy to trigger the simultaneous failure of both glass layers than specimen No. 3, with one FT glass layer.

(a) Double layered specimens

(b) Triple layered specimens

Fig. 7. Breakage energy and peak impact force of SGP LG specimens.

Figure 7 (b) reveals that the peak impact force at the second breakage is larger than that at the first breakage; e.g. for specimen No. 7 in BS4 a 29% increase in peak impact force can be seen, and in BS5 there is a 38% increase. The peak impact force at the third breakage is demonstrated to be the lowest on most occasions, with the reduction ratio reaching 22% in the No. 5 (bolted fixing) group, and 58% in the No. 8 group (edge clamped), when compared to that at the first breakage. At the third breakage, the tension is sustained by the SGP interlayer at the moment that all glass layers fail. The lower Young's modulus of SGP interlayer (around 0.3 GPa) than the glass layer (around 70 GPa) leads to the largest deflection and greatest impactor contact time, so that the impact force appears to be the lowest. Likewise, in the double layered specimens, a 30% reduction in the peak impact force can be seen in the No. 1 group at the second breakage in **Fig. 7 (a)**.

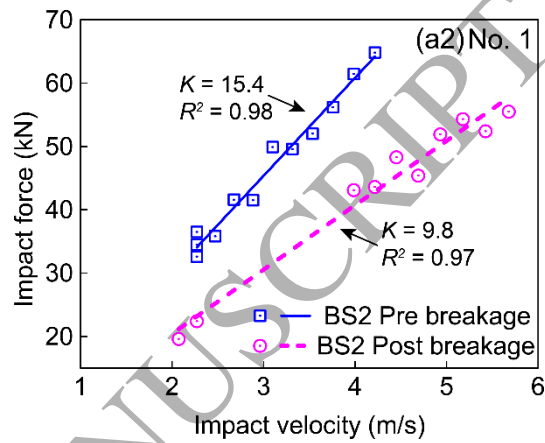
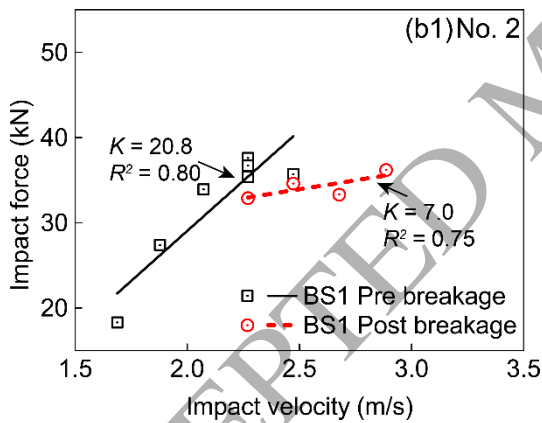
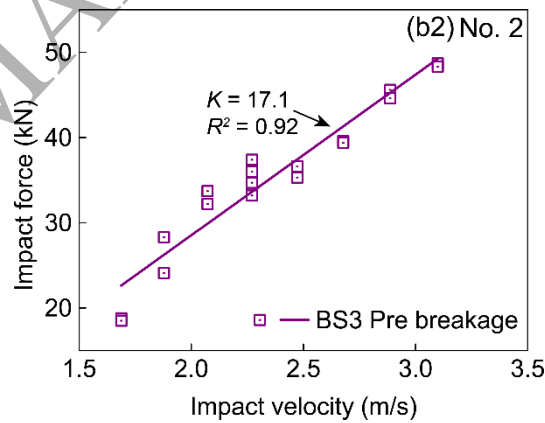
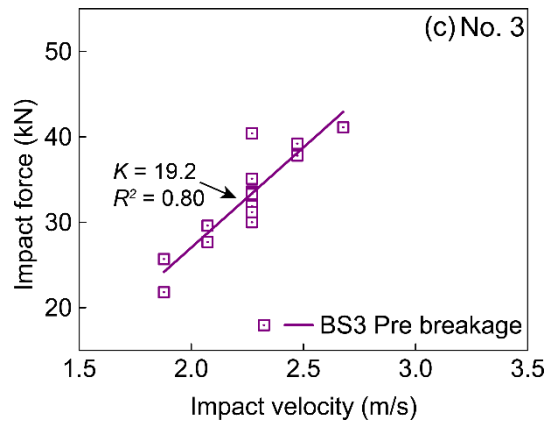
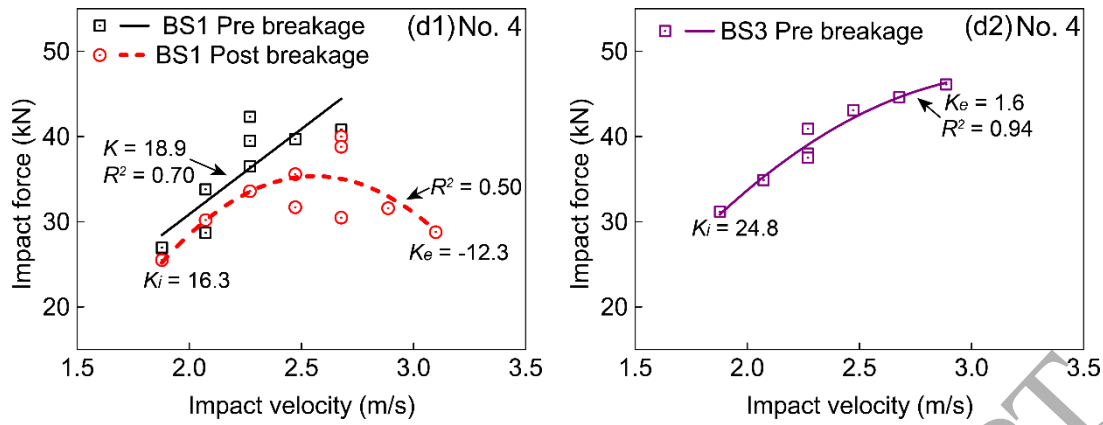
As shown in **Fig. 8**, the pre-breakage regression line of the double layered specimens is linear in most cases except the No. 4 group (**Fig. 8 (d)**), where obvious nonlinearity can be observed when the impact velocity is greater than $2.5 \text{ m}\cdot\text{s}^{-1}$. This implies that for the 3 mm thick SGP interlayer, the glass stiffness remains constant until breakage. However, when SGP thickness increases to 5 mm, there occurs some stiffness reduction while the impact velocity approaches the breakage velocity in BS3. This trend is more obvious in the post-breakage stage of BS1 (**Fig. 8 (d1)**).

Comparing specimens No. 1 (**Fig. 8 (a1)**) and 2 (**Fig. 8 (b1)**) in BS1, a 25% reduction in

slope in the pre- breakage stage, and an 8% reduction in slope in the post-breakage stage is observed as the specimen dimensions increase from 1000×1000 mm to 1500×1500 mm. A greater reduction in slope, of approximately 32 % in the pre-breakage stage, can be seen when the interlayer thickness increases to 5 mm when comparing specimen No.s 1 (**Fig. 8 (a1)**) and 4 (**Fig. 8 (d1)**).

Fig. 8. Peak impact force versus impact velocity in double layered specimens.

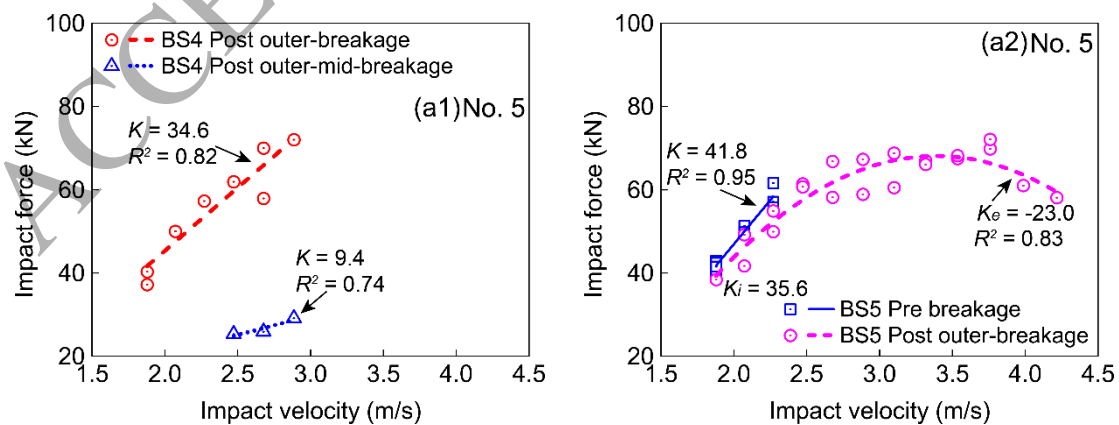
For the No. 5 (**Fig. 9 (a1)**) and No. 7 (**Fig. 9 (c1)**) groups shown in **Fig. 9**, there is an absence of data in the pre-breakage stage. This is because there were not many attempts before the glass breakage occurred. Only the post outer-breakage stage (i.e. after the outer layer breaks) in these two groups are presented. The regression lines in the No. 6 (**Fig. 9 (b1)**) and No. 7 (**Fig. 9 (c2)**) groups exhibit obvious nonlinearity in the post outer-breakage stage. As shown in **Fig. 9**, common trends for all the specimens can be observed: the impact force in the pre-breakage stage remains proportional to the impact velocity in the triple layered specimens; and an evident decline in the K value can be seen in the final post breakage stage. Nearly identical K values can be found for both the No. 6 (**Fig. 9 (b1, b2)**) and No. 8 groups (**Fig. 9 (d1, d2)**) in the pre-breakage stage, indicating a good consistency in the dynamic stiffness of the triple layered specimens in the pre-breakage stage. Thus, a rational assumption of the pre-breakage stiffness for specimens No. 5 and No. 7 can be made in the breakage sequence of BS4.

The K value of the final breakage stage for the No. 5 group in BS4 (**Fig. 9 (a1)**), i.e. post outer-mid-breakage, shows a remarkable decrease of 78% compared to the pre-breakage stage, and 73% compared to the post outer-breakage stage. Similarly, a decreased ratio can be found in the No. 7 group (**Fig. 9 (c1)**), in which the K value of the post outer-mid-breakage stage experiences an 80% reduction compared to the pre breakage stage, and a 73% reduction compared to the post outer-breakage stage. In contrast to the high decreasing ratio in BS4, the K value of the No. 8 group in the final breakage stage in BS6 (**Fig. 9 (d2)**) presents only a 36% decrease. The above comparison implies that in the case of both outer and middle layers breaking, the LG panel will possess low stiffness, while when only the middle layer is intact, the LG panel still has reasonably high dynamic stiffness.

Fig. 9. Peak impact force versus impact velocity in triple layered specimens.

Figure 9 shows that the dynamic stiffness of the LG panels with HS glass layers, i.e. the No. 6 (**Fig. 9 (b1)**) and No. 7 (**Fig. 9 (c2)**) groups, enters a rapid declining phase when approaching the breakage velocity at approximately $3.0 - 3.5 \text{ m}\cdot\text{s}^{-1}$ when the mid-glass layer breaks suddenly. In contrast, the LG panels made entirely of FT glass layers, i.e. the No. 5 (**Fig. 9 (a2)**) and No. 8 (**Fig. 9 (d1)**) groups, present a prolonged declining phase until the mid-glass layer breaks at nearly $4.0 - 5.0 \text{ m}\cdot\text{s}^{-1}$. This indicates that the triple layered LG panels comprising FT glass layers are characterised as having better ‘ductility’ in the post outer-breakage stage under impact, compared to those hybrid glass panels containing HS glass layers. As shown with specimen No. 8, the dynamic stiffness of edge clamped panels remains almost stable when subjected to increasing impact velocity, showing a slight decline in the K value.

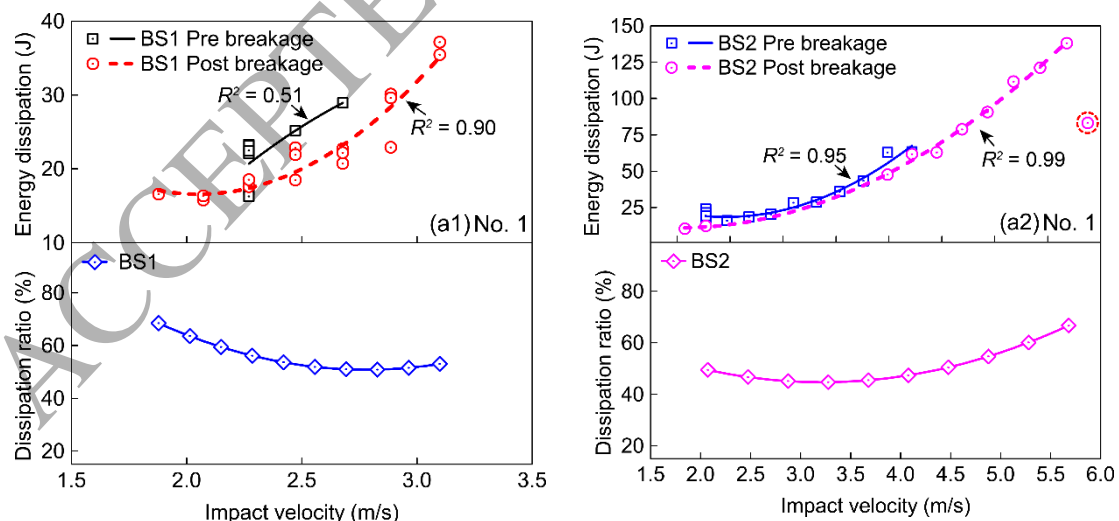
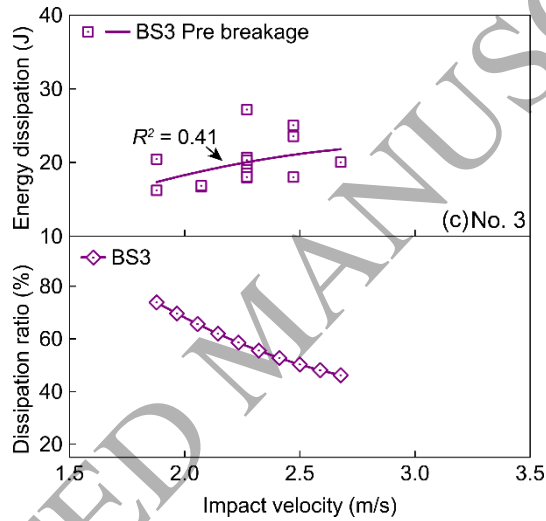
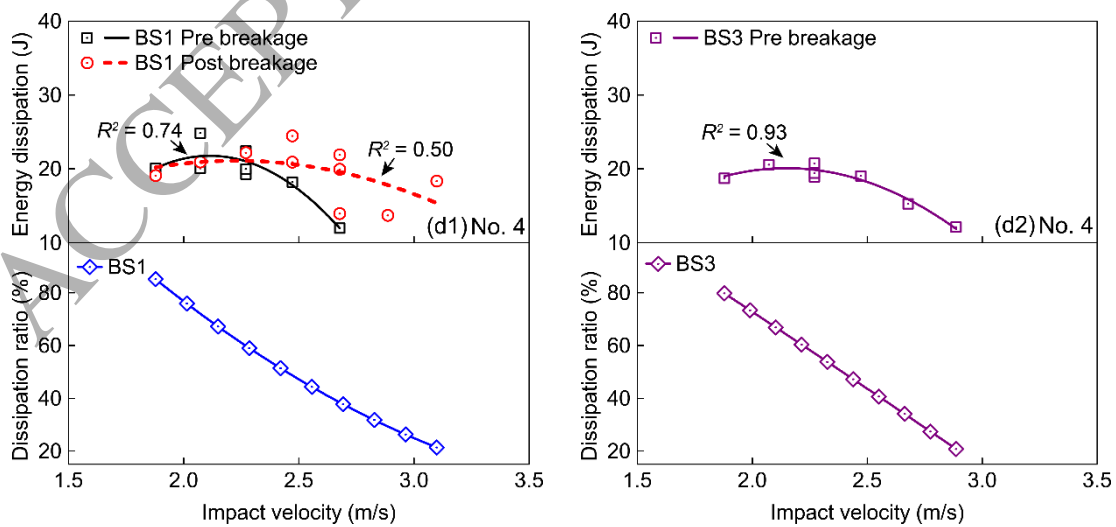
It can be seen in **Fig. 10** that the energy dissipation in all the double layered specimens having a BS1 and BS3 breakage sequence is less than 45 J in the elastic stage. The specimens with a HS glass layer (**Fig. 10 (c)**) or thicker SGP interlayer (**Fig. 10 (d1, d2)**) present a declining trend of energy dissipation ratio as the impact velocity increases, varying from nearly 90 % at $1.7 \text{ m}\cdot\text{s}^{-1}$ to 18 % at $3 \text{ m}\cdot\text{s}^{-1}$. It is found that a negative effect may be imposed on the energy dissipation ratio when the interlayer thickness increases to 5 mm in the No. 4 group, for which the ratio declines more rapidly than for the No. 2 (**Fig. 10 (b1, b2)**) and No. 3 (**Fig. 10 (c)**) groups when increasing the impact velocity. The negative effect of thicker interlayer on the energy dissipation further indicates that the glass is more likely to accumulate the impact damage in the No. 4 group. Such damage accumulation by thicker interlayer even causes the declining trend of $P_{max} - V$ curve as shown in the Fig. 8 (d1). Moreover, the energy dissipation in No. 4 is the lowest in the double layered specimens. This group presents a descending trend that is different from the other groups, where most results have an ascending trend regardless of the breakage sequence, except for No. 2 in BS1 (**Fig. 10 (b1)**) that behaves in a non-monotonic fashion. This again indicates that a thicker interlayer can have a negative effect on dissipating energy. Unlike the monotonic descending trend, the energy dissipation ratio in specimen No. 1 (**Fig. 10 (a1)**) presents an ascending branch after

reaching its minimum, close to the first breakage velocity as shown in **Fig. 10**.

Fig. 10. Impact energy dissipation and dissipation ratio variation of double layered specimens.

The behaviour of specimen No. 2 in BS1, as shown in **Fig. 10 (b1)**, indicates that the energy dissipation of No. 2 experiences a non-monotonic trend with an inflexion point near the impact velocity of $2.5 \text{ m}\cdot\text{s}^{-1}$. Such a trend consists of a peak in the pre-breakage stage and a trough in the post-breakage stage. Only one specimen presents this particular trend and it may be caused by an unusually strong adhesion between the glass and the interlayer. Strong adhesion tends to lead to the outer glass layer and the SGP interlayer having greater local strain and a higher strain rate, and thus the breakage of the outer glass layer is more likely to be triggered [36]. This assumption can be validated by comparing the crack patterns of the two No. 2 specimens broken in different sequences as shown in **Fig. 11**. It can be seen that the outer glass layer of the specimen in BS3 shatters into ‘dice’ of similar size, while the area near the impact point cracks into large fragments in a ‘starburst’ pattern (**Fig. 11 (a)**). In contrast, the outer glass layer of the specimen in BS1 shatters into large glass fragments of irregular shape (**Fig. 11 (b)**). Such irregular shapes are probably due to the stronger adhesion between the glass and interlayer. Once one of the FT glass layers breaks, the intact glass holds the broken counterpart through adhesive shear action so that the locked-in stress can be released slowly. In contrast, weak adhesion does not provide such interaction, and thus the glass breaks into a typical fragmentation pattern, namely small ‘dice’.

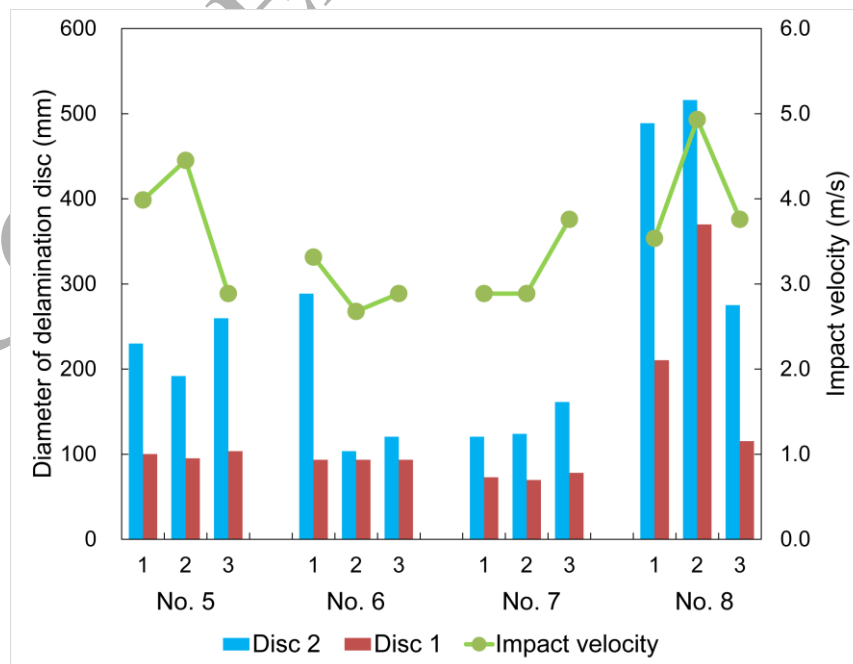
The sizes of the Disc 1 and Disc 2 delamination zones and the corresponding impact velocity of each triple layered specimen are recorded and shown in **Fig. 16**. It is worth noting that delamination in most double layered specimens is not evident, except for in specimen No. 1 that presents typical Type I delamination as shown in **Fig. 13**. The sizes of the delamination zones of the double layered specimens are therefore not considered here. It can be seen from **Fig. 16** that the specimens with bolted connections show consistent results for Disc 1 sizes from the repeated tests in the same group. The mean diameters of Disc 1 in specimens No. 5, No. 6 and No. 7 are 100 mm, 93 mm and 74 mm, respectively. The Disc 1 sizes of these three groups remain stable and independent of impact velocity in the later impact attempts. In contrast, the Disc 2 sizes of the triple layered specimens exhibit evident dependency on impact velocity; as does the Disc 1 size of specimen No. 8. The Type II delamination zone continues to grow when impact velocity increases. This dependency indicates that edge clamping or having SGP adhesion interfaces at both sides is more likely to cause continuous delamination under repeated impacts. However, the outer and inner glass fragments, which are glued with only one SGP interlayer or with a bolted connection, are less likely to debond if they are located at a certain distance from the impact point.

**Fig. 16.** Size of delamination disc of triple layered specimens.
