In-situ, time resolved monitoring of uranium in BFS:OPC grout. Part 2: Corrosion in water

To reflect potential conditions in a geological disposal facility, uranium was encapsulated in grout and submersed in de-ionised water for time periods between 2–47 weeks. Synchrotron X-ray Powder Diffraction and X-ray Tomography were used to identify the dominant corrosion products and measure their dimensions. Uranium dioxide was observed as the dominant corrosion product and time dependent thickness measurements were used to calculate oxidation rates. The effectiveness of physical and chemical grout properties to uranium corrosion and mobilisation is discussed and Inductively Coupled Plasma Mass Spectrometry was used to measure $^{238}\text{U}_{(\text{aq})}$ content in the residual water of several samples.

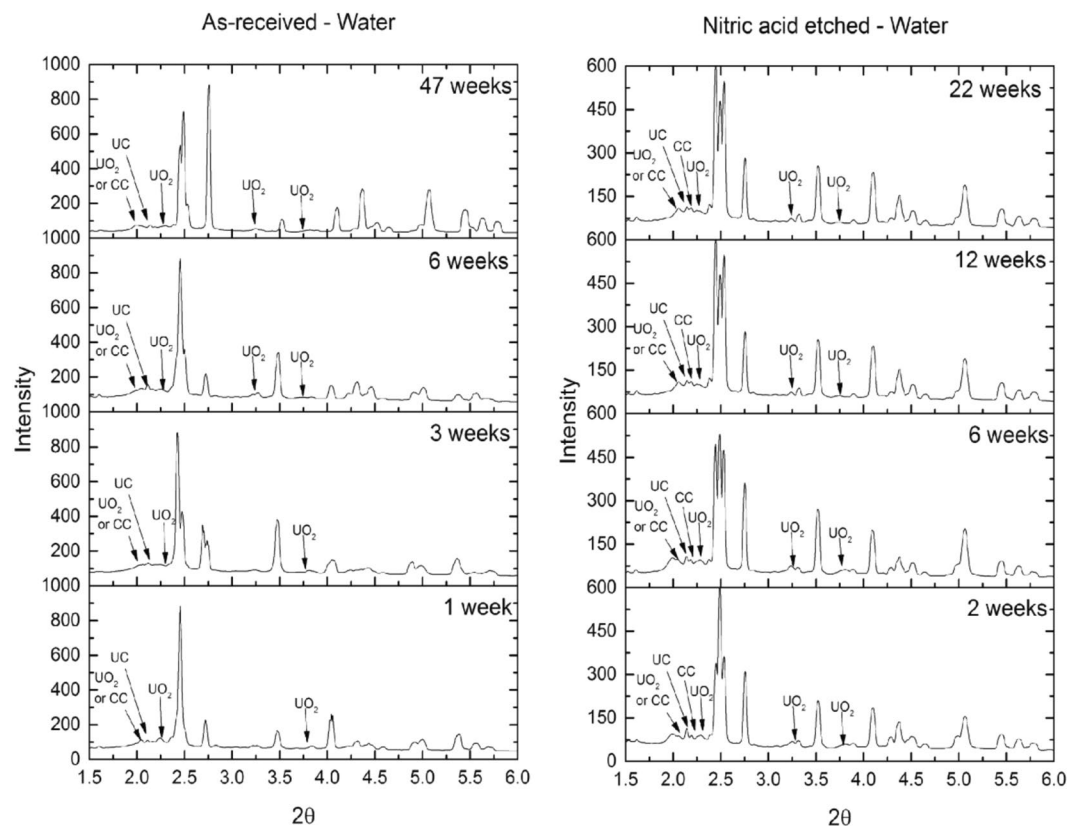
Figure 1. XRPD exhibiting the evolution of as-received and nitric acid etched, grout encapsulated uranium when submerged to de-ionised water over time. All unlabelled peaks are attributed to uranium metal. CC = Calcium carbonate (CaCO_3).

XRPD line scan data across each uranium rod and grout were averaged for each sample and shown in Fig. 1. Over the 47-week period, UO₂ was identified as the dominant corrosion product and no strong evidence of UH₃ was observed.

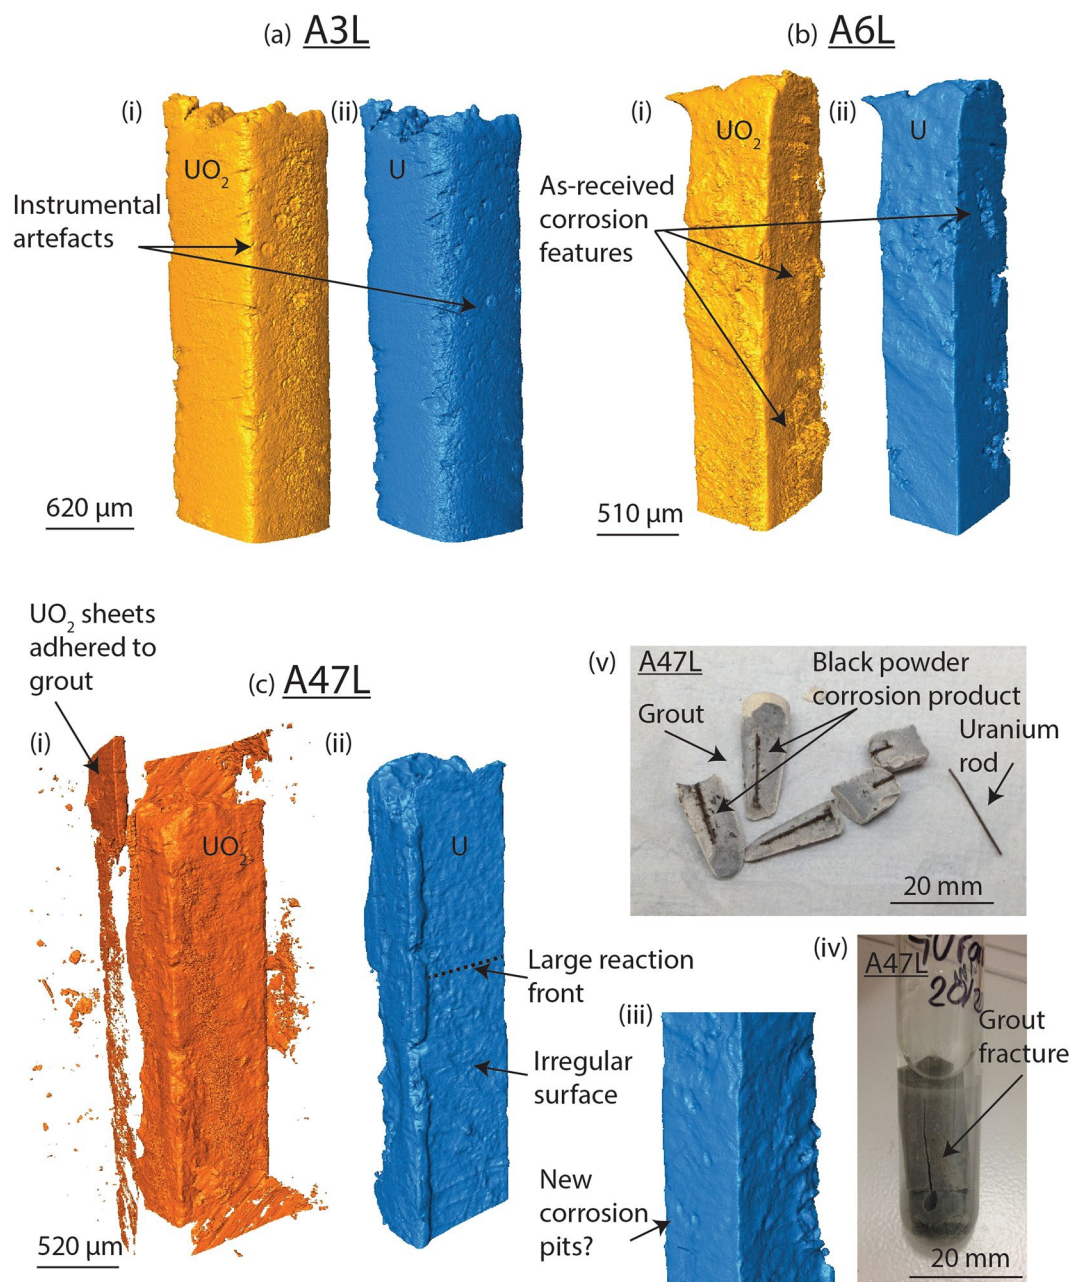
Figure 2. 3D renders of the as-received uranium encapsulated in grout, after submersion in de-ionised water for time periods up to 47 weeks. Each sample is displayed in pairs; yellow or orange representing the corrosion product (UO₂) and blue the uranium metal. Since the XRT quality was significantly lower using higher beam energies (115.6 keV), the corrosion product renders from the first beam time are highlighted in yellow ((a)(i) and (b)(i)), whilst the sample examined using lower energy (113.3 keV – beam time 2) is displayed in orange ((c)(i)). In general, a decrease in the number of instrumental artefacts, sharper imaging and reduced x-ray absorption by the uranium metal was observed using lower energies, allowing clearer identification and analysis of the corrosion product morphology. Photographs (c)(iv–v) show sample A47L before and after removal from the reaction cell respectively.

XRT data for the 'as-received' and nitric acid etched samples are shown in Figs. 2 and 3 respectively.

As-received samples (Group A). Sample A3L showed an irregular surface, but no significant difference between the uranium metal (Fig. 2(a)(i)) and corrosion product morphology (Fig. 2(a)(ii)) was observed, indicating that if any corrosion had occurred, it was relatively uniform across the metal surface. In comparison, A6L showed an irregular surface which exhibited a degree of pitting (≤250 µm diameter), filled with a corrosion product of ≤40 µm thick. Similar features were observed in characterisation of the metal surface prior to grout encapsulation using secondary electron microscopy imaging shown in the online supplementary (Fig. S1) of our previous study in C. Stitt *et al.*². In agreement with XRPD here, previous Secondary Ion Mass Spectrometry (SIMS) (Supplementary Fig. S2 of²) also detected UO₂ in addition to carbon, therefore these morphological features are most likely attributed to UO₂ formation during previous localised water corrosion. Between corrosion masses, the formation of a uniform corrosion layer indicated typical UO₂ development.

Sample A47L appeared considerably more corroded than when previously analysed as A3L (Fig. 2(c)). Before synchrotron examination, a fracture in the grout was noticed (Fig. 2(iv)) and subsequently during transfer between the reaction and transportation cell, the entire sample disintegrated into three sections (Fig. 2(v)). Inspection of the metal and corrosion products revealed a fine black powder adhered both to the uranium metal and grout where the uranium metal was originally positioned. The sample was reconstructed with Kapton tape

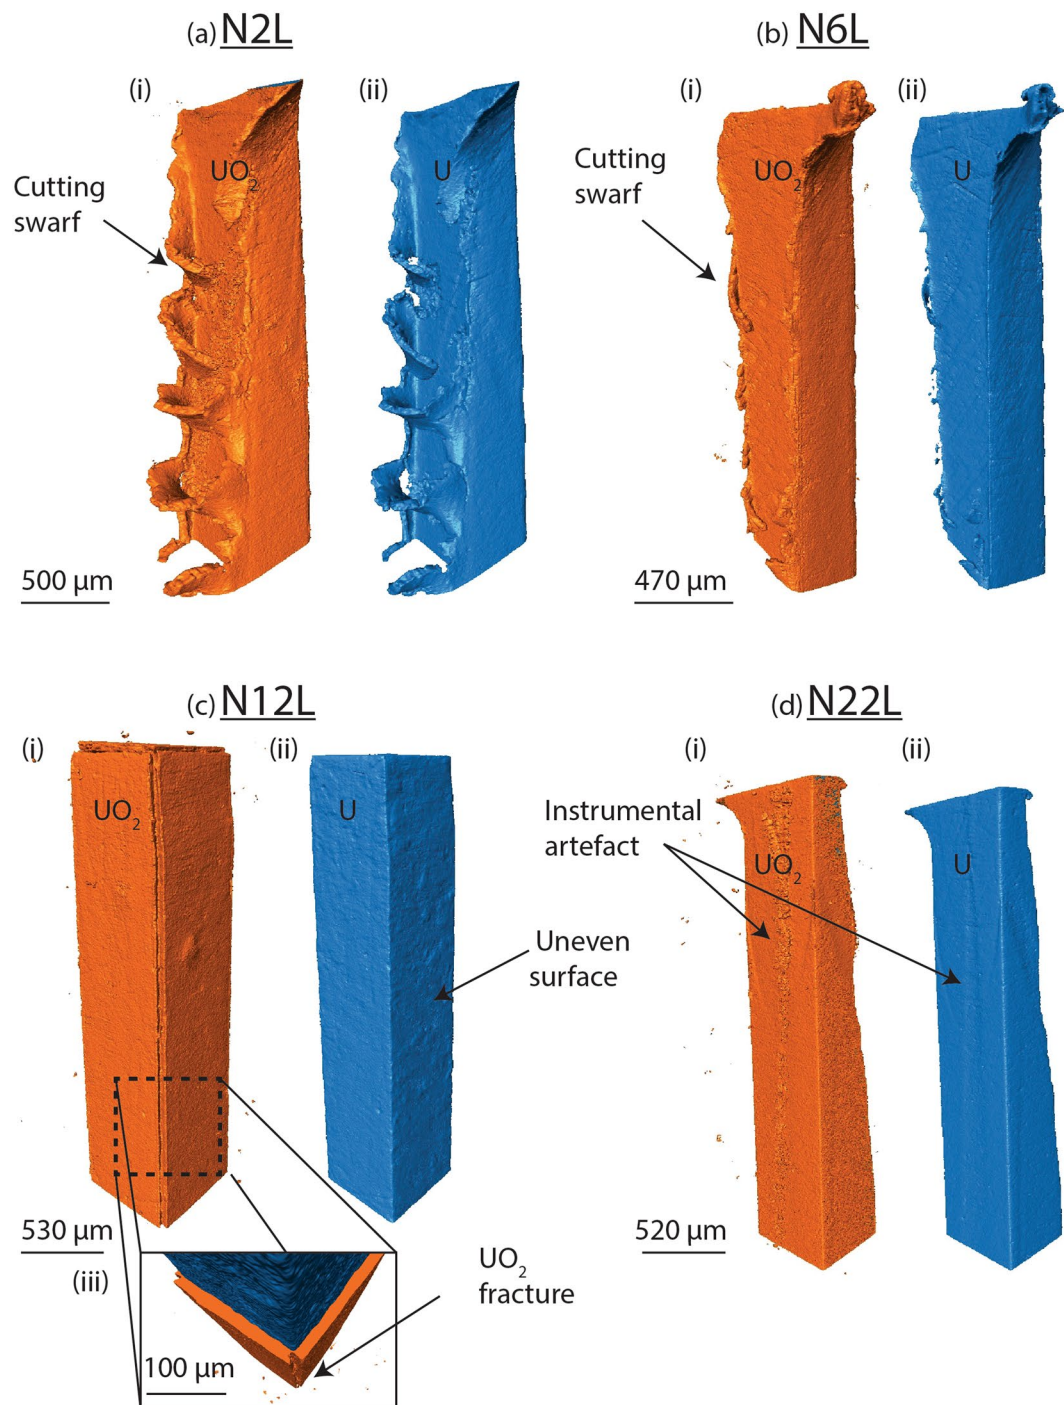
Figure 3. 3D renders of the nitric acid etched uranium, encapsulated in grout and submersed in de-ionised water for time periods up to 22 weeks. The corrosion products are exhibited in orange (left) and the uranium metal in blue (right).

Nitric acid etched samples (Group N). The nitric acid etched samples also retained some as-received metal features (Fig. 3). For example, high speed cutting caused excess swarf to form along the cut edges of samples N2L and N6L. On these features, oxide growth was observed to be thicker compared to the flat sample surface. However, overall the nitric acid etched samples showed evidence of typical, relatively uniform oxide growth across the metal surface. Table 2 shows an increase in oxide thickness over time, excluding samples N6L and N12L, which showed noticeably larger average oxide layer thicknesses compared to the remaining samples. Cross sections displaying both the grout and uranium in Figs. 5(b) and (c), reveal that the oxide layer had grown uniformly across all uranium metal faces, excluding the apexes where $17\text{--}42\mu\text{m}$ wide micro-fractures had formed in the grout and split the oxide at these positions. This morphology was expected of sample A47L, prior to it disintegrating. The metal surface of sample N12L (Fig. 3(c)(ii)) also showed a slightly irregular surface, indicating an uneven distribution of oxide rates across the metal surface. Despite reaction in water for a longer period of time, the oxide thickness exhibited on sample N22L was comparable to that of N2L.

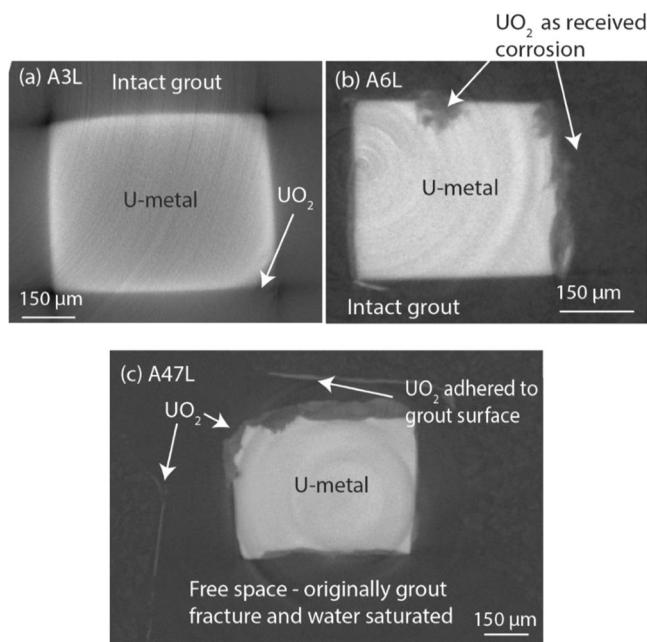
Figure 4. Tomographic cross sections of the as-received samples (A3L-A47L). Note that the cross sections for A3L and A47L are not taken at the same position on the sample.

Average oxide thickness measurements were obtained from cross sections of the XRT renders at 80 different positions along the length of each sample and are displayed in Table 2. Selected cross sections of the as-received and nitric acid etched uranium samples are displayed in Figs 4 and 5 respectively.

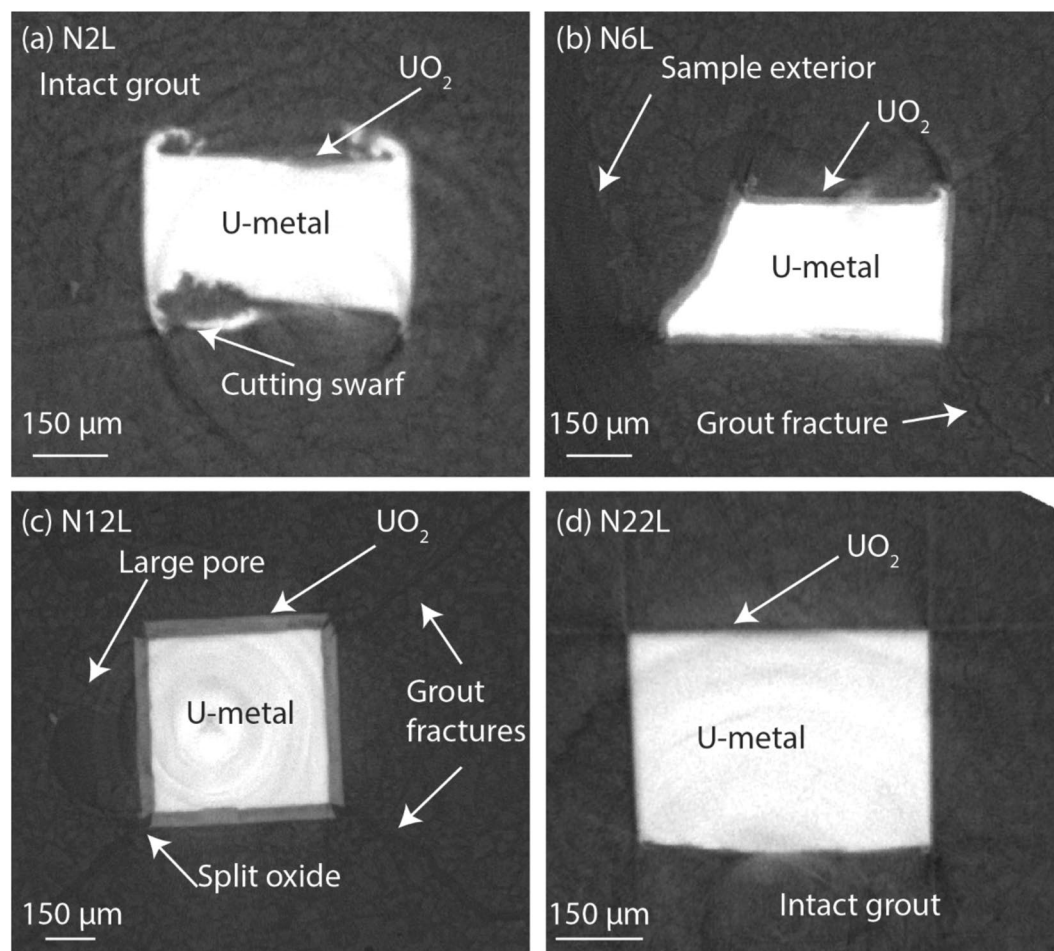
Figure 5. Tomographic cross sections of the nitric acid etched samples N2L-N22L. Note the grout fractures observed in N6L and N12L.

The grout split at all four apexes of the cuboid shaped uranium metal (Fig. 5(c)). Therefore the grout failure observed in samples N6L, N12L and A47L was most likely caused by the volume expansion associated with transformation of uranium to UO_2 (approximately double). Considering grout fracturing did not occur on sample N22L which had corroded for a longer time period than both N6L and N12L, it is expected an additional source of oxidising species was available for the latter two samples which allowed accelerated development of oxide to thicknesses sufficient to weaken the encasing grout. Establishment of the oxidising species source may have originated from two factors: (1) experimental error and (2) chance. Experimental errors include poor formation of the grout. For example, drying out of the grout during synchrotron preparation (evacuation to 5×10^{-4} mbar) at 3 weeks and then re-submersing sample A47L may have weakened the grout by removing essential water required for grout hydration thereby decreasing the grout strength. However, this was not observed to be a problem in the water vapour exposed samples in². Alternatively, the position of the uranium metal within the grout may have been advantageous for the diffusion of oxidising species to the metal surface. The uranium rod in sample N6L was highly angled within the grout and on closer inspection a large portion of the uranium was positioned near the edge of the grout. Figure 5(b) shows a clear breach in the grout between the uranium and exterior water where a water pathway had established.

Sample N12L did not appear to show any grout discrepancies or advantageous positioning of the uranium. However, a large 250 μm diameter pore (Fig. 5(c)) was observed close to the uranium rod, which may have temporarily stored water to fuel uranium oxidation before the grout fractured and subsequently increased water accessibility and further oxidation. If this is the case, a mode of water transport across the metal surface must have been available since the UO_2 thickness was relatively uniform across all metal surfaces of sample N12L. UO_2 formed during water oxidation usually yields stoichiometric $\text{UO}_{2.00}$, which is reportedly tightly packed and least favourable for diffusion than other oxides^{26,27}. However, here the oxide would have probably been non protective, since growth beyond 0.1 μm thickness produces internal stress that cause the oxide to fracture and spall, promoting diffusion through the oxide layer²⁰. Consistent with our previous studies²⁸, evidence of strong UO_2 -grout bonding was exhibited in sample A47L, but again the XRPD resolution was insufficient to identify any mineralisation at this interface.

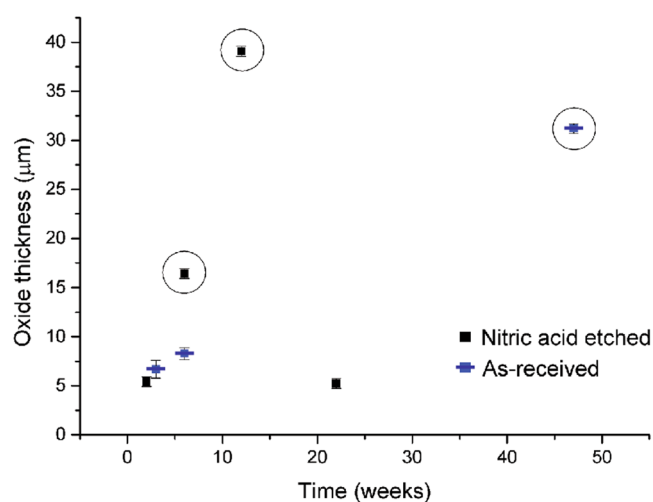
Figure 6. A plot demonstrating the change in UO_2 thickness on all samples, over time. Circled samples presented grout fracturing. Values and errors are extracted from Table 2.

Figure 6 compares the oxide growth of all the uranium samples encapsulated in grout and exposed to water over different lengths of time. Two oxide growth behaviours were observed: (1) Samples N2L and N22L exhibited similar oxidation thicknesses to the water vapour exposed samples described in². (2) Samples N6L, N22L and A47L showed accelerated corrosion and also displayed grout fracturing. Thus, the occurrence of grout failure appeared independent of the time allowed for corrosion.

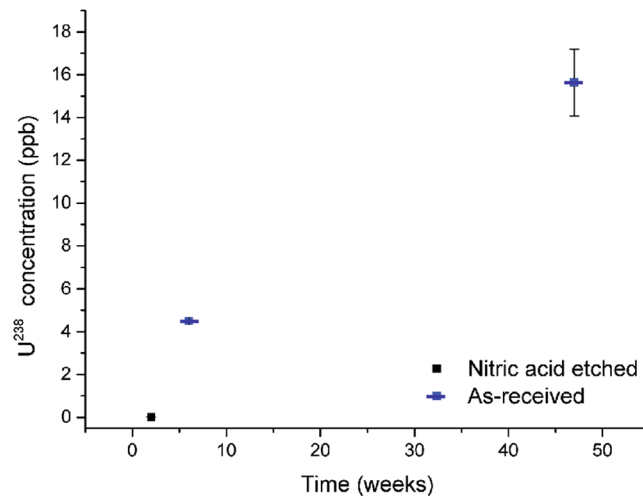
Figure 7. The concentration of ^{238}U detected in the residual water of samples N2L, A6L and A42L. For comparison, the average drinking water concentration of uranium in the US in the 1980s was 2.55 ppb³⁹.

The concentration of ²³⁸U in the residual waters of samples N2L, A6L and A47L are displayed in Fig. 7. Over a 47-week period, the concentration of ²³⁸U increased by an order of magnitude, demonstrating increased mobilisation of uranium within the grout. However, as previously mentioned sample A47L exhibited grout fracturing which may have enhanced uranium mobilisation by directly exposing the metal and UO₂ to water.

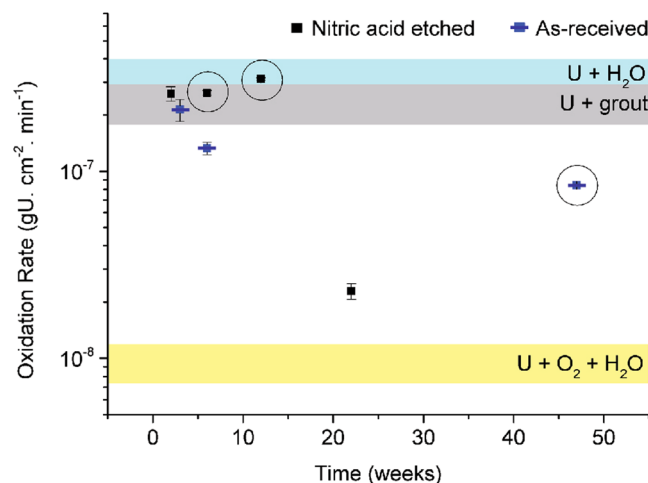
Figure 8. A plot demonstrating the variability in oxide growth rates of grout encapsulated uranium metal, when submersed in water for extended periods of time. Each band represents the oxidation rate at 25 °C, calculated from the empirically derived equations (2–5) displayed at the beginning of this section and sourced from^{3,17,18,21,22}. These results are compared to the rates calculated from the oxide thicknesses determined here. The error bars originate from the errors viewed in Table 2.

The oxidation rates of uranium encapsulated in grout and submersed in water showed an overall decrease over time (Fig. 8). Similar to the water vapour exposed samples in reference², the rates commenced with $\text{U} + \text{H}_2\text{O}$ dominated oxidation for the first 6 weeks, which slowly decreased toward a $\text{U} + \text{O}_2 + \text{H}_2\text{O}$ oxidation rate with time. Since the aqueous chemistry results suggested low dissolved oxygen and a chemically reducing environment in all samples, this pattern is not attributed to the introduction of oxygen to the system. Instead this was more likely caused by the formation of C-S-H phases (where C = CaO, S = SiO_2 and H = H_2O) and mineralisation around grout grains during the first few months of hydration, reducing grout permeability and therefore

preventing water diffusion to the metal surface^{1,24,25}. The three samples which exhibited grout fracturing (circled in Fig. 8) conveniently demonstrate this point. These samples displayed significantly higher oxidation rates in comparison to samples with intact grout, since their grout fractures provided a pathway for water to access the uranium metal. This behaviour clearly shows that in intact grout, the supply of oxidising species to the uranium metal is a limiting factor to uranium oxidation.

The oxidation rate of both water vapour exposed² and water submersed (Fig. 8) encapsulated uranium showed evidence of eventually plateauing and reaching a steady state. If the rate of oxidation observed by the water vapour exposed uranium sample A50 (50 week water vapour exposure leading to 7.16 μm average oxide thickness)² continued, then an 19% volume expansion would occur after 2 years of encapsulation. If the oxidation rate continued to decrease toward the $\text{U} + \text{O}_2 + \text{H}_2\text{O}^{17}$ or the $\text{U} + \text{O}_2^{21}$ empirically derived oxidation rates at 25 °C (Fig. 8), then much longer time periods of approximately 4 and 30 years would be required to cause grout failure by uranium oxidation when in unconfined, surface storage or GDF conditions. Considering the Magnox Encapsulation Plant at Sellafield commenced waste encapsulation in 1990, these figures suggest it is likely that some grout fracturing may have occurred within some containers as a result of uranium oxidation³⁵. However, these figures neglect the reinforcement provided by the outer stainless steel container and higher compressive stresses present in large volumes of grout.
