Failure investigations into interspersed railway tracks exposed to flood and washaway conditions under moving train loads

Khairul Anuar, Mohamad Ali Ridho; Kaewunruen, Sakdirat

DOI:
10.1016/j.engfailanal.2021.105726

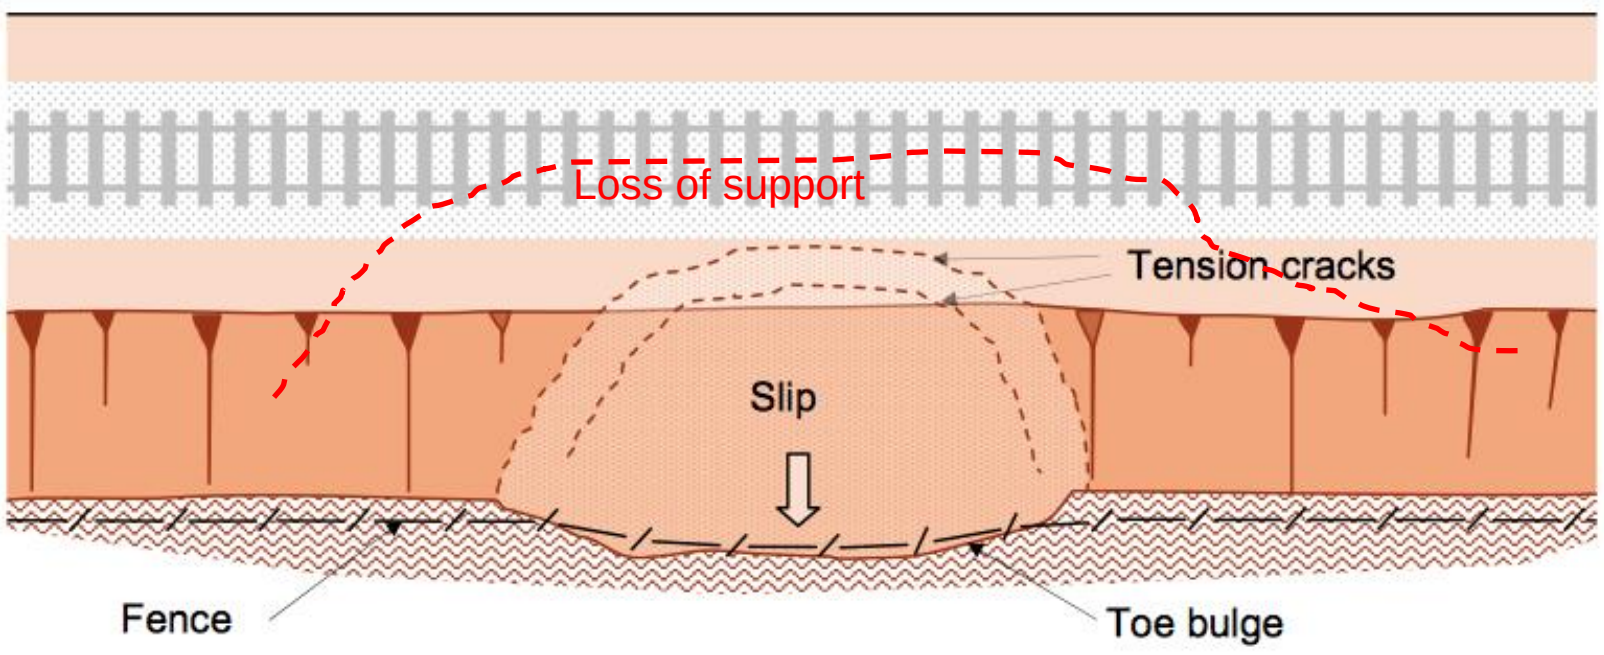
In a case that the gradient or vertical slope of railway tracks and corridor is steep, the runoffs can cause erosion of formation and cause ballast washaway. This event will completely eliminate the ballast and track formation that support the track systems. The severity of this incident depends on the volume and the speed of runoff and whether any water-borne debris exists. If the railway corridor has been properly designed (e.g. with a crossfall tapering towards the drainage), the ballast washaway might occur partially (e.g. only half of track support) but the scale of damage might be large (e.g. a large number of sleepers are affected). If the flood condition exists, rail engineers may not be able to observe the affected zone until major damages incur such as land slide, derailments, etc. For instance, land slip could also occur as illustrated in Fig. 5. Initially, loss of track support will occur, followed by tension cracks and land slips. Track engineers are generally unable to observe or notice occurrences of the loss of track support.

Fig. 5. Risks of heavy rail falls and runoff, and flood conditions.

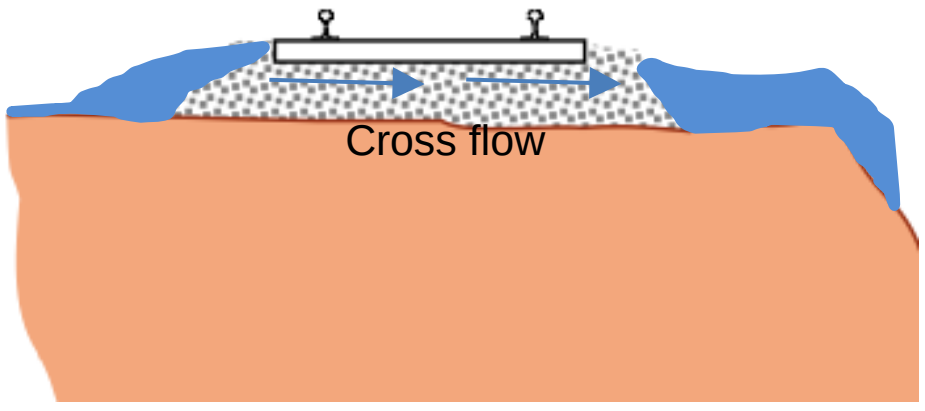
Fig. 6. Cross runoff causing ballast washaway

When a railway track is located in an inclined plane of terrain, cross water runoffs can also cause ballast washaway, as illustrated in Fig. 6. The cross flow can infiltrate the ballast and erode the ballast particles (and potentially formation), causing the ballast washaway (loss of track support), and eventually land slips. When the track system is exposed to a large area with ballast washaway, any operation of a train is reckless.

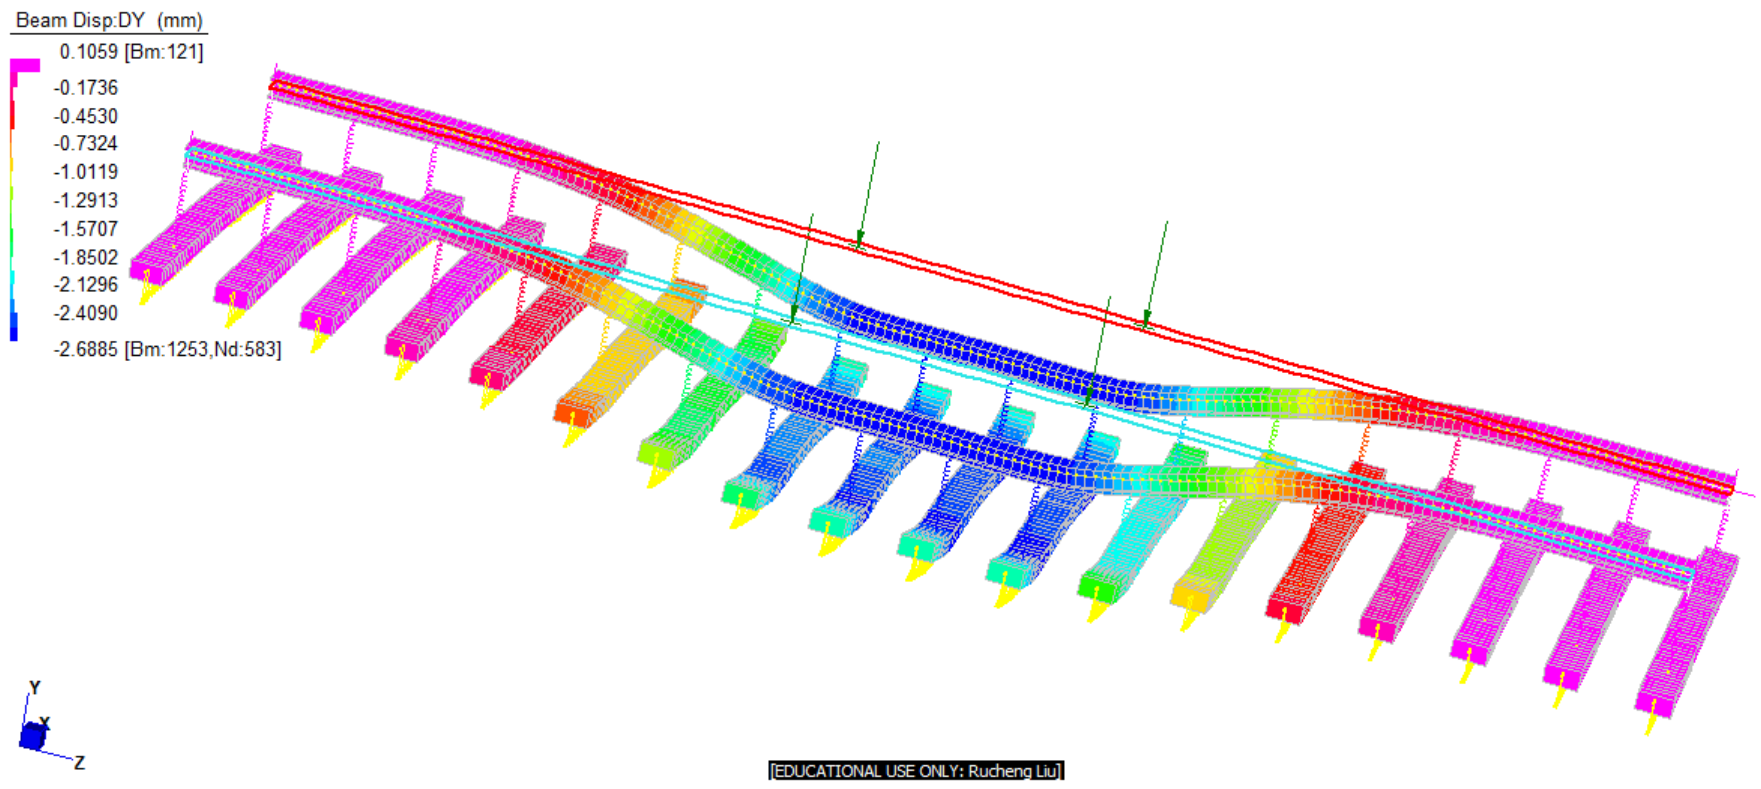
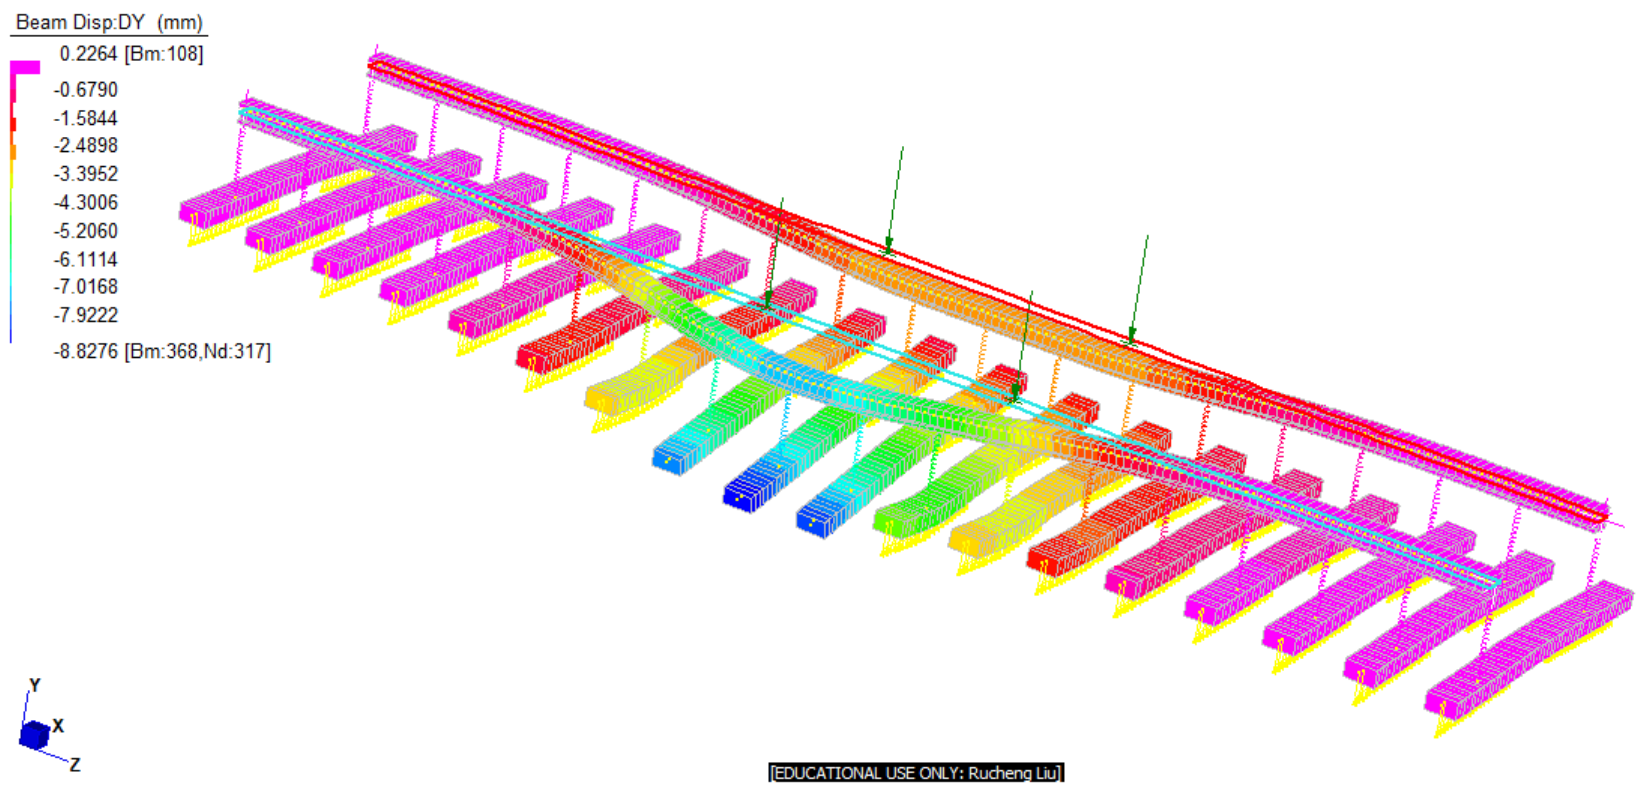
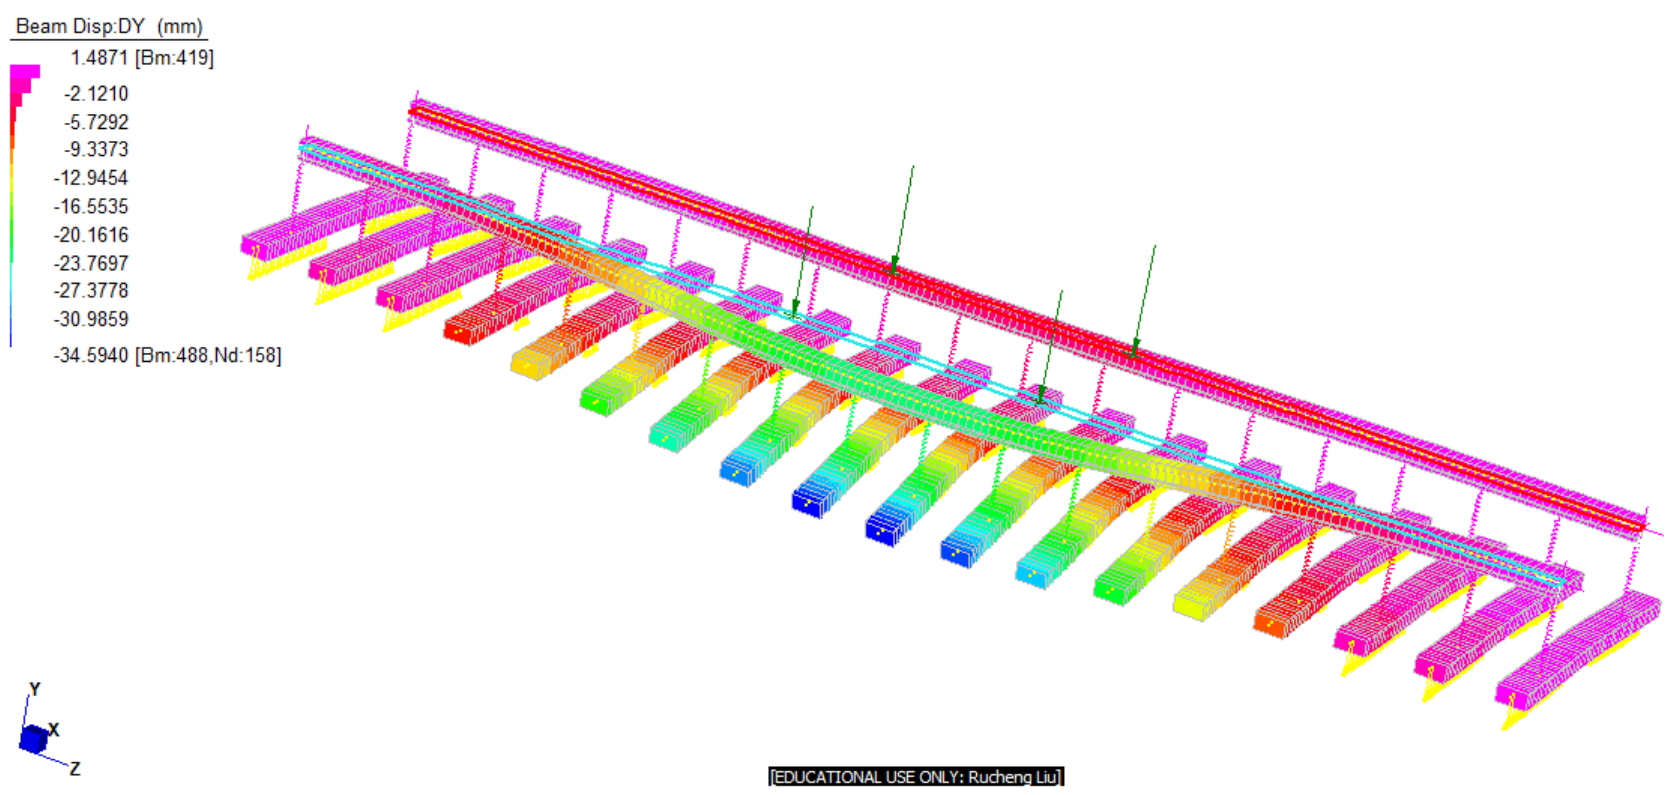
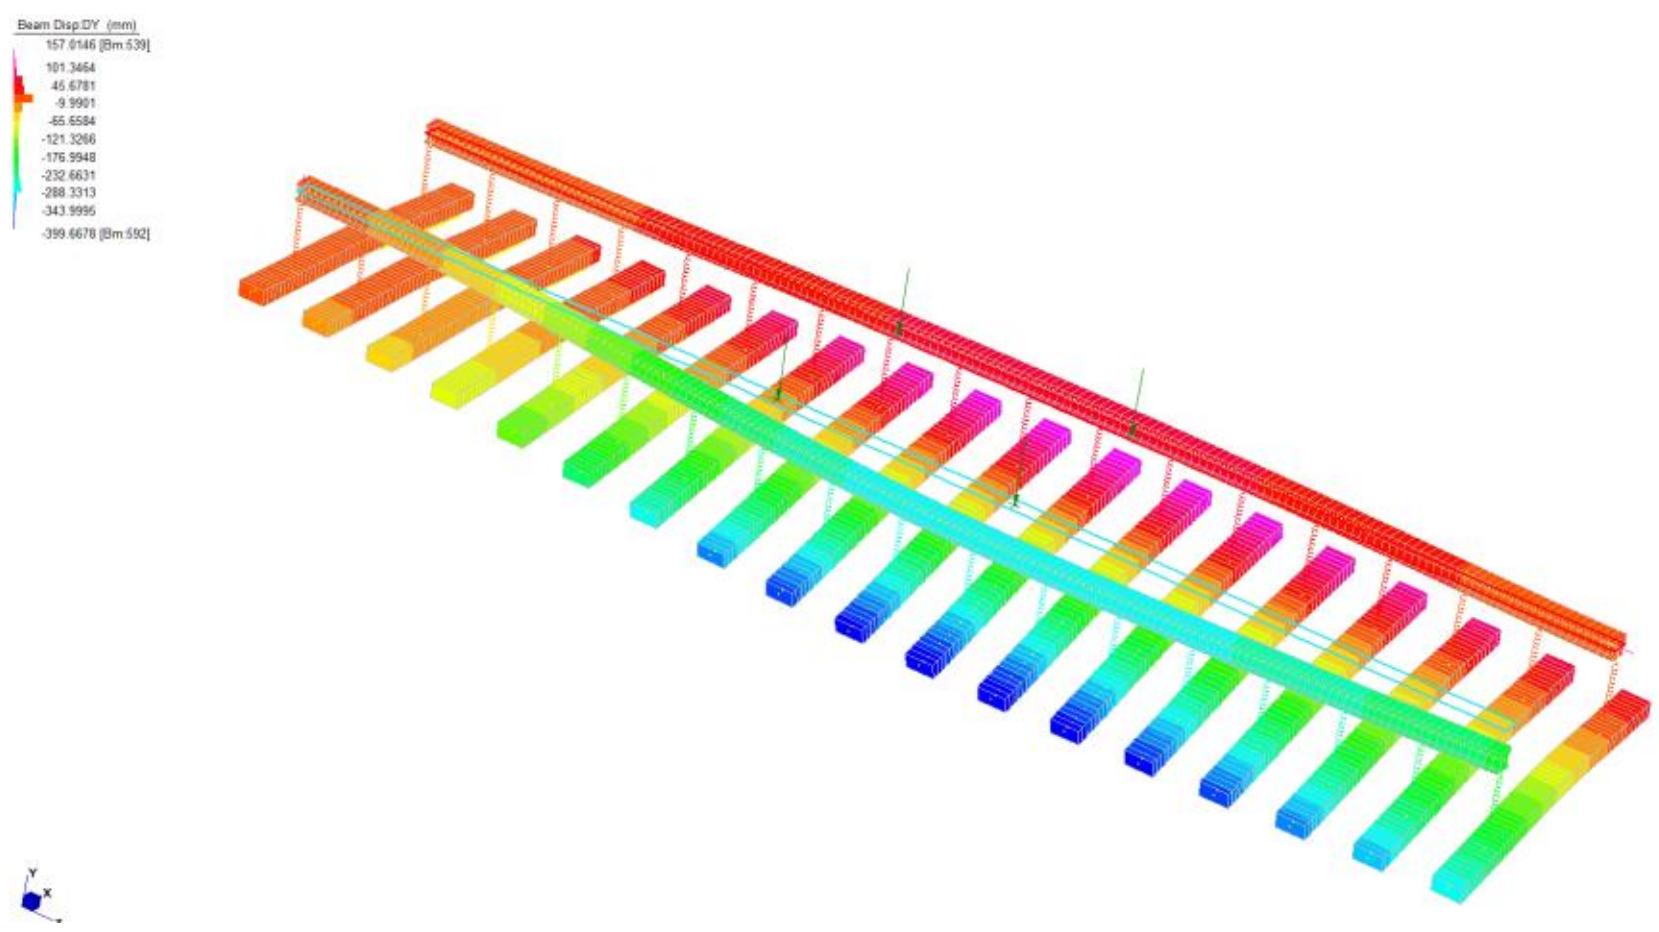
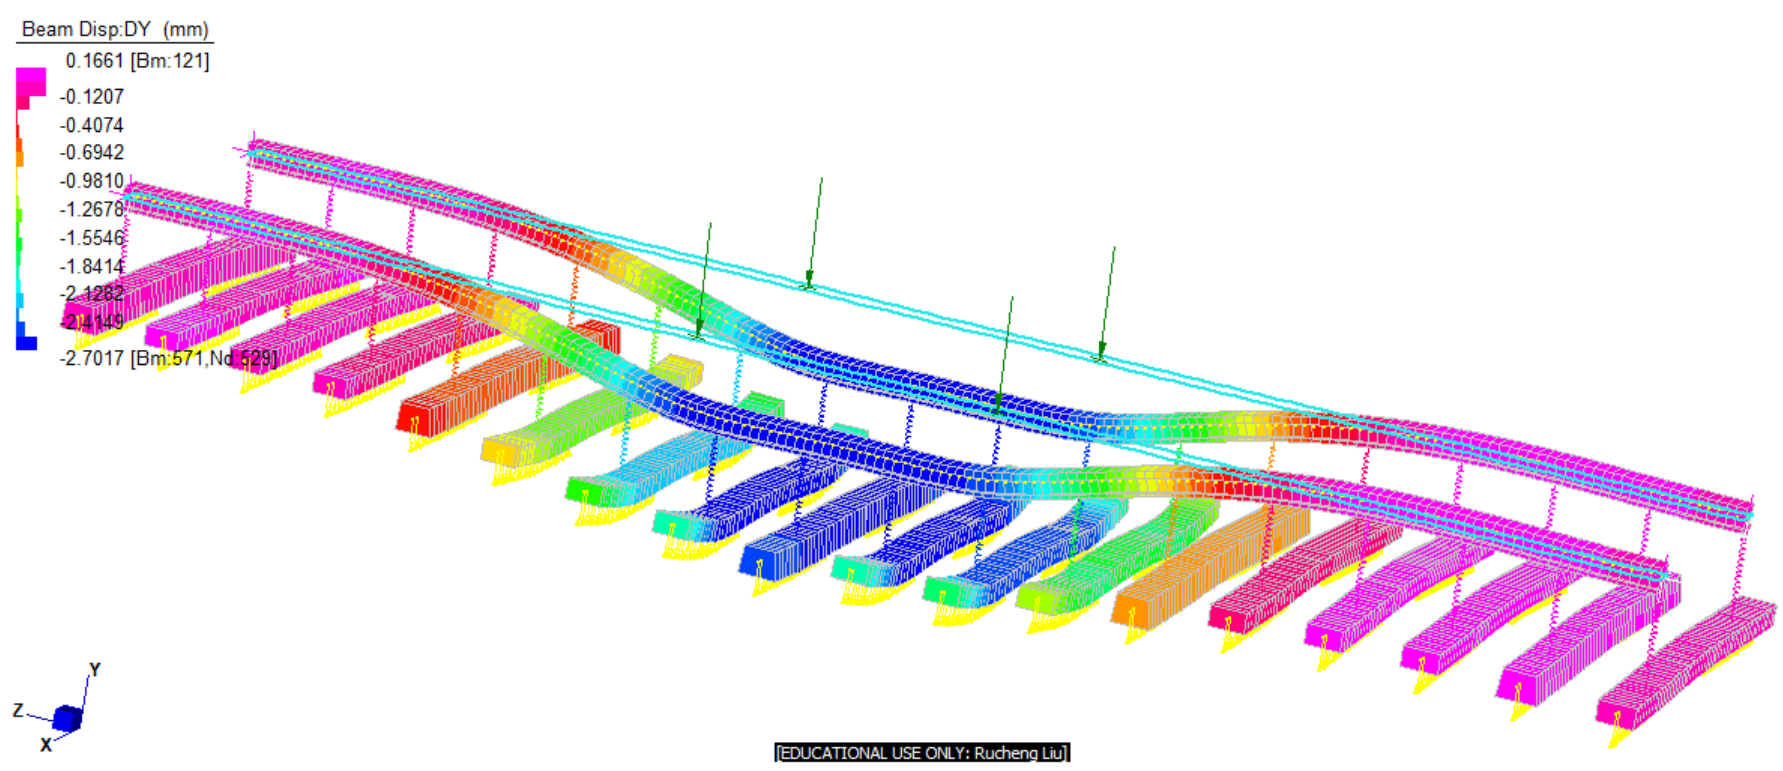
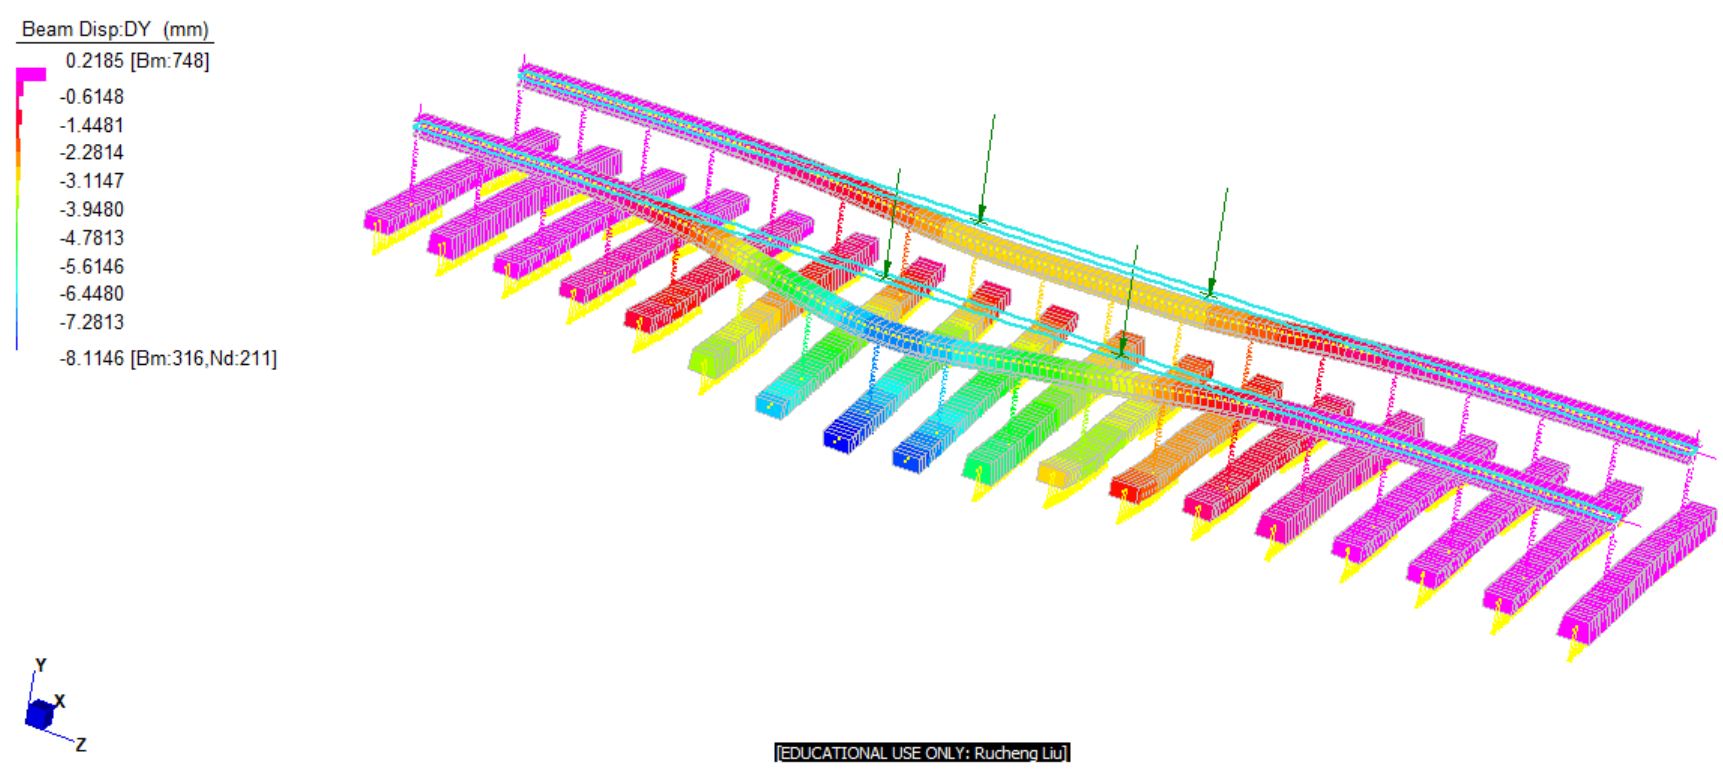
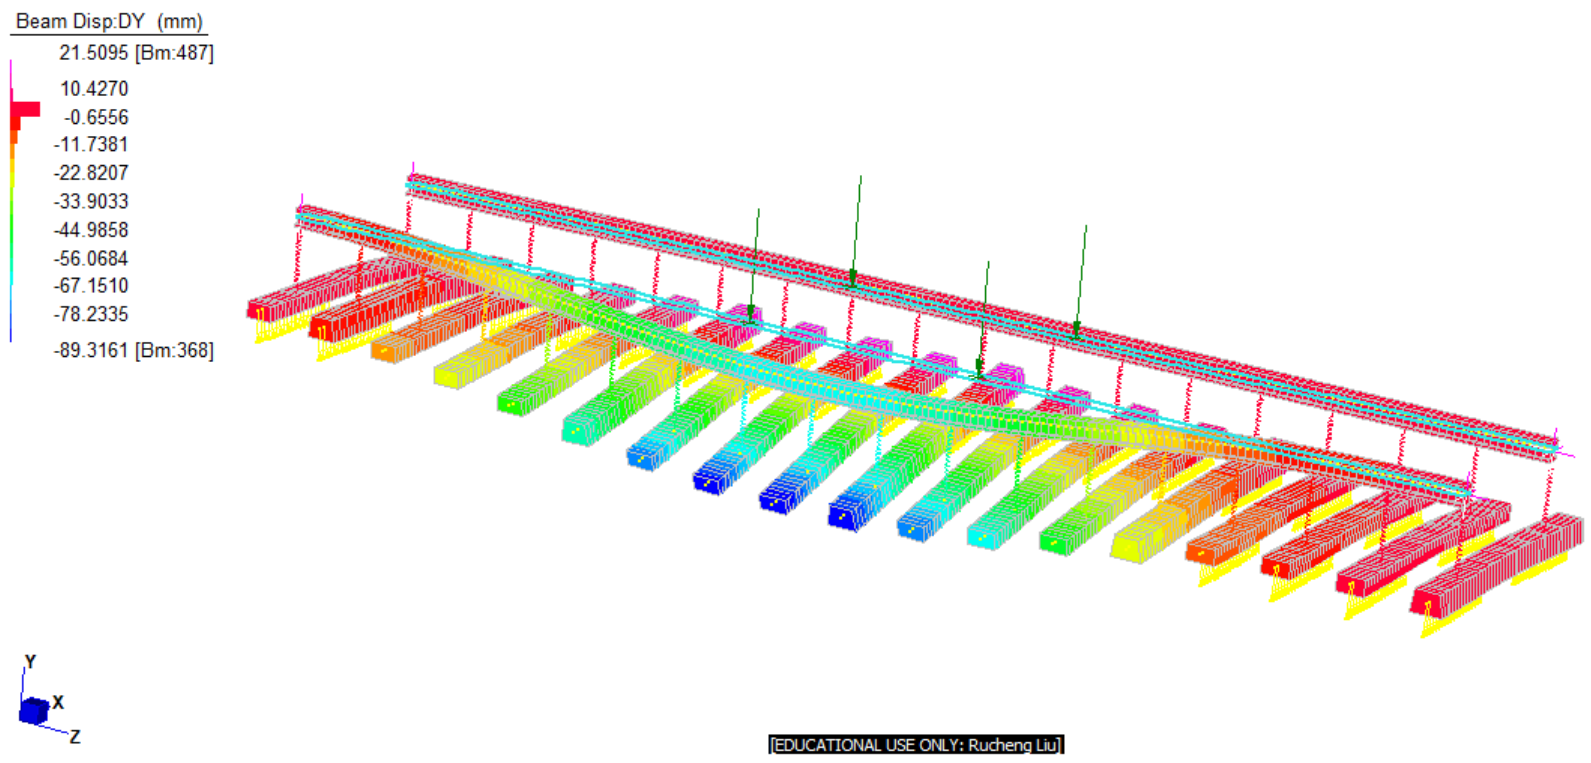
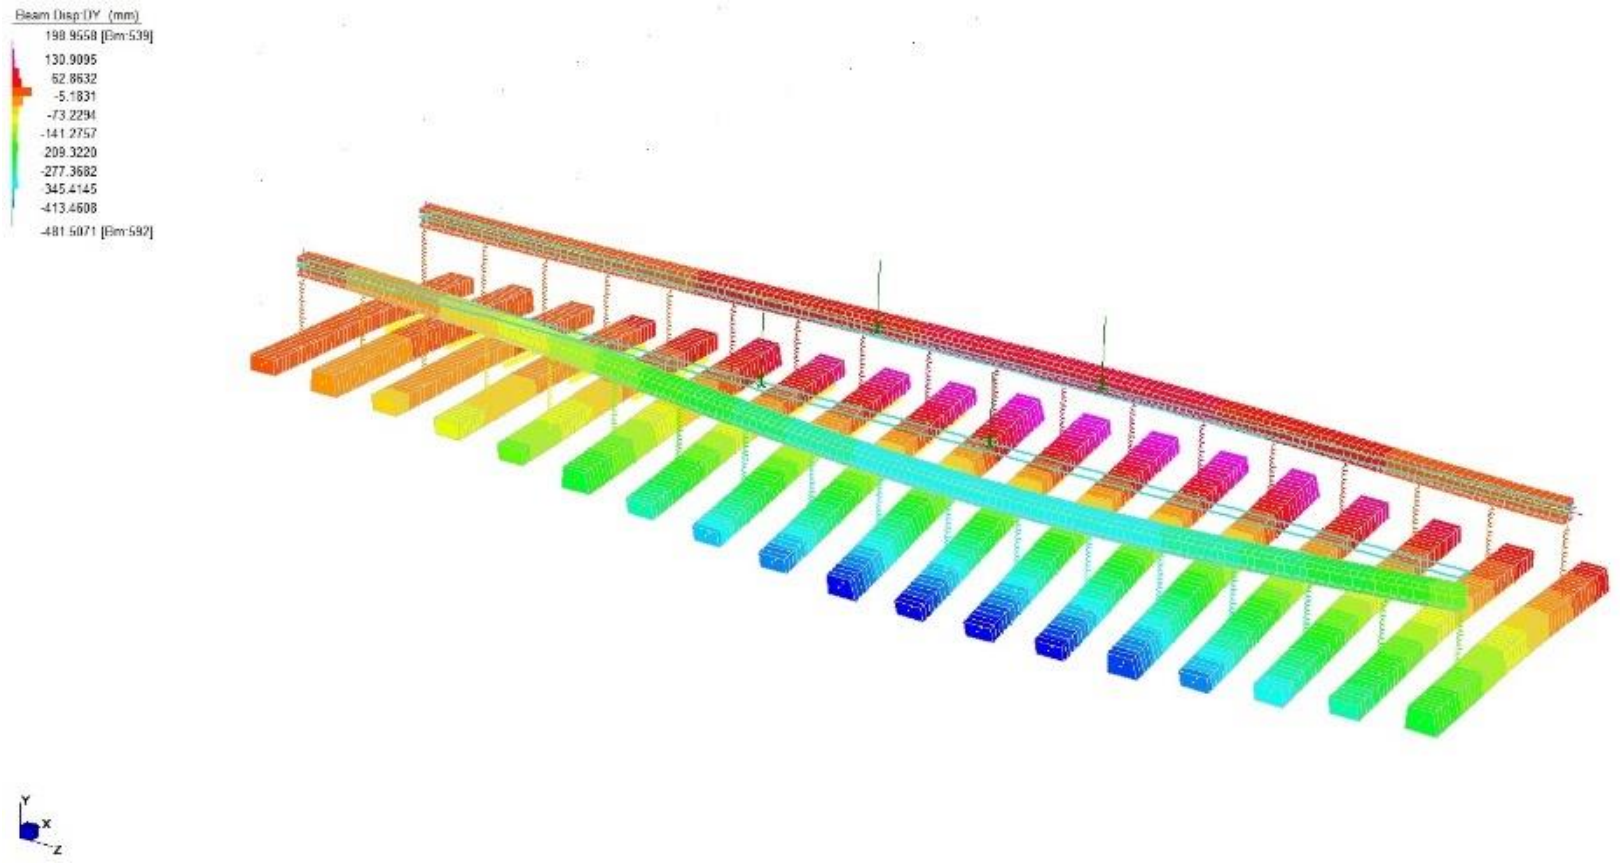
Fig. 8. Dynamic responses to 120km/h moving train loads of track systems exposed to flood and washaway conditions

It is clear from Fig. 8 that the train loads incur the difference in dynamic rail displacements on left and right rails. This difference at a position is often referred to as ‘cross level’. When a train bogie or a train body travels over the differential cross levels, the twists in the train body or bogie can incur. These twists can cause train derailments. The twist on train body is often called ‘long twist’ while the twist on train bogie is called ‘short twist’. These twist limits can be illustrated in Fig. 9 (adopted from a maintenance standard of Transport for NSW, Australia). If the track twists reach E2 and E1, this situation is at danger and requires emergency actions. The train could derail when travel over E2/E1 conditions.

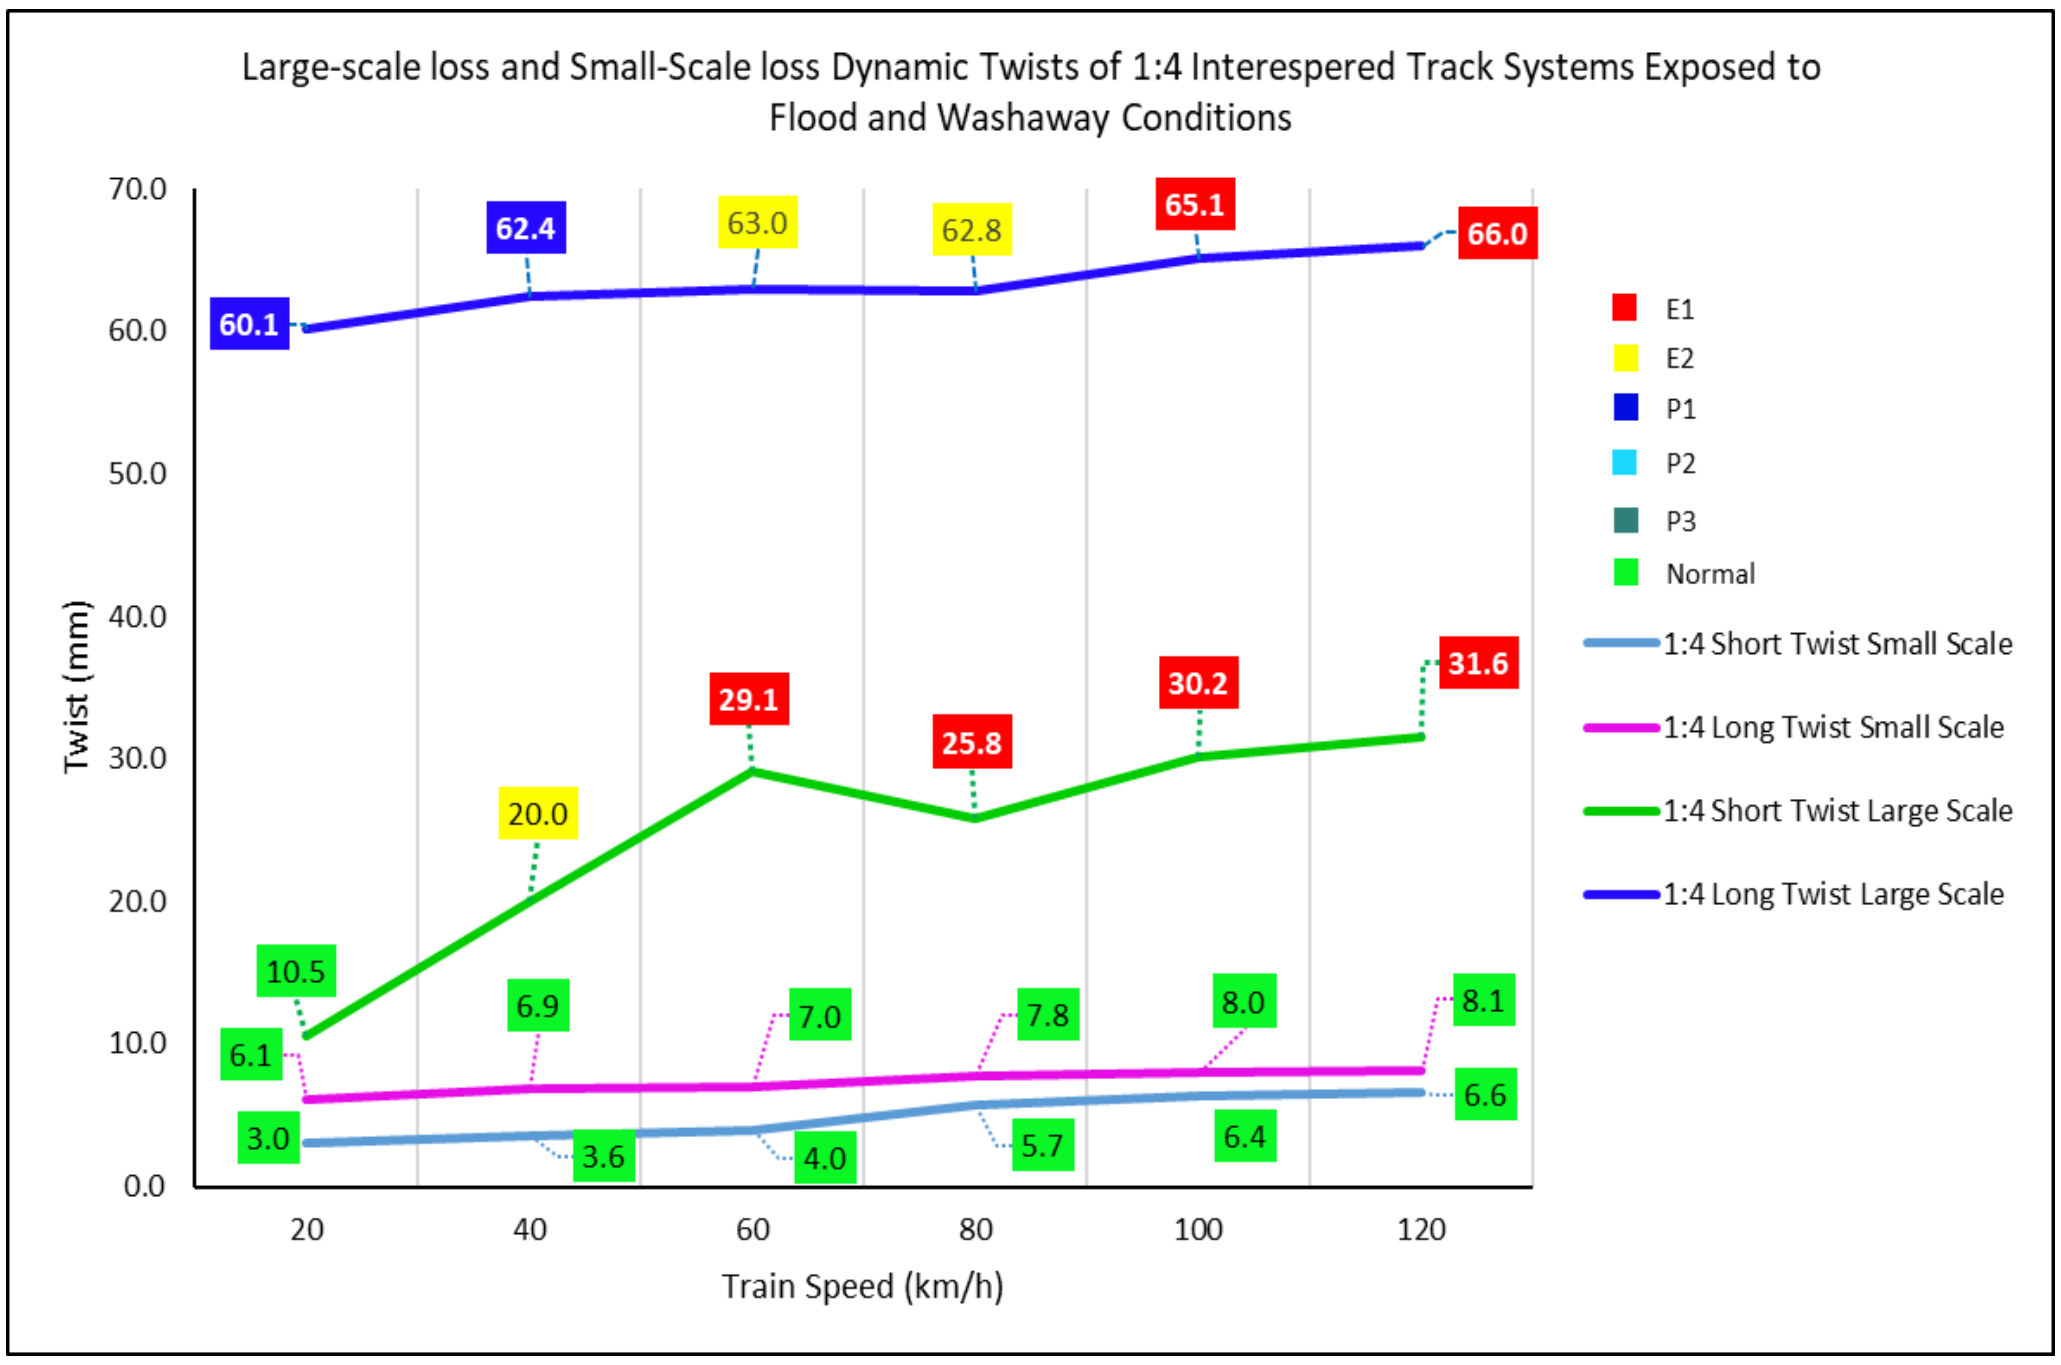
The dynamic twists of the interspersed track systems considering the losses of support conditions are shown in Fig. 10. The short twist is determined using 2m , while the long twist is based on 14m cord. The twist results have been correlated with the risk colours shown in Fig. 9 (green is normal, light blue is P2, dark blue is P1, yellow is E2, red is E1).

Fig. 10. Dynamic twists of 1:4 interspersed track systems exposed to flood and washaway conditions (unit in mm.). Colour backgrounds are correlated with risk profiles defined in Fig.9.

From Fig. 10, it should be noted that N is normal condition; P3 is a situation needed to repair within 3 months; P2 is a situation needed to repair within 28 days; P1 is a situation needed to repair within 7 hours; E2 is a situation needed to repair within 24 hrs; E1 is a situation needed to repair immediately. This implies that when the 1:4 interspersed track is exposed to large scale loss of support condition, it could be very dangerous to operate a train above 40 km/h. In fact, it will still be at risk when a train travels at 20 km/h since the long twist defect could derail the train, especially when the train could also have certain defects (e.g. stiff bogies, deflated suspensions, etc.). On this ground, it is clear that rail operators should be very careful in train operations when the railway tracks become vulnerable due to flood and washaway conditions. In order to mitigate this issue, engineers should consider applying ballast bond solutions to enable free drainage whilst reinforce the ballast particles [24]. This insight will help track engineers develop appropriate climate change adaptation method and policy for operations of interspersed railway tracks facing extreme rainfall and flooding conditions.

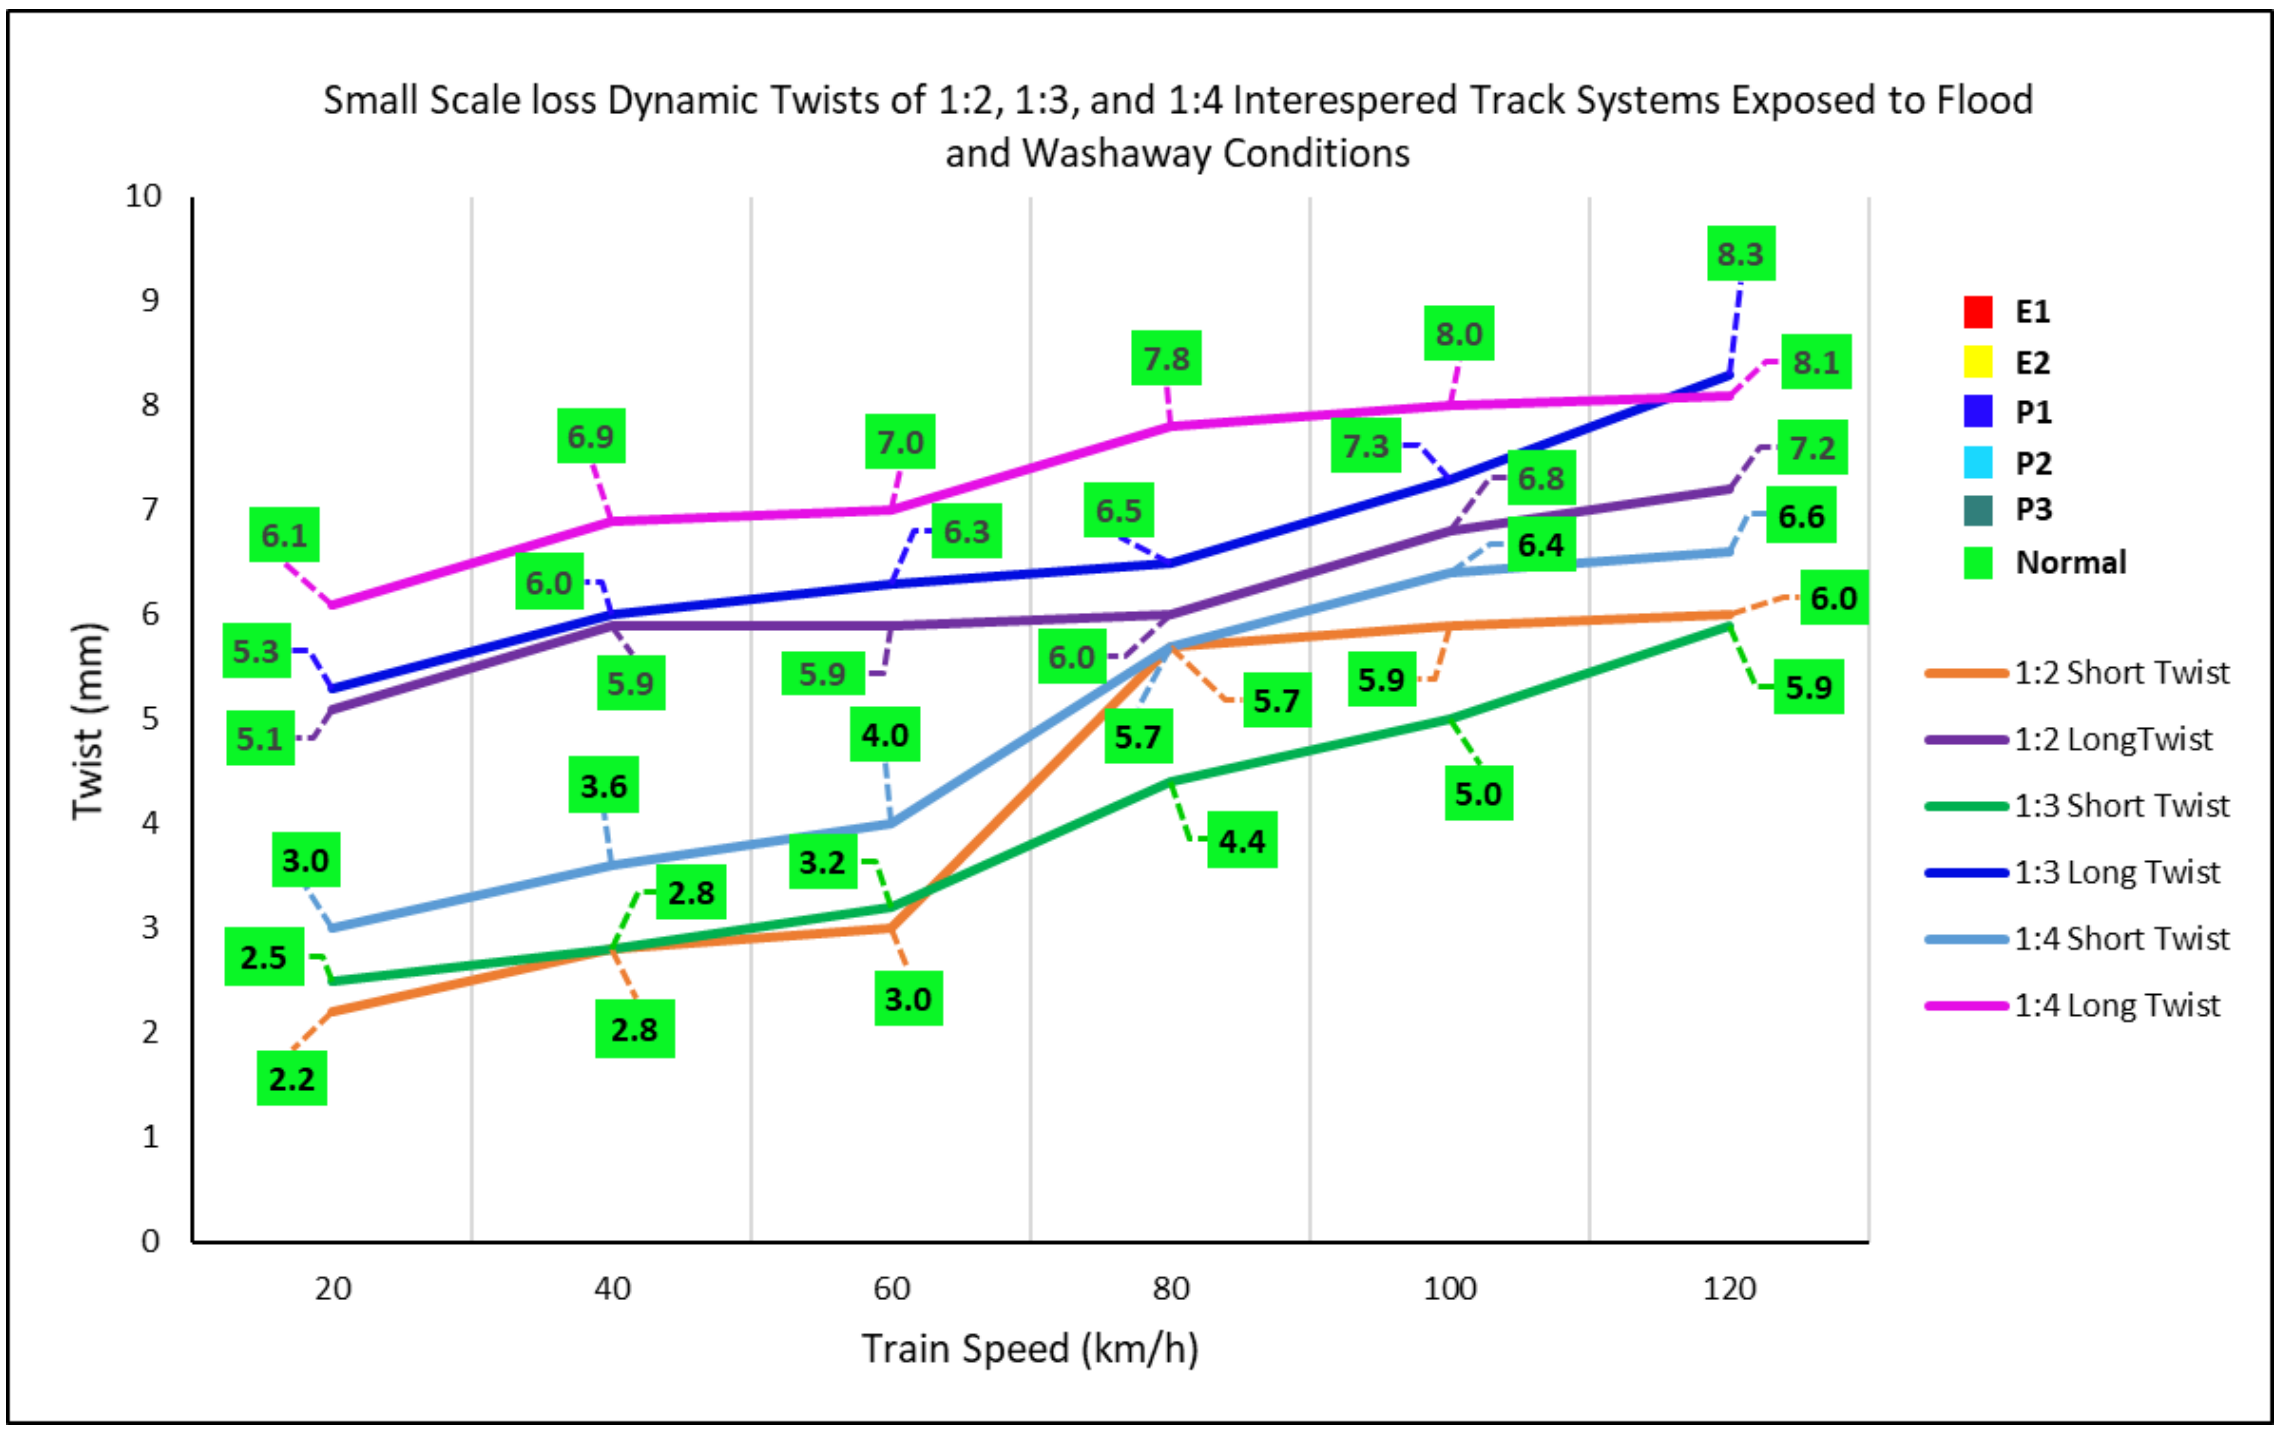
Fig. 11. Small-scale loss dynamic twists of 1:2, 1:3, and 1:4 interspersed track systems exposed to flood and washaway conditions (unit in mm.). Colour backgrounds are correlated with risk profiles defined in Fig.9.

According to Fig. 9, the dynamic response for interspersed track 1:2, 1:3, 1:4 exposed to small-scale loss from Fig. 11 will not cause any issue in terms of short and long twist. It is safe to operate the train on a small-scale loss track even at 120 km/h. Nevertheless, the situation might change if the train not in a favourable state.

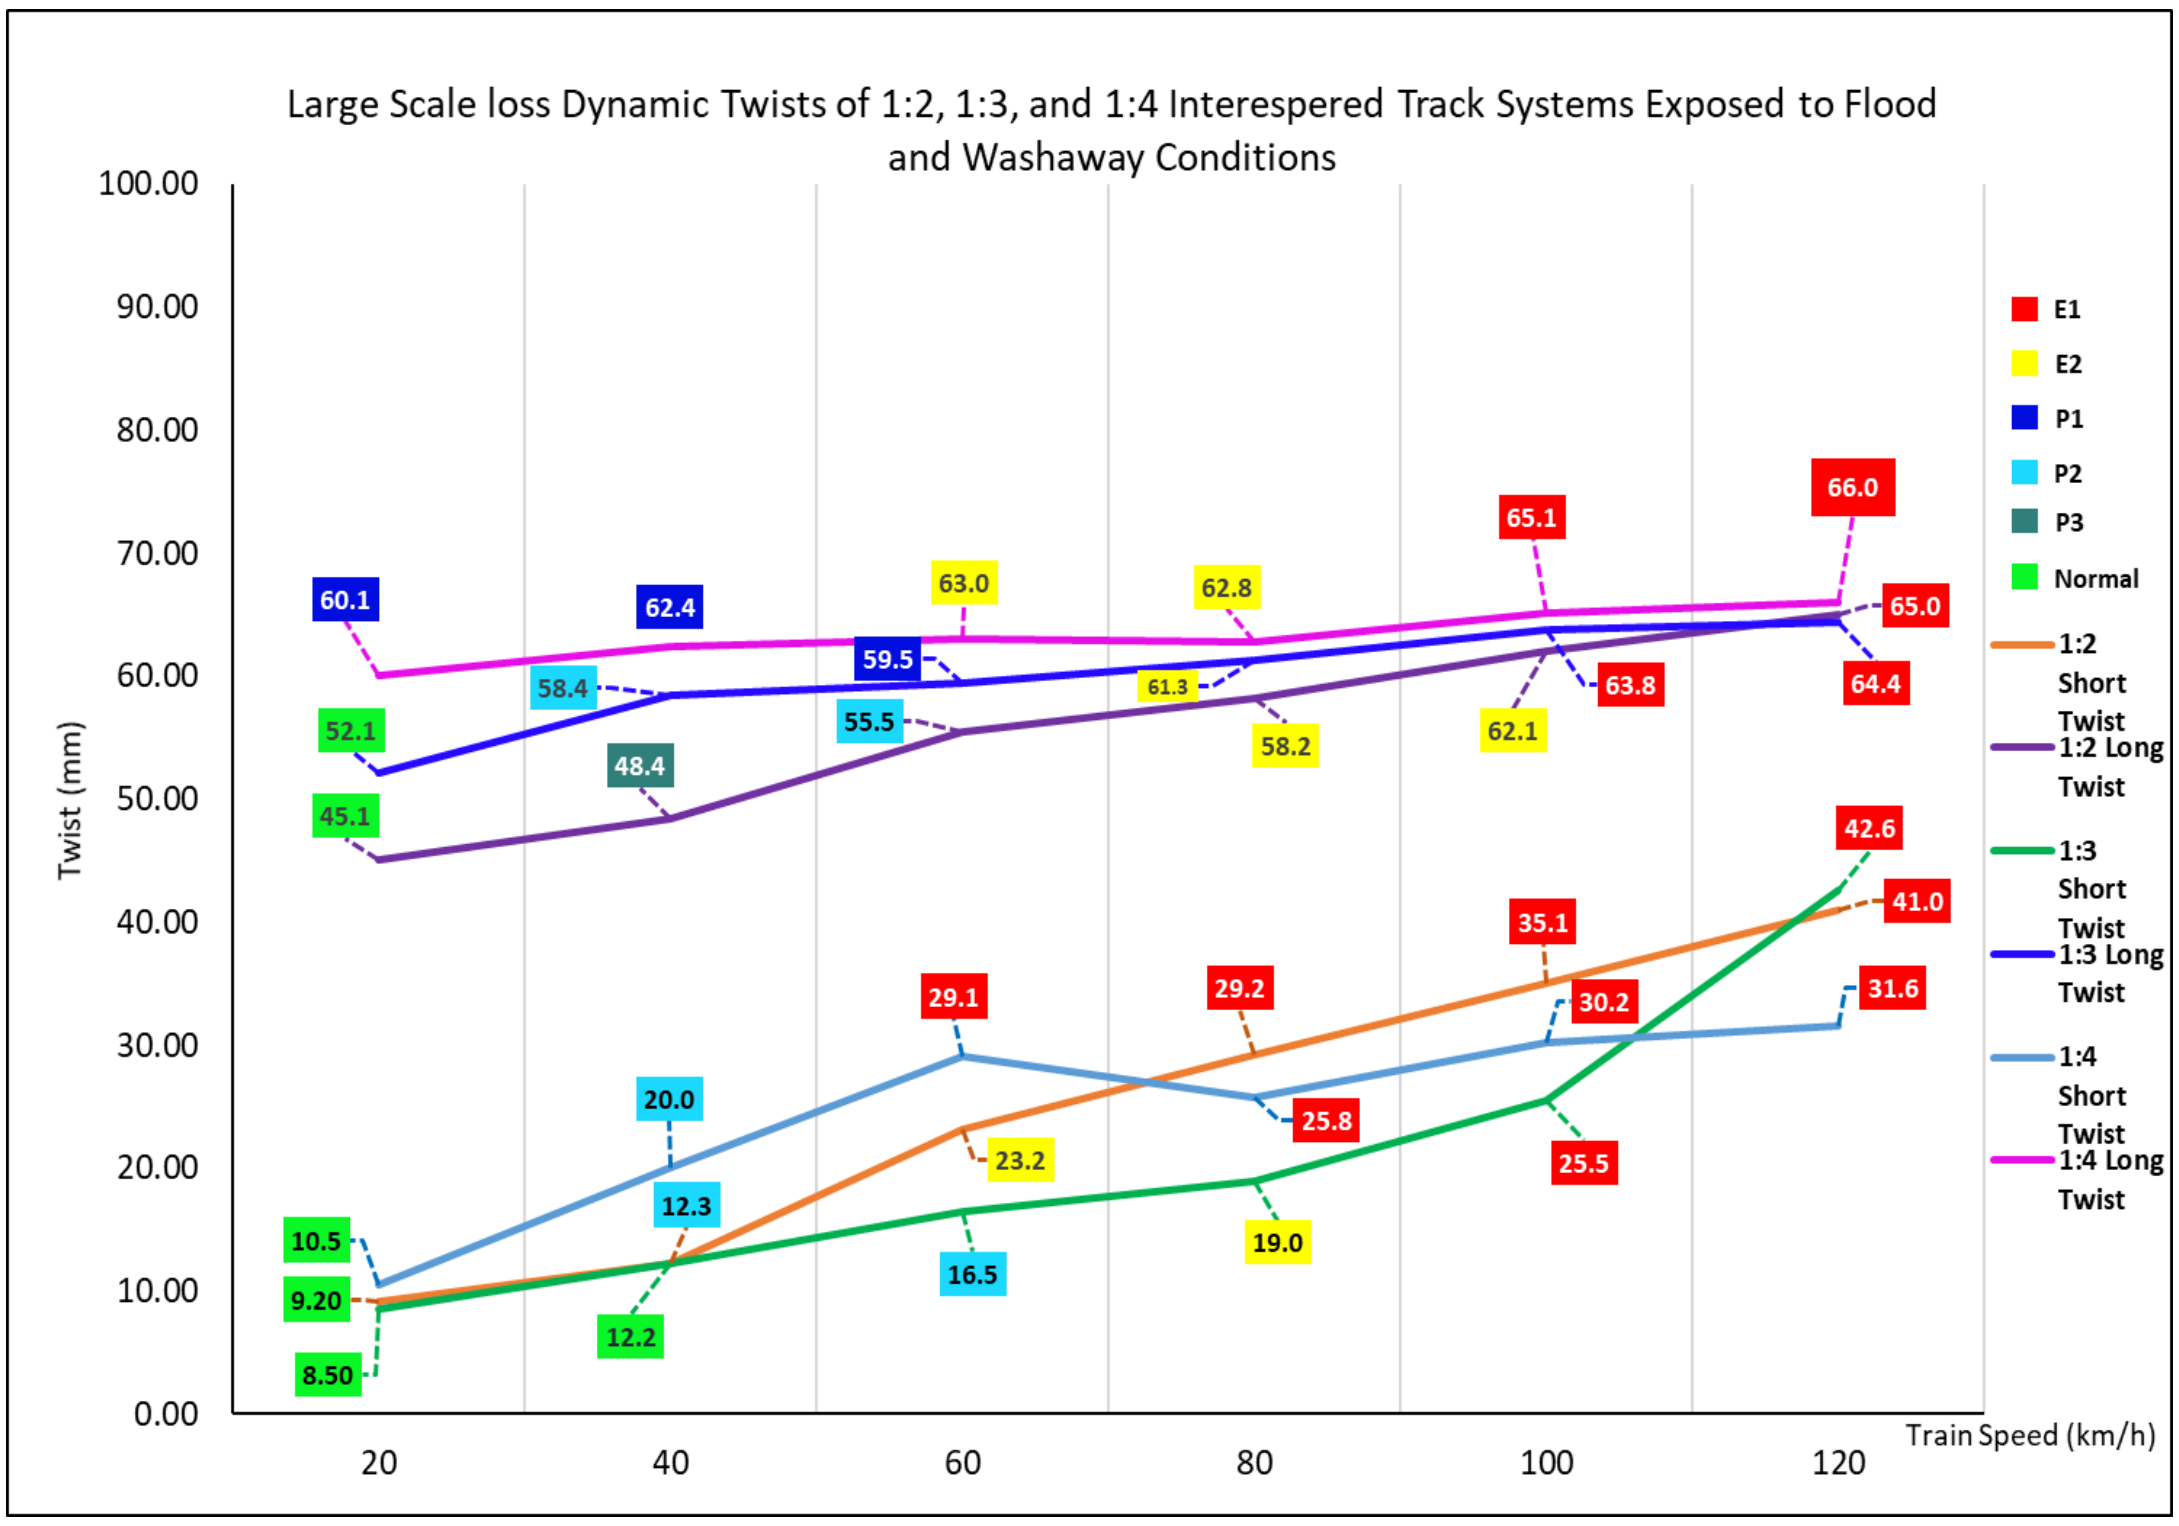
Fig. 12. Large-scale loss dynamic twists of 1:2, 1:3, and 1:4 interspersed track systems exposed to flood and washaway conditions (unit in mm.). Colour backgrounds are correlated with risk profiles defined in Fig.9.

Based on Fig. 12, it is relatively dangerous to operate above 60km/h on interspersed track 1:4 exposed to large-scale loss. Immediate repair is needed to ensure the safety of the train operation since the dynamic twist could lead to train derailment The interspersed track 1:2, 1:3, 1:4 exposed to large-scale loss is very vulnerable to dynamic twist where the train only allowed to operate not more than 40 km/h.
