Failure investigations into interspersed railway tracks exposed to flood and washaway conditions under moving train loads

Khairul Anuar, Mohamad Ali Ridho; Kaewunruen, Sakdirat

DOI:
10.1016/j.engfailanal.2021.105726

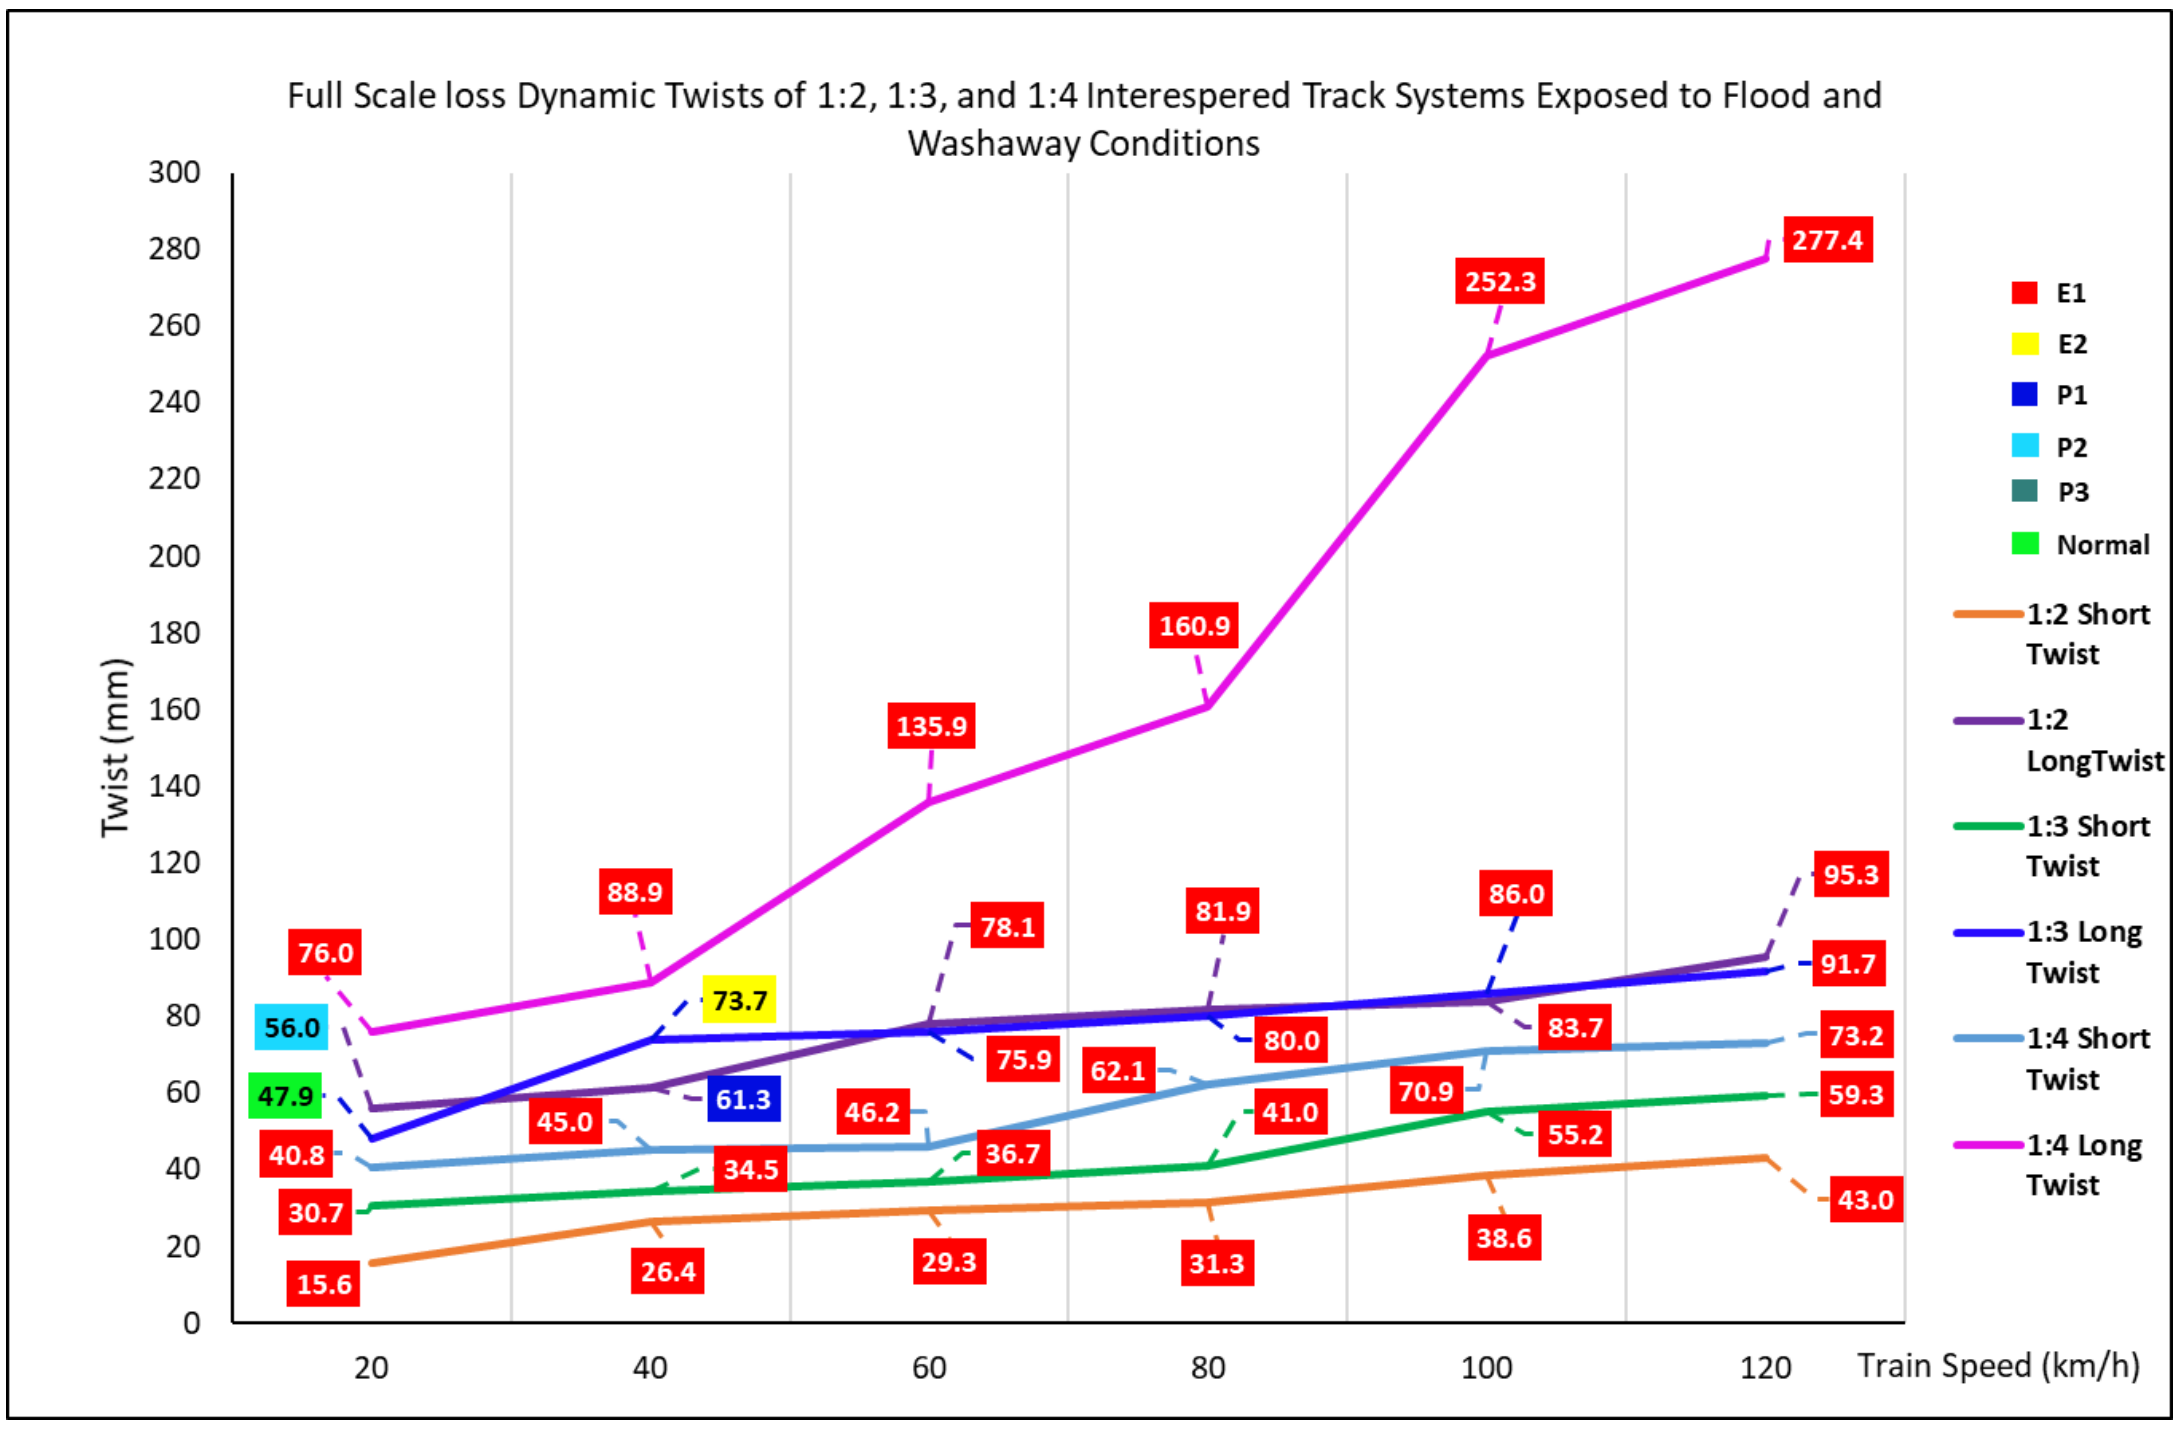
Fig 13. Full-scale loss dynamic twists of 1:2, 1:3, and 1:4 interspersed track systems exposed to flood and washaway conditions (unit in mm.). Colour backgrounds are correlated with risk profiles defined in Fig.9

In Fig. 13, the figure shows Interspersed track exposed to full-scale loss is very dangerous for the trains to operate even with a vigilant monitoring. Even at speed of 20 km/h will cause short twist which lead to E1 situation (immediate repair). In short, immediate maintenance should be carried as it is impossible for a train to utilize its functionality as it’s only allowed to operate below than 20 km/h. This will definitely affect the operation of the rail service. Moreover, the ballast support and sleepers might expose to several defects such as structural cracks and pulverized ballast. In addition, the interspersed track known to has inconsistent track stiffness which cause uneven settlement and foundation failure resulting in track deterioration overtime. Hence, it is crucial for the rail operators to take immediate action and come up with a truly predictive track maintenance to improve the reliability of infrastructure asset maintenance and life cycle management.

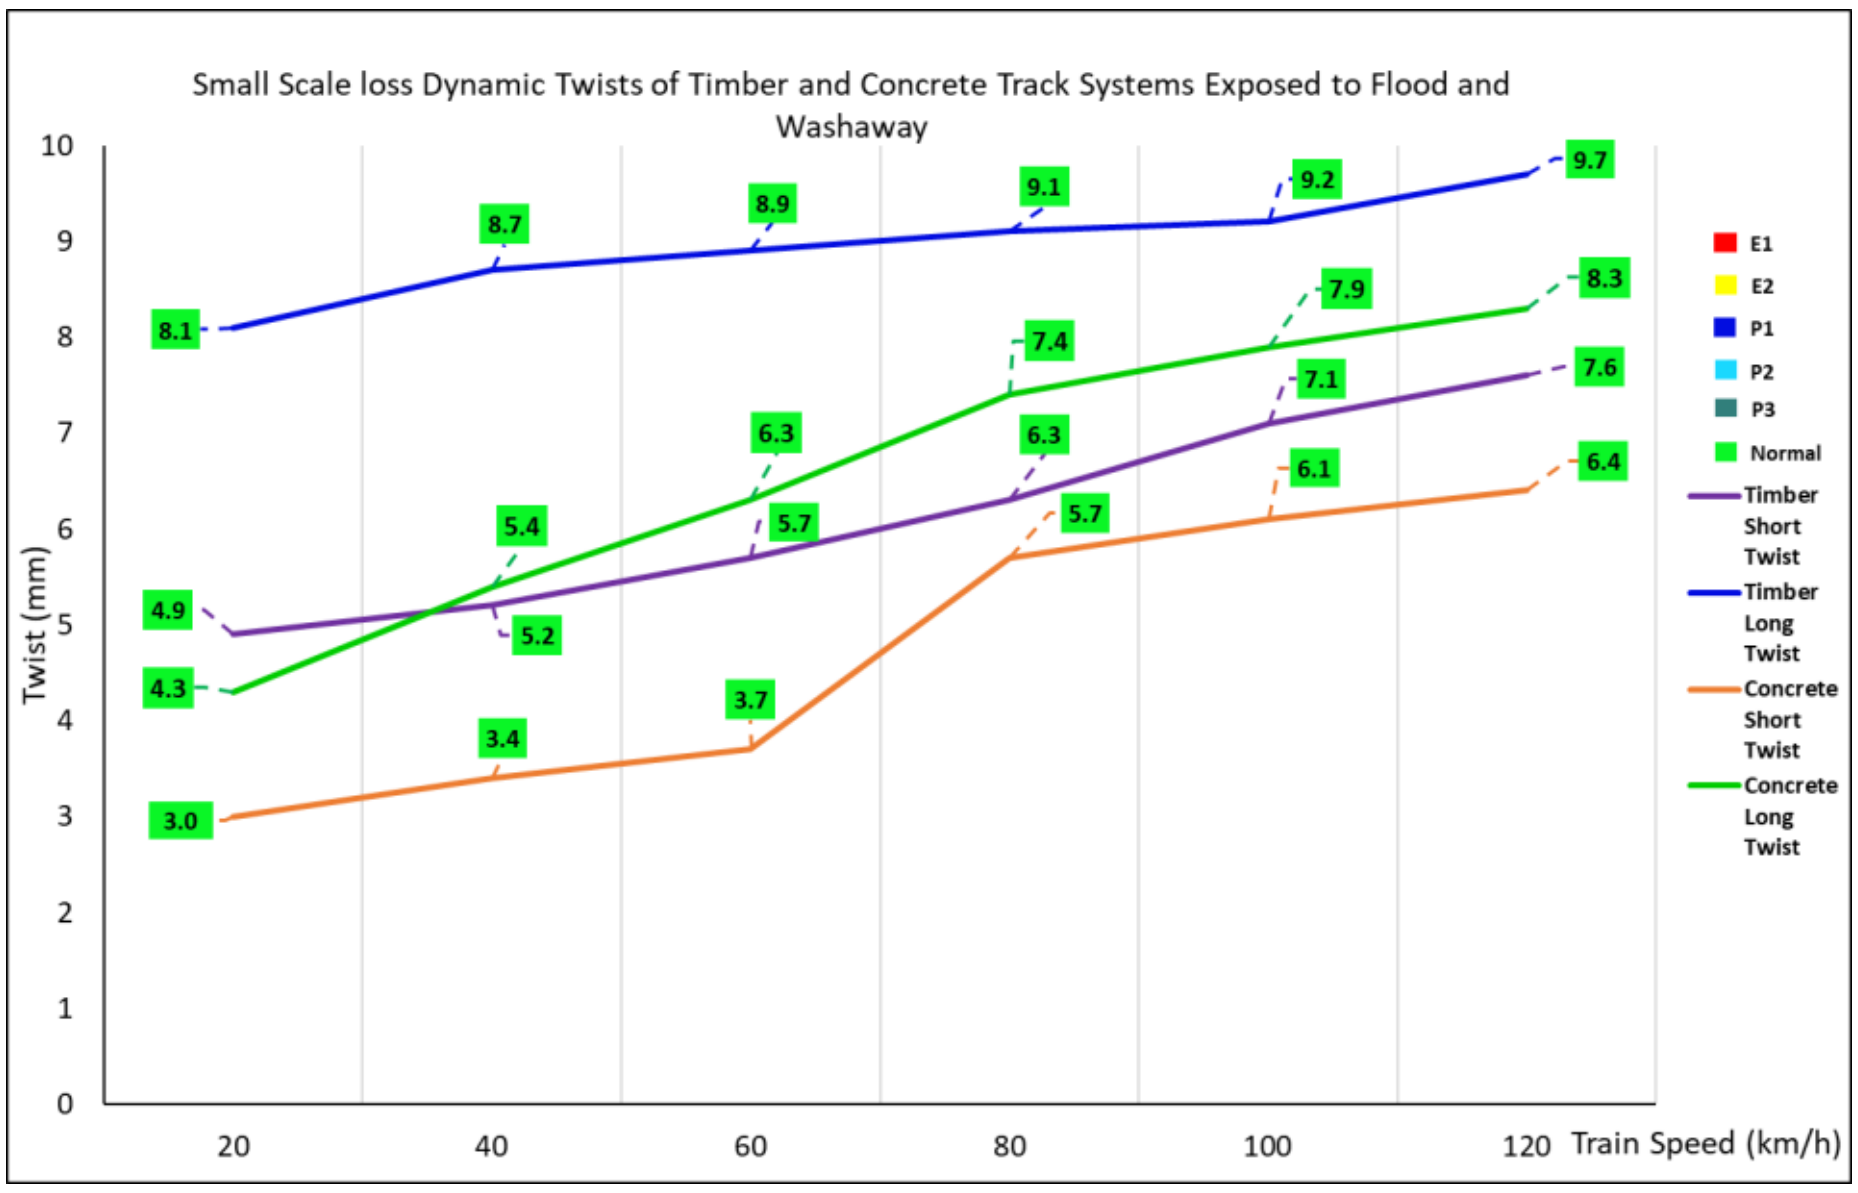
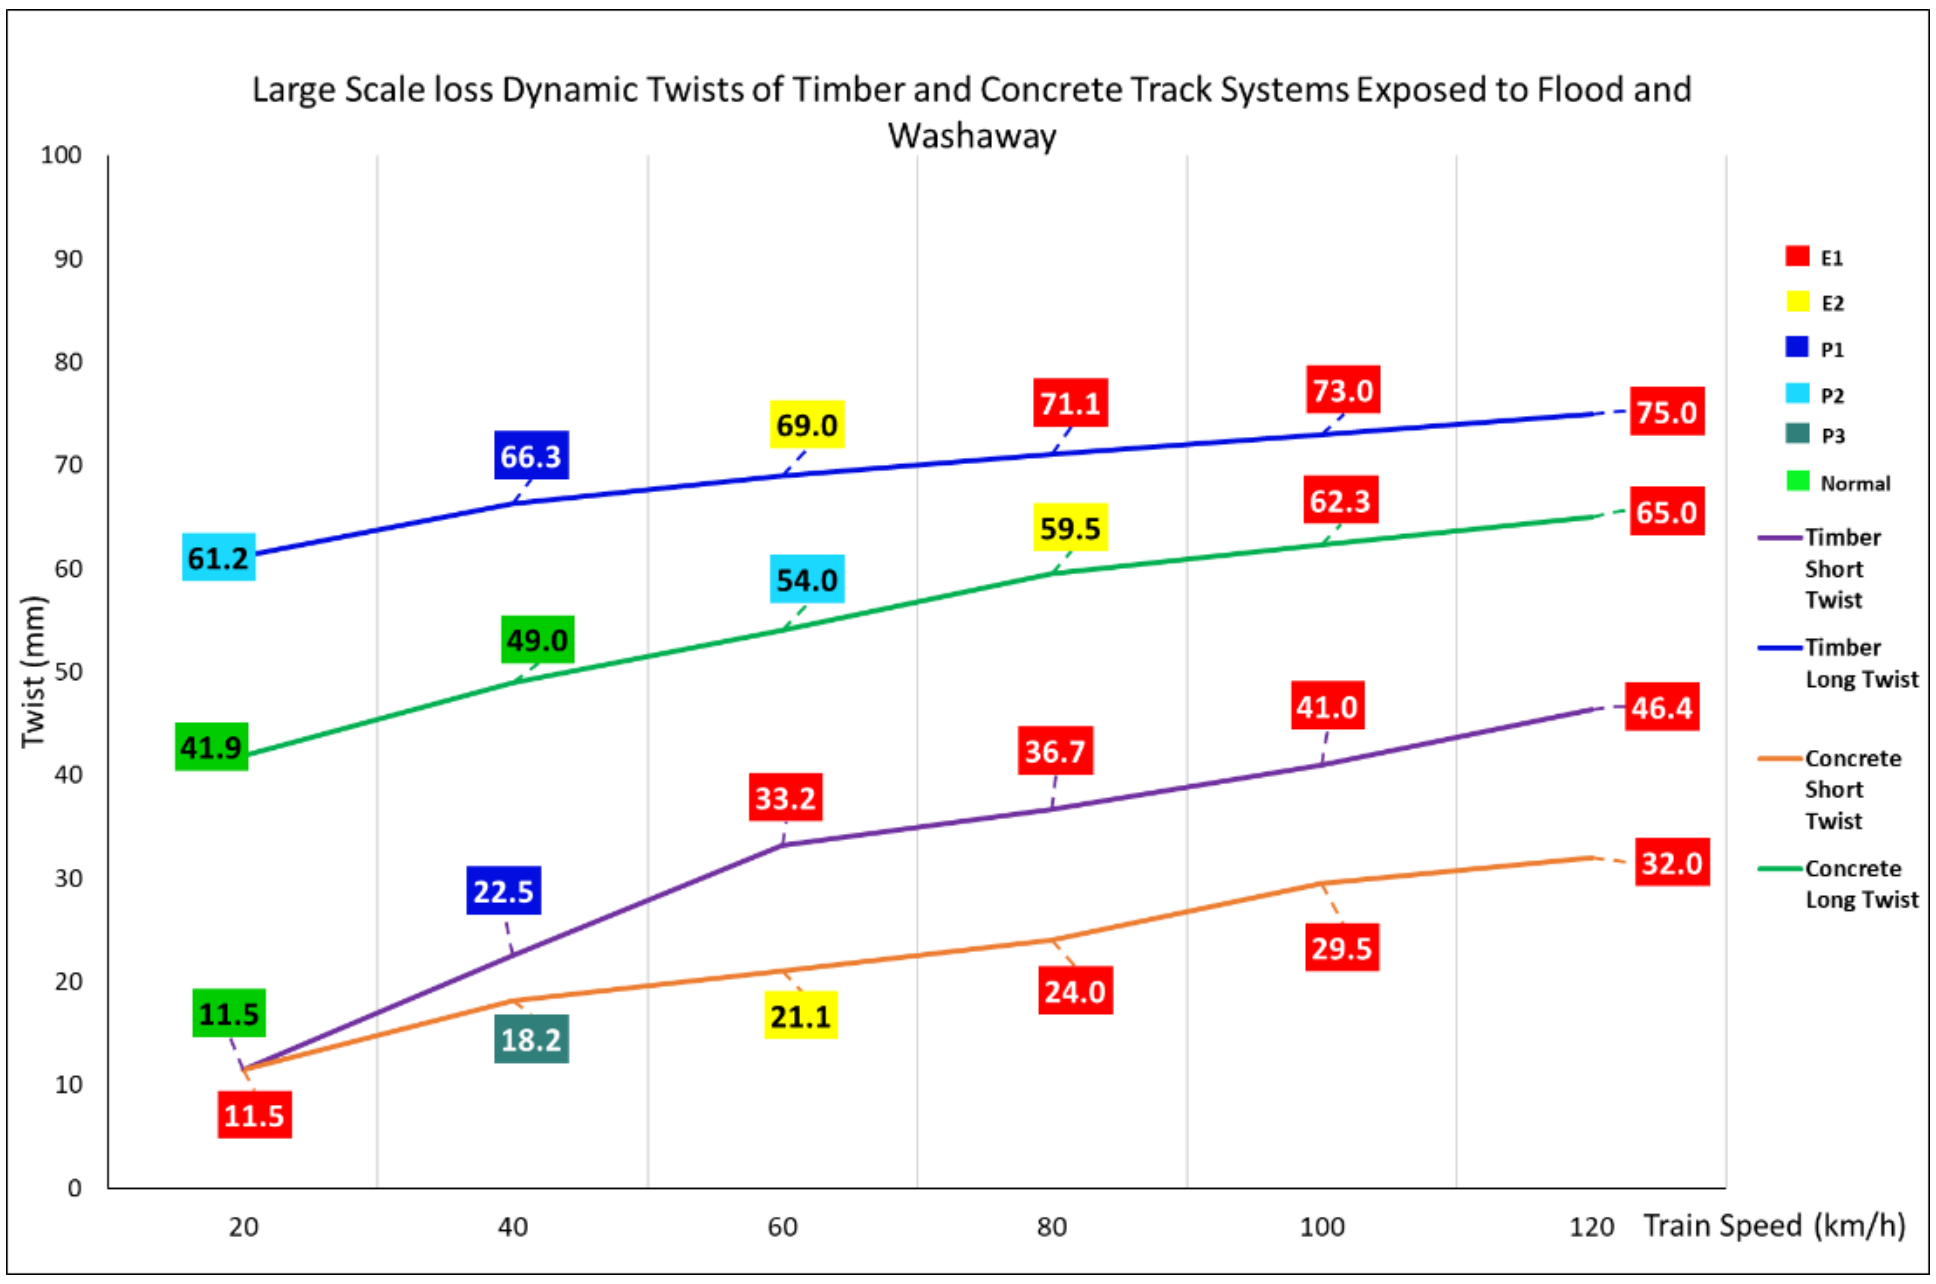
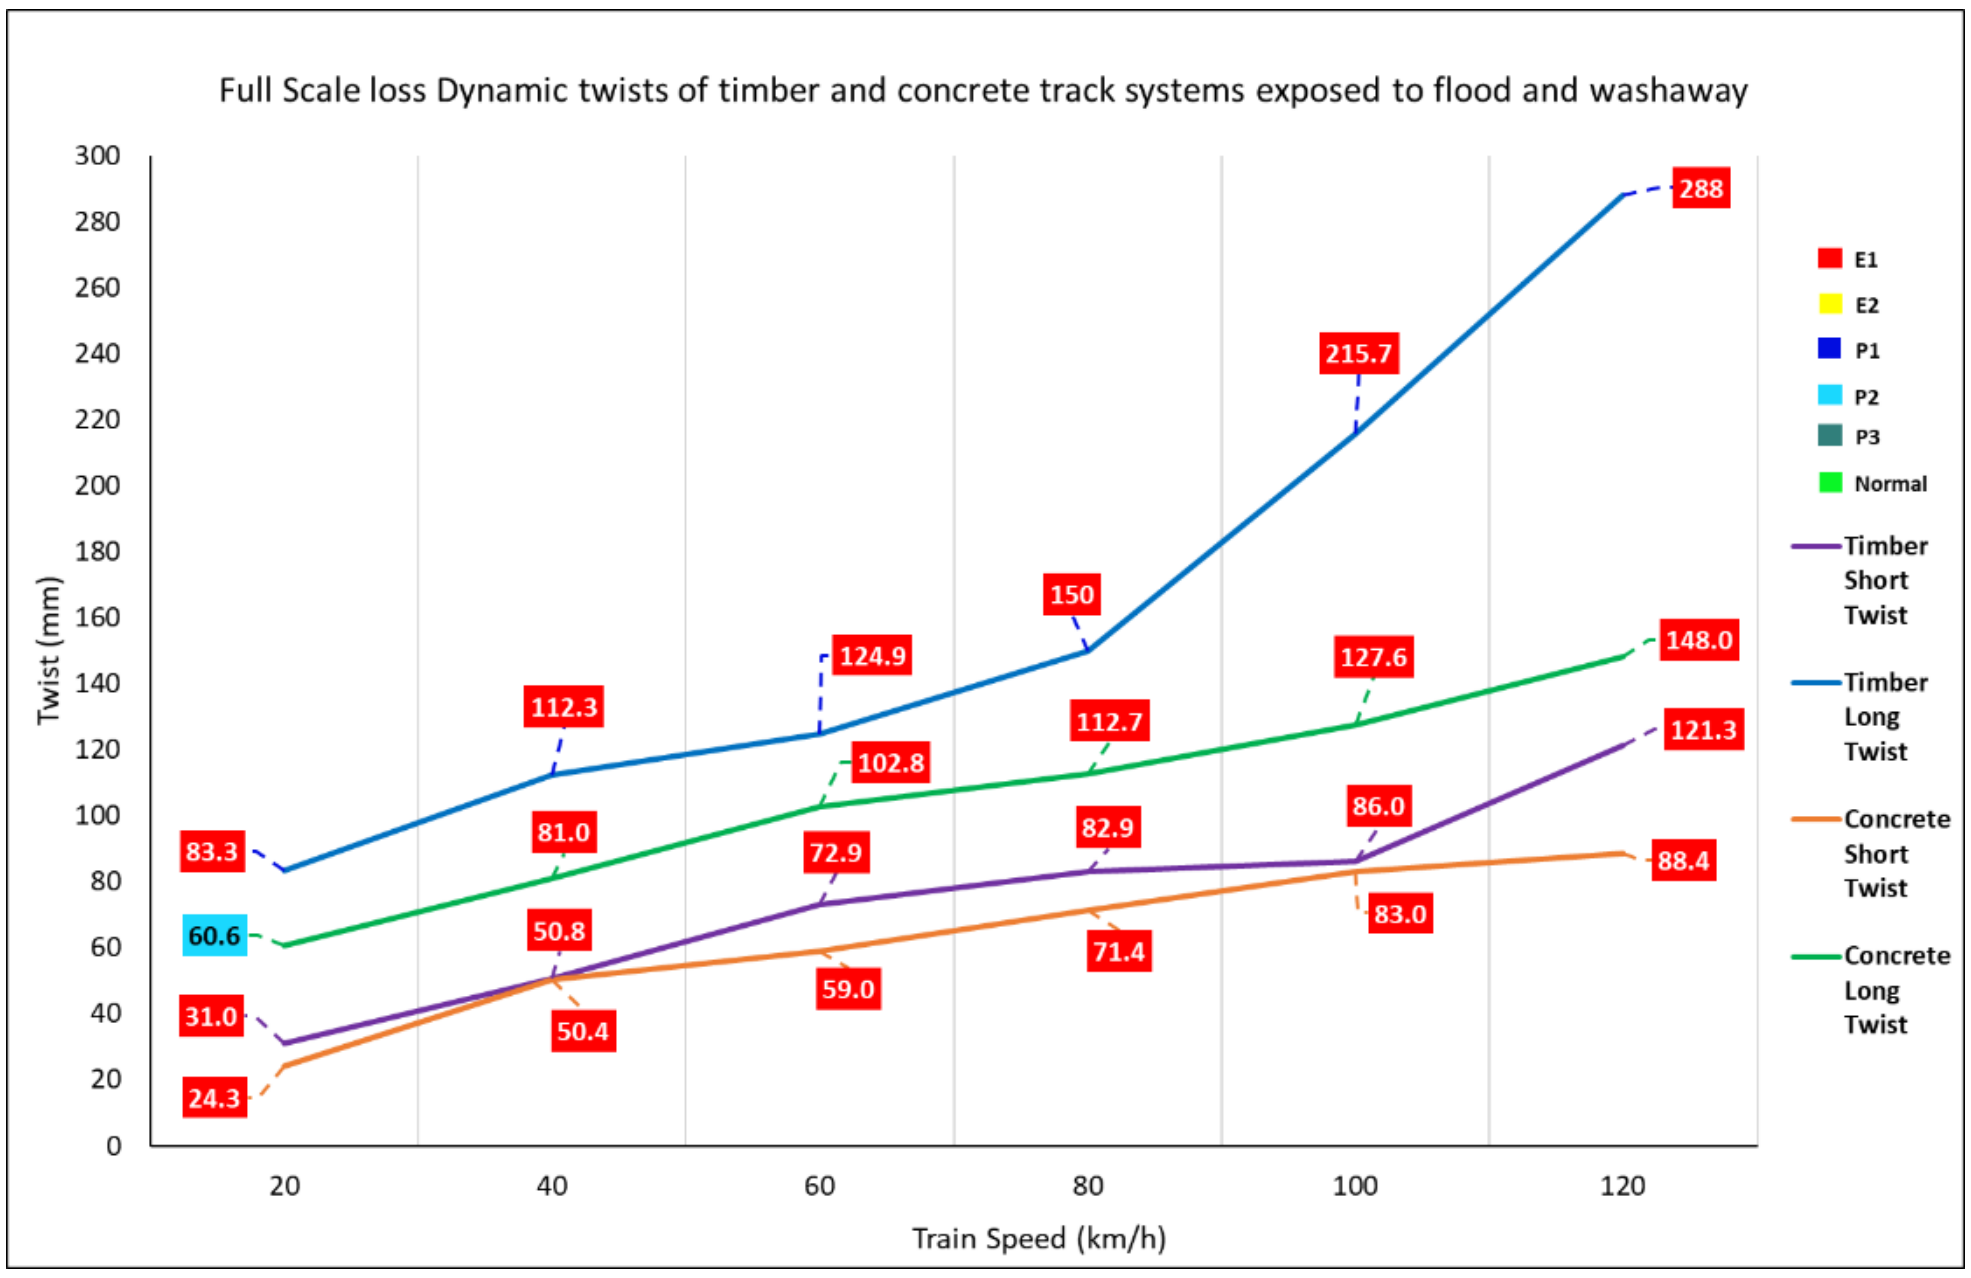
Fig. 14. Small scale loss dynamic twists of timber and concrete track systems exposed to flood and washaway conditions (unit in mm.). Colour backgrounds are correlated with risk profiles defined in Fig.9.

Fig. 15. Large scale loss dynamic twists of timber and concrete track systems exposed to flood and washaway conditions (unit in mm.). Colour backgrounds are correlated with risk profiles defined in Fig.9.

Fig. 16. Full scale loss dynamic twists of timber and concrete track systems exposed to flood and washaway conditions (unit in mm.). Colour backgrounds are correlated with risk profiles defined in Fig.9.

From Fig. 14, small-scale loss will not cause any issue even if the train operated at 120 km/h. However, looking at large-scale (Fig. 15) and full-scale loss (Fig. 16), timber sleepers long twist reading's reach up to 288.0 mm (full-scale loss) when the train operates at 120 km/h. This is due to the difference between timber and sleepers in terms of properties and geometry resulting in difference of dynamic twist data. Full-scale loss is extremely unsafe for a train to operate on and the track engineers must carry on an immediate repair (E1 situation) as the strength formation and capacity of the rail completely diminished.

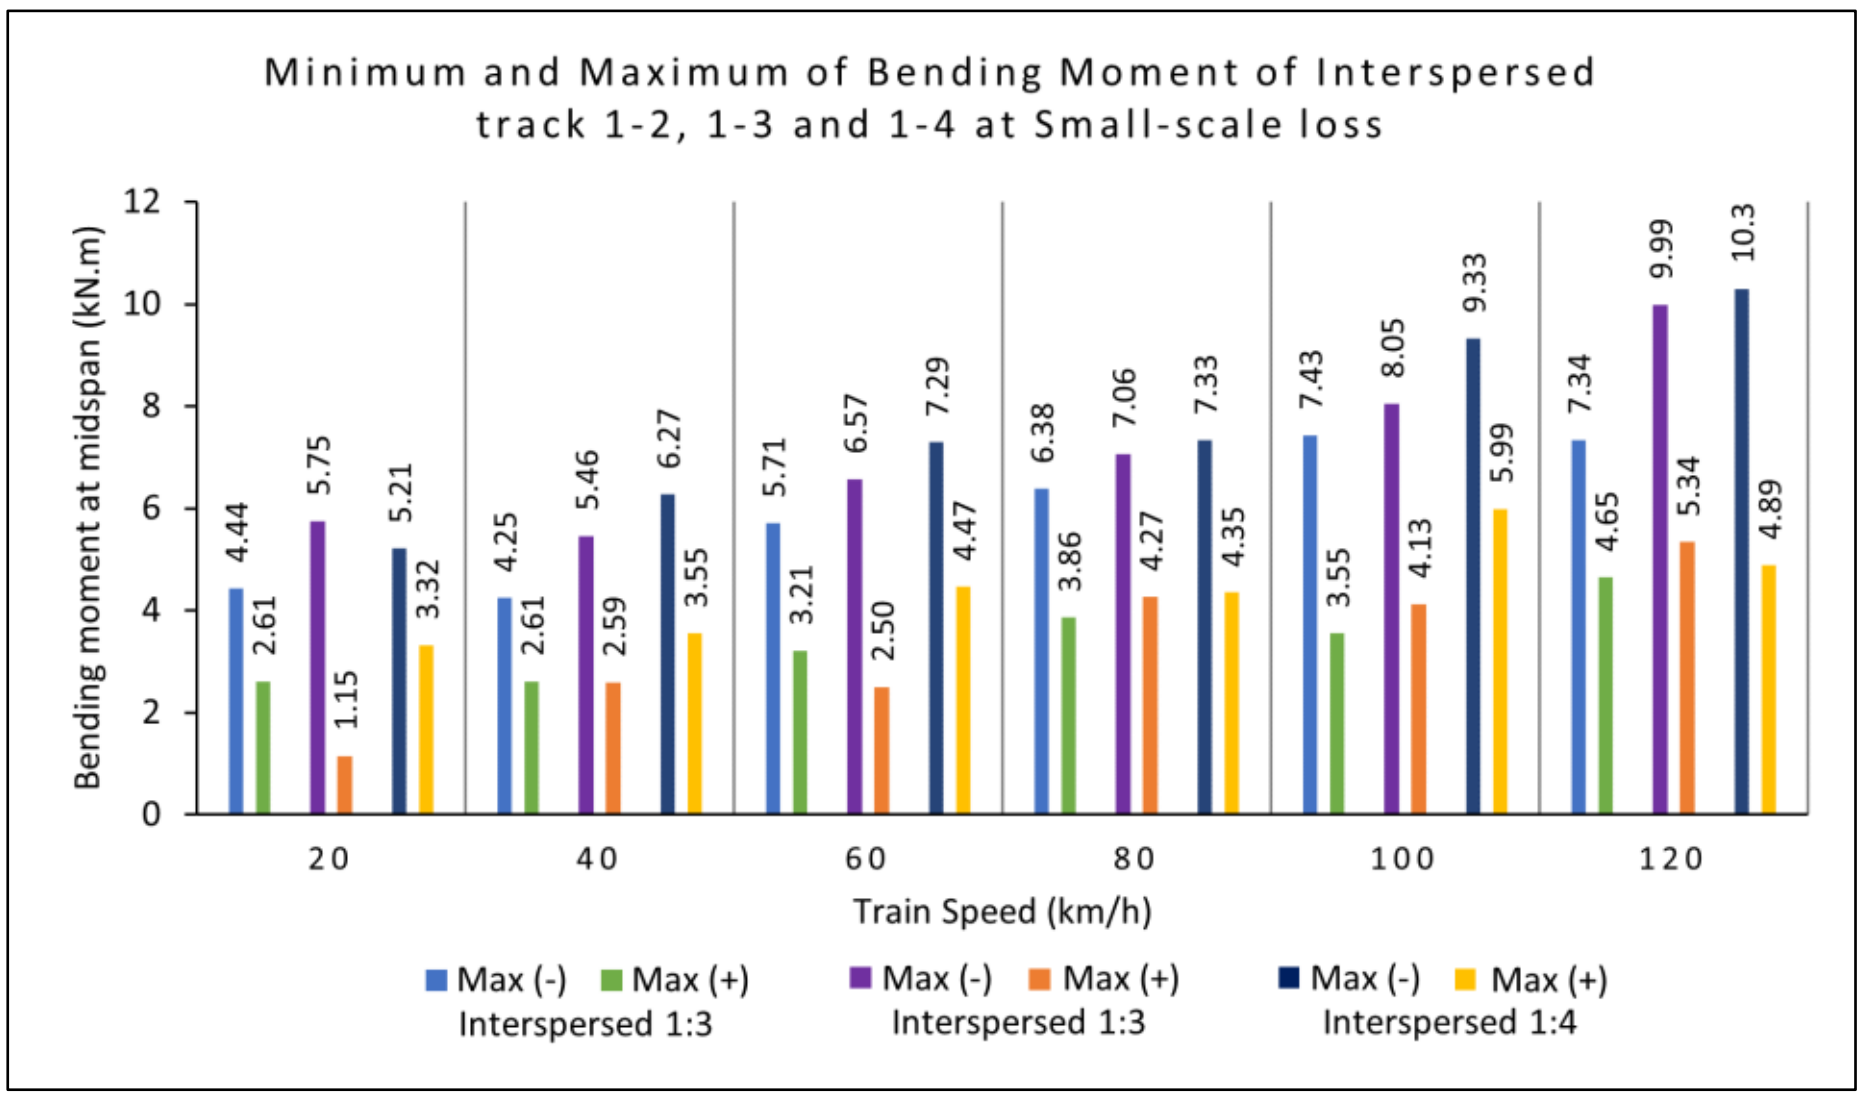
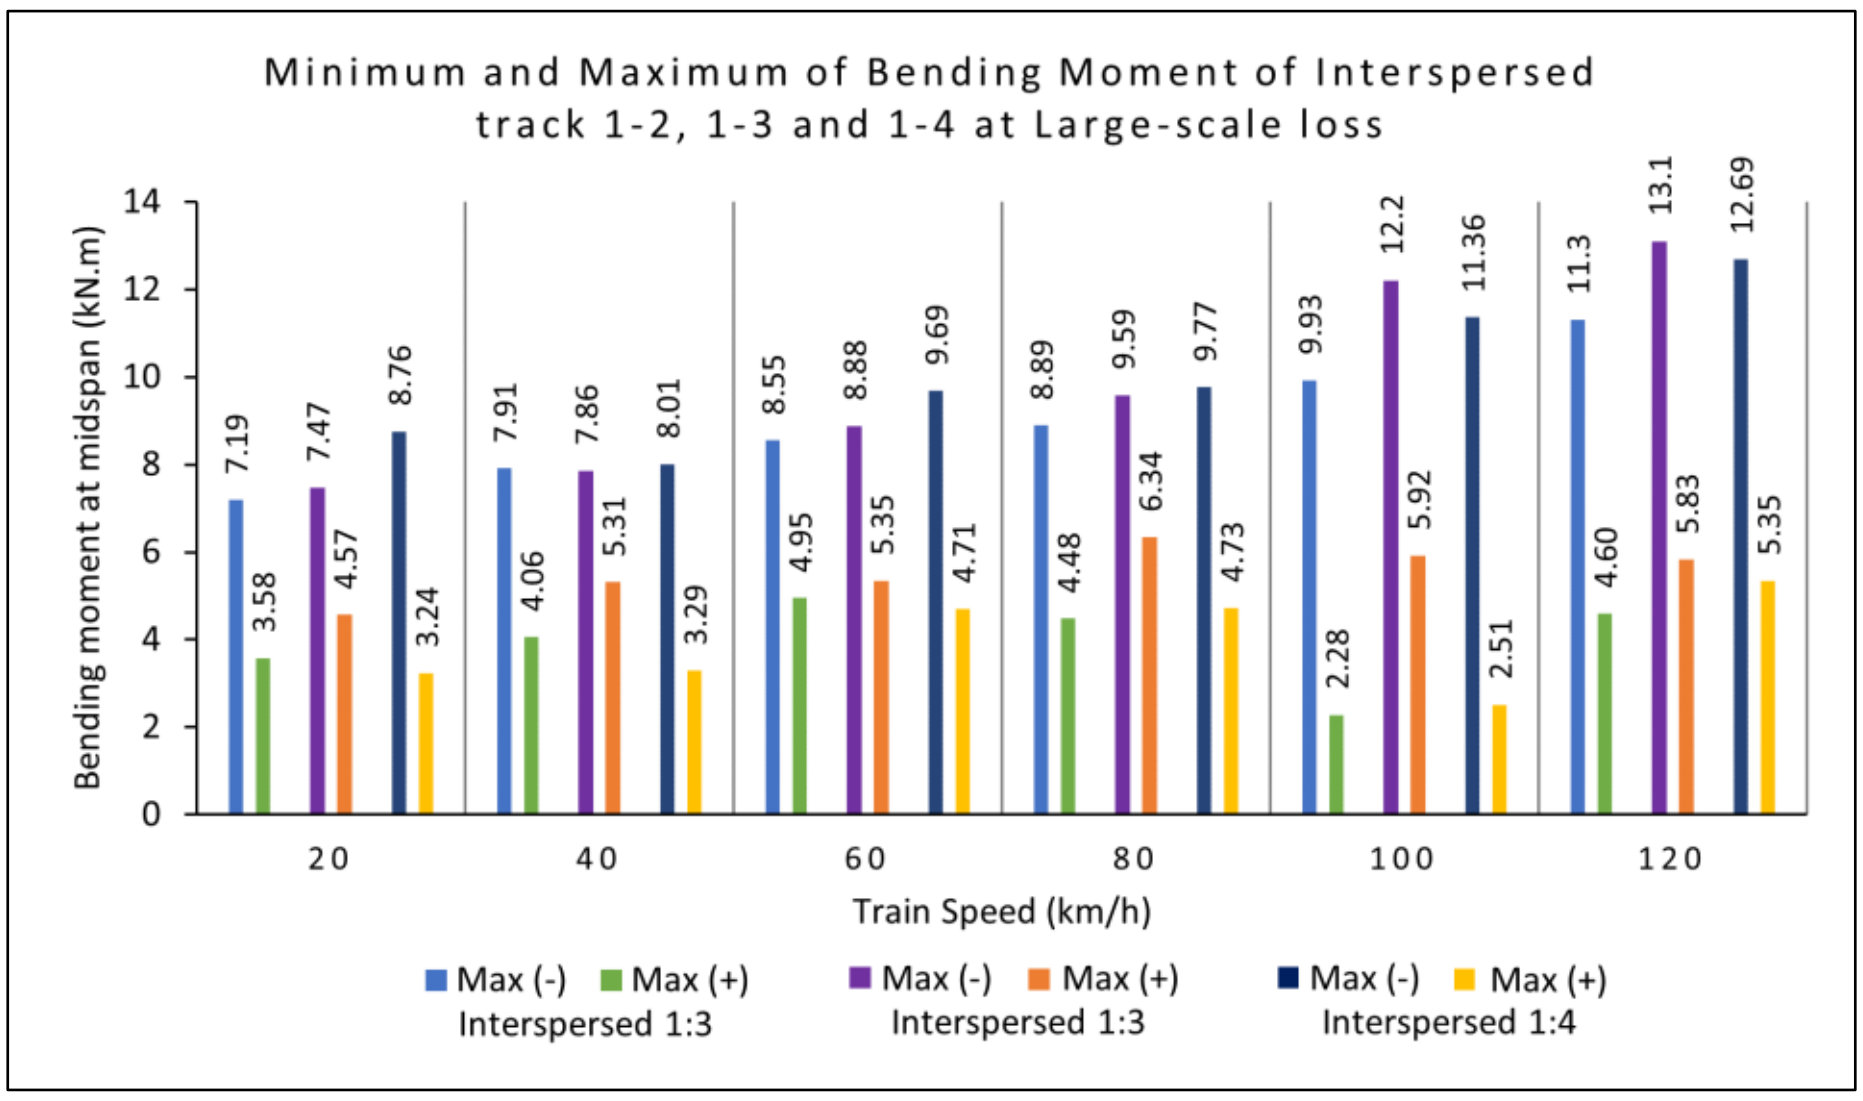
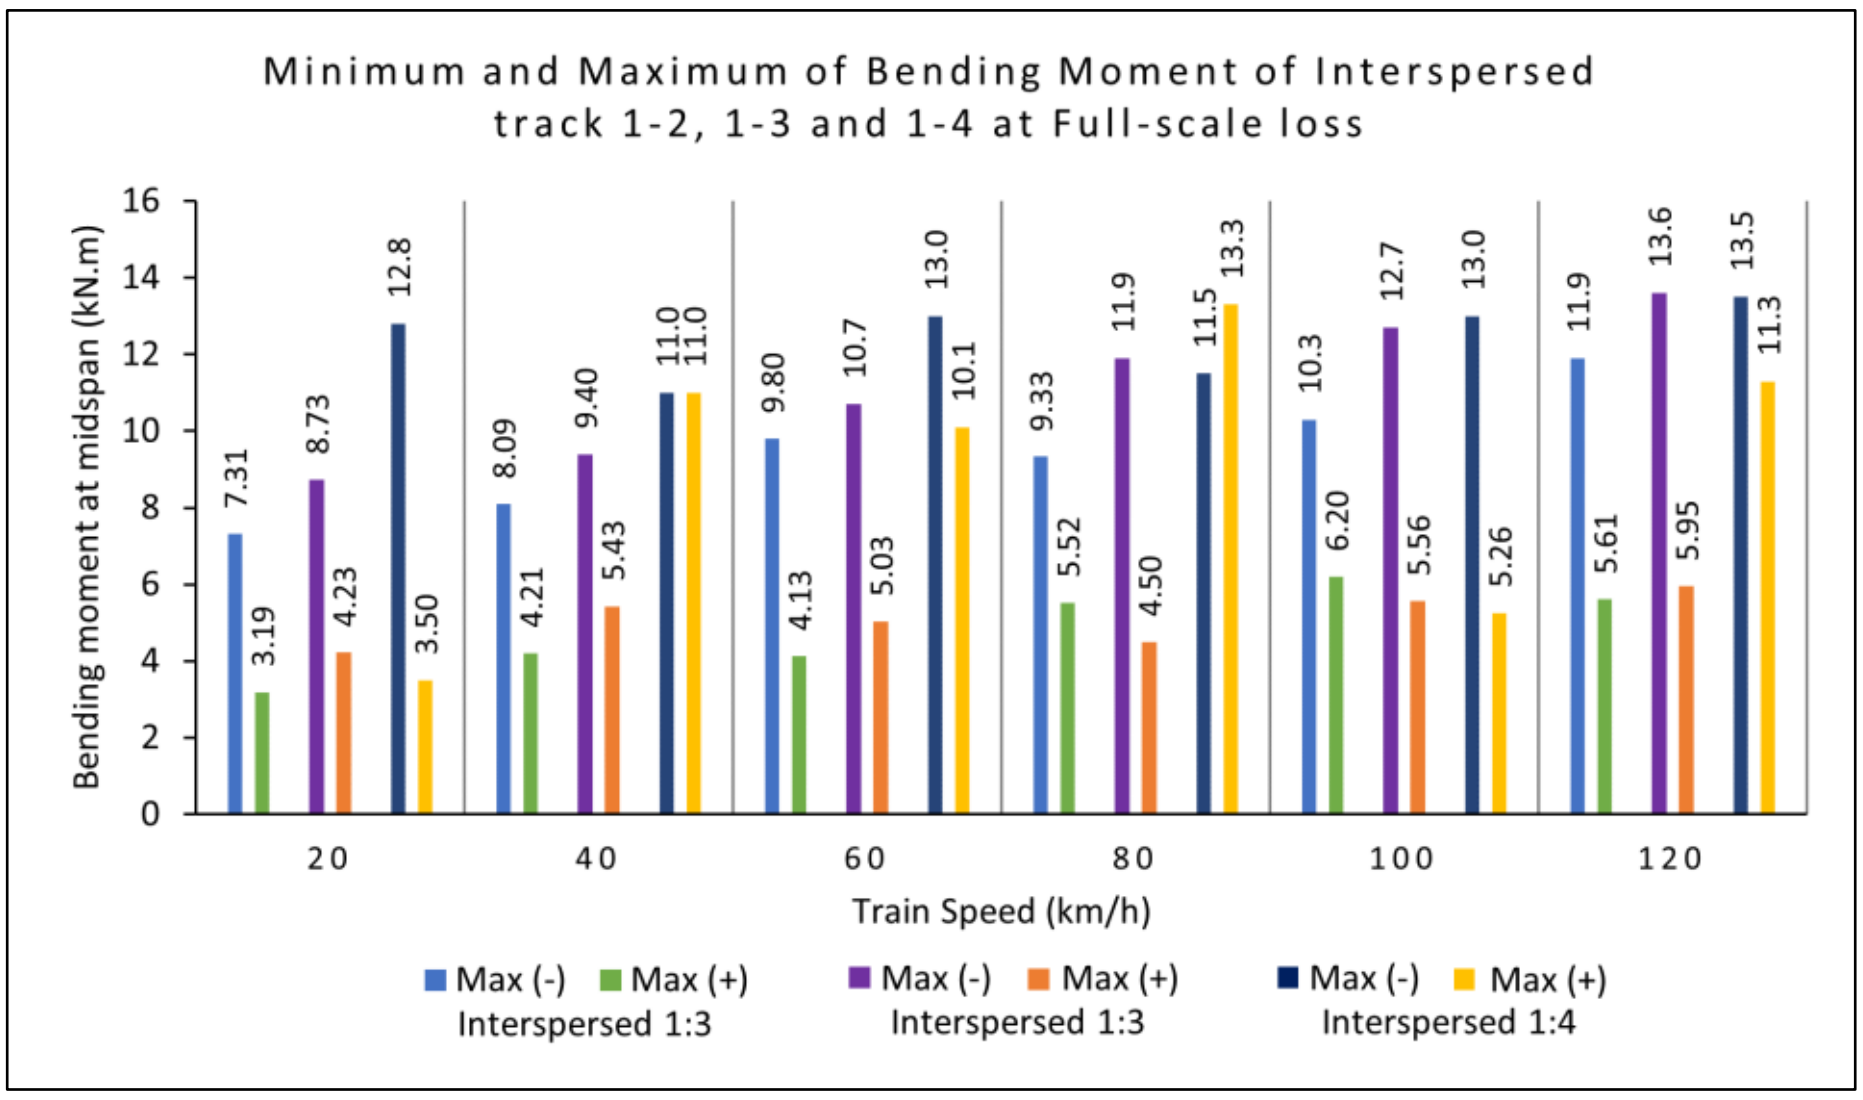
Fig. 17 Minimum and maximum of bending moment of interspersed track 1-2, 1-3 and 1-4 at small-scale loss

Fig. 18. Minimum and maximum of bending moment of interspersed track 1-2, 1-3 and 1-4 at large-scale loss

Fig. 19. Minimum and maximum of bending moment of interspersed track 1-2, 1-3 and 1-4 at full-scale loss

The interspersed track 1:2 has better performance in terms of flexural response for small-scale loss (Fig. 17), large-scale loss (Fig. 18) and full-scale loss (Fig. 19) while the bending moment for interspersed track 1:3 is comparable to the interspersed track 1:4 in some cases. For instance, the bending moment of interspersed track 1:3 came out higher than interspersed track 1:4 for large-scale (Fig. 18) and full-scale loss (Fig. 19) but not for small-scale loss (Fig. 17). All in all, this inconsistency of stiffness in interspersed track might influence the flexural response of this track which causing one side hogging of the damaged sleepers (half damaged sleepers).

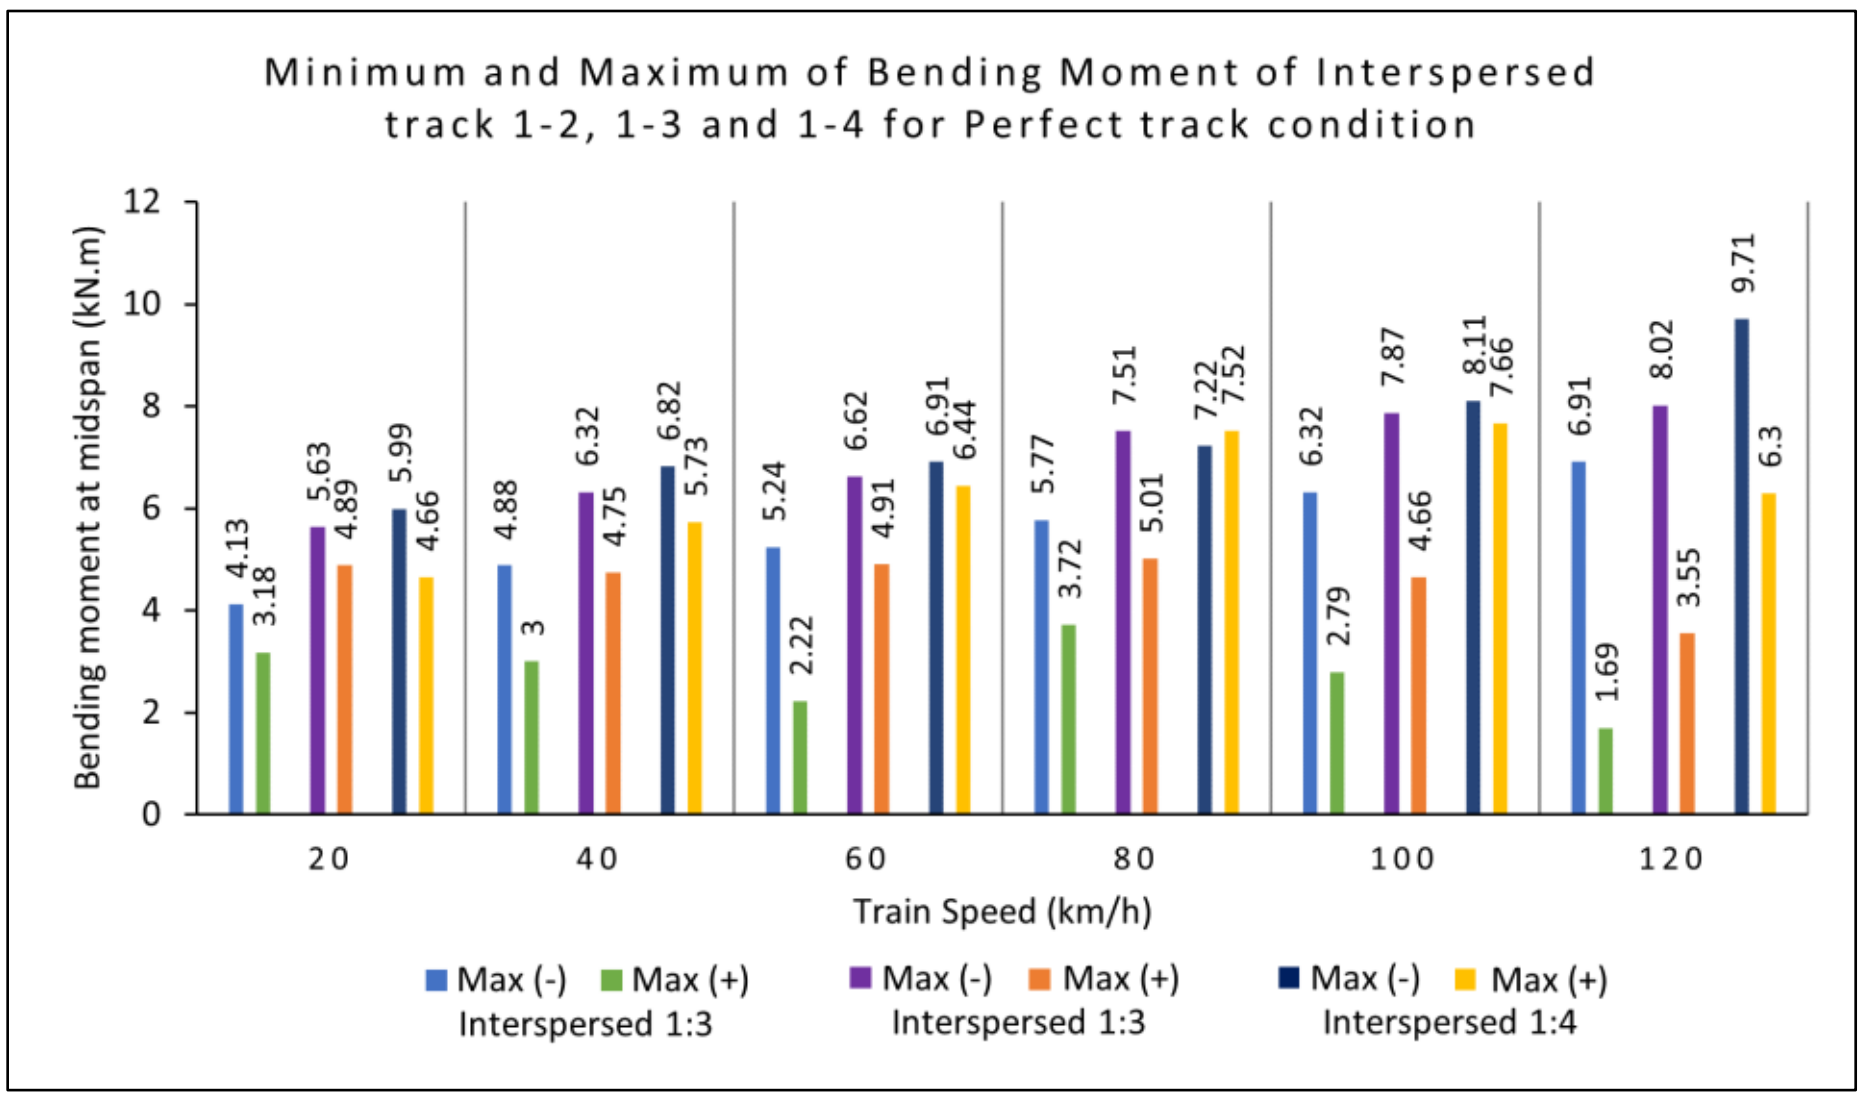
Fig. 20. Minimum and maximum of bending moment of interspersed track 1-2, 1-3 and 1-4 for perfect track condition

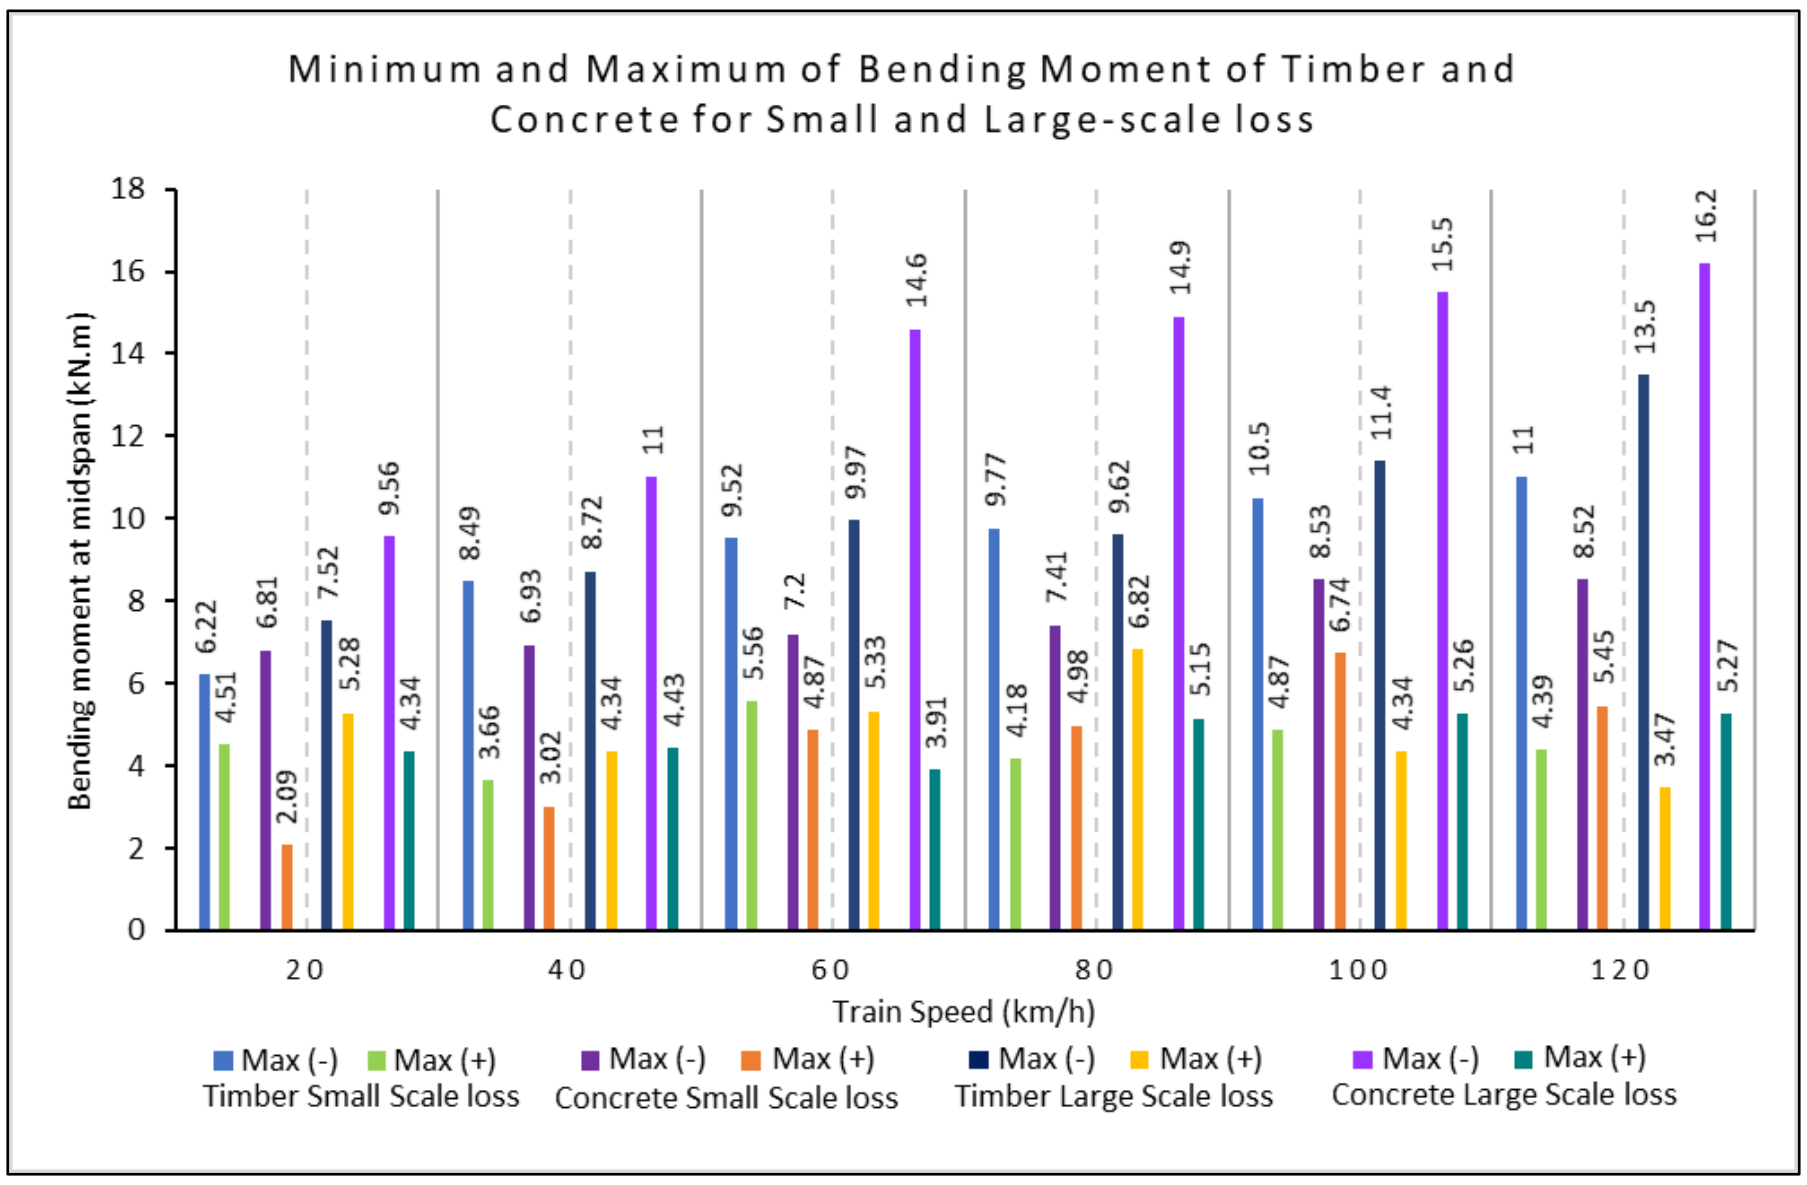
Fig. 21. Minimum and maximum of bending moment of timber and concrete for small and large-scale loss.
