Failure investigations into interspersed railway tracks exposed to flood and washaway conditions under moving train loads

Khairul Anuar, Mohamad Ali Ridho; Kaewunruen, Sakdirat

DOI:
10.1016/j.engfailanal.2021.105726

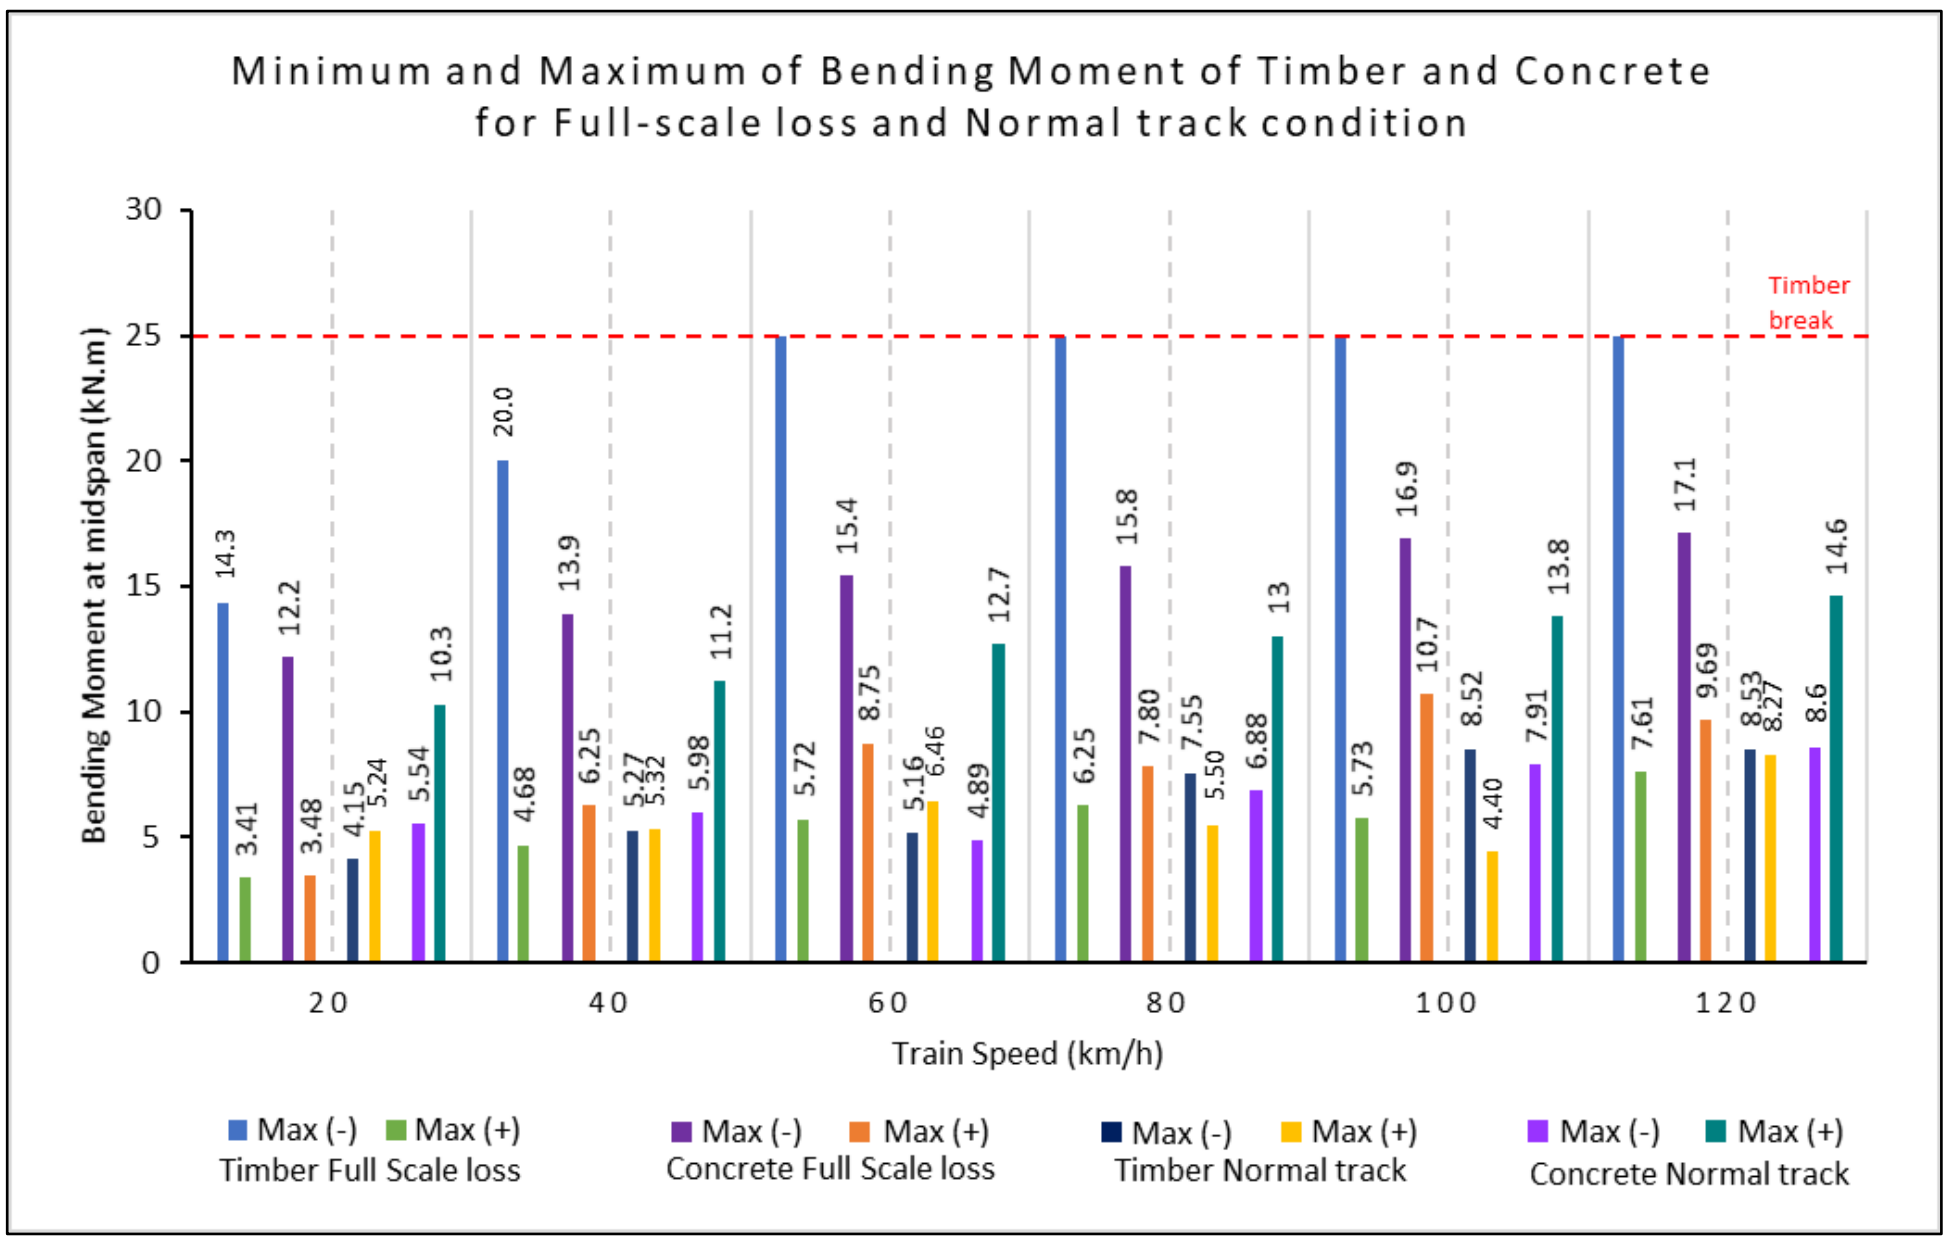
Fig. 22. Minimum and maximum of bending moment of timber and concrete for full-scale loss and Normal track.

In Fig. 22, the maximum bending moment for timber sleepers, full-scale loss, at train speed of 60 km/h, 80 km/h, 100 km/h and 120 km/h, exceeded the maximum value the timber sleepers able to withstand which is 25 kN.m causing the timber sleepers to fail. Full-scale loss has the worst flexural response compared to small-scale loss which is expected to be so. It is highly advisable not to operate the trains on a full-scale loss track which may cause a catastrophic incident.
