Flood characterization based on forensic analysis of bridge collapse using UAV reconnaissance and CFD simulations

Loli, Marianna; Mitoulis, Stergios; Tsatsis, Angelos; Manousakis, John ; Kourkoulis, Rallis; Zekkos, Dimitrios

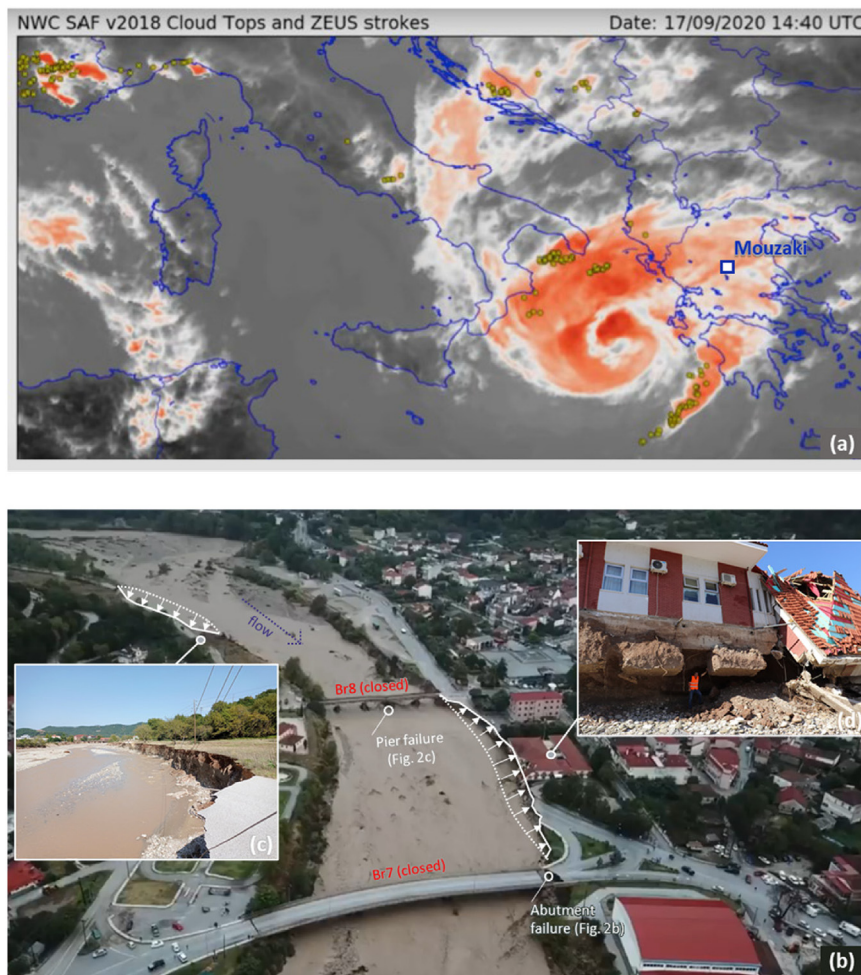
Fig. 2. Impact of the medicane: (a) satellite image of Ianos from METEOSAT-11 on 17/09/20 at 14.40 UTC (Zekkos and Zalachoris, 2020); (b) drone footage captured on September 19, 2020 (by local media) showing the extent of damage in the town of Mouzaki and photos of select failures caused by riverbank erosion: (c) roadway washout; and (d) collapsed hospital.

Fig. 2b shows the dramatic condition in which the town of Mouzaki was found one day after the end of the storm. Flash flooding and overflowing of Pamissos river led to widespread devastation including erosion of its gabion-protected riverbanks, sweeping away roadways (Fig. 2c), cars (causing one fatality), and electricity poles. The area was left without power soon after the onset of the storm while its only hospital collapsed due to scour of its foundations, albeit with no fatalities as it was timely evacuated (Fig. 2d).

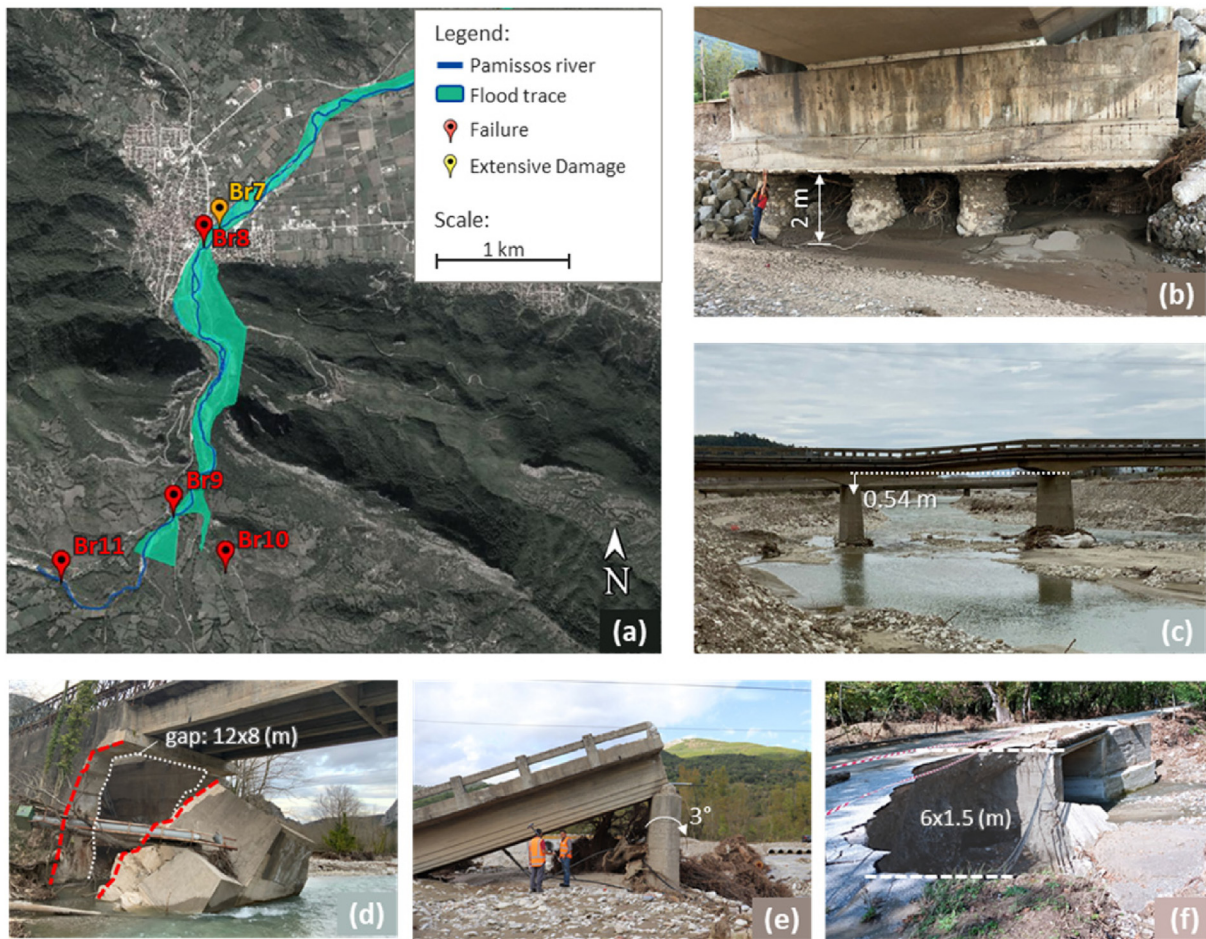
All five bridges that exist in the area, within a radius of 3 km from the town's centre, suffered extensive damage or complete failure, resulting in a widespread loss of serviceability of the local transportation network. Following the labelling of reported damages adopted by Zekkos and Zalachoris (2020), Fig. 3 shows the location of the bridges in addition to the trace of flooding along Pamissos river, as estimated by the E.U. Copernicus Emergency Management Service. The photos (Fig. 3b–f) demonstrate the inability of most infrastructure assets to withstand this flood, irrespective of the structural characteristics and construction age. It is worth mentioning that the latter ranged substantially, from 23 years (Br7, Fig. 3b) to 70 years (Br8, Fig. 3b). Common failure patterns include:

i) Extensive damage of abutments, with partial or complete wash away of backfill, indicating extreme peak discharges along Pamissos and its secondary streams.

ii) Substantial scouring of foundations, leading to deformations and collapse of piers of the older structures that were supported on shallow foundations (Fig. 3c, e).

iii) Significant debris built up contributing to failure especially in the case of intermediate piers.

Indicative of the extreme magnitude of erosive forces that impacted the riverbanks of Pamissos is the 2 m deep scour hole that exposed the piled foundation of the NW abutment of Br7, a relatively modern motorway bridge. Incidentally, the bridge was inspected only two months before the event and was found intact (Mitoulis et al., 2021), which suggests that the massive scour hole was the result of this single flood.

**Fig. 3.** Impact on bridges: (a) map of flood trace in the area of Mouzaki showing the situation on 24/09/2020 (5 days after the event) as per the post-event assessment by the E.U. Copernicus Emergency Management Service, with locations and photos of severely damaged bridges along Pamissos river (flowing from South to North) and its secondary streams: (b) Br7; (c) Br8; (d) Br9; (e) Br 11; and (f) Br 10.

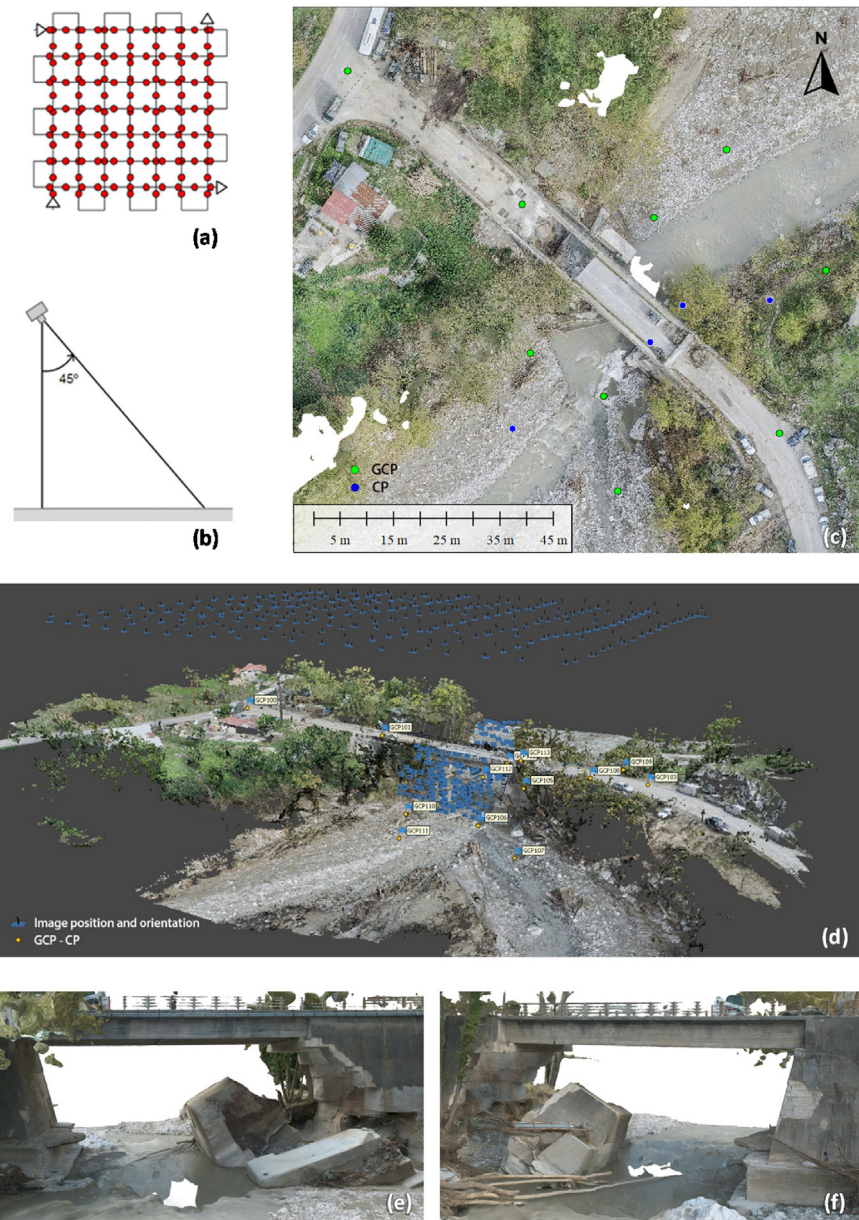
The use of UAV mapping in this study was essential in enabling the rapid collection of perishable data, necessary for the interpretation of failure. Crucially, it allowed for a thorough site reconnaissance and mapping of a complex three-dimensional target, such as a failed bridge, with maximum safety, while the integrity of structural remains was under investigation. The produced 3D model was useful for: (i) Measurement of the geometric features of the structural components, and production of an idealized 3D geometry for use in the numerical analyses; (ii) Measurement of channel width and depth for use as input in the analysis of water flow; (iii) Identification of the joints and reproduction of these, as interfaces, in the mechanical model; (iv) Mapping of the observed rupture path for comparison with the numerically computed failure patterns; (v) Confirming that the eastern, standing, abutment showed no measurable deformation and damage was concentrated on the failed abutment (West).

Fig. 5e–f displays views of the 3D mesh showing the collapsed abutment. A 3D visualization of the bridge model is freely available online (https://skfb.ly/6VXHW) to facilitate understanding of the failure pattern.

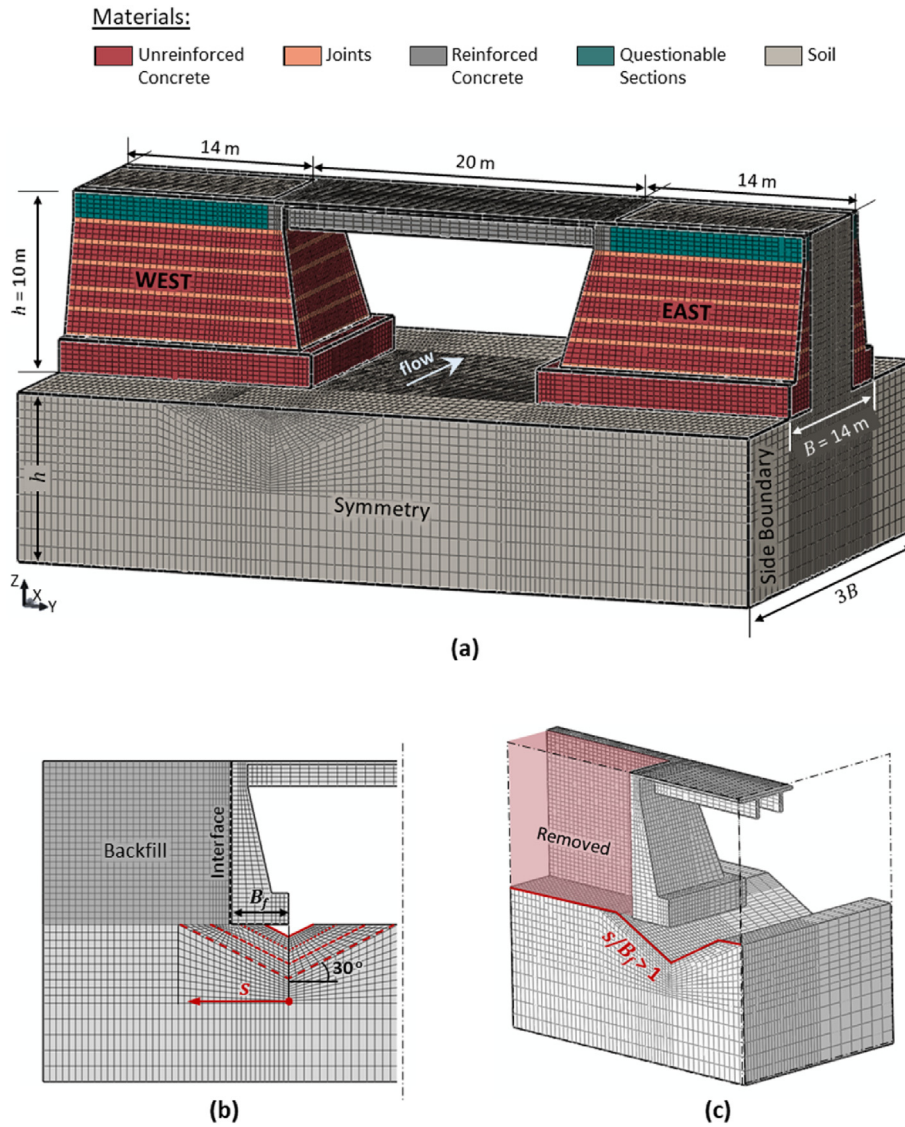
Fig. 8. 3D FE model (Model A) used in the mechanical analysis of scouring effects: (a) materials, selected dimensions, and boundaries; (b) abutment elevation and closer view of the scour hole geometry, and (c) 3D model: simulation of backfill loss (showing a quarter of the model).

Therefore, we assume complete loss (removal) of the backfill, when $s/B_f > 1$, as shown in Fig. 8c.

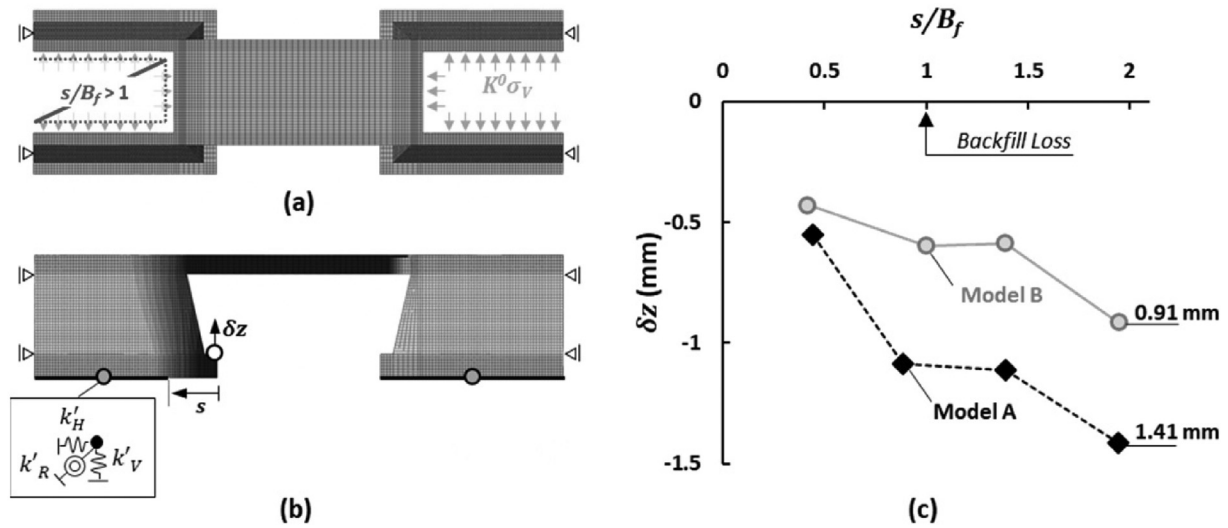
Fig. 10. Modelling of scour hole evolution: (a) plan and (b) side view of simplified model B; (c) comparison with settlements predicted by Model A with reference to the mid-point of the abutment footing.

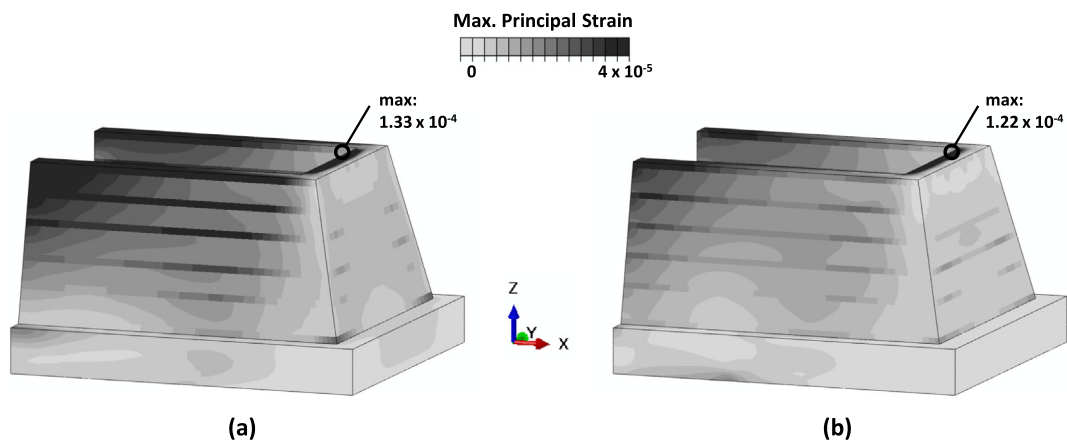
Fig. 11. Plastic strains developed at the concrete walls of the abutment for $s/B_f = 1.94$ in (a) the full model (model A), compared to (b) the bridge-on-springs model (model B).

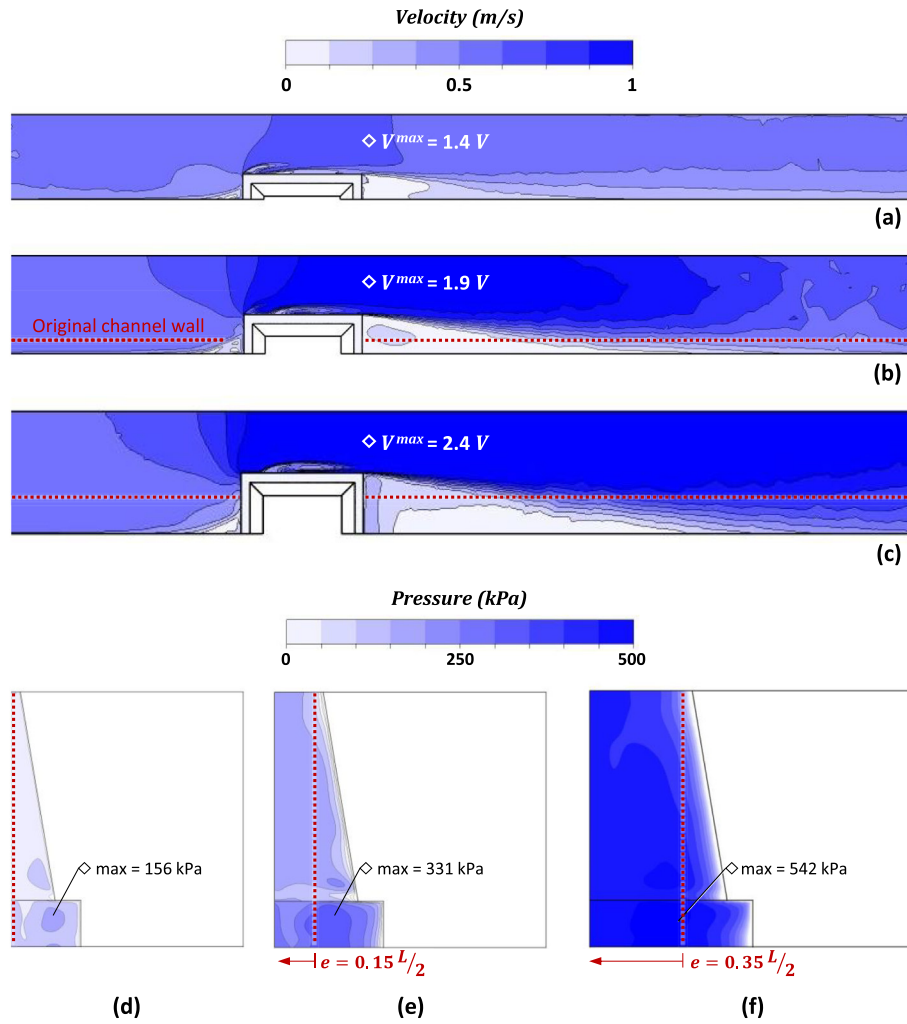
The surface velocity contour plots of Fig. 16a–c show how flow around the abutment is influenced by *BR*, and hence by *e*. As the abutment blocks a significant part of the channel area, the flow separates, at some distance ahead of it, and accelerates towards the centreline. Contraction leads to substantially amplified streamwise velocities at the bridge opening, from 1.4 *V*, when *BR* = 0.3, to as much as 2.5 *V* when *BR* = 0.5. The structure of the flow downstream of the abutment is also affected. Flow separation becomes significant, as evidenced by the zero velocity zones. A massive wake develops for *BR* > 3, extending over 3 abutment widths (*W*) downstream.

The pressure on the upstream face of the abutment rises accordingly. For an inlet velocity of *V* = 0.6 m/s and *BR* = 0.3, the computed pressure field (Fig. 16d) displays an almost linear distribution with depth, reaching a maximum of 156 kPa. Pressures become more uniform and 2–3 times higher in magnitude for *BR* = 0.4–0.5 (Fig. 16e–f). As a result, the drag coefficient (C_D) shows a strong dependence on *BR*. Table 3 lists drag and lift coefficients for the three levels of *BR*. Although our analysis considered a range of inlet velocities ($1 \times 10^6 < Re \leq 1 \times 10$ (Marchi et al., 2010)), drag and lift coefficients showed little variation with respect to *Re*, as commonly found in RANS simulations (Catalano et al., 2003; Benim et al., 2007). Lift coefficients seem unaffected by *BR*. However, this is not the

Fig. 16. Effect of increasing blockage due to lateral channel expansion on (a)–(c) streamwise flow velocities and (d) – (f) pressure at the upstream wall of the abutment, for constant inlet $V = 0.6$ m/s.

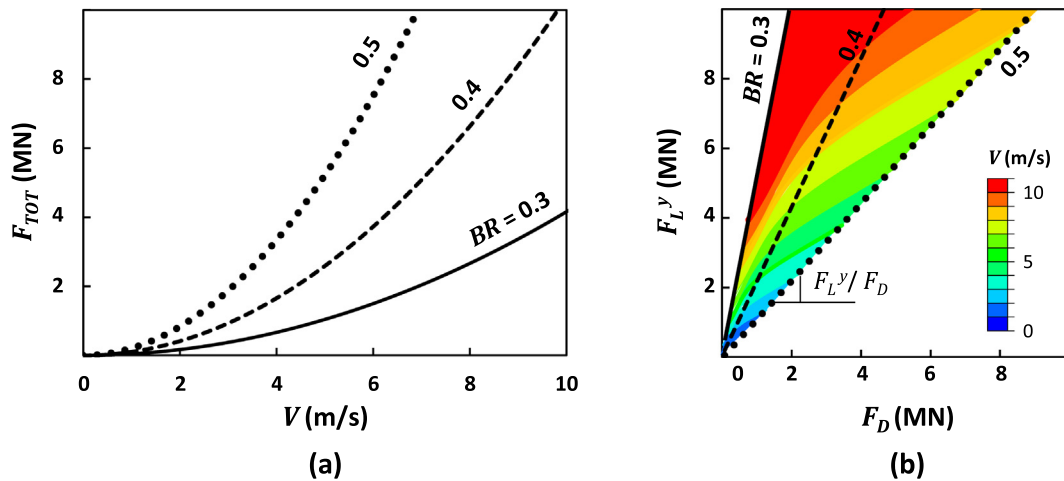
Hence, hydrodynamic loading increases in all three directions with increasing BR. This is evident in Fig. 17a which plots the total force with respect to V. Interestingly, increasing BR also leads to a drastic drop of the gradient of the loading path F^Y_L/F_D (Fig. 17b), implying a tendency of the drag component to predominate over lift.

A forensic investigation of the flow conditions that led to the collapse of the western abutment of Br9 is based on the previously discussed evidence that the BR has a strong influence on the $F_D - F_L$ loading path (Fig. 17b).

Fig. 17. Steady-state hydrodynamic loading of the abutment: (a) total force with respect to inlet velocity and (b) drag – (spanwise) lift loading paths for the different blockage ratios considered.

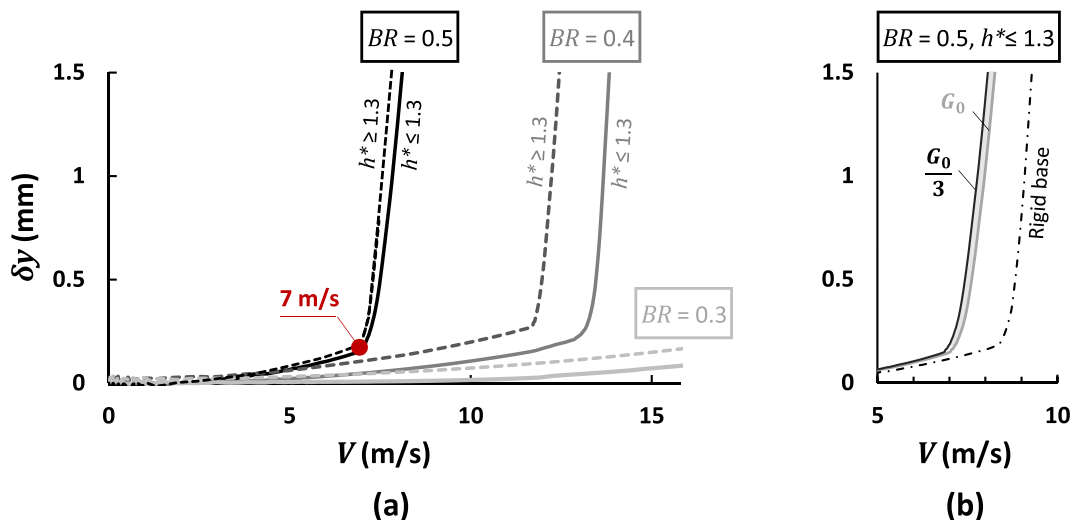
Figs. 18 and 19 summarize selected results from the parametric investigation of the combined scour–flow blockage effects. The onset of failure is easily recognisable in the plots of Fig. 18a, where the spanwise displacement of the abutment δy (with reference to the mid-point of its footing) is shown as a function of V. As expected, scour penetration, associated with increased BR, reduces substantially the tolerance for high flow velocities.

Fig. 18. Spanwise horizontal displacements computed at the mid-point of the collapsed footing with respect to inlet flow velocity for (a) all the investigated scenarios of combined scour – deck inundation – lateral flow constrictions scenarios, and (b) various assumptions for the secant soil stiffness $G_{sec}/G_0 = 0.33$–1.

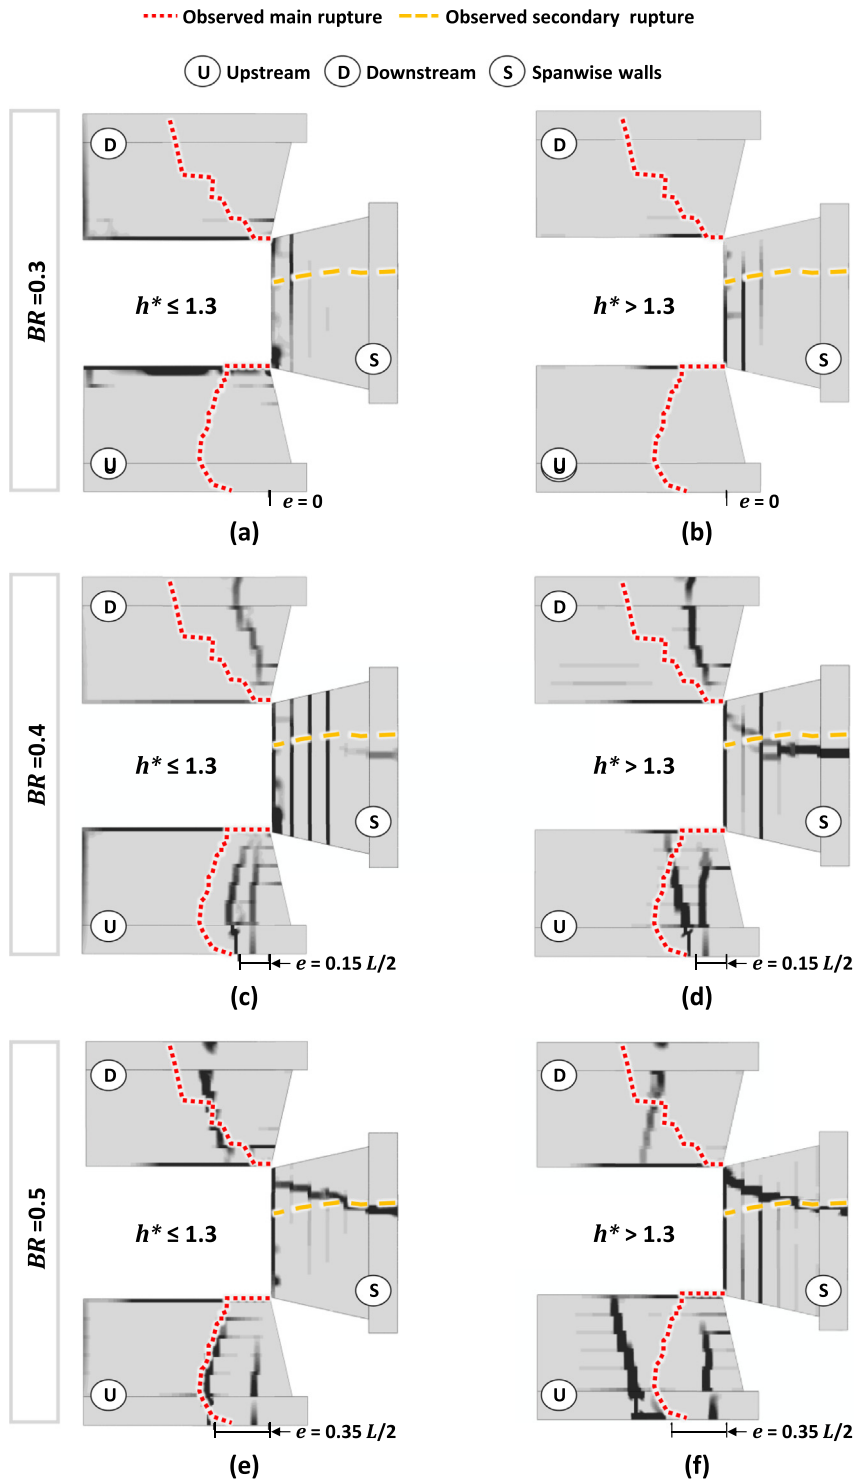
Rather unrealistic velocity magnitudes (exceeding 16 m/s) would be required to cause failure with $BR \leq 0.3$. By contrast, higher blockage due to lateral (westward) expansion of the stream lowers the safety margin to 12 m/s and 7 m/s for $BR = 0.4$ and $BR = 0.5$, respectively.

Interestingly, the role of deck inundation (h^*) appears less significant, especially at high levels of s and BR. In fact, results from simulations with $BR = 0$ indicate that the observed failure pattern cannot be reproduced if the effect of the deck–flow interaction is considered in isolation, i.e., assuming no scour or blockage.

Fig. 19. Comparison of observed rupture pattern with predicted plastic strain localizations for: (a) $V = 16$ m/s, $BR = 0.3$, $h^* \leq 1.3$; (b) $V = 16$ m/s, $BR = 0.3$, $h^* > 1.3$; (c) $V = 14$ m/s, $BR = 0.4$, $h^* \leq 1.3$; (d) $V = 13$ m/s, $BR = 0.3$, $h^* > 1.3$; (e) $V = 8$ m/s, $BR = 0.5$, $h^* \leq 1.3$; (f) $V = 8$ m/s, $BR = 0.5$, $h^* > 1.3$.
