Framing Failures in Wood-Frame Hip Roofs under Extreme Wind Loads

Sarah A. Stevenson¹, Gregory A. Kopp^{1*} and Ayman M. El Ansary²

Wood-frame residential roof failures are among the most common and expensive types of wind damage. Hip roofs are commonly understood to be more resilient during extreme wind in relation to gable roofs. However, inspection of damage survey data from recent tornadoes has revealed a previously unstudied failure mode in which hip roofs suffer partial failure of the framing structure. In the current study, evidence of partial framing failures and statistics of their occurrence are explored and discussed, while the common roof design and construction practice are reviewed. Two-dimensional finite element models are developed to estimate the element-level load effects on hip roof trusses and stick-frame components. The likelihood of failure in each member is defined based on relative demand-to-capacity ratios. Trussed and stick-frame structures are compared to assess the relative performance of the two types of construction. The present analyses verify the common understanding that toenailed roof-to-wall connections are likely to be the most vulnerable eleme

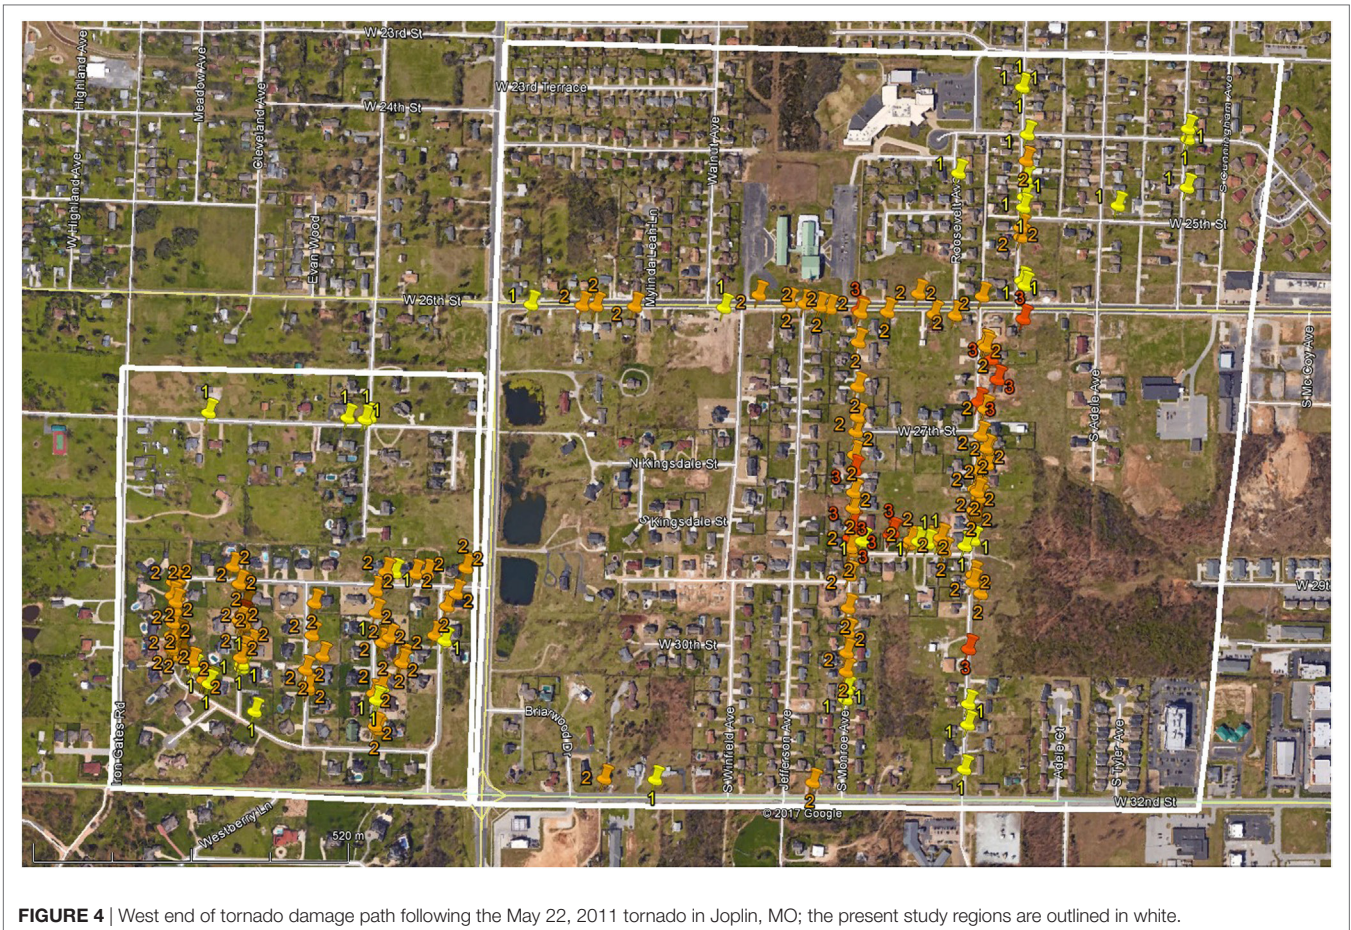
Two study areas, outlined in white on **Figure 4**, are analyzed and the occurrence of different failure modes is assessed. The damage photos at the marked locations were inspected and the perceived mode of failure is noted. In this pass through the data, each separate residence was assessed as to whether the damage appeared to be RTWC, sheathing, or framing failure. Beyond roof damage, wall failures corresponding to DOD-7 are included. The study areas were selected based on the characteristics of the houses. Historical imagery from Google Earth is used to identify the original shape of the studied roofs. Region 1, on the left side of **Figure 4**, is found to contain houses that appeared to be newer, most with steep-sloping hip roofs and large building footprints. The homes in Region 2 mostly appear to be older, masonry homes with shallow wood-framed roofs.

FIGURE 4 | West end of tornado damage path following the May 22, 2011 tornado in Joplin, MO; the present study regions are outlined in white.

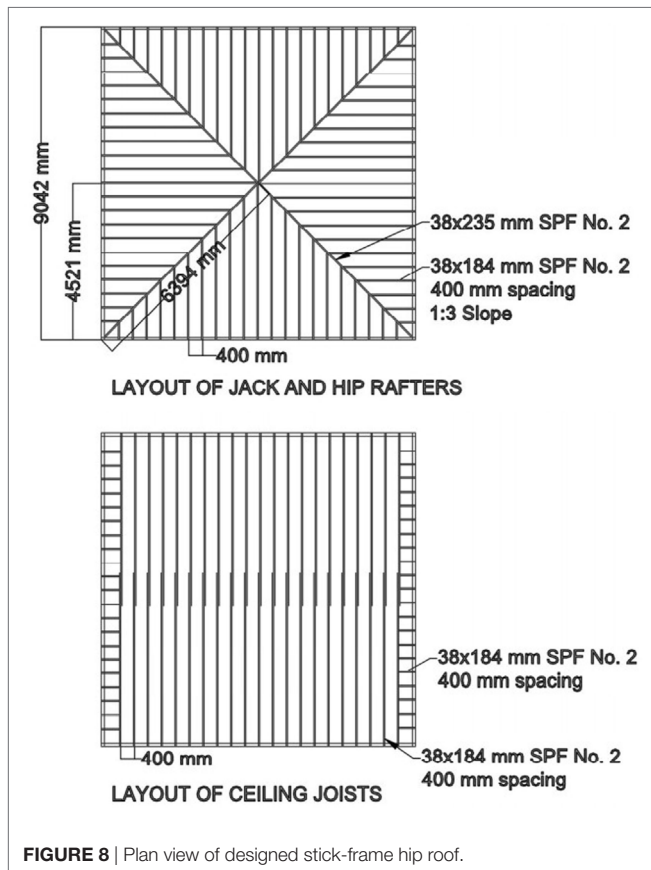
For the stick-frame roof, Section 9.23 of the NBCC (Canadian Commission on Building and Fire Codes, 2010) is used to determine the appropriate member placement and sizing requirements, in addition to the minimum number and direction of nails in each joint. The resulting structure is illustrated in **Figure 8** with member sizes and spacing labeled. The member layout of stick-frame roofs induces load sharing between the faces and individual members of the roof. The hip rafter transfers loads between members on adjacent faces of the roof and the sheathing plays a role in the member-to-member system effects across a single face.

FIGURE 8 | Plan view of designed stick-frame hip roof.

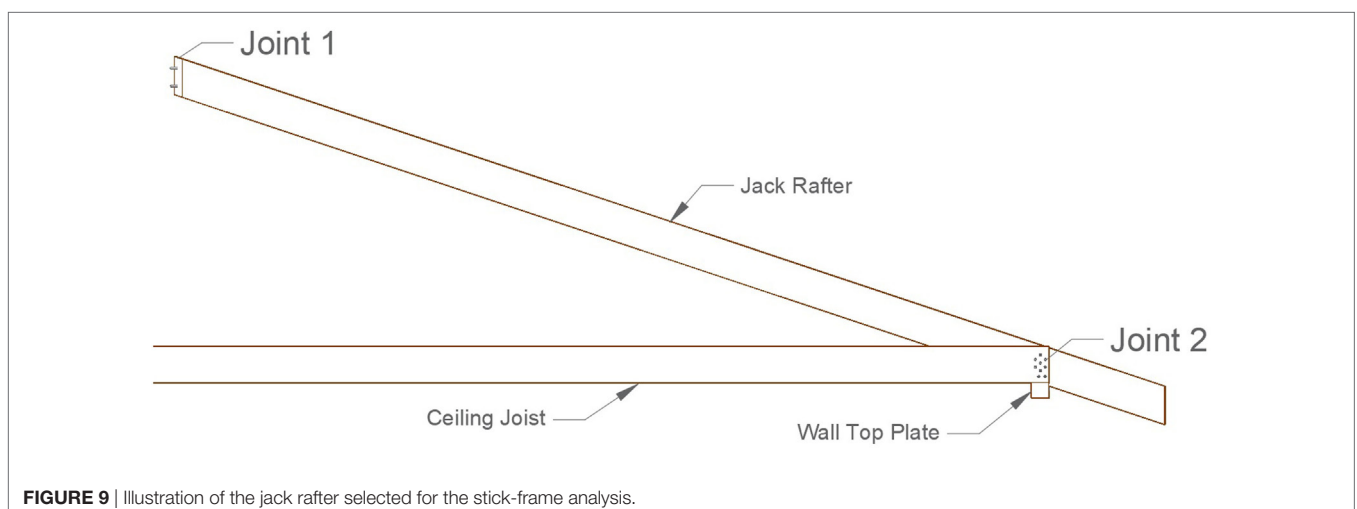
Due to this layout, it is not possible to extract a two-dimensional cross-section from the roof for analysis, as was effectively done in the trussed roof. Instead, the present analysis of the stick-frame roof is simplified by studying a single, representative jack rafter. Upon inspection, the rafters nearest to the center of the roof are deemed to be under the highest demand under roof pressures, due to having the longest unsupported spans. The central jack rafters are expected to experience the highest moments and shear internal forces, and their joints will need to resist the largest support reactions. The faces of the roof are identical and so the selected jack rafter, shown in **Figure 9**, represents four different jack rafters within the roof.

FIGURE 9 | Illustration of the jack rafter selected for the stick-frame analysis.
