Framing Failures in Wood-Frame Hip Roofs under Extreme Wind Loads

Sarah A. Stevenson¹, Gregory A. Kopp^{1*} and Ayman M. El Ansary²

Wood-frame residential roof failures are among the most common and expensive types of wind damage. Hip roofs are commonly understood to be more resilient during extreme wind in relation to gable roofs. However, inspection of damage survey data from recent tornadoes has revealed a previously unstudied failure mode in which hip roofs suffer partial failure of the framing structure. In the current study, evidence of partial framing failures and statistics of their occurrence are explored and discussed, while the common roof design and construction practice are reviewed. Two-dimensional finite element models are developed to estimate the element-level load effects on hip roof trusses and stick-frame components. The likelihood of failure in each member is defined based on relative demand-to-capacity ratios. Trussed and stick-frame structures are compared to assess the relative performance of the two types of construction. The present analyses verify the common understanding that toenailed roof-to-wall connections are likely to be the most vulnerable eleme

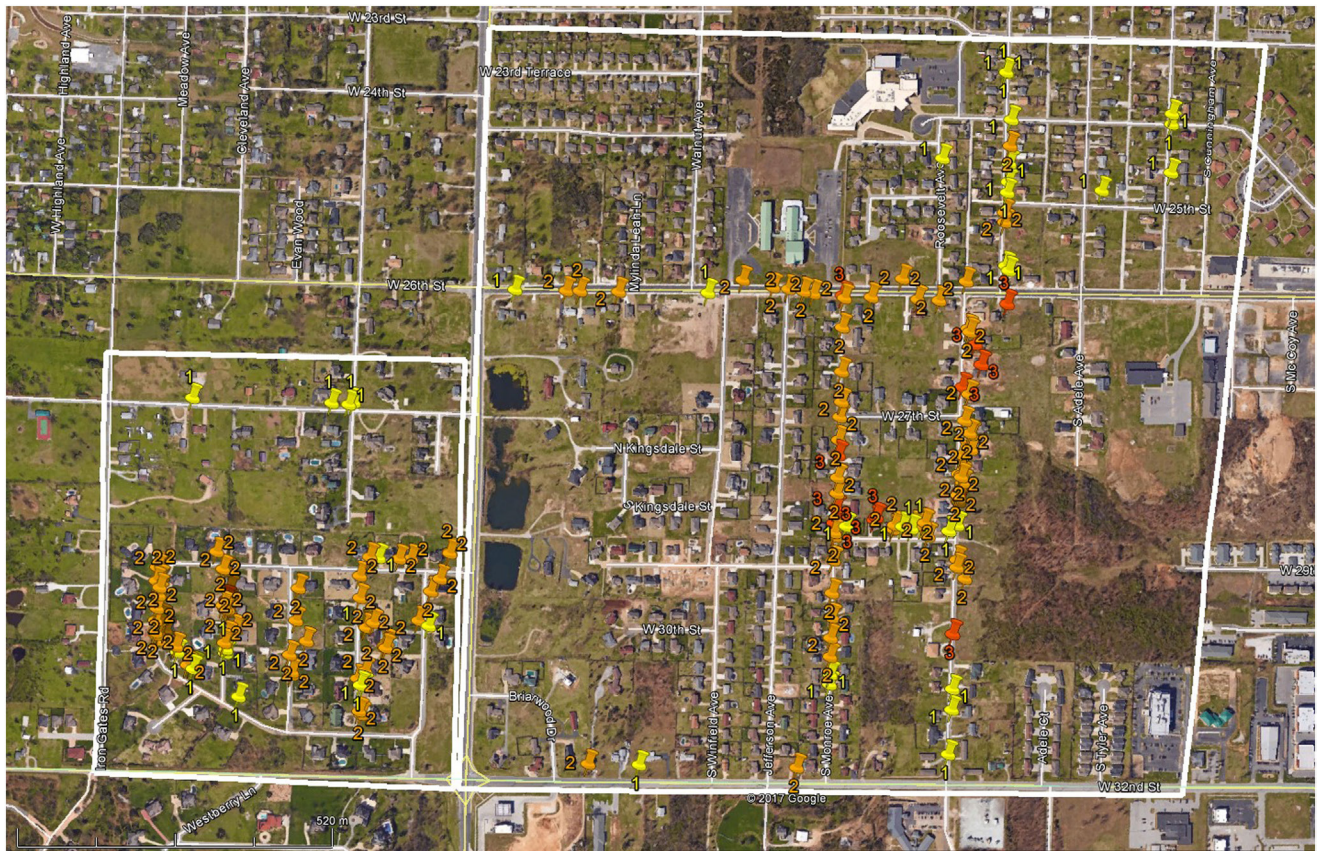
Two study areas, outlined in white on **Figure 4**, are analyzed and the occurrence of different failure modes is assessed. The damage photos at the marked locations were inspected and the perceived mode of failure is noted. In this pass through the data, each separate residence was assessed as to whether the damage appeared to be RTWC, sheathing, or framing failure. Beyond roof damage, wall failures corresponding to DOD-7 are included. The study areas were selected based on the characteristics of the houses. Historical imagery from Google Earth is used to identify the original shape of the studied roofs. Region 1, on the left side of **Figure 4**, is found to contain houses that appeared to be newer, most with steep-sloping hip roofs and large building footprints. The homes in Region 2 mostly appear to be older, masonry homes with shallow wood-framed roofs.

FIGURE 4 | West end of tornado damage path following the May 22, 2011 tornado in Joplin, MO; the present study regions are outlined in white.

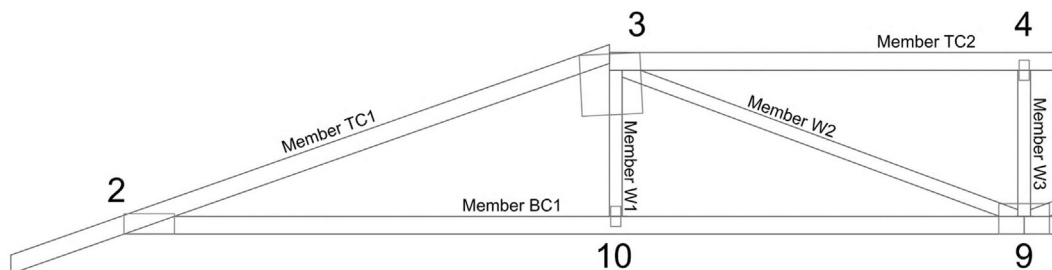
The two-dimensional D/C analysis in this work uses a single MPC truss, based on those used in the full-scale hip roof tested by Henderson et al. (2013). **Figure 7** illustrates the layout of the truss; only half of the truss is shown due to symmetry. Following analysis of the truss, a stick-frame hip roof was designed to match the profile and plan geometry of the trussed roof from Henderson et al. (2013), in order to provide a point of comparison.

FIGURE 7 | Half of the modeled truss, with joints and members labeled.

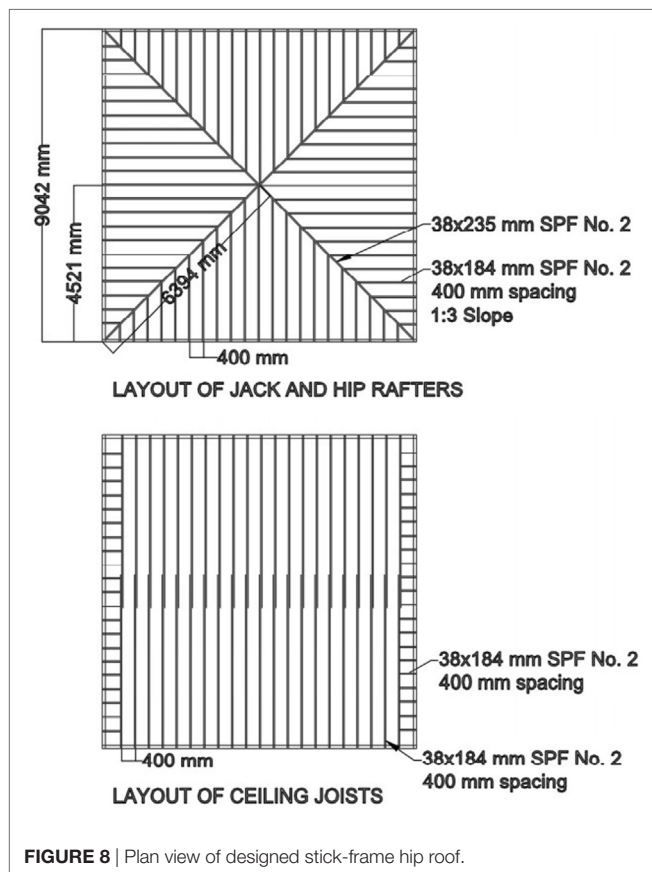
For the stick-frame roof, Section 9.23 of the NBCC (Canadian Commission on Building and Fire Codes, 2010) is used to determine the appropriate member placement and sizing requirements, in addition to the minimum number and direction of nails in each joint. The resulting structure is illustrated in **Figure 8** with member sizes and spacing labeled. The member layout of stick-frame roofs induces load sharing between the faces and individual members of the roof. The hip rafter transfers loads between members on adjacent faces of the roof and the sheathing plays a role in the member-to-member system effects across a single face.

FIGURE 8 | Plan view of designed stick-frame hip roof.

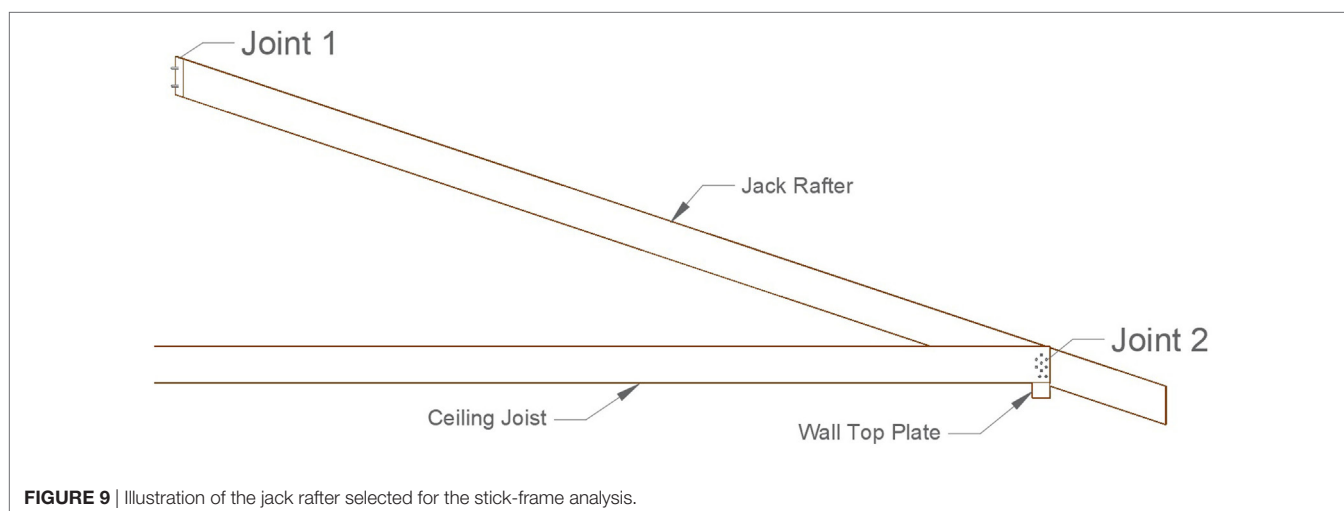
Due to this layout, it is not possible to extract a two-dimensional cross-section from the roof for analysis, as was effectively done in the trussed roof. Instead, the present analysis of the stick-frame roof is simplified by studying a single, representative jack rafter. Upon inspection, the rafters nearest to the center of the roof are deemed to be under the highest demand under roof pressures, due to having the longest unsupported spans. The central jack rafters are expected to experience the highest moments and shear internal forces, and their joints will need to resist the largest support reactions. The faces of the roof are identical and so the selected jack rafter, shown in **Figure 9**, represents four different jack rafters within the roof.

FIGURE 9 | Illustration of the jack rafter selected for the stick-frame analysis.
