Influence of lay-up configuration and feed rate on surface integrity when drilling carbon fibre reinforced plastic (CFRP) composites

Li, Maojun; Soo, Sein; Aspinwall, D.k.; Pearson, D.; Leahy, W.

Li, M, Soo, S, Aspinwall, DK, Pearson, D & Leahy, W 2014, 'Influence of lay-up configuration and feed rate on surface integrity when drilling carbon fibre reinforced plastic (CFRP) composites', *Procedia CIRP*, vol. 13, pp. 399-404. <https://doi.org/10.1016/j.procir.2014.04.068>

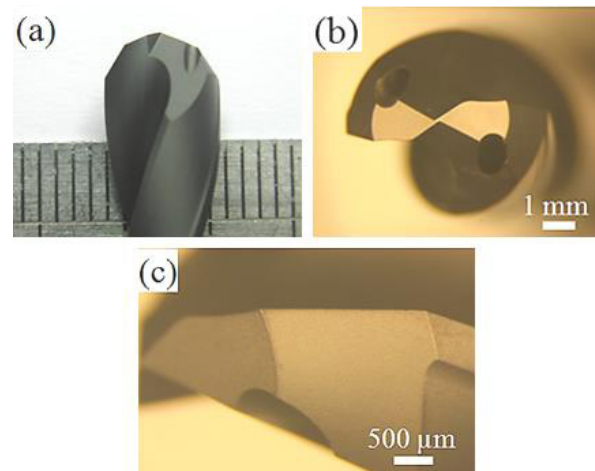
Fig. 1. Diamond coated drill tip (a) side view; (b) end view; (c) cutting lip

Autoclave cured CFRP laminates with 3 different configurations/fibre orientations were employed. These involved manually laid up unidirectional (UD) pre-pregs (0.26mm thick) with Type 1 and Type 3 laminates comprising 40 plies with a thickness of 10.4mm, whereas Type 2 laminates were 9.36mm thick consisting of 36 plies. The lay-up sequences were [45/0/135/90]_{5S}, [40/0/135/0/90/0/135/0/45]_{2S} and [45/0/135/135/135/90/45/45/45/0/135/135/90/45/45/0/135/135/90/45]_S for Types 1, 2 and 3, respectively. The CFRP laminates were made of intermediate modulus (294GPa), high tensile strength (5880MPa) carbon fibre impregnated with epoxy resin resulting in a fibre weight fraction of 64 to 68%. The fibre volume of the CFRP composite following curing was 60%, with an overall tensile strength and modulus of 2950MPa and 154GPa respectively [10]. Plates measuring 100×100mm were produced for the trials. Tools employed for the work were 6.38mm diameter CVD-diamond coated tungsten carbide (WC) drills, having optimised double point geometry (130° and 60° angles) designed for improved chip breaking and enhanced chip evacuation [11], see Fig. 1.

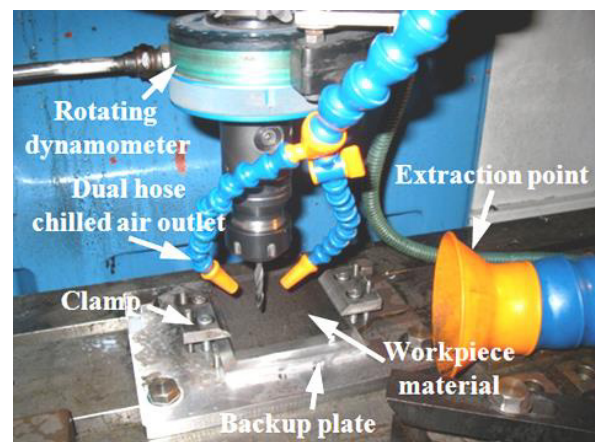
Fig. 2. Drilling experimental setup

All tests were carried out on a Matsuura FX-5 vertical high speed CNC machining centre with a variable spindle capable of up to 20,000rpm rated at 15kW. The machine was fitted with a Filtermist dust extraction system for removing airborne CFRP dust particles $\geq 0.3\mu\text{m}$. A chilled air environment ($\sim 8^\circ\text{C}$) was utilised in each trial and was generated using a Nex-Flow vortex tube (type 56030FD), which was directed to the cutting zone through two adjustable nozzle hoses at a pressure

of 0.4 bar. The CFRP workpieces for tool wear/life testing were held in a bespoke drilling jig with an array (10×10) of pre-fabricated 7mm diameter clearance holes, see Fig. 2 for experimental setup.

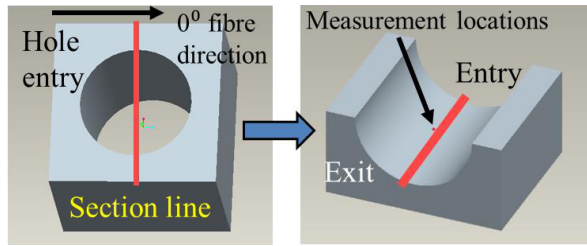
Fig. 3. Schematic of hole sectioning and surface measurement locations

The end of test criteria was a maximum flank wear (VB_{max}) of 0.3mm or drilling of 384 holes. The first and last holes drilled from each trial were sectioned (approximately along the centre of the hole) using a diamond slitting saw for subsequent machined surface analysis, see schematic in Fig. 3. Workpiece surface roughness (2D parameters) at the hole entrance and exit were evaluated using a Taylor Hobson Talysurf 120L with cut-off and evaluation lengths of 0.8 and 4mm respectively (replicated twice) while 3D topographic maps were obtained over a scan area of $8 \times 1\text{mm}$ at $\sim 1\text{mm}$ beneath the hole entrance. Tool flank wear was measured using a toolmaker's microscope equipped with a micrometre stage (0.001mm resolution) and corresponding wear scar images captured using a digital

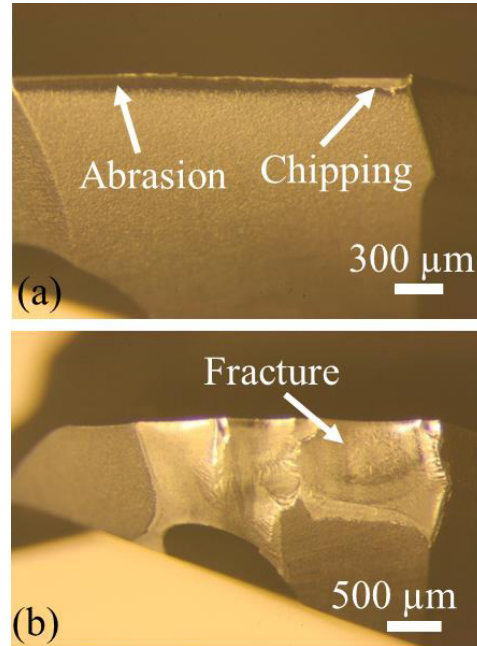
Fig. 4. Drill wear scar in (a) Test 3 after 384 holes; (b) preliminary test at a feed rate of 0.6mm/rev after 1 hole

Tool wear progression followed a similar trend irrespective of feed rate or workpiece configuration, with all trials achieving 384 holes. The highest flank wear recorded at test cessation was 123 μ m in Test 3 while Test 4 showed the lowest flank wear level with a VB_{max} of 102 μ m. The relatively low variation (21 μ m) in tool wear levels between tests was most probably due to the difference in tool-workpiece contact time, which was 1.33 and 1.00s per hole when operating at 0.2 and 0.4mm/rev respectively. Abrasion and chipping/peeling of the CVD diamond coating (at the cutting edge corner) were the primary wear modes for all of the drills inspected, and was similar to that shown in Fig. 4(a). In preliminary testing at a feed rate of 0.6mm/rev, both

cutting lips experienced catastrophic fracture at the flank surface after drilling only one hole as shown in Fig. 4(b), due to the high thrust force experienced (~1304N).

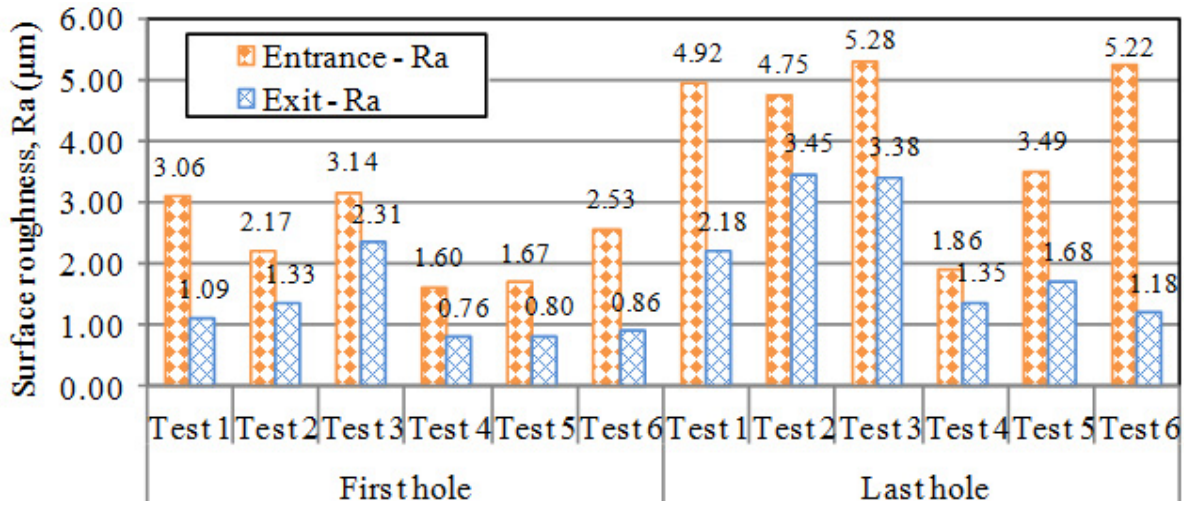
Fig. 5. Surface roughness (Ra) results for all tests at entrance and exit location for the first and last hole

Fig. 5 details surface roughness (R_a) values measured at the entry and exit positions in both the first and last holes drilled for all tests. Hole roughness was generally higher in Type 3 workpieces (Tests 3 and 6) at both feed rate levels, which was due to the larger number of plies (14) orientated at 135°. Increasing feed rate from 0.2 to 0.4mm/rev led to lower R_a in all of the samples analysed, which was attributed to a decrease in tool wear when operating at higher feed rates, as a result of the shorter interaction period between the tool and workpiece [6]. Furthermore, the R_a measured in the vicinity of the hole exit location was consistently found to be lower (by up to ~80%) compared to the entrance section, which was possibly due to a 'ploughing' or 'polishing' effect when operating at the very low feed rate of 0.01mm/rev. An analysis of skewness (R_{sk}) showed that all values were negative, indicating that the machined surfaces were typically dominated by sharp/deep valleys, most likely the result of fibre pull out/matrix loss. Conversely, the relatively high kurtosis (R_{ku}) values recorded (> 3) suggests the presence of sharp peaks on the measured profiles, which was likely from uncut/re-deposited fibres on the hole surfaces.

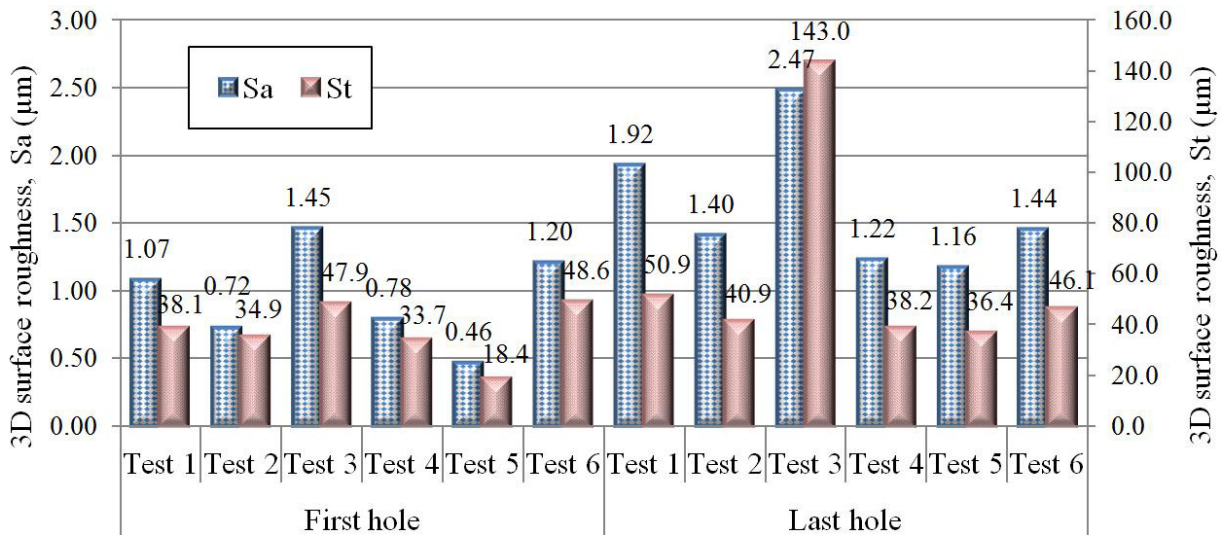
Fig. 6. Surface roughness (Sa and St) results for first and last holes in all tests

Fig. 6 details the measured 3D roughness parameters (Sa and St) for the first and last holes drilled in each of the experiments (all tests drilled 384 holes). The trends were largely similar to corresponding Ra data with hole surface quality generally deteriorating as tool wear increased (up to ~ 150% higher Sa value at test cessation in Test 5) and when operating at the lower feed rate level (deviation of ~ 21 – 72%). In terms of CFRP lay-up configuration, the Type 2 material was found to give the lowest roughness with minimum Sa values of 0.46 and 1.16μm when utilising new and worn tools respectively in Test 5. An analysis of variance (ANOVA) showed that both workpiece material and feed rate were statistically significant at the 5% level with respect to Sa,

lay-up having the greater effect with a percentage contribution ratio (PCR) of 83.7% compared to only 16.2% for feed rate. In addition, the variation in St (total height of the surface) was similar to that of the Sa parameter with a maximum of 143.0μm for the last hole in Test 3.

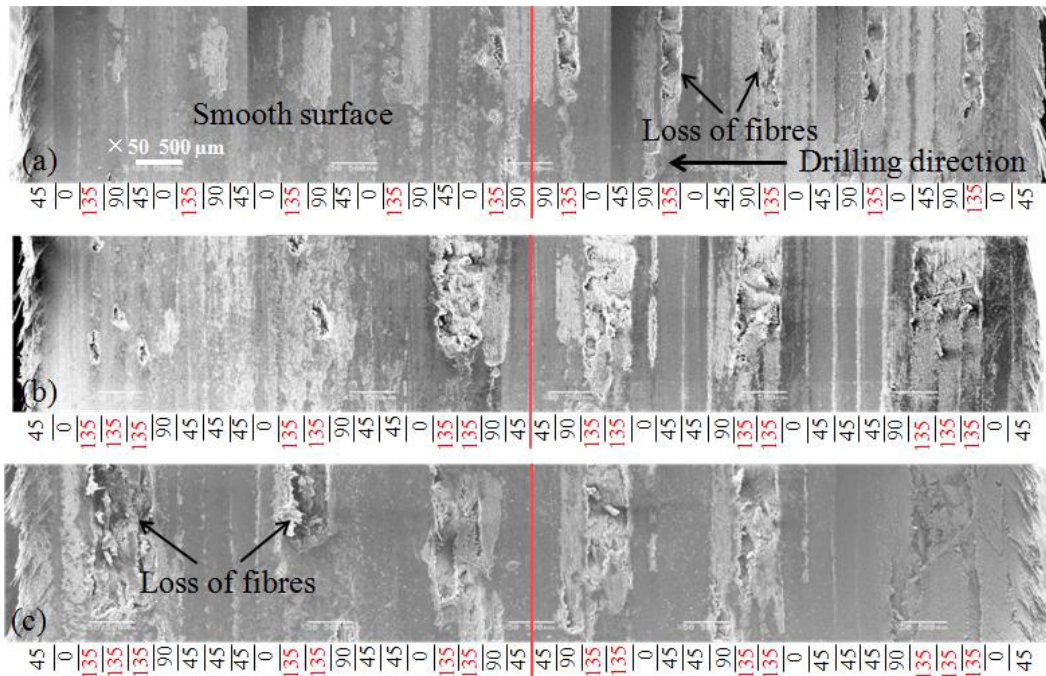
Fig. 8. Hole surface integrity in (a) Test 4 - hole 1; (b) Test 6 - hole 1; (c) Test 6 - hole 384

Subsequent SEM analysis of selected cross sectioned hole surfaces confirmed that cavities due to fibre/matrix loss were primarily concentrated at plies with 135° orientation, while those at 0°, 45° and 90° were largely free of damage, see Fig. 8. The surface quality of holes machined using new drills was significantly better towards the exit location, with minimal signs of defects even at the 135° ply; see Fig. 8(a) and Fig. 8(b), as a result of the 0.01mm/rev feed rate employed. When assessing the last hole drilled however, workpiece damage was evident even at the exit position, which suggests that tool wear/edge condition was the dominant factor affecting hole surface quality; see Fig. 8(c). During machining, fibres in the 135° direction were typically subjected to intense elastic bending (instead of shearing) by pressure from the tool cutting edge. As the load exceeded the fibre yield strength, failure occurred below the cutting plane/surface with the debris removed as the tool passed, thereby creating a cavity/groove on

the surface. In contrast, fibres in the 0° direction suffered cracking due to buckling or were ‘peeled off’/separated and slid up the tool rake face while fibre fracture typically initiated at the tool tip (without elastic bending) for plies in the 45° and 90° orientations [1].

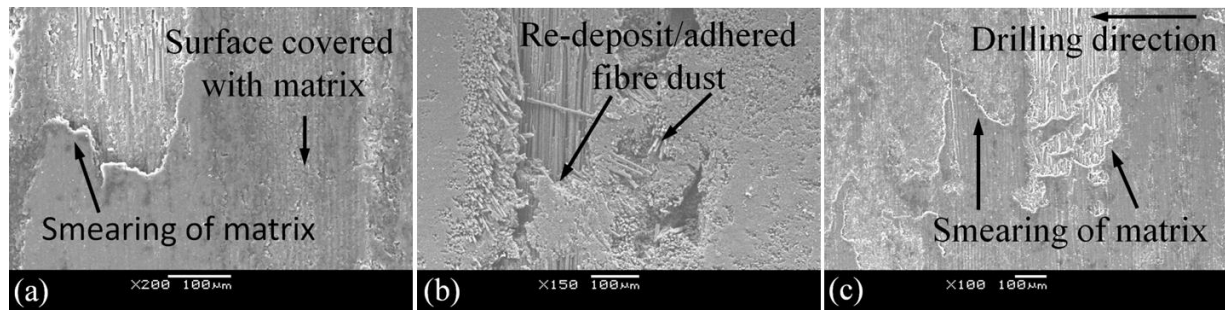
Fig. 9. SEM micrographs showing surfaces near the exit location in (a) Test 1 - hole 1; (b) Test 1 - hole 384; (c) Test 5 - hole 1

Fig. 9 shows sample SEM micrographs of surfaces near the hole exit location (drilled at feed rate of 0.01mm/rev). Observations showed that smearing of melted matrix material was prevalent when drilling with new tools. This was possibly due to the increased tool-workpiece contact time at the low feed rate resulting in relatively higher interface temperatures. The poor thermal conductivity of CFRP was a further contributory factor in relation to resin melt, which typically occurs at 300 - 400°C [12]. Conversely, adhered or re-deposited fibre dust and fibre/matrix cracking similar to that shown in Fig. 9(b) was evident as tool wear increased, with severity highly dependent on ply orientation and drill edge sharpness.
