Repair of Aerospace Composite Structures Using Liquid Thermoplastic Resin

Khan , Tayyab; Hafeez, Farrukh; Umer, Rehan

Khan , T, Hafeez, F & Umer, R 2023, 'Repair of Aerospace Composite Structures Using Liquid Thermoplastic Resin', *Polymers*, vol. 15, no. 6, 1377. <https://doi.org/10.3390/polym15061377>

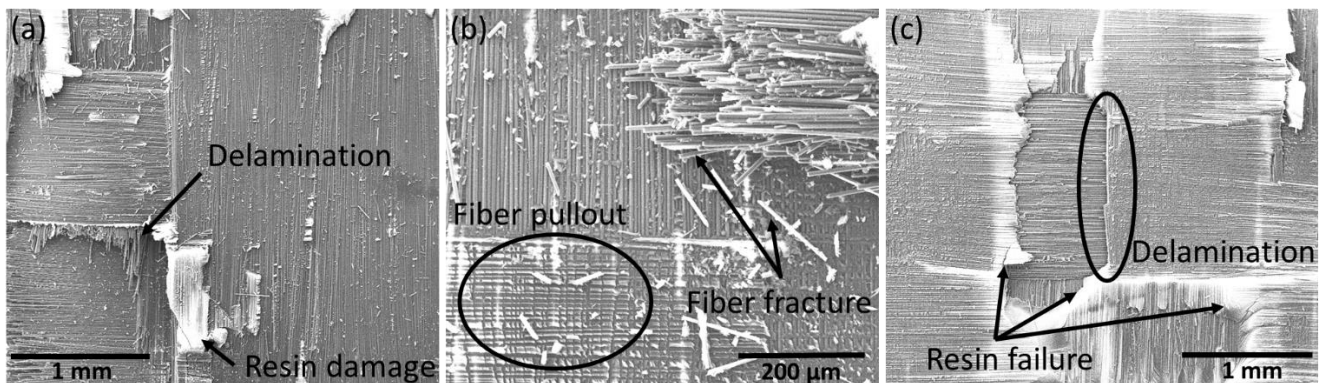
Figure 10. SEM micrographs showing different failure modes in the samples repaired at room temperature after flexural testing (a) delamination, (b) fiber pullout and fracture and (c) resin failure and delamination.

The results in Section 3.4 demonstrated that even though the strength of the repaired samples was recovered to up to 97% that of the pristine samples, all the repaired specimens exhibited a similar delamination failure mode. The failure of the scarf-repaired specimens at both room temperature and 210 °C after flexural testing was thoroughly investigated through SEM micrographs. Both Type A and Type B specimens exhibited similar failure modes; therefore, only the fractographic analysis for the Type A specimens is considered here. The SEM images of the Type A specimens repaired at ambient temperature are shown in Figure 10. As expected, the failure at the microscopic level was mainly comprised of delamination at the tow level. Apart from the delamination failure mode, rigorous fiber fracture was also observed throughout the delaminated surfaces (Figure 10b). Upon failure, multiple fibers were also pulled out of the specimens. Along with this, excessive liquid thermoplastic resin failure was observed across the edges of individual fiber tows, promoting the delamination failure. The SEM micrographs also revealed a fiber–matrix interface failure mode, especially in the fiber fracture regions. Nonetheless, macroscopic delamination was the most dominant failure mode in both Type A and Type B specimens repaired at room temperature, due to the incomplete scarf repair.

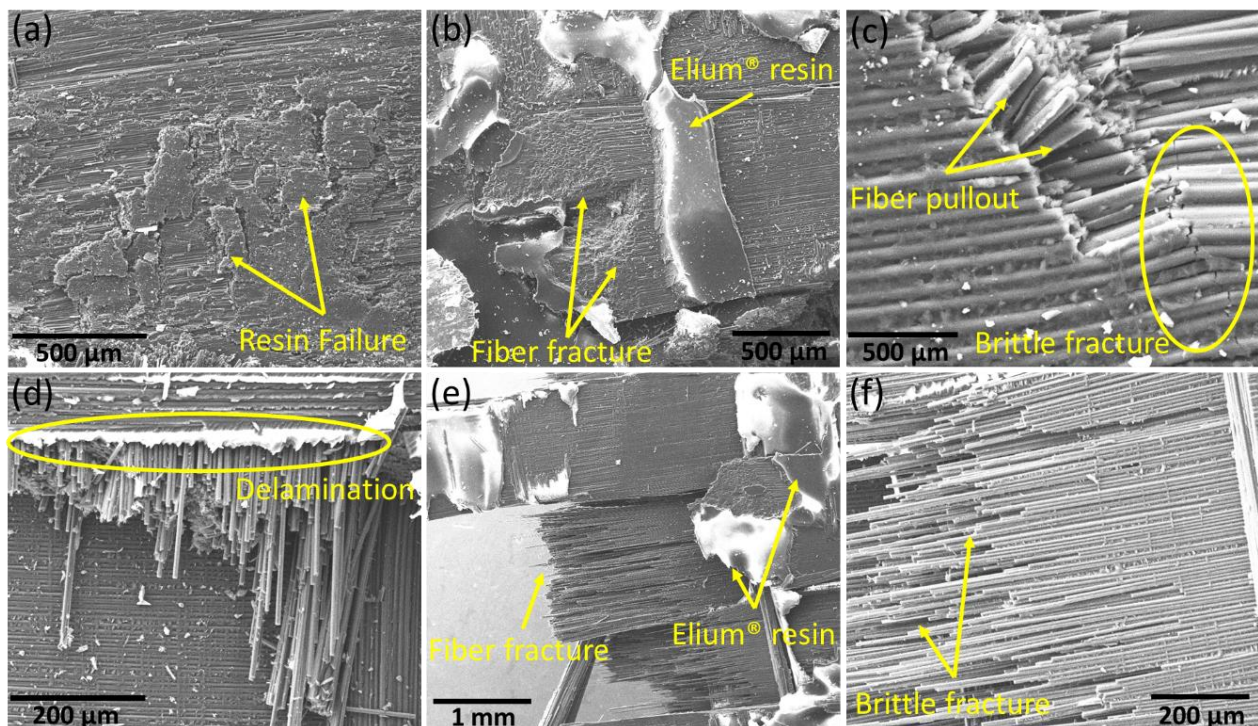
Figure 11. SEM micrographs showing different failure modes in the samples repaired at 210 °C after flexural testing (a–c) Type A and (d–f) Type B specimens.

As mentioned before, increasing the repair temperature to 210 °C significantly influenced the flexural properties of the repaired specimens and hence their microstructures upon failure. The SEM micrographs of the Type A and Type B specimens repaired at 210 °C upon failure after flexural testing are shown in Figure 11a–c and Figure 11d–f, respectively. The failure comprised a dominant delamination mode along with resin damage and fiber fracture. The micrographs showed a stronger bond between the liquid thermoplastic resin and the composite laminates. The failure was mainly comprised of bulk liquid thermoplastic resin failure in the form of patches on both the top and bottom sides of the repaired laminates. Along with this, the fibers were also pulled out and fractured upon the complete failure of the scarf joints, as the scarf geometry was pulled out due to complete delamination. The carbon fibers exhibited the commonly observed brittle fracture mode, especially along the edges of the scarf joints [42].

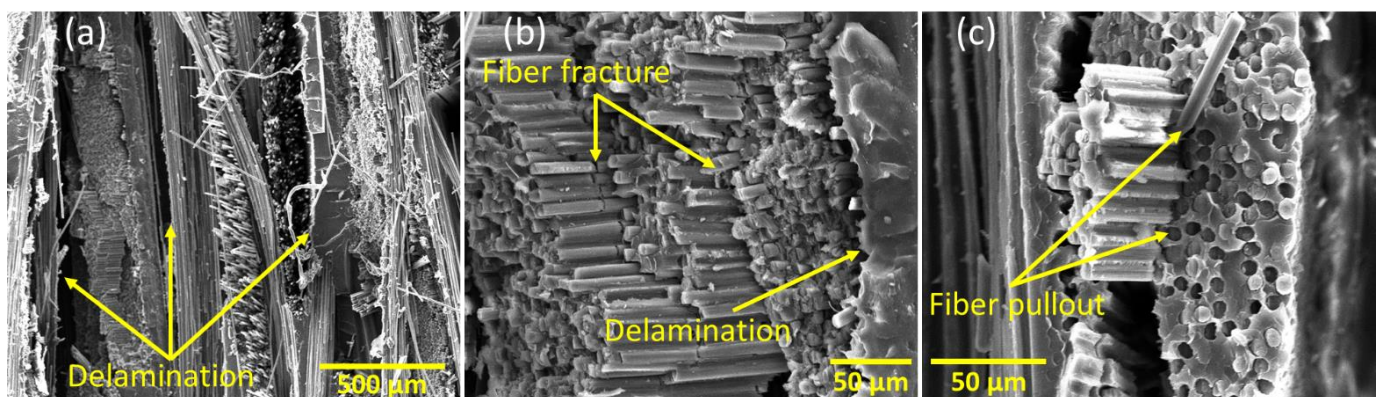
Figure 12. SEM micrographs showing different failure modes in the pristine specimens (a) delamination, (b) fiber fracture and (c) fiber pullout.

The failure of the pristine specimens without any scarf joints was also investigated at a microscopic level after subjecting them to flexural tests. The SEM micrographs in Figure 12 showed that the pristine CFRP specimens exhibited a dominant brittle fiber fracture failure mode commonly observed in carbon-fiber-based composite laminates [3]. Apart from that, the microscopic failure comprised delamination, fiber pull out, fiber cracking, and resin damage. Numerous studies in the literature have observed similar failure modes in CFRP composite specimens [42–45]. The results also showed a strong interface between the fibers and the thermosetting matrix, which was primarily due to the high surface roughness of the carbon fibers. As a result of this surface roughness, the surface area per unit volume of the fibers increased, and a stronger bond was established due to mechanical interlocking [3]. Based on this strong bonding, most of the fractured regions showed the collective brittle failure of carbon fibers and the matrix.
