Cautionary note on use of focused ion beam sectioning as technique for characterising oxidation damage in Ni based superalloys

Cautionary Note on the use of Focussed Ion Beam (FIB) Sectioning as a Technique for Characterising Oxidation Damage in Ni-based Superalloys

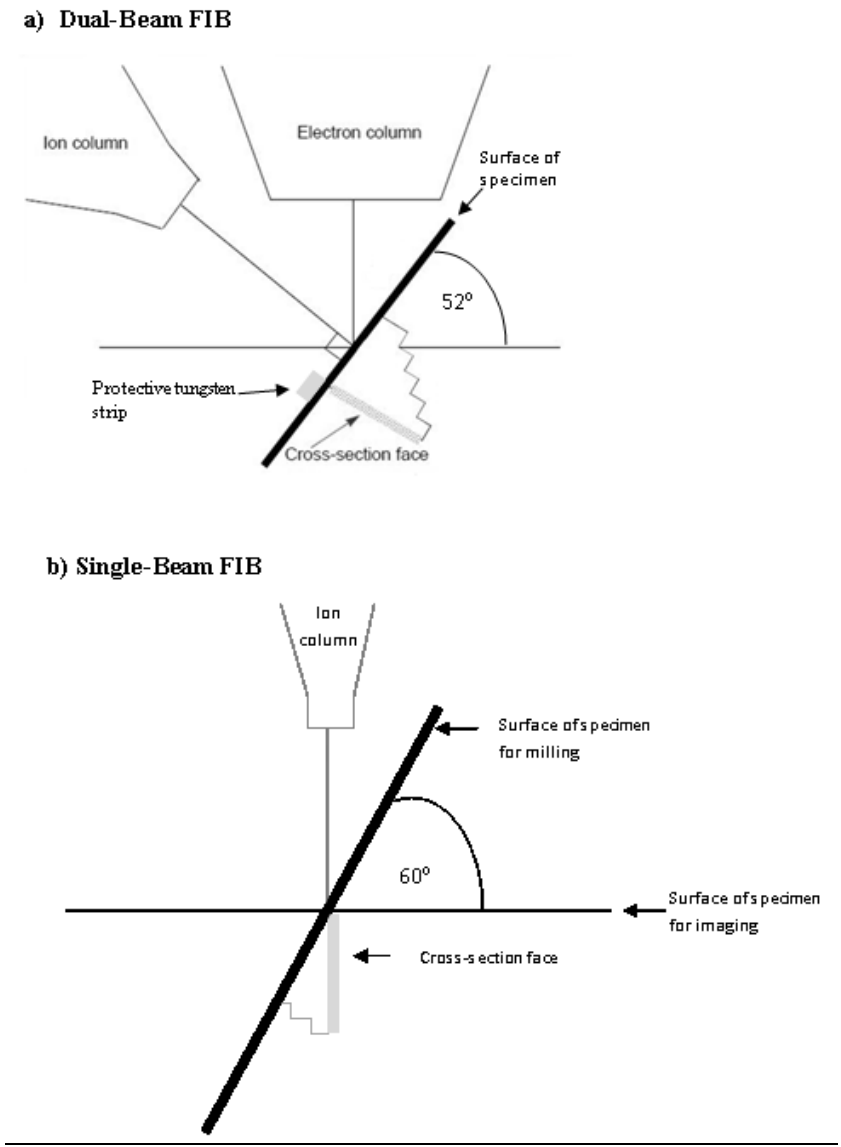
Figure 4. Schematic diagrams of how the sectioning was achieved by a) dual-beam (adapted from [15] and b) single-beam FIB microscopy.

The dual-beam capability allowed the cross-section to be imaged at every stage using the secondary electrons produced by an electron beam (SE_{electron})¹, without moving the sample (Figure 4a).
