Wind Turbine Tower Collapse Cases: A Historical Overview

Ma, Yang; Martinez-Vazquez, Pedro; Baniotopoulos, Charalampos

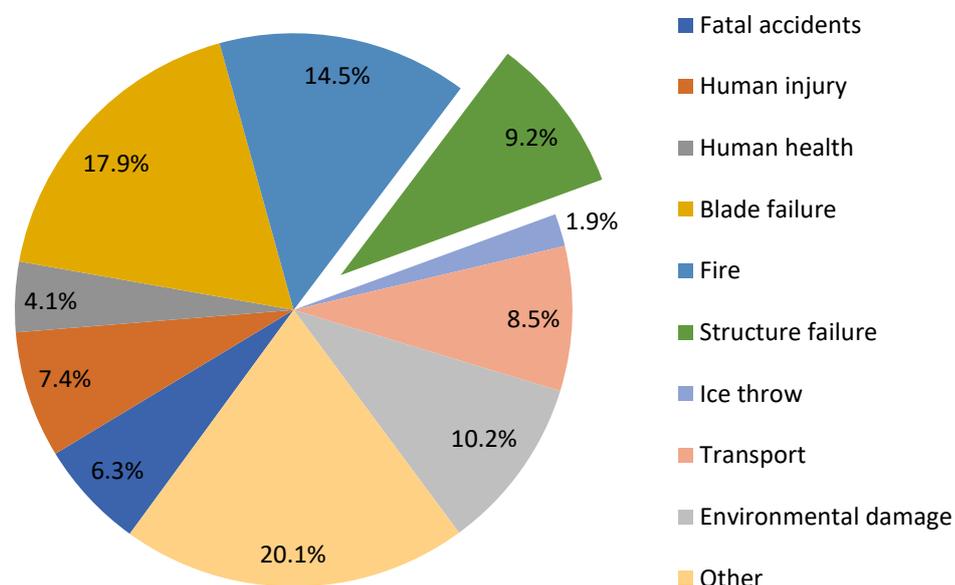
Fig. 1 Failure type distribution of wind turbine incidents recorded between 1980 – 2016 (CWIF, 2017)

To date, a fair amount of wind turbine accidents are still recorded each year whilst the rate of occurrence over the last 20 years has increased. A report of Caithness Windfarm Information Forum (CWIF) revealed that in the past four decades and till 31 Dec 2016, there were 1,999 wind power plant accidents among which 126 were classified as fatal (CWIF, 2017). Fig. 1 shows that blade failure accumulates the largest number of incidents accounting for 17.9% of the total, followed by fire which accumulates 14.5%. Structural failure, including tower collapse and turbine damage, is the fourth largest type in the list accumulating 9.2% of the overall toll.

Fig. 1 shows that blade failure concentrates the maximum percentage of collapse cases, arguably due to the fact that this failure type often derives in chain reactions. Blades are made up of composite fibre having stable performance against aerodynamic forces although depending highly on the quality of their manufacturing. Blades may deform flapwise or be subject to significant lagged and torsional deformations, hence exhibiting ductile performance. Their connection components however tend to be exposed to large deformation occurring at high rates over time which makes them susceptible to fracture (Hau, 2013).

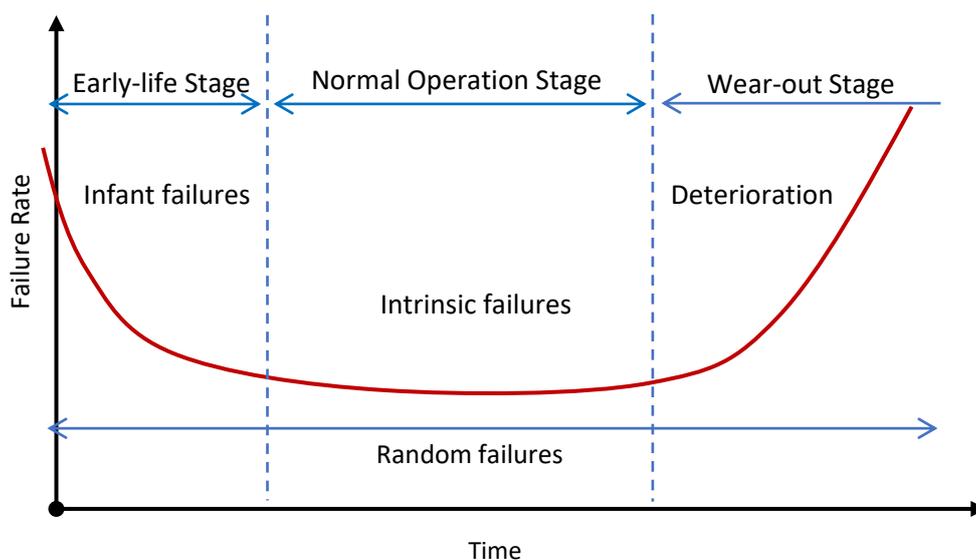
The overall failure rates of wind turbine components fit a bathtub curve which varies over time (Nielsen, 2013). The bath-tub curve involves three typical stages: early-life, normal operation and wear-out, as shown in Fig. 2.

Fig. 2. A Bathtub Curve for Failure Rate vs. Time

Tower failure tends to occur in the early-life stage, also called infant failure. This mostly relates to faulty construction, material defects, and defective design. During normal operation, the failure rate keeps fairly steady and the structure exhibits the lowest hazard in its lifespan. Common causes of failure during this period relate to defective operation, improper maintenance, and early material deterioration. The failure rate increases again near the end stage of the life span mainly due to wear-out of parts after considerable operational time, consequences of inadequate maintenance, or fatigue effects (Hau, 2013). The timing of structural failure has also been examined by Stenberg (2010) to find that the number of failures in Finland raises after 15 years of operation. This observation was reinforced by (Carlstedt, 2004) who reported that annual failure rates in Sweden increase after the 14th operation year. Overall, failure rates at any stage of the Bathtub curve seem to correspond to two major reasons:

The recorded collapse cases have often derived from human errors such as poor quality control, faulty construction, erroneous operation, and improper maintenance during the normal operation and wear-out stages represented in Fig. 2. This is therefore an area of improvement which well-managed operation and maintenance could raise power generation over sustained periods of 20 years or more (Kovács et al., 2011, Ding and Tian, 2012, Walford, 2006).

Quality control weakens for example when unqualified components are installed onto the wind turbine. This practice usually leads to infant failure as per Fig. 2. Chou and Tu (2011) conducted an investigation on the tower collapse that occurred when Typhoon Jangmi hit Southeast China in 2008. Then, a 62 m high wind turbine tower located in Taichung Harbor collapsed. A post-failure analysis revealed that at 17.3 m above the ground, where the joint between the lower and middle shell segments lied, the 30 mm-diameter connecting bolts were fractured. Due to this, the middle and upper section snapped down to the ground. Investigators collected samples of both the broken and other intact bolts found on site and tested the mechanical properties. The report revealed that both failed and intact bolts did not meet the requirements of the relevant design standard JIS-B1051 (JIS, 2000). According to this, all broken bolts did not have the required yield and ultimate strength while only half of the intact bolts have properties close to the strength baseline. In this event, the wind speed recorded fell within limits where structural survival is expected. The forensic study also revealed that the inaccurate installation of bolts generated locked-in effects involving stress concentration and creep, which undermined the effective bolt strength.
