# Precracked Reinforced Concrete T-Beams Repaired in Shear with Bonded Carbon Fiber-Reinforced Polymer Sheets

Dirar, Samir; Lees, J; Morley, C

Dirar, S, Lees, J & Morley, C 2012, 'Precracked Reinforced Concrete T-Beams Repaired in Shear with Bonded Carbon Fiber-Reinforced Polymer Sheets', *ACI Structural Journal*, vol. 109, no. 2, 109-S20, pp. 215-224.

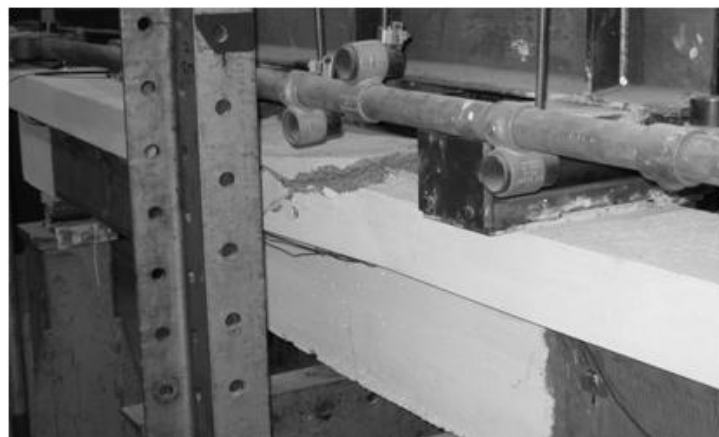
**Fig. 8–Flexural failure of F/295/LP1/3.3.**

Specimen F/295/LP1/3.3 failed in flexure due to the crushing of the concrete in the compression zone at the middle of the beam as shown in **Fig. 8**. This result is important as it shows that the externally bonded CFRP sheets can change the mode of failure from a brittle shear failure to a ductile flexural failure. The CFRP composites in the two shear spans of F/295/LP1/3.3 were still intact and bonded to the beam web at failure.

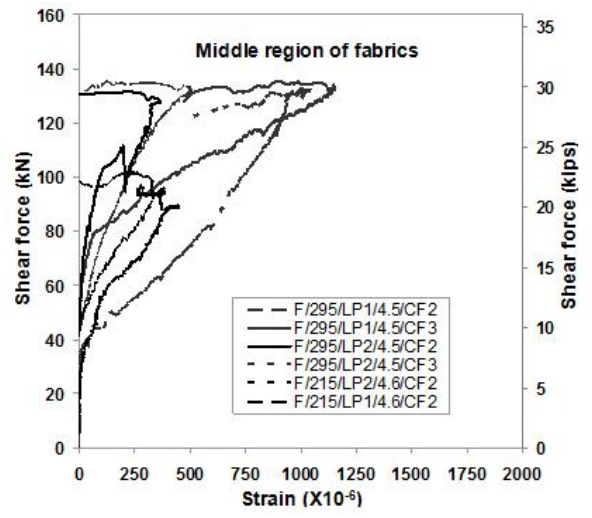
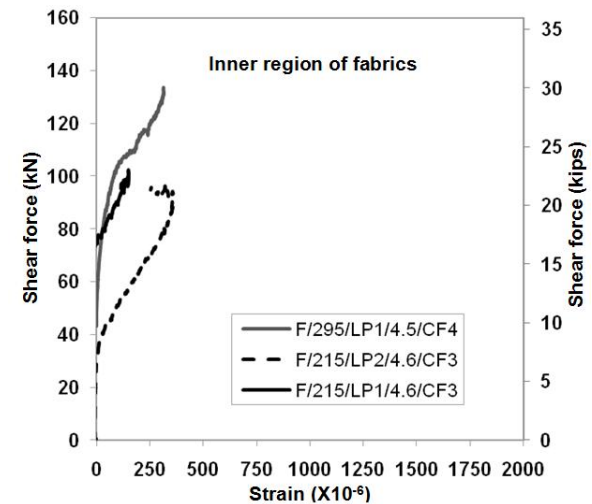
Fig. 9–Shear force versus strain in the internal and external shear reinforcement.

The outer and middle shear links in the unstrengthened beams started to function only after a shear force of between 30 kN (6.74 kips) and 45 kN (10.12 kips) (see **Fig. 9**). Thereafter, the

strain in the stirrups increased significantly with increasing load. Most of the shear links in this group attained their yield strain after a shear force of approximately 90 kN (20.23 kips). This was expected since these links were crossed by the major shear cracks. The outer and middle shear links in the strengthened beams experienced five phases during loading. In the initial phase, which is bounded on the upper end by a shear force between 35 kN (7.87 kips) and 45 kN (10.12 kips), the contribution of the shear links to the resistance was negligible. In the second phase, which included loading to 70% of the unstrengthened shear capacity, the shear links started to develop strain due to the initiation and propagation of inclined cracks. In the third phase, unloading to 40% of the unstrengthened shear capacity reduced the strain in the outer and middle shear links. The fourth phase is marked by the addition of the CFRP sheets and the stiffer response shown by the transverse steel reinforcement on further reloading. The transverse steel strain showed limited increases with increasing load until, in the final stage, yielding was achieved in most cases. The transverse steel reinforcement that yielded is easily identified by the plateaus featured in **Fig. 9**. **Fig. 9** also shows that the inner links carried the least amount of strain in all test specimens. The strains in this group of transverse reinforcement developed at a relatively low rate even after the formation of shear cracks. This is mainly because the beam region close to the load pad, where the inner links were located, did not experience significant inclined cracking.

The shear force-strain curves for the externally bonded CFRP sheets in the shear spans where failure occurred are shown in **Fig. 9**. The positions of the strain gauges are given in **Fig. 3**. The fabrics are categorized into “outer fabrics” (CF1), “middle fabrics” (CF2 and CF3 in the 350 mm [13.78 in.] deep specimens, and CF2 in the 270 mm [10.63 in.] deep specimens) and “inner fabrics” (CF4 in the 350 mm [13.78 in.] deep specimens and CF3 in the 270 mm [10.63 in.] deep specimens). Some strain gauges failed during testing and their results were discarded due to the erroneous data they provided.

The curves feature two phases. In the first phase, the fabrics started to resist the further opening of existing shear cracks at the inception of the final reloading stage. They continued to develop tensile strain with increased load up to approximately the peak loads. In the second stage, the fabrics started to debond and finally peeled off. Debonding is indicated by the reversing of the shear force-strain curves.

In a given beam, the middle fabrics – represented by CF3 in the 350 mm (13.78 in.) deep specimens and CF2 in the 270 mm (10.63 in.) deep specimens – developed the highest strain.

The TR 55<sup>5</sup> predictions overestimated the contributions of the externally bonded CFRP sheets to the shear force capacity with a mean predicted to experimental ratio of 1.64 and a standard deviation of 0.62. The inaccuracy of the TR 55<sup>5</sup> predictions stems from the inaccuracy of its effective strain model. TR55<sup>5</sup> predicts that the effective strain in the CFRP sheets of F/295/LP1/4.5, F/295/LP2/4.5 and F/215/LP1/4.5 is approximately 2560 micro-strain, 2650 micro-strain and 2810 micro-strain respectively. The experimentally measured CFRP strain for these beams varied between 125 micro-strain and 1200 micro-strain (see **Fig. 9**).
