# A very rare vascular complication of the Edwards expandable eSheath during transcatheter aortic valve replacement

avulsion, self-expanding sheaths, transcatheter aortic valve implantation, vascular complication

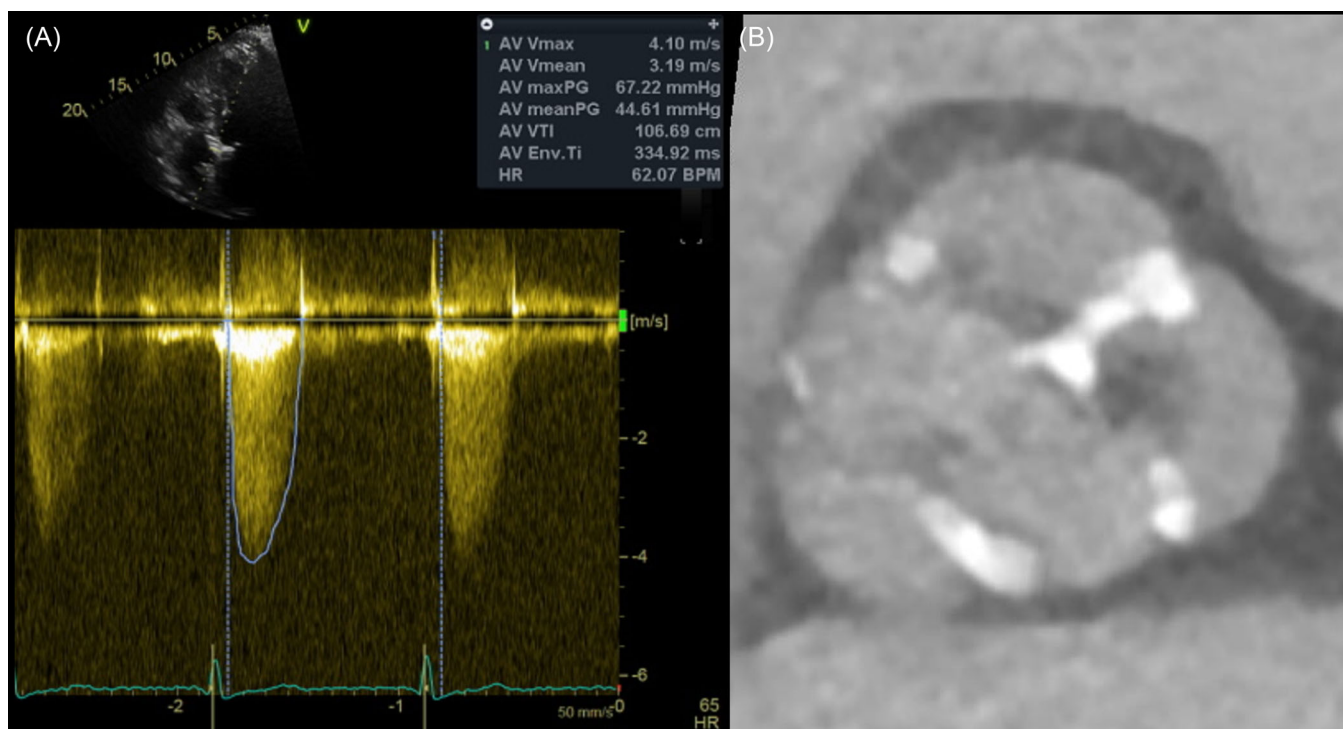
**FIGURE 1** (A) Continuous Doppler across the aortic valve. (B) Computed tomography short axis at the level of the aortic valve showing a severely calcified bicuspid aortic valve with a fusion of left and right leaflets. AV, aortic valve; HR, heart rate; VTI, velocity time integral. [Color figure can be viewed at [wileyonlinelibrary.com](http://wileyonlinelibrary.com)]

The patient was discussed by the Heart Team and deemed high risk for surgical intervention but appropriate for TAVR. An electrocardiography-gated TAVR protocol computed tomography (CT) angiogram for preprocedural planning was undertaken. The aortic valve was bicuspid (Sievers type 1) with severe calcification and a calcified raphe between the right and left cusps (Figure 1B). The annular area was measured at 709 mm<sup>2</sup> and there was no calcification in the annulus or the left ventricular outflow tract. The

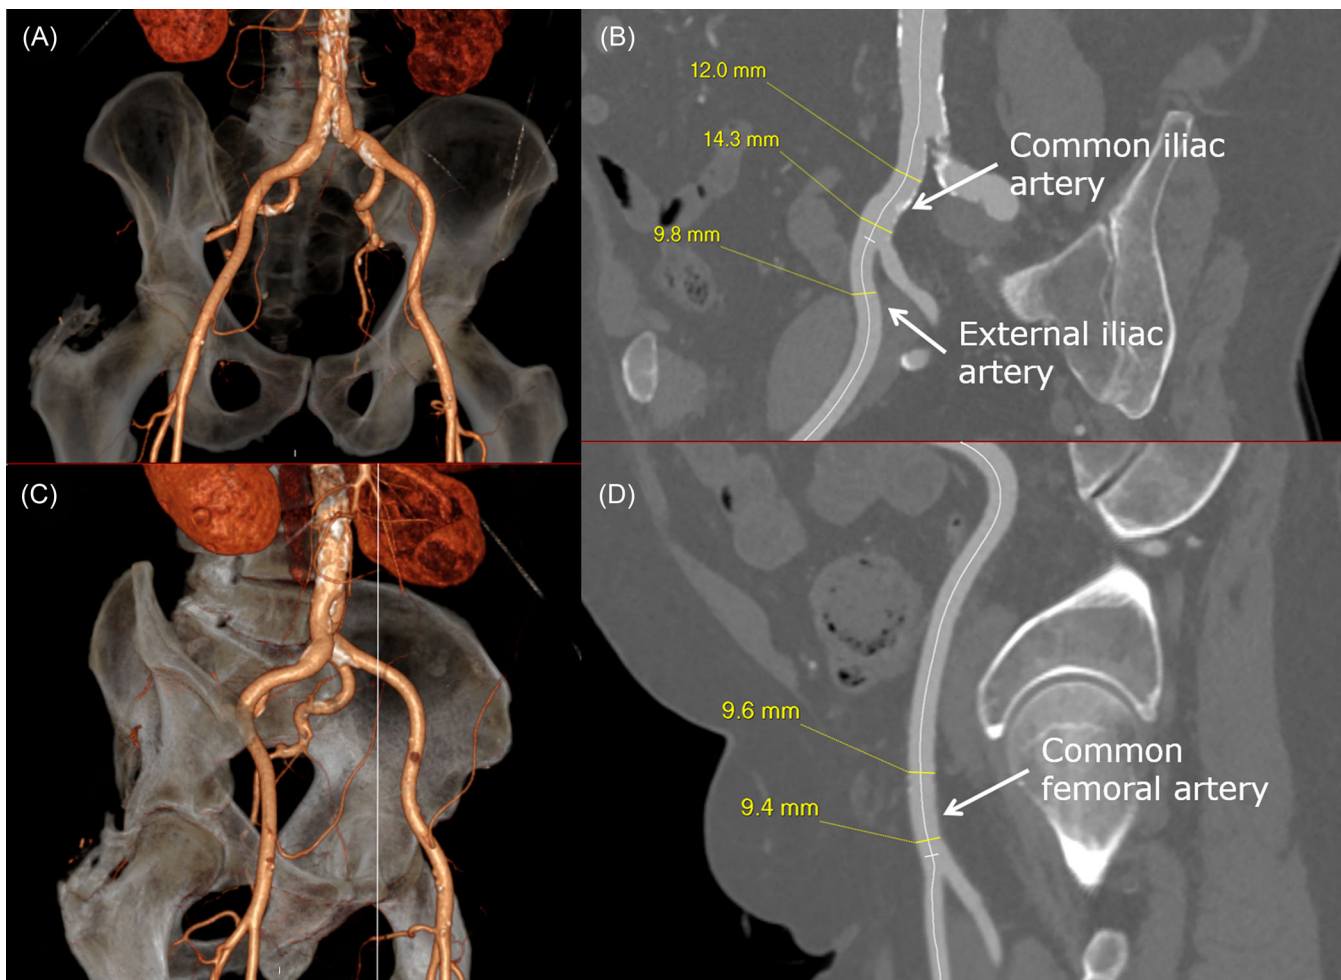
**FIGURE 2** (A) Anteroposterior projection at the level of the iliofemoral arteries showing minimal calcification and tortuosity. (B) Longitudinal reconstruction at the level of the bifurcation of the right common iliac and external iliac artery showing minimal calcification and diameter  $>9$  mm throughout. (C) Right anterior oblique  $30^\circ$  projection at the level of the iliofemoral arteries showing minimal calcification and tortuosity. (D) Longitudinal reconstruction at the level of the bifurcation of the right common femoral artery showing minimal calcification and a diameter of  $>9$  mm throughout. [Color figure can be viewed at [wileyonlinelibrary.com](http://wileyonlinelibrary.com)]

The right common femoral, external iliac, and common iliac arteries had no significant tortuosity or atherosclerotic disease and were free of calcification with a minimum diameter of 9.4 mm (Figure 2A–D). Based on these measurements, TAVR with a 29-mm Sapien 3 THV (Edwards Lifesciences) via percutaneous right femoral access was planned.

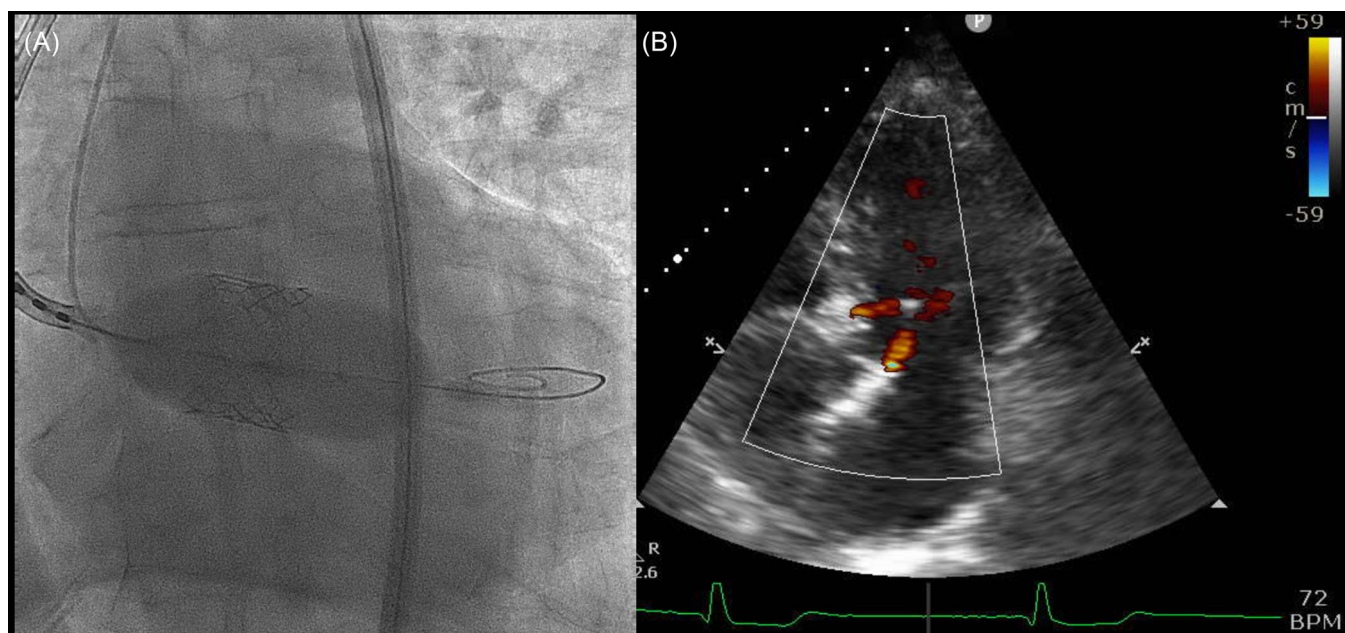
**FIGURE 3** (A) Deployment of a 29-mm Sapien 3 transcatheter heart valve. (B) Postdeployment echocardiogram showing mild paravalvular leak. [Color figure can be viewed at [wileyonlinelibrary.com](http://wileyonlinelibrary.com)]

The patient was admitted electively and the procedure was performed under conscious sedation in a catheter laboratory with transthoracic echocardiographic monitoring. A 16-Fr eSheath was inserted in the right common femoral artery using ultrasound guidance and micropuncture technique. Two suture-mediated closure devices (Proglides; Abbott Vascular) were deployed in a standard preclose fashion. The aortic valve was crossed and an Amplatz Extra Stiff guidewire (Cook Medical) was positioned in the left ventricle. In light of severe aortic valve calcification and horizontal angulation of the ascending aorta predilatation with a 25-mm balloon was undertaken before THV placement. In view of the large size of the annulus, the 29-mm S3 THV deployment balloon was overfilled by 4 cc.<sup>5</sup> The THV was inserted into the 16F eSheath, using the loader, and advanced into the descending aorta without difficulty. Here, the THV was loaded onto the deployment balloon and advanced into the native aortic valve. The THV was deployed with rapid ventricular pacing via the left ventricular guidewire (Figure 3A).<sup>6</sup> Postdeployment transthoracic echocardiogram showed minor paravalvular regurgitation and no pericardial effusion (Figure 3B).

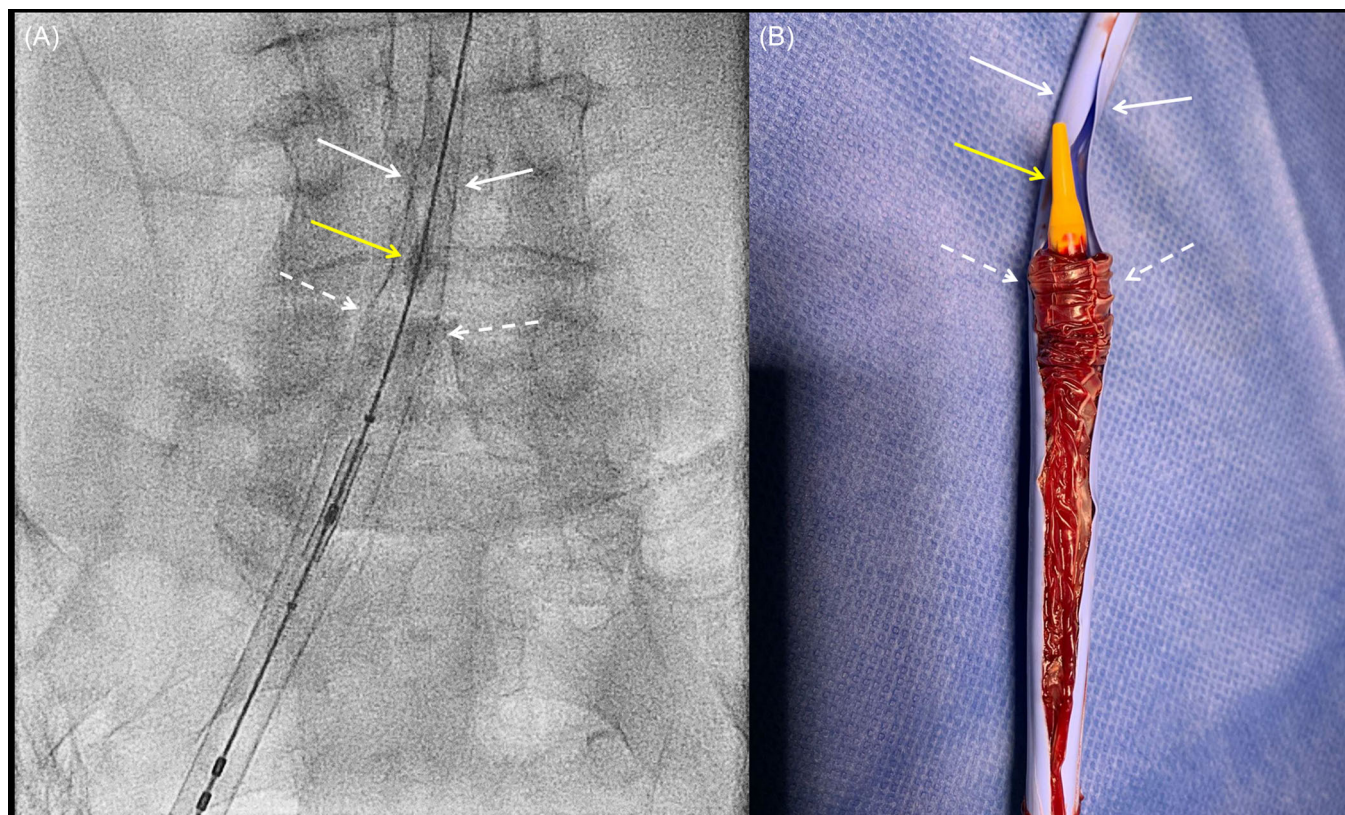
Fluoroscopy revealed a modestly increased profile of the section of the eSheath containing the deployment balloon (Figure 4A). It was not noticed at this time but a later review of the fluoroscopic image also showed a smaller-than-normal profile of the eSheath distal to the catheter nosecone (Figure 4A).

On seeing the widened profile of the delivery balloon in the eSheath, the Commander catheter was readvanced until the tip of the nosecone emerged from the tip of the eSheath. Negative suction to ensure full deflation was reapplied with the 50 cc luer lock syringe. On this occasion, there was some aspiration of blood-stained fluid, suggesting loss of integrity of the hypotube.

**FIGURE 4** (A) Anteroposterior fluoroscopic image showing the deformed eSheath with deflated THV balloon retracted into the eSheath. Continuous white arrows point to the relatively collapsed distal segment of the eSheath due to the stripping of the inner lining. Yellow arrow points to the nosecone. White dashed arrows point to the swelling of the eSheath due to the concertinaed inner lining. (B) Ex vivo findings of the same eSheath. Continuous white arrows point to the collapsed distal segment of the eSheath stripped of the inner lining. Yellow arrow points to the nosecone. White dashed arrows point to the swelling of the eSheath caused by the retracted, concertinaed inner lining. [Color figure can be viewed at [wileyonlinelibrary.com](http://wileyonlinelibrary.com)]

We hypothesize that this unusual complication was related to an interaction between the stiff, deflated deployment balloon of the Commander catheter, and the tip of the eSheath, which resulted in the separation of the lining from the outer wall. The free edge of the separated inner lining was then dragged down with the balloon increasing its profile and resulting in its exposure to the vessel wall through the open seam of the eSheath. The rigid concertinaed lining around the balloon then came into direct contact with the vessel wall through the open seam in the outer coat, causing abrasion and eventual avulsion of the vessel. The balloon did not rupture and the damage to the balloon hypotube occurred secondary to retrieval efforts.

This is the first instance of femoral artery avulsion at our institution in over 1500 procedures and occurred in the hands of a highly experienced operator. The injury was surprising as the vessels were large caliber, free of disease, and in the absence of excessive force. We believe that knowledge of this rare complication may lead to actions that may mitigate or even prevent vascular injury. We propose that if resistance is encountered on withdrawing the Commander balloon into the E sheath tip and an appearance of the eSheath similar to that observed in this case (Figure 4A) is witnessed, then stripping of the lining may have occurred. In this circumstance, we would recommend *advancing* the balloon until the nose cone just

exits the eSheath. This maneuver should straighten the concertinaed lining. The eSheath and Commander should then be removed en bloc while maintaining the guide wire position with no further attempts to retrieve the Commander catheter through the eSheath. A fresh eSheath may then be inserted and an inspection made for vascular injury. We believe these actions may avoid the injury caused by the concertinaed lining.

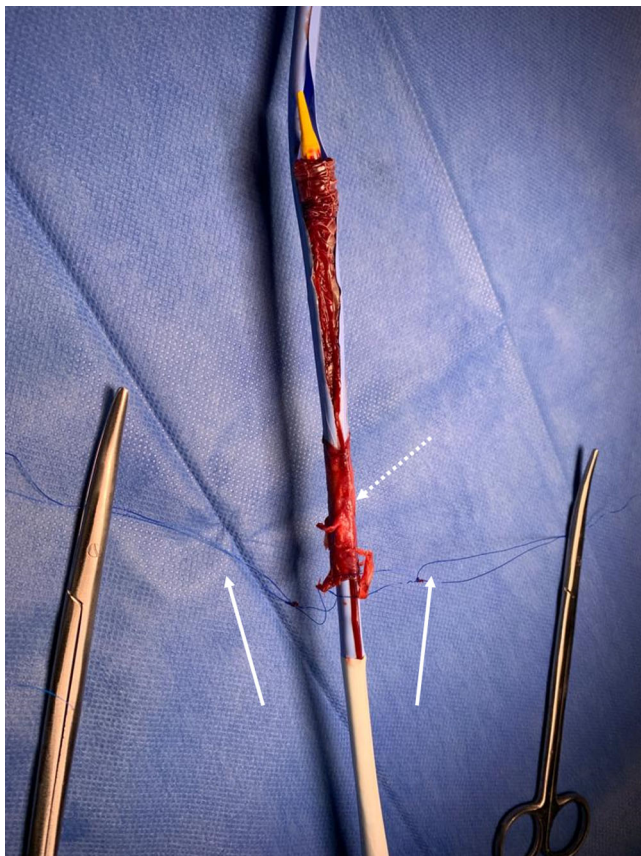
At surgery, avulsion of the right external iliac and common femoral arteries was confirmed but with no further identification of damage proximally. Following cross-clamp of the proximal common

**FIGURE 5** Segment of avulsed iliofemoral artery wrapped around the eSheath (white dashed arrow). White continuous arrows point to the Proglides sutures still attached to the arterial access point. These were removed intact with the avulsed vessel and eSheath. [Color figure can be viewed at [wileyonlinelibrary.com](https://onlinelibrary.wiley.com/doi/10.1111/j.1522-2675.2023.01002.x)]

Upon ex vivo inspection of the retrieved eSheath, it was apparent that it had lost its integrity with the separation of the inner lining from the outer plastic component. We hypothesize that retrieving the THV deployment balloon through the eSheath resulted in the stripping of the inner lining of the eSheath, resulting in a concertina effect and formation of a large diameter noncompressible swelling around the balloon (Figure 4B). This swelling led to the splitting of the eSheath seam bringing the concertinaed inner lining into direct contact with the vessel wall, causing abrasion and avulsion of the vessel. The ex vivo observations were consistent with the fluoroscopic findings. Although the diameter of the iliofemoral vessels was well above the minimum recommended diameter by the valve manufacturer (6 mm), the increased diameter of the clustered inner lining likely exceeded the inner diameter of the vessel, resulting in vessel avulsion and consequent hemorrhage.

iliac artery a Dacron graft was placed connecting healthy parts of the external iliac artery proximally and common femoral artery distally. Good distal perfusion in the right leg was confirmed at the conclusion of the procedure.

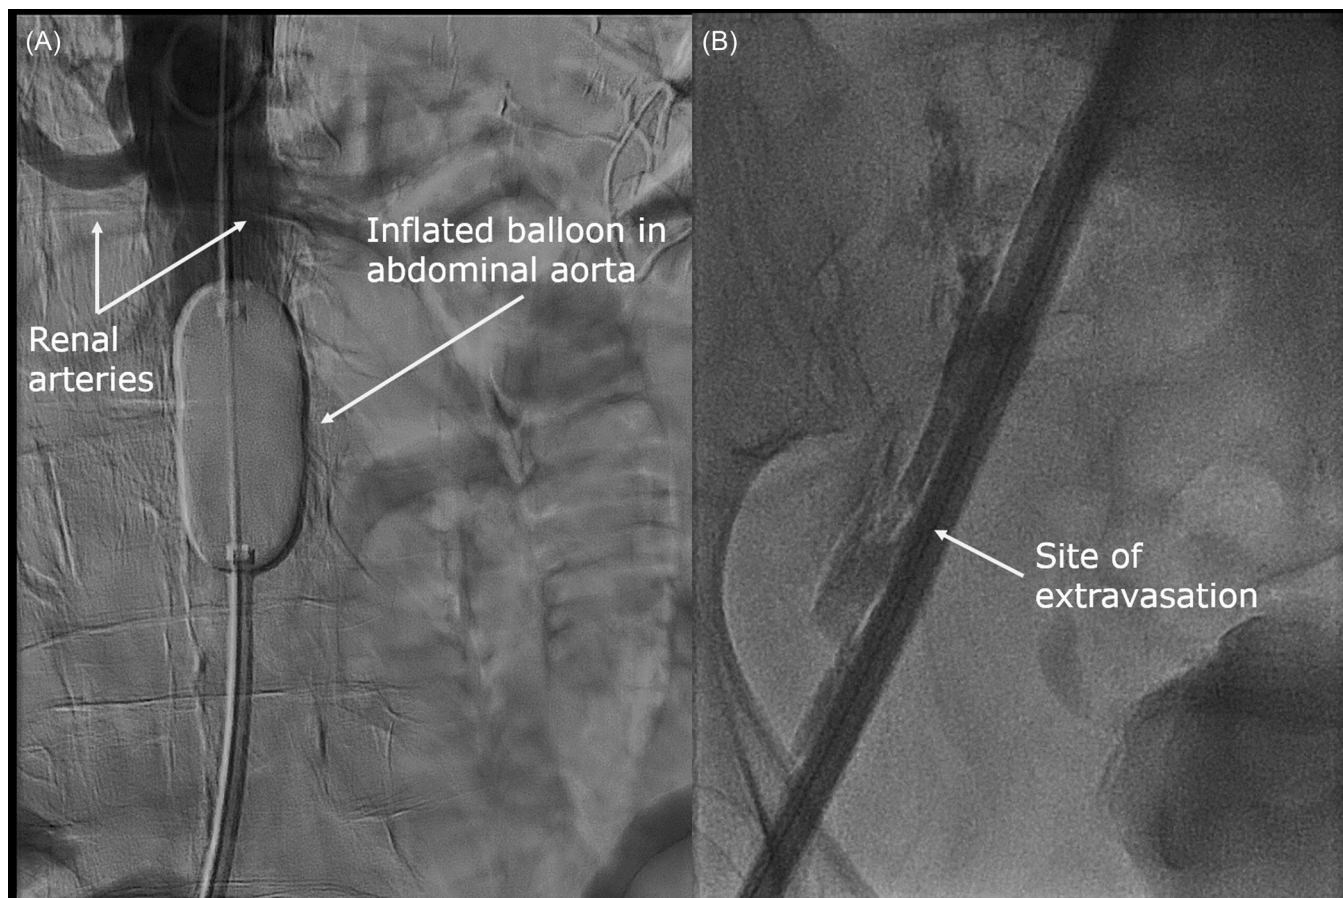
We anticipated that there may have been damage to the iliofemoral vasculature, potentially with extravasation, and simultaneously readied a 32-mm Coda balloon (Cook Medical) for inflation in the abdominal aorta. The volume to inflate the Coda balloon was

determined from the infrarenal diameter of the abdominal aorta from the preprocedure planning CT and the size chart of the Coda balloon. Upon en block retrieval of the Commander catheter and the eSheath from the right femoral artery, some modest, but not excessive, resistance was encountered. Upon removal, it became evident that a segment of the external iliac and common femoral artery had been avulsed with the eSheath (Figure 5). There was a precipitous drop in blood pressure due to presumed blood loss from the external iliac artery. Immediately, the new 16F eSheath was advanced over the guidewire, which was still in place, followed by the Coda balloon, which was advanced and inflated in the abdominal aorta. Hemostasis was confirmed with the Coda balloon positioned below the renal arteries (Figure 6A and Supporting Information: Video 1). An angiogram through the eSheath showed escape of contrast through the external iliac vessel (Figure 6B and Supporting Information: Video 2). Blood pressure recovered quickly with fluid resuscitation. The on-call vascular team was called and an on-table emergency pelvic exploration was undertaken under general anesthesia.

**FIGURE 6** (A) Digital subtraction angiography. Inflated Coda balloon in the abdominal aorta. Renal arteries opacified with contrast above the Coda balloon. No contrast opacification past the Coda balloon confirming hemostasis. (B) Site of extravasation from external iliac artery.

The Coda balloon is a dedicated compliant over-the-wire balloon for large vessel temporary occlusion. It comes in two sizes, 9 Fr, which dilates up to 32 mm, and 14 Fr, which dilates up to 46 mm. The final diameter of the balloon is dictated by the inflation volume as per the manufacturer's volume/balloon diameter nomogram. The 9-Fr balloon is compatible with a minimum 12-Fr sheath. Alternative large-vessel occlusive balloons are available in the market including but not limited to the REBOA balloon (BVM Medical), Standard Occlusion Balloon Catheter (Boston Scientific), and QXMedical Occlusion Balloon Catheter (QXMedical).

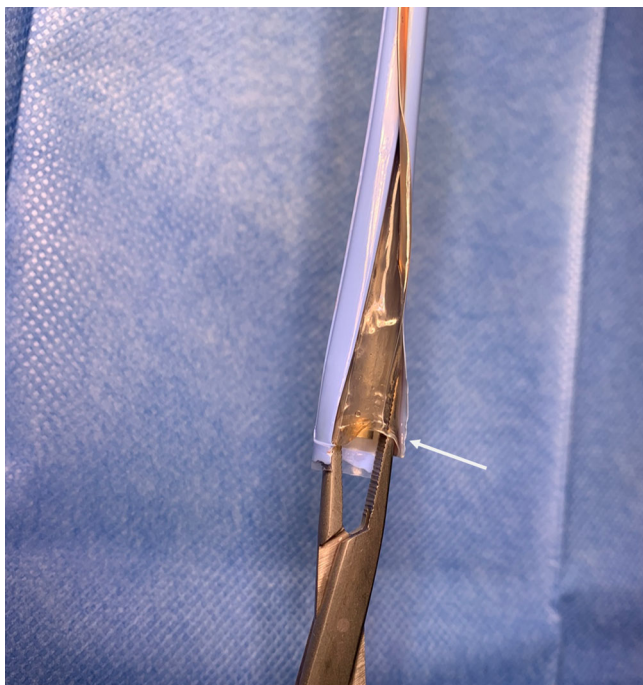
In a bench model with a used 14F eSheath from an uncomplicated case with a 23-mm Sapien 3 Ultra, we observed a small gap between the inner lining and the outer coat (Figure 7). The inner lining can be stripped from the more rigid outer coat with relative ease (Supporting Information: Video 3).

**FIGURE 7** Used 14F eSheath after an uncomplicated case with a 23-mm Sapien 3 Ultra. A gap is evident between the inner and outer coats (arrow). [Color figure can be viewed at [wileyonlinelibrary.com](http://wileyonlinelibrary.com)]

The inner lining of the eSheath is made of polytetrafluoroethylene, otherwise known by its trade name Teflon<sup>®</sup>. This polymer provides the elongation/expansion and lubricity properties to the eSheath. The inner lining is attached to the outer plastic cover, which is made of high-density polyethylene and polyurethane, which provide tensile strength and low friction properties.
