A Future for Vacuum Arc Remelting and Electroslag Remelting—A Critical Perspective

John Campbell

School of Metallurgy and Materials, Faculty of Engineering, University of Birmingham, Birmingham B15 2TT, UK; jc@campbelltech.co.uk

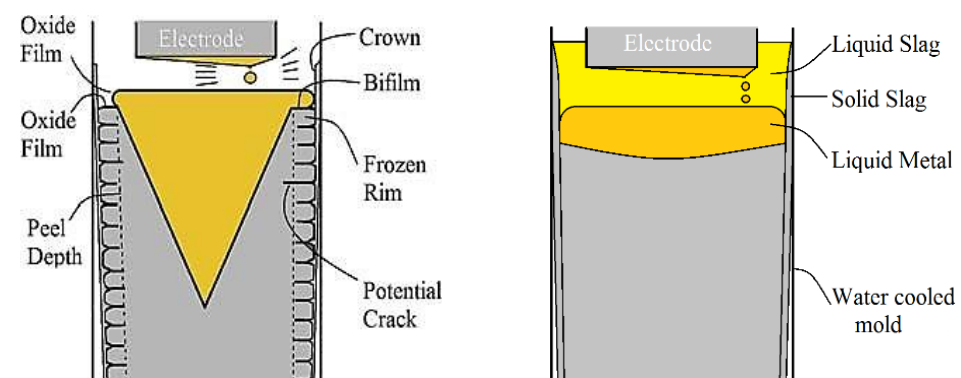
Both vacuum arc remelting (VAR) and electroslag remelting (ESR) processes (Figure 1) produce ingots of steel and Ni alloys which are regarded as ultimate achievers of clean metals. Both processes are in principle impressively simple, in which an electrode carries electrical current which can melt the tip of the electrode, gradually building up an ingot drop by drop. In VAR the heat is generated by an arc, whereas in ESR a layer of an oxide slag melts the tip by the resistive heating of the slag.

Figure 1. VAR and ESR processes.

VAR is a commendably simple process, as outlined in Figure 1, in which the electrical current flows down the electrode, arcs across to the top of the ingot, generating sufficient heat to melt the tip of the electrode. Droplets of liquid metal fall through the arc gap, gradually building up the ingot contained in the water-cooled mold. This clean, electrical processing of the liquid metal as droplets through a vacuum has been regarded as an iconic process, delivering a large ingot with low volatiles, especially hydrogen, but also low values of other undesirable residuals such as lead (Pb). With such a simple, elegant process, what could go wrong?

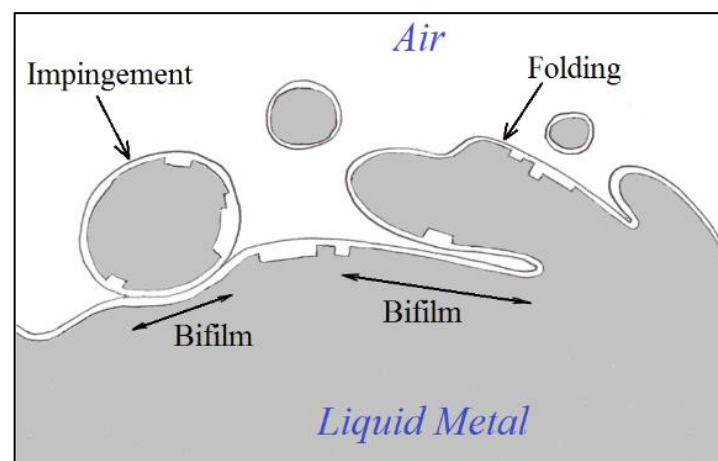
A breaking wave of water is an action in which the body of water turns to impinge on itself, with the two water surfaces coming together to assimilate seamlessly. This action is so obvious we do not trouble ourselves to think about it. However, in the case of liquid metals, the impact of two bodies of liquid is not a trivial or obvious event. In nearly all cases with our liquid metals and alloys (with some interesting exceptions which we have no time for here), the liquid has an oxide film on its surface, usually even under conditions of a normal industrial vacuum. Microscopically, the oxide film has a dry, rough, upper surface, which is the surface involved in the fold-over or impact collision, with the result that the two opposed surfaces, having impinged, do not wet, but remain unbonded, as a crack (Figure 2). The crack is submerged and suspended in the bulk of the liquid metal, where it can be frozen in place to become a crack in the solidified casting. Under very turbulent conditions, the cast metal can be filled with a dense snowstorm of cracks. They are found to vary in size from micrometers in diameter to the size of newspapers (such large sizes are not unusual; they are to be seen in tonnage nickel and steel castings), and thicknesses usually from nanometers to micrometers. Such thin cracks are a challenge to detect by NDT (non-destructive testing), but they can usually be detected on a fracture surface, and identified as bifilms by their wrinkles and folds characteristic of thin films originating on a mobile liquid surface [1].

Figure 2. The creation of bifilms by entrainment mechanisms: folding and impingement [1].

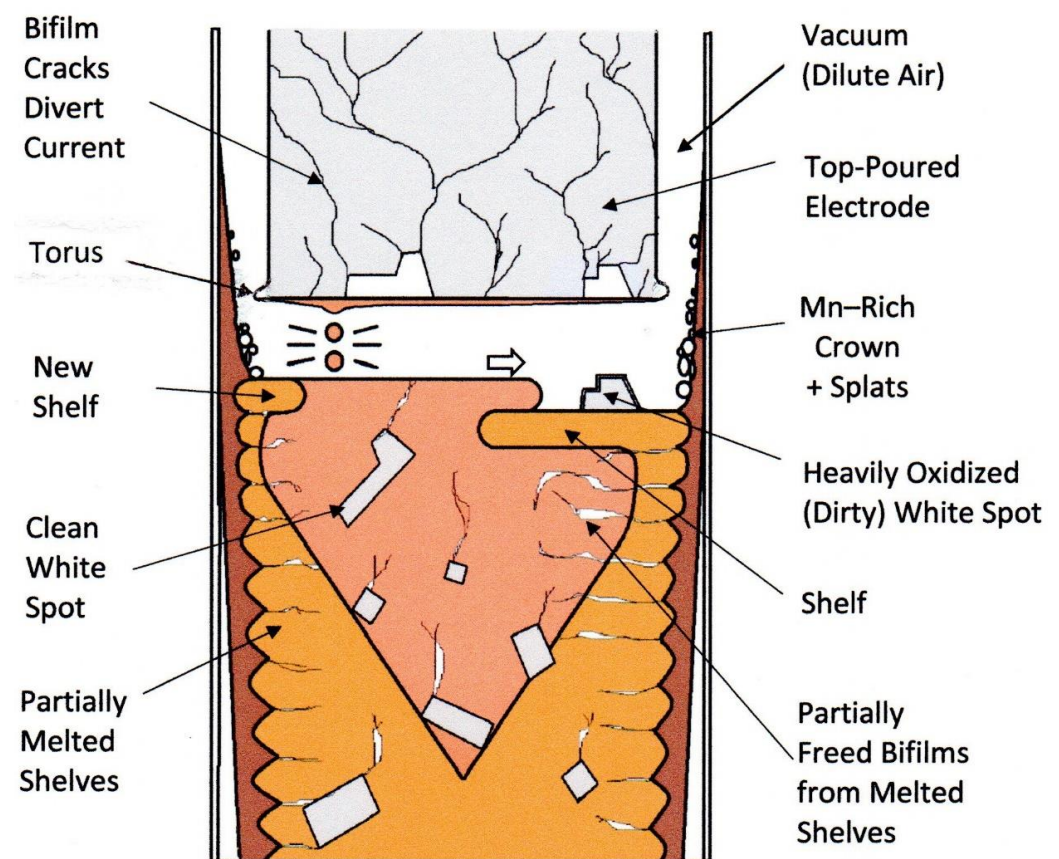
The problems start in the electrode (Figure 3). The high electrical current for melting is at a rather low voltage, and so in general the current is not able to cross the bifilm cracks—the cracks consisting of two insulating oxide ceramics separated by an ‘air gap’. The ‘air gap’ being the colloquialism for the region where the two films do not touch face-to-face, but contain random regions of entrained environment, which could be air or vacuum, plus additional gases such as hydrogen which tend to diffuse in to this crack-like void, and argon which may be a remnant of the vacuum flushing gas, or the remnant 1 per cent of argon from the entrapped air after oxygen and nitrogen have reacted to thicken the bifilms with additional layers of oxide and nitride [1].

Figure 3. VAR process showing defect production.

During normal melting, when the arc is tolerably axial, the crown builds up on the water-cooled wall of the mold as a region of splatter and condensed vapors, mainly Mn vapor, making the crown rich in Mn (Figure 3). During normal operation, the rising melt submerges the crown, which then becomes the metallic skin of the casting, effectively coating the pancake stack structure of the ingot, hiding its intervening cracks under a smooth surface layer of Mn-rich metal.

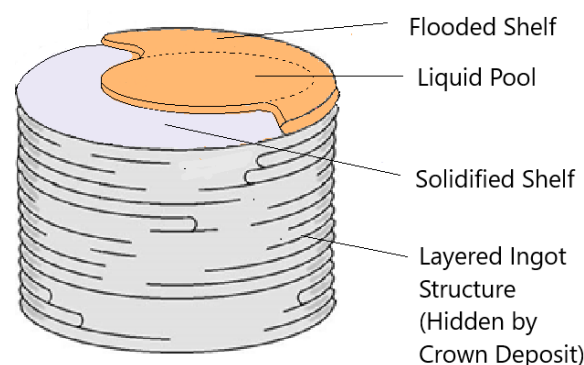
The liquid pool is generally assumed to be in the top center of the ingot. To the writer’s knowledge, all computer simulation studies have made this assumption. However, of course, the liquid metal pool will tend to follow the movement of the arc off center, particularly if the arc remains off center for a lengthy period (Figure 4). The far side of the ingot, solidifying against the water-cooled mold, now grows inwards, extending as a ‘shelf’. Such shelf formation has been observed directly by Zanner [6] in an experimental VAR unit specially modified with a side window.

Figure 4. The build-up of a VAR ingot in layers, separated by deeply penetrating circumferential bifilm cracks.

The problem introduced by the growth of the shelf is that the surface of the shelf is now exposed to the oxidizing environment of the 'vacuum', and now has time to grow a thick oxide.

The upward advance of the liquid metal in the pool is now modified. The pool surface, particularly at its cooler outer edges, will have a thin oxide film, so that the combined action of surface tension and the surface film will hold the liquid metal together, preventing its spread over the shelf. However, as the liquid in the pool rises sufficiently high (about 8 mm, the height of a sessile drop of liquid steel) to overflow the shelf, it rolls over the oxide already formed on the shelf, rolling out and laying down its own oxide as a track-laying vehicle lays down its tracks as it progresses. The mechanism is well-known as a producer of major horizontal cracks in castings [1]. The result, therefore, is the creation of an extended area of thin dry oxide laid down face-to-face over an extended area of thick dry oxide, constituting an extensive bifilm crack which can occupy significant areas of the ingot. Its thin/thick film asymmetry is a common bifilm morphology. The horizontal cracks developed by the submerging of the shelves are likely to be serious defects. It is expected that they could extend over significant areas of the ingot.
