## Biocompatibility and Surface Integrity of Zirconia Ceramics Treated by Laser-plasma Driven Shock-waves

*Recent Progress in Materials*  
2022, volume 4, issue 4  
doi:10.21926/rpm.2204025

### Abstract

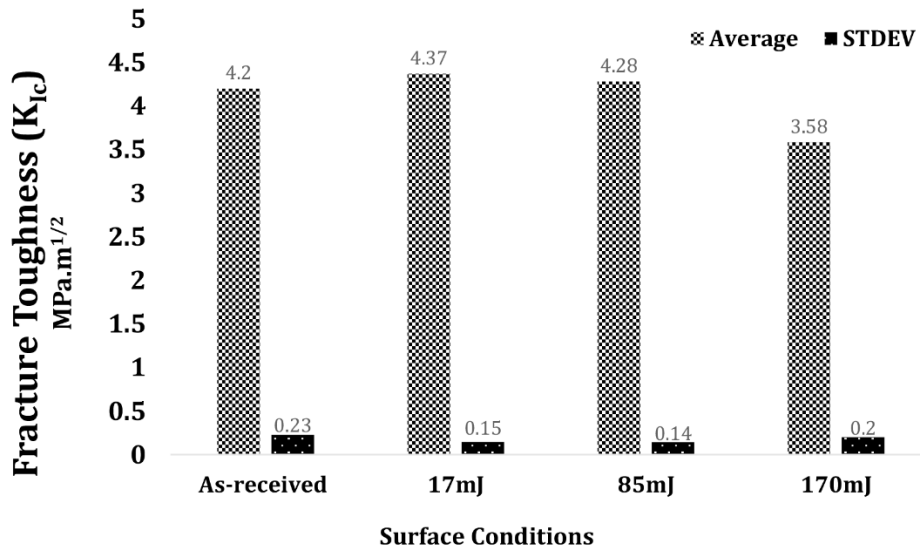
**Figure 9** Surface fracture toughness of the as-received, untreated and laser shock treated ZrO<sub>2</sub> ceramics for various laser energies, calculated from the Anstis, Chantikul, Lawn & Marshall Equation shown in section 2.5.

The calculated surface fracture toughness of the different samples is depicted in Figure 9. Fracture toughness values obtained via the hardness testing technique are influenced by harness testing generated crack lengths shown in the previous section. The as-received sample's fracture toughness is calculated as 4.20 MPa.m<sup>1/2</sup>. When the laser energy is 17 mJ (and when the crack length - induced from the hardness testing indentation has decreased) the calculated fracture toughness increases to 4.37 MPa.m<sup>1/2</sup>. This represents an increase of 4% of the fracture toughness compared to the as-received sample. When the laser energy is 85 mJ, the fracture toughness calculated is 4.28 MPa.m<sup>1/2</sup> as expected, it is lower than in the 17 mJ sample, but higher than the as-received one as the average crack length is in between that from the 17 mJ and as-received sample (see Figure 10). This represents an increase of 1.9% in fracture toughness compared to the as-received sample. For the 170 mJ laser shock treated sample the fracture toughness drops heavily down markedly to 3.58 MPa.m<sup>1/2</sup> which is a decrease of 14.7% in regard to the as-received sample. This occurred naturally due to the onset of larger surface cracks from the laser shock treated region of the 170 mJ laser energy shock treatment.

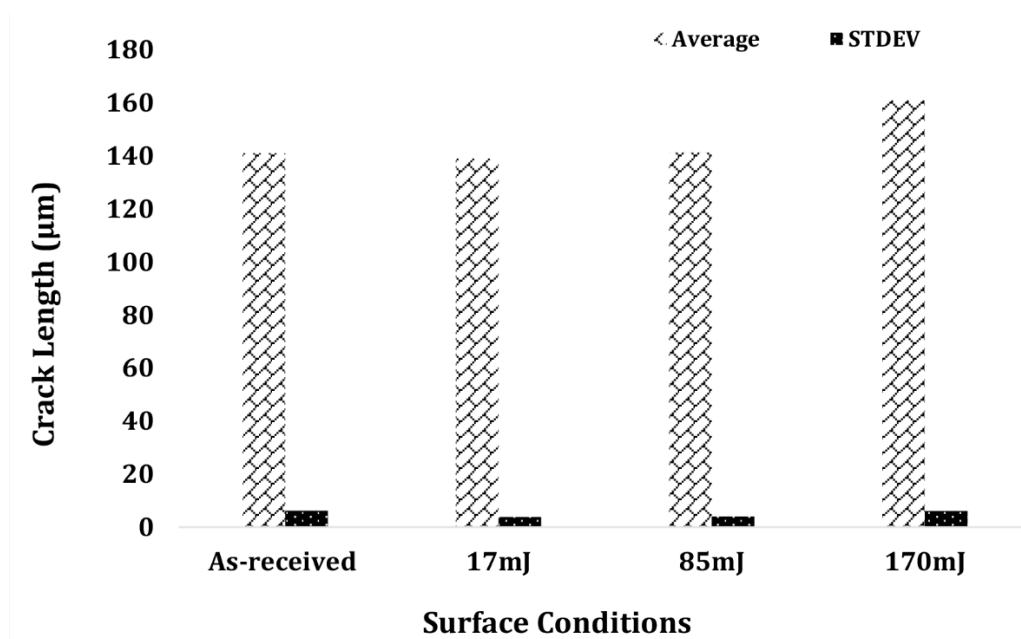
**Figure 10** Shows the crack lengths of laser shock strengthened ZrO<sub>2</sub> with 17 mJ, 85 mJ, and 170 mJ and the as-received surface.
