Inspection and structural health monitoring techniques for concentrated solar power plants

1 Inspection and structural health monitoring techniques for concentrated 2 solar power plants

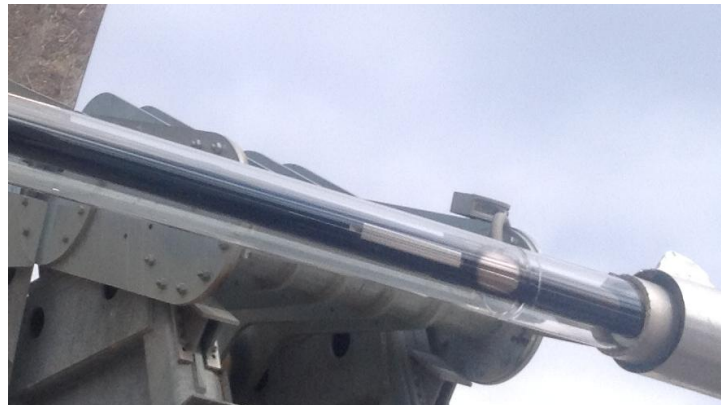
Figure 3: Typical solar absorber tube used in parabolic trough and LFR CSP plants.
[schematic taken from reference 7].

6 Solar absorber tubes operate under very harsh conditions. CSP plants make use of a wide
7 range of materials for the manufacture of key structural components including plain carbon
8 steels (cold storage tanks and secondary piping) and stainless steels (solar absorber tubes,
9 valves, primary coolant system piping, hot storage tanks and pumps). The schematic in figure
10 3 shows the main features of a typical solar absorber tube.
11

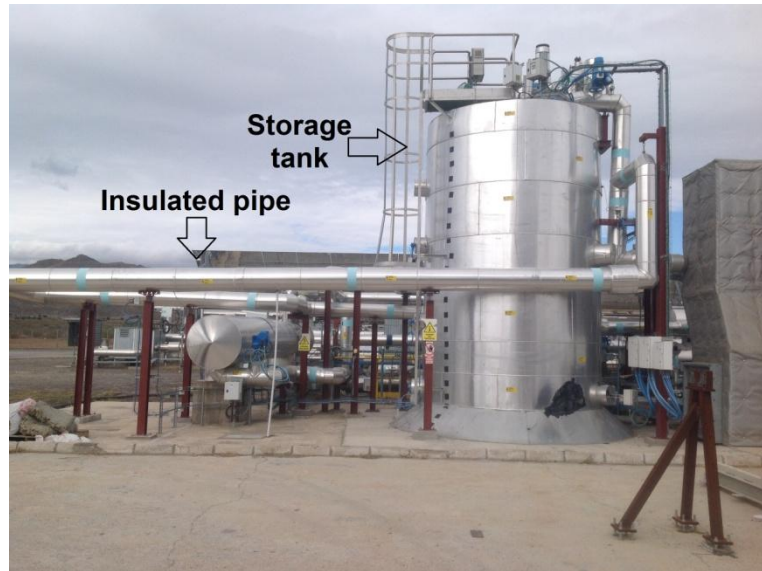
Figure 4: The photograph shows insulated pipelines and a molten salt storage tank at PSA, Tabernas Desert, Spain.

34
35
36 In CSP plants the coolant system piping is insulated to minimise heat losses during plant
37 operation as shown in Figure 4. Therefore inspection can only be carried out only after
38 removing the insulation which is a very time consuming and expensive process.
