Microstructural characterization and fatigue response of alloy Ti-46Al-5Nb-1W with varied surface quality and thermal exposure history

Z.W. Huang, J.P. Lin, B. Feng

The stress controlled fatigue behaviour of a coarse-grained fully lamellar TiAl alloy Ti-46Al-5Nb-1W has been investigated under no exposure, block exposure and individual exposure-oxidation conditions (exposure for 10000 h at 700°C) to assess the effects of surface roughness, stress concentration, oxidation and inner microstructural changes. The alloy is observed to be sensitive to surface damage, but less sensitive to V-notch even after exposure because the surface area sampling the highest stress significantly reduces the EDM impact and exposure effect. Unlike grain-refined alloys, both shot peening and electropolishing offered a moderate and roughly the same increase in fatigue limit, indicating that for a coarse-grain fully lamellar alloy the control factor for fatigue is lamellar colony size. Fatigue performances are improved for all surfaces when subjected to block exposure, attributed to a long-term annealing which outweighs the harmful effects from microstructural embrittlement. After individual exposure-oxid

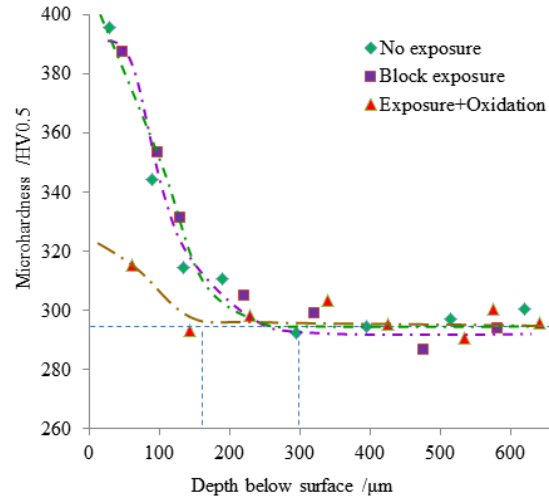
Fig. 5 Micro hardness profiles of shot peened specimens before and after thermal exposure.

increased by 36% (Fig. 5). It is noted that Group A and B show almost the same hardened layer because the only difference between them was the inner microstructural changes occurred in the latter.

For Group C samples, however, shot peening was conducted before individual exposure. As shown in Fig. 5, the individually exposed-oxidised samples demonstrate a significantly reduced near-surface hardening region. The enhanced hardness value by peening was decreased from 400 MPa before exposure to 325 MPa after it, only 10% higher than the bulk value. The thickness of the hardened region reduced to 150 μm , which is half the originally hardened depth, attributed to stress relaxation by exposure and oxidation. Thermal relaxation of surface hardening is a widely observed phenomenon. As reported previously, both the microhardness and compressive residual stress induced by shot peening can be reduced significantly after 50-h annealing at 650°C [13]. A stress relief mechanism was suggested, which may result from relatively easy annealing-out of unstable debris defects [13] and from defect rearrangement, which has been recognised by HRTEM (high-resolution transmission electron microscopy) observation [33]. Normal view of the electropolished surface before exposure is presented in Fig. 6a. Roughness of the electropolished surface was decreased significantly, $R_a=0.26 \mu\text{m}$, which is less than 1/5 of the shot-peened value. It is realised that all the procedures used (mechanical grinding, polishing and final electropolishing) are capable of removing a $\sim 150\text{-}200 \mu\text{m}$ thick surface layer, which can get rid of the whole EDM-damaged surface layer. The surface defects were therefore eliminated sufficiently. Observation from a cross sectional view in Fig. 6b reveals that such a surface finish on the maximum-stress side is smooth and nearly defect-free.

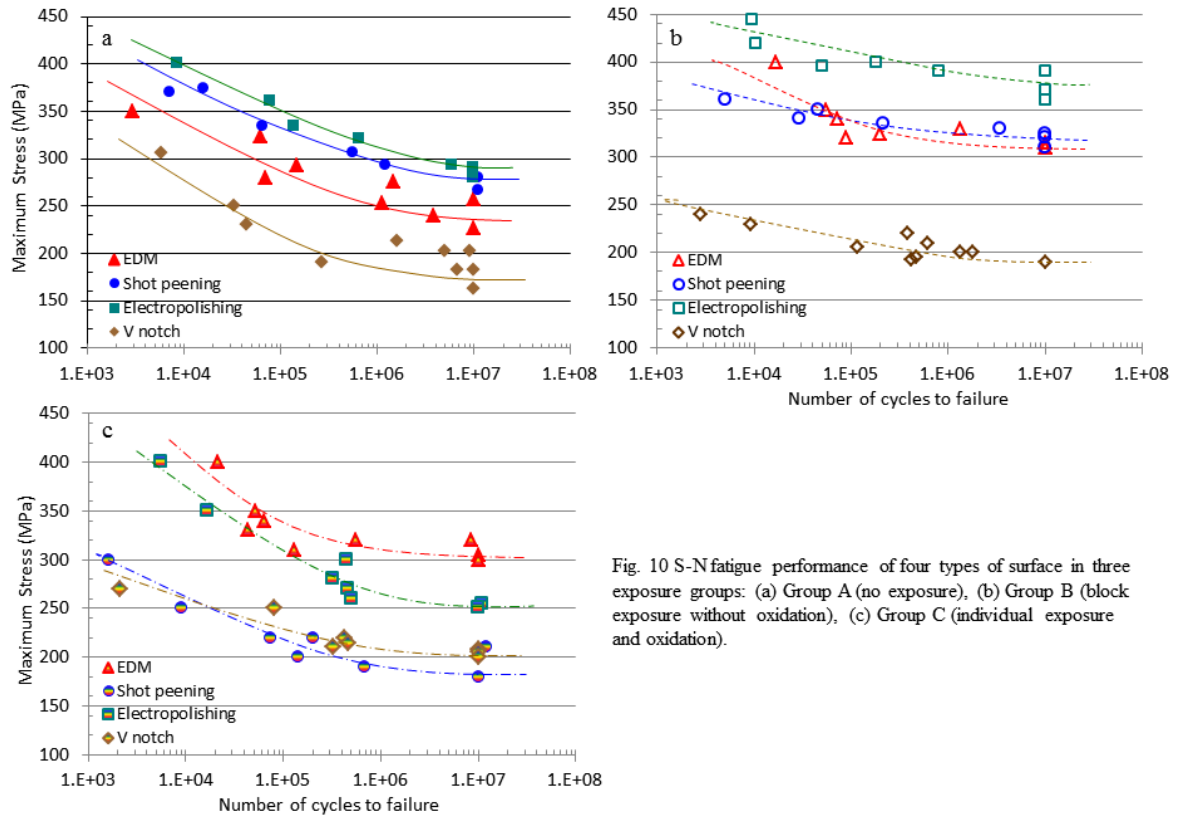
Fig. 10 S-N fatigue performance of four types of surface in three exposure groups: (a) Group A (no exposure), (b) Group B (block exposure without oxidation), (c) Group C (individual exposure and oxidation).

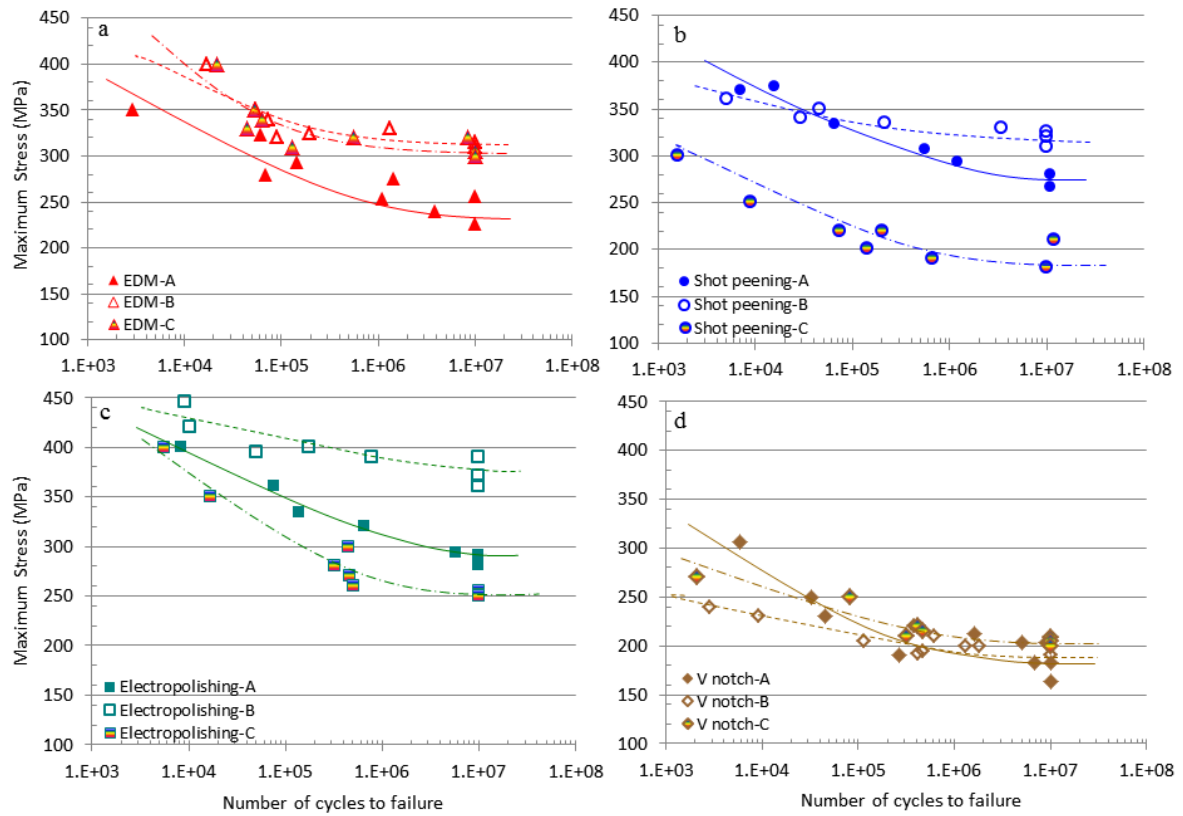
Fig. 11 S-N fatigue performance of four types of surface in three exposure conditions: (a) EDM, (b) shot peening, (c) electropolishing and (d) V notch (A, B, C denote Group A, B, and C, respectively).
