## In-situ, time resolved monitoring of uranium in BFS:OPC grout. Part 1: Corrosion in water vapour

Uranium encapsulated in grout was exposed to water vapour for extended periods of time. Through synchrotron x-ray powder diffraction and tomography measurements, uranium dioxide was determined the dominant corrosion product over a 50-week time period. The oxide growth rate initiated rapidly, with rates comparable to the  $U + H_2O$  reaction. Over time, the reaction rate decreased and eventually plateaued to a rate similar to the  $U + H_2O + O_2$  reaction. This behaviour was not attributed to oxygen ingress, but instead the decreasing permeability of the grout, limiting oxidising species access to the metal surface.

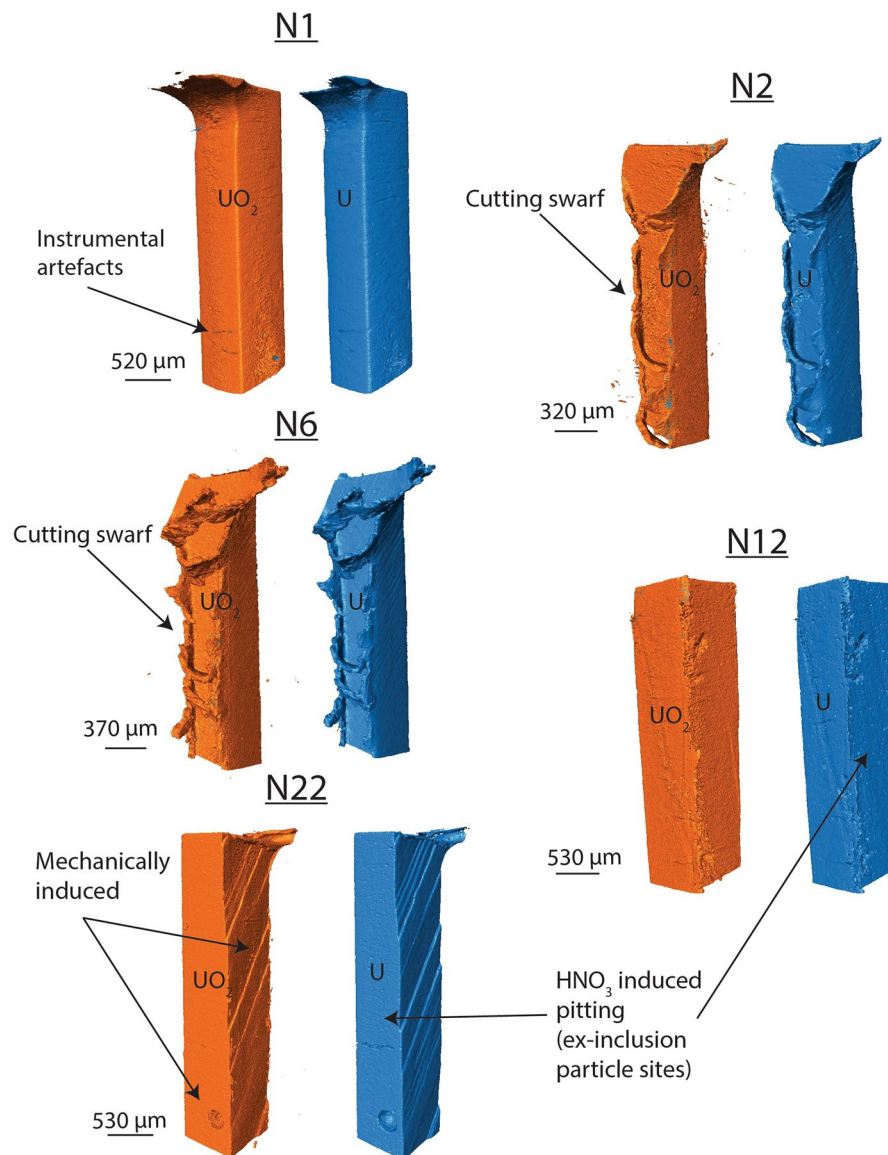
**Figure 3.** 3D renders of the nitric acid etched samples. The corrosion products are exhibited in orange (left) and the uranium in blue (right).

The nitric acid etched samples XRT also showed some as-received features (Fig. 3): excess swarf, from high speed cutting of the sample (for example N2 and N6); large spherical holes and ridges assumed to have formed during the metal casting process, as both were present in the corrosion product and uranium metal render; and small  $\sim 18\ \mu\text{m}$  diameter pits, with a spatial density of  $39.9\ \text{pits}\cdot\text{mm}^{-2}$  attributed to the pitting of removed inclusion particles after nitric acid etching (see Supplementary Fig. S3). However, consistent with XRPD analysis, uniform growth of a continuous corrosion layer across the metal surface was observed, indicative of uranium oxide formation.

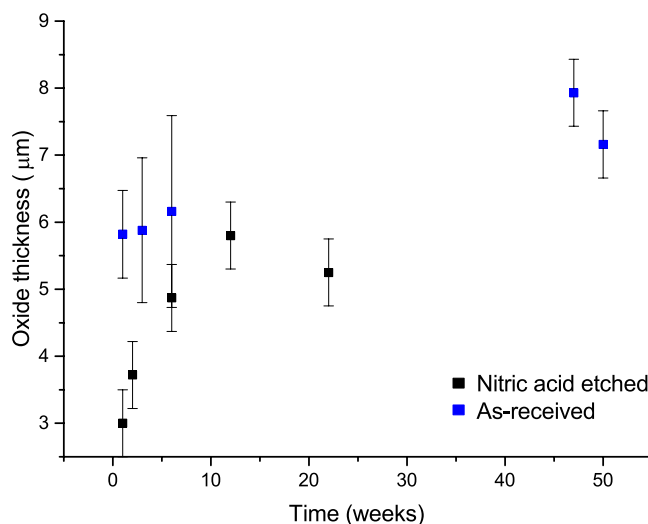
**Figure 4.** A plot demonstrating the change in  $\text{UO}_2$  thickness on each uranium sample when exposed to water vapour over time. Values and errors are extracted from Table 2.

Overall, we observed limited visual change between grout encapsulated uranium samples exposed to water vapour over progressively longer periods of time. We used cross sections at multiple positions of each sample render to measure the oxide thickness at 80 locations, and the average oxide thickness, with an associated error and range are shown in Table 2. In general, the oxide thickness of the uranium samples was observed to increase over time. More specifically, over the first 12 weeks the nitric acid etched uranium oxide growth appeared to initially grow rapidly, but then the growth rate decreased by 22 weeks (Fig. 4). Oxide thicknesses were greater and displayed a greater range on the ‘as-received’ samples owing to the initial corrosion layer present prior to encapsulation in grout.
