Failure of Overhead Line Equipment (OHLE) Structure under Hurricane

Chayut Ngamkhanong¹, Sakdirat Kaewunruen¹, Rui Calçada², Rodolfo Martin³

ABSTRACT: Presently, in modern railway systems, train or rolling stocks are powered by electricity through the overhead wire or the third rail on ground. Overhead line equipment (OHLE) is the component for the electric train which provides electric power to the train. OHLE is, for one or two tracks, normally supported by cantilever masts. OHLE is one of vulnerable components in railway system due to its slenderness. Note that, as previously recorded, the strong hurricane caused substantial damage over the large area and possibly knocked the train out of the track and cause electricity failures on OHLE. In fact, cantilever mast subjected to wind and hurricane actions may fail due to the incorrect design, material defects, improper support connections and its foundation etc. In this study, a mast structure with varying rotational soil stiffness is used to construct dynamic influential lines for soil-structure integrity prediction. Finite element model updating technique has been used to perform the dynamic responses of OHLE considering soil-st

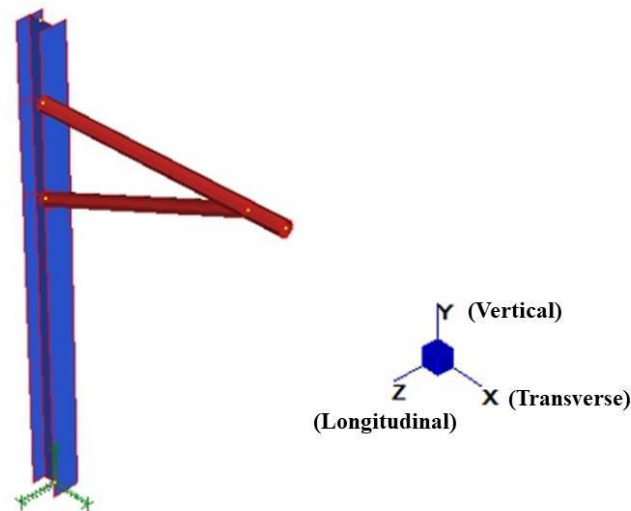
FIG. 2. 3-Dimensional model of OHLE

Three-dimensional modelling of single mast structure is constructed using finite element package STRAND7 (G+D Computing, 2001). The linear static solver is used based on the assumption that structure is in linear range and loading is static. The single cantilever mast structure made by steel is constructed, FIG 1. The 2-D schematic load to structure with support springs is shown in FIG 2. The typical H-section steel (Section area: $2.219 \times 10^{-2} \text{m}^2$, $I_{zz}: 5.08 \times 10^{-4} \text{m}^4$, $I_{xx}: 1.84 \times 10^{-4} \text{m}^4$) is used and connected to the cantilever which made of round steel to support the overhead contact wire. The steel used has the young modulus of $2 \times 10^5 \text{MPa}$, density of 7850kg/m^3 and poisson's ratio of 0.25. The rotational and translational springs are applied at the support. The parametric study of the soil stiffness is conducted. It is assumed that translational stiffness of support is fully fixed in all directions, while the rotational stiffness is varied from 500 to 1000000 kNm/rad (fully fixed support condition). It is noted that the rotational stiffness is affected by the soil-structure interaction condition and the quality of support connection (Kanvinde et al., 2012; Rodas et al, 2017; Krystosik, 2018). The support stiffness can be decrease due to the connection failure such as broken bolt, yielding weld, improper design and construction etc. and soil erosion and degradation. It is noticeable that the soil-structure interaction plays a significant role in the sensitivity of structural vibration. The quality of support connection and ground condition considerably influences the soil-structure stiffness (Ngamkhanong et al., 2017).

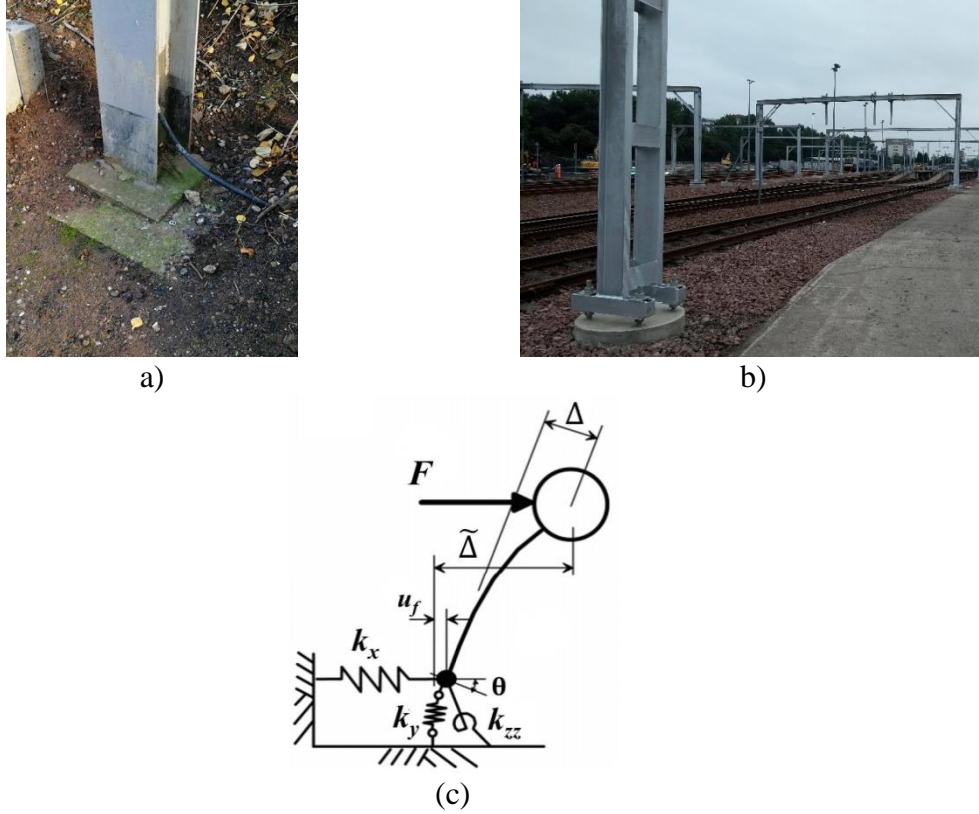
FIG. 3. Support of a) cantilever mast b) frame mast and c) Schematic load to structure with rotational flexibility at support

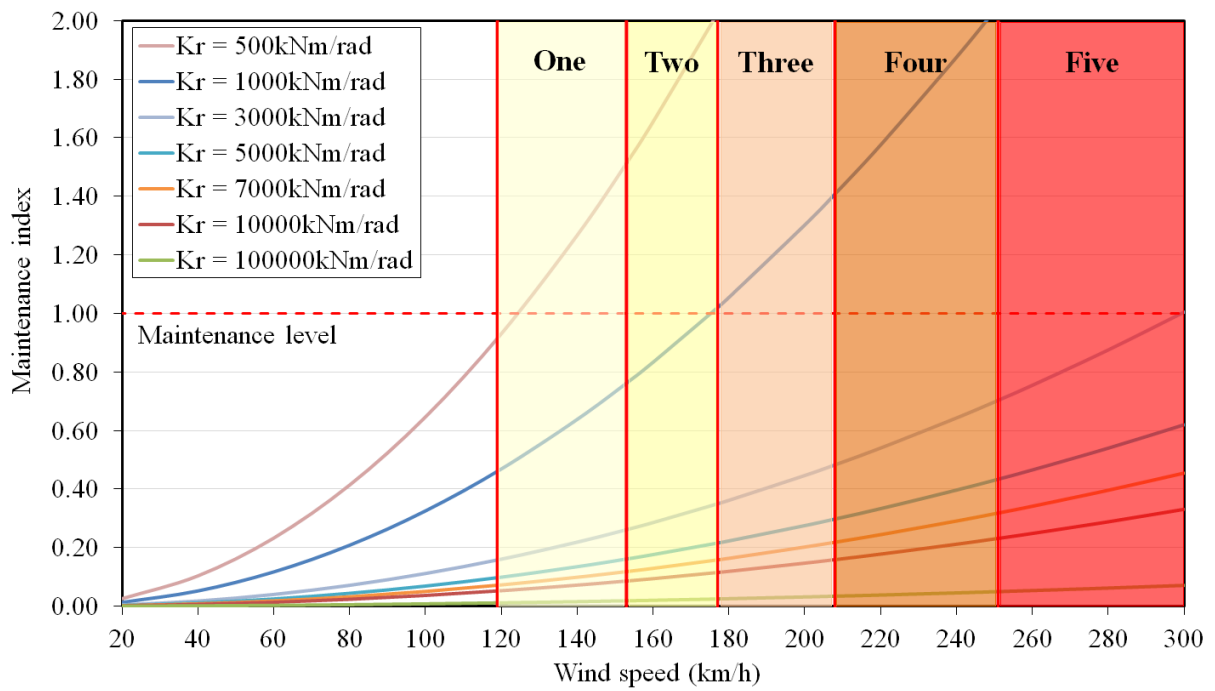
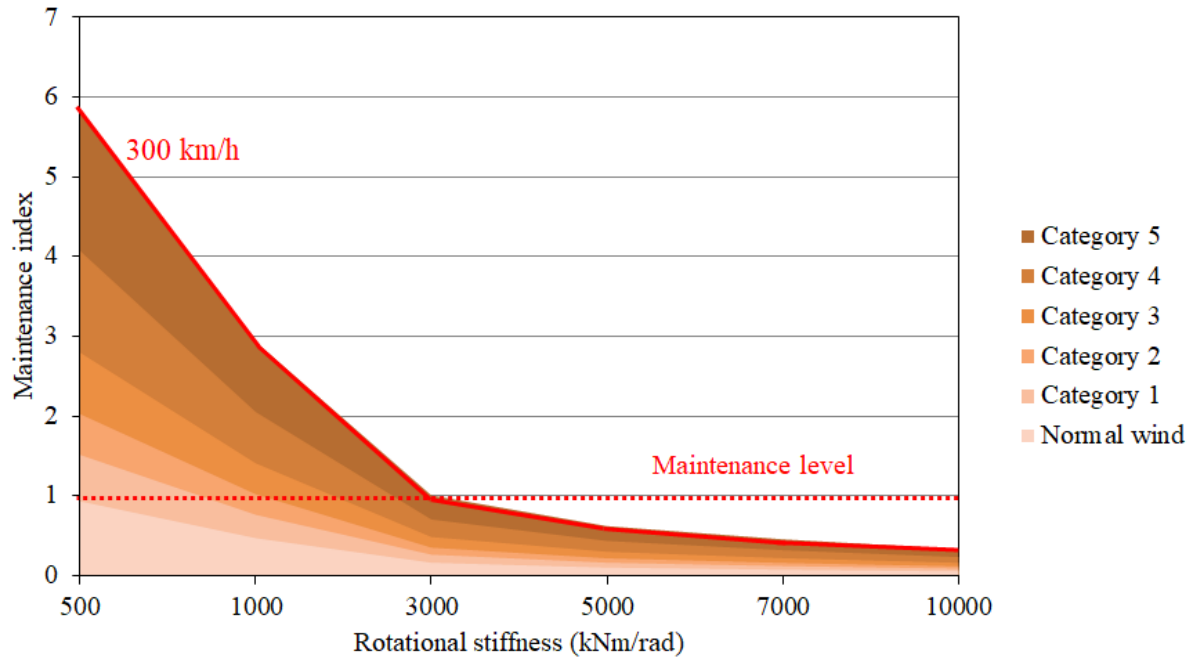
FIG. 5. Maintenance index

The maintenance index of the OHLE at various stiffness conditions under different wind speed is presented in FIG. 5. It is clear that the strong wind or hurricane can significantly knock the electric system of the train. The results shown that the maintenance level can be reached when the rotational stiffness of the support is lower than 3000kNm/rad which is represented by the poor support interaction such as low number of bolts, size of foundation, soil condition etc. It is noted that, the hurricane category one can possibly make a failure of the OHLE when the mast has the support stiffness of 500kN/rad. However, the effect of strong wind can be mitigated by improving the support stiffness to be higher than 3000kNm/rad. It is interesting to note that the strongest wind that has occurred, cannot fail the OHLE since the structure has a fully fixed support. The maintenance is only about 0.1 in this case.

The linear static analysis is used for wind action. The loads obtained by the calculation are applied to the mast structure in perpendicular direction. The nodal displacement at the cantilever, which is the location of contact wire, are taken into consideration and will be compared with the maintenance index. The ratio between the overhead contact wire displacement and allowable displacement is indicated as maintenance index. It is assumed and noted that the allowable displacement used is the construction tolerances of contact stagger above the track to avoid wearing a groove in the pantograph according to RailCorp (2011). The construction tolerance of 50mm of contact wire is used as the allowable lateral displacement. Thus the maintenance index is the value between 0 and 1. The pantograph can possibly lost contact with the contact wire when the maintenance index reaches 1.
