Failure of Overhead Line Equipment (OHLE) Structure under Hurricane

Chayut Ngamkhanong¹, Sakdirat Kaewunruen¹, Rui Calçada², Rodolfo Martin³

¹School of Engineering, University of Birmingham, Birmingham, UK

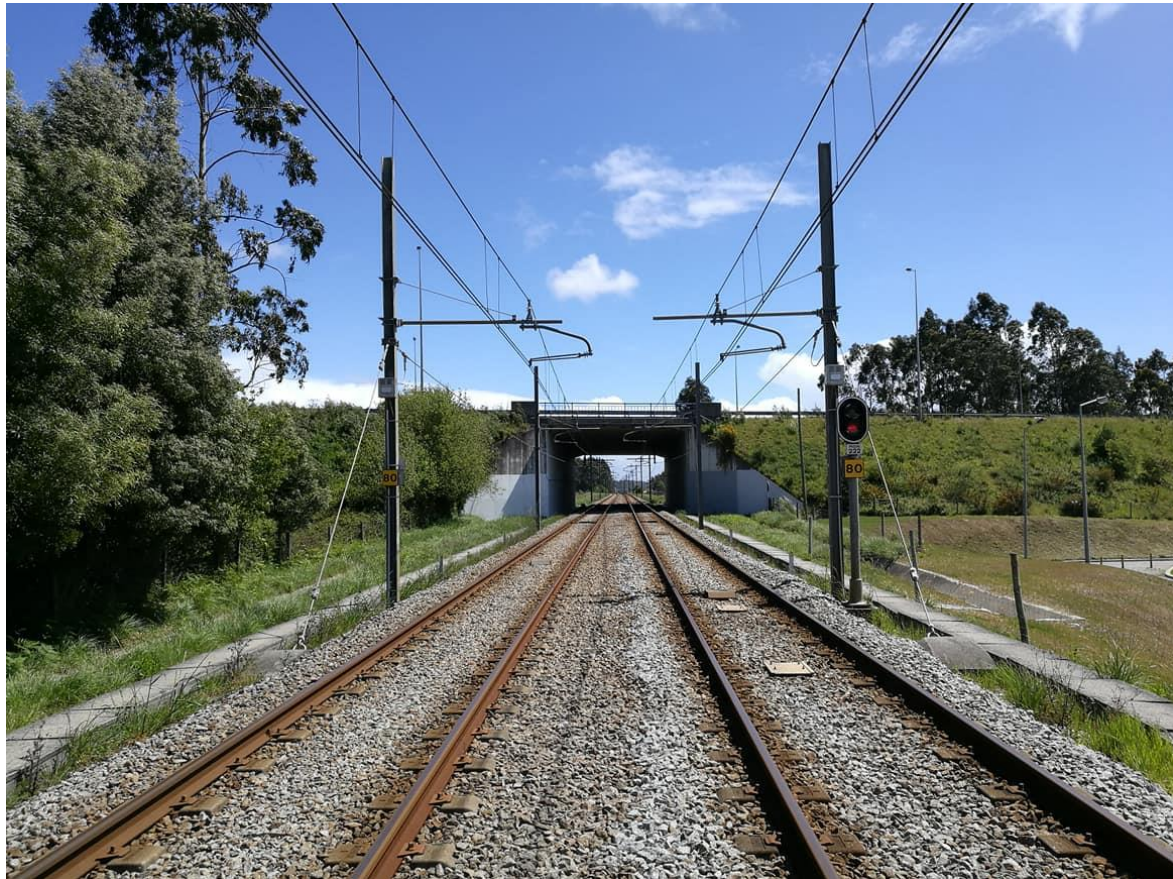
FIG. 1. Single mast structure supporting OHLE

Three-dimensional modelling of single mast structure is constructed using finite element package STRAND7 (G+D Computing, 2001). The linear static solver is used based on the assumption that structure is in linear range and loading is static. The single cantilever mast structure made by steel is constructed, FIG 1. The 2-D schematic load to structure with support springs is shown in FIG 2. The typical H-section steel (Section area: $2.219 \times 10^{-2} \text{ m}^2$, I_{zz} : $5.08 \times 10^{-4} \text{ m}^4$, I_{xx} : $1.84 \times 10^{-4} \text{ m}^4$) is used and connected to the cantilever which made of round steel to support the overhead contact wire. The steel used has the young modulus of $2 \times 10^5 \text{ MPa}$, density of 7850 kg/m^3 and poisson's ratio of 0.25. The rotational and translational springs are applied at the support. The parametric study of the soil stiffness is conducted. It is assumed that translational stiffness of support is fully fixed in all directions, while the rotational stiffness is varied from 500 to 10000000 kNm/rad (fully fixed support condition). It is noted that the rotational stiffness is affected by the soil-structure interaction condition and the quality of support connection (Kanvinde et al., 2012; Rodas et al, 2017; Krystosik, 2018). The support stiffness can be decrease due to the connection failure such as broken bolt, yielding weld, improper design and construction etc. and soil erosion and degradation. It is noticeable that the soil-structure interaction plays a significant role in the sensitivity of structural vibration. The quality of support connection and ground condition considerably influences the soil-structure stiffness (Ngamkhanong et al., 2017).

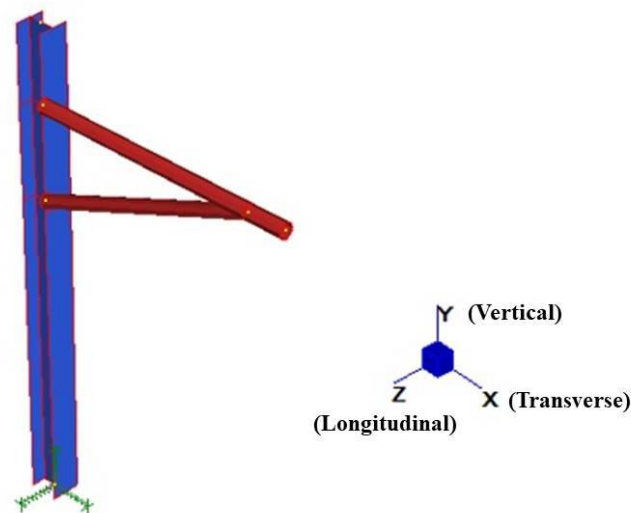
FIG. 2. 3-Dimensional model of OHLE

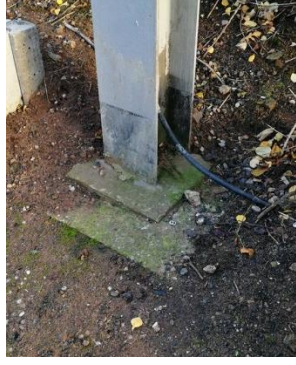
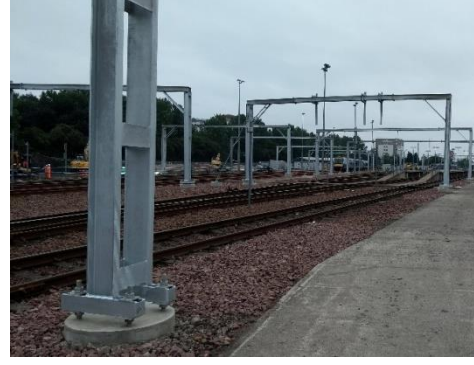
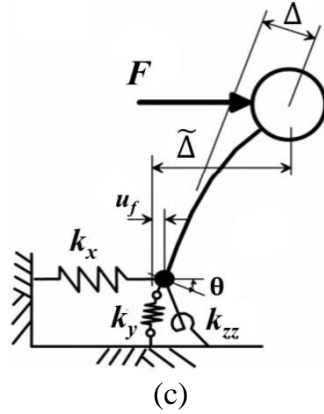
FIG. 3. Support of a) cantilever mast b) frame mast and c) Schematic load to structure with rotational flexibility at support

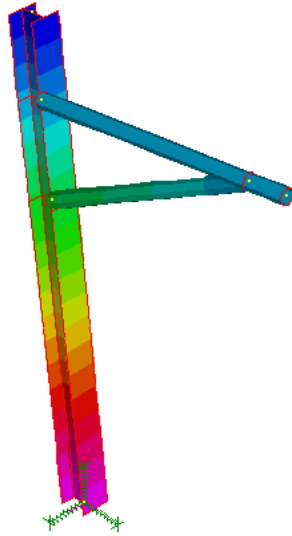
The applied forces equivalent to the wind speed up to 300 km/h are applied to the mast structure. The displacement response of the mast structure in transverse direction subjected to the hurricane is presented in FIG. 4. The displacement response at the cantilever mast is then used to calculate the maintenance limit. The rotational stiffness considered is between 500 and 100000kNm/rad (fully fixed support).

FIG. 4. Structural response of the mast structure subjected to hurricane.

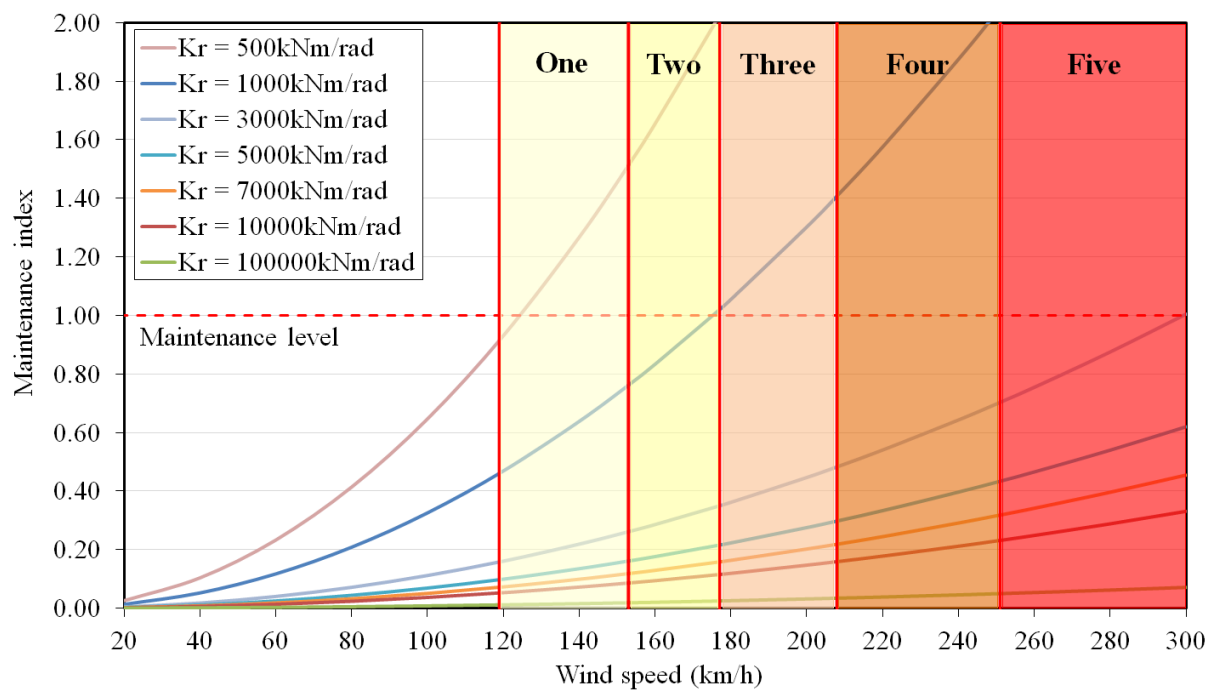
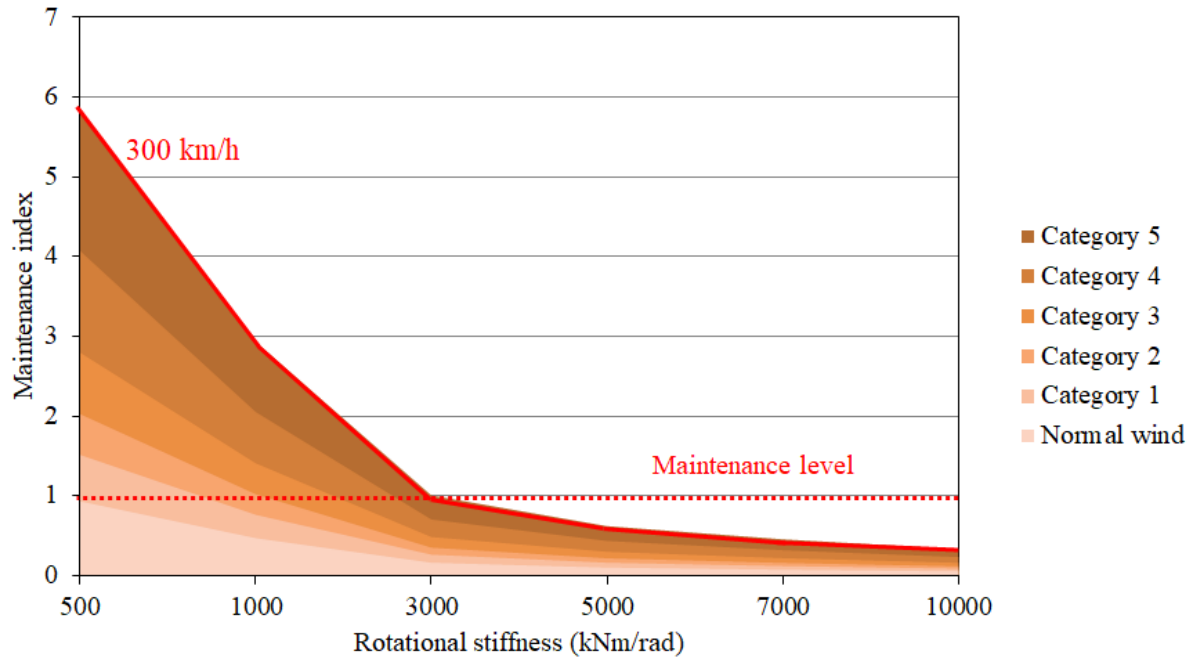
FIG. 5. Maintenance index

The maintenance index of the OHLE at various stiffness conditions under different wind speed is presented in FIG. 5. It is clear that the strong wind or hurricane can significantly knock the electric system of the train. The results shown that the maintenance level can be reached when the rotational stiffness of the support is lower than 3000kNm/rad which is represented by the poor support interaction such as low number of bolts, size of foundation, soil condition etc. It is noted that, the hurricane category one can possibly make a failure of the OHLE when the mast has the support stiffness of 500kN/rad. However, the effect of strong wind can be mitigated by improving the support stiffness to be higher than 3000kNm/rad. It is interesting to note that the strongest wind that has occurred, cannot fail the OHLE since the structure has a fully fixed support. The maintenance is only about 0.1 in this case.
