Hydrological Classification, a Practical Tool for Mangrove Restoration

Anne F. Van Loon^{1,2*}, Bram Te Brake^{3,4}, Marjolein H. J. Van Huijgevoort^{4a}, Roel Dijkma⁴

Mangrove restoration projects, aimed at restoring important values of mangrove forests after degradation, often fail because hydrological conditions are disregarded. We present a simple, but robust methodology to determine hydrological suitability for mangrove species, which can guide restoration practice. In 15 natural and 8 disturbed sites (i.e. disused shrimp ponds) in three case study regions in south-east Asia, water levels were measured and vegetation species composition was determined. Using an existing hydrological classification for mangroves, sites were classified into hydrological classes, based on duration of inundation, and vegetation classes, based on occurrence of mangrove species. For the natural sites hydrological and vegetation classes were similar, showing clear distribution of mangrove species from wet to dry sites. Application of the classification to disturbed sites showed that in some locations hydrological conditions had been restored enough for mangrove vegetation to establish, in some loca

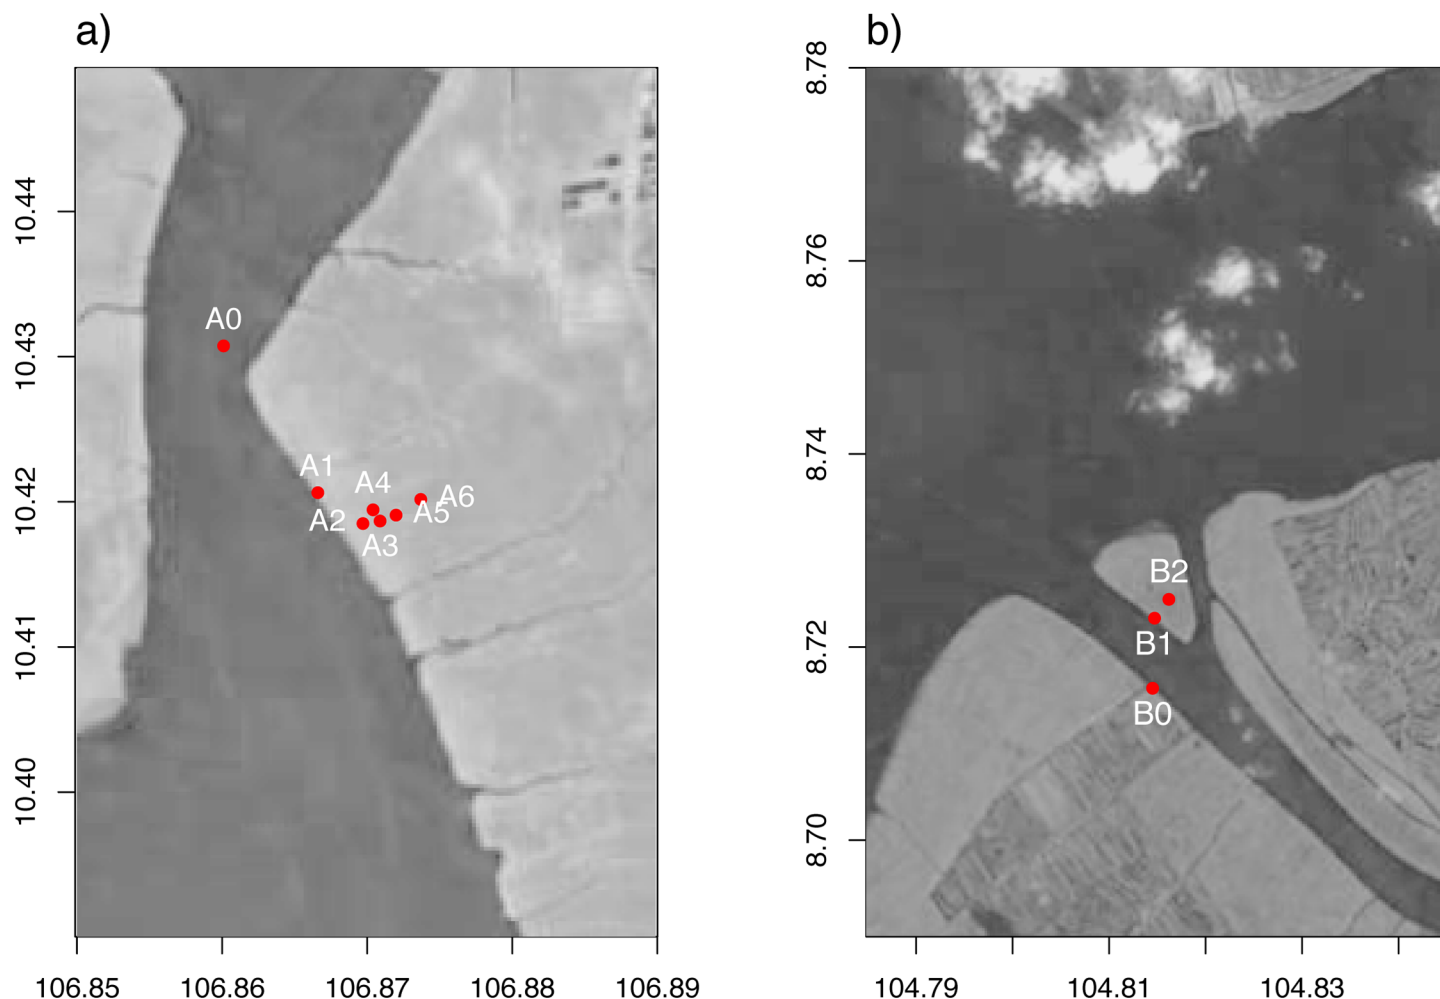
Fig 2. Location of measurement sites in Vietnam. a) Can Gio, b) Ca Mau. Measurement sites in open water (A0, B0) and in the mangrove forest (see Table 4). Landsat data available from the U.S. Geological Survey.

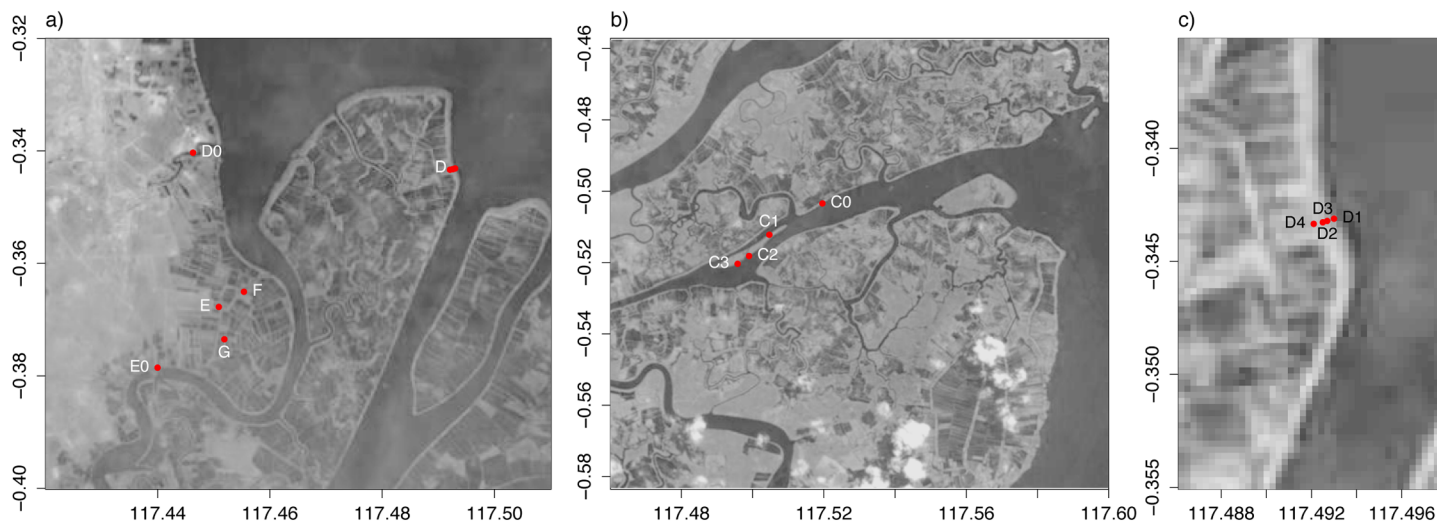
Fig 3. Location of measurement sites in Mahakam—Indonesia. a) measurement sites in open water (D0, E0) and inland (D–G), b) measurement sites of location C, c) measurement sites of location D (see Table 4). Measurement sites in location E, F, and G are too close together to indicate separately. Landsat data available from the U.S. Geological Survey.

Measurements were taken at several locations in the delta focusing on natural (C and D) and hydrologically disturbed (E, F and G) conditions (Fig 1d). Location C is on an elongated island in the river about 9 km inland from the coast (Fig 3a). The vegetation has a natural mix of different species (Table 4). Location D is in the northern part of the delta at the coast (Fig 3b). Measurements were done in a transect of 100 m perpendicular to the coast (Fig 3c). Vegetation shows a distribution from *Sonneratia alba* J.Smith at the coast to *Acrostichum Aureum* L. inland (Table 4).

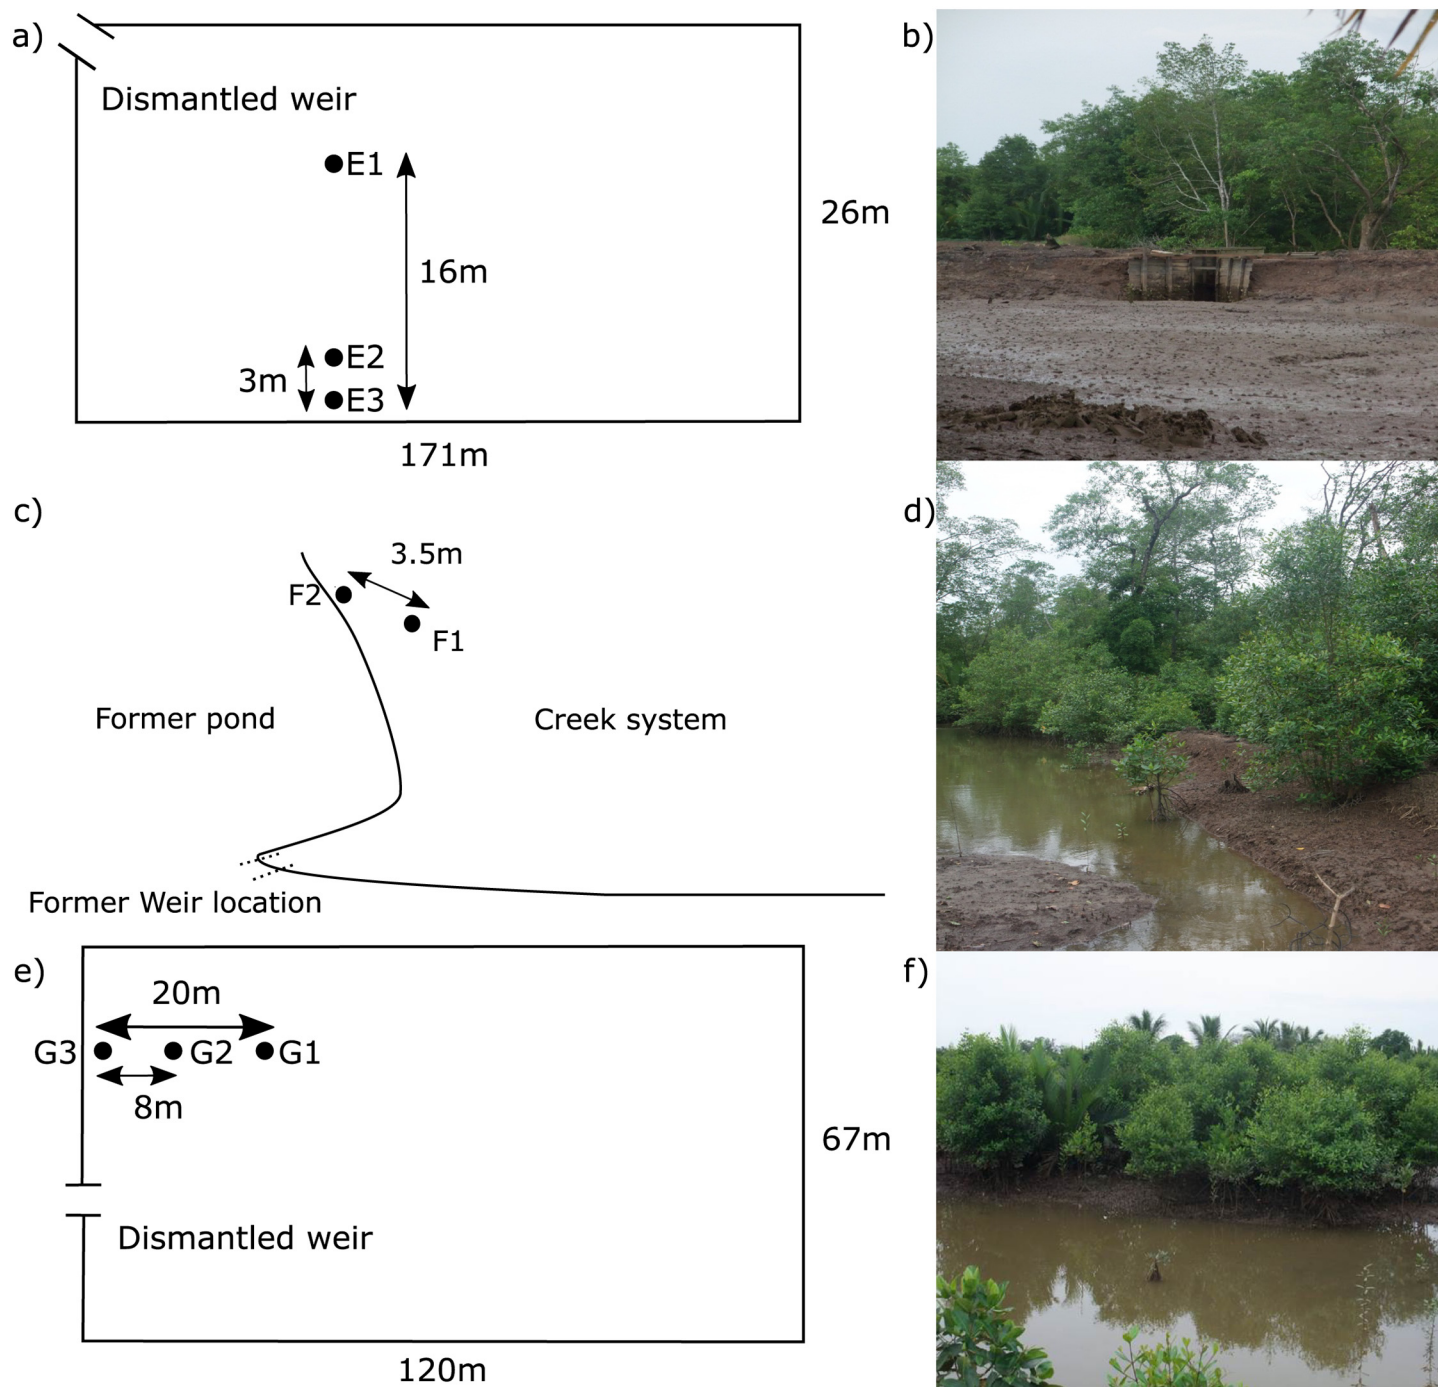
Fig 4. Measurement sites in location E–G in Mahakam—Indonesia. a) measurement setup location E, b) photo location E, c) measurement setup location F, d) photo location F, e) measurement setup location G, f) photo location G.

Locations E, F and G were chosen as examples of restoration sites with disturbed hydrological conditions (Fig 1d and Table 4). Location E is a shrimp pond abandoned since 2008 and with dikes around the pond still present (Fig 4a and 4b). There are some natural *Nypa Fruticans* Wurmb and planted coconut palms around the edges, but no vegetation inside the pond. Site F is a shrimp pond in the process of restoration with 10 years of new growth in and around

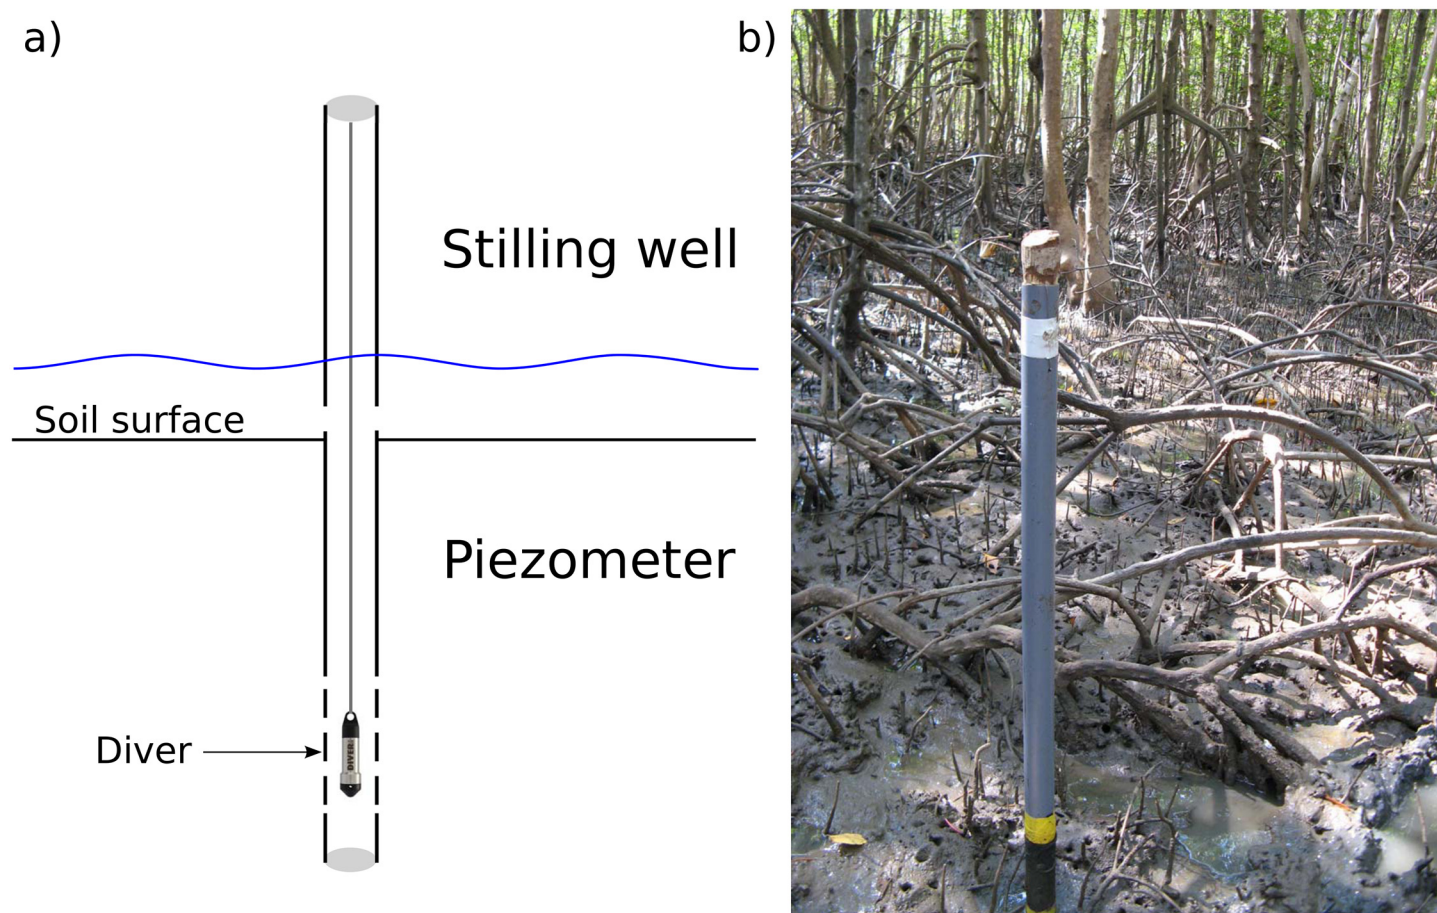
Fig 5. Water level measurement set up. a) diver installed in tube that serves as stilling well above soil surface and as piezometer below soil surface, b) installation in the field.

Since the observed water levels represent water both on and under the surface, we had to estimate surface level for each site. We used a method to derive surface level directly from the water level data. At ebb, measured water levels drop following the tide until surface level is reached, after which reduced subsurface flow velocities result in a lower falling rate of water

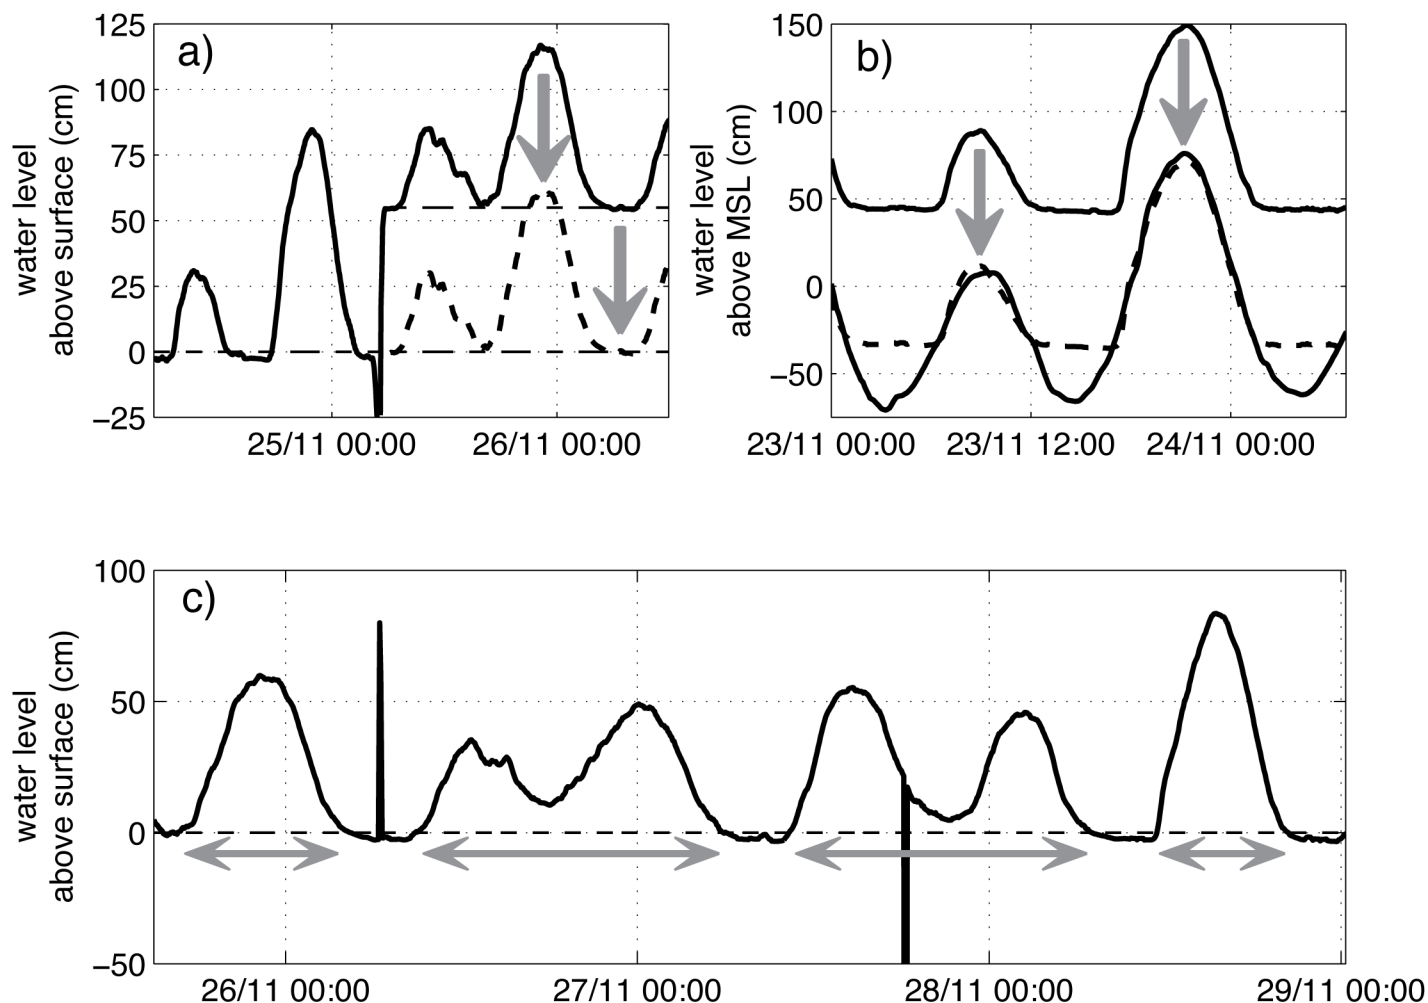
Fig 6. Example of time series of water levels to show the methodology used for time series analysis. a) estimation of surface level from nod point and correction of changes in reference level, b) estimation of elevation with respect to mean sea level, c) correction of measurement errors and calculation of duration of inundation. The horizontal dashed lines represent estimated soil surface level.

By counting the measurement intervals with water levels above soil surface level, inundation durations and number of inundations were obtained. The minimum duration of inundation and dry-fall was set at 15 minutes to remove measurement errors, outliers, and small fluctuations in water levels (Fig 6c). [65] and [30] found that duration of inundation is most important in determining mangrove species distribution. We applied two variables related to duration of inundation (i.e. average duration per inundation and per day) that are relevant in irregular tidal regimes [39]. Based on these two variables, sites were then classified into hydrological classes using Table 2.

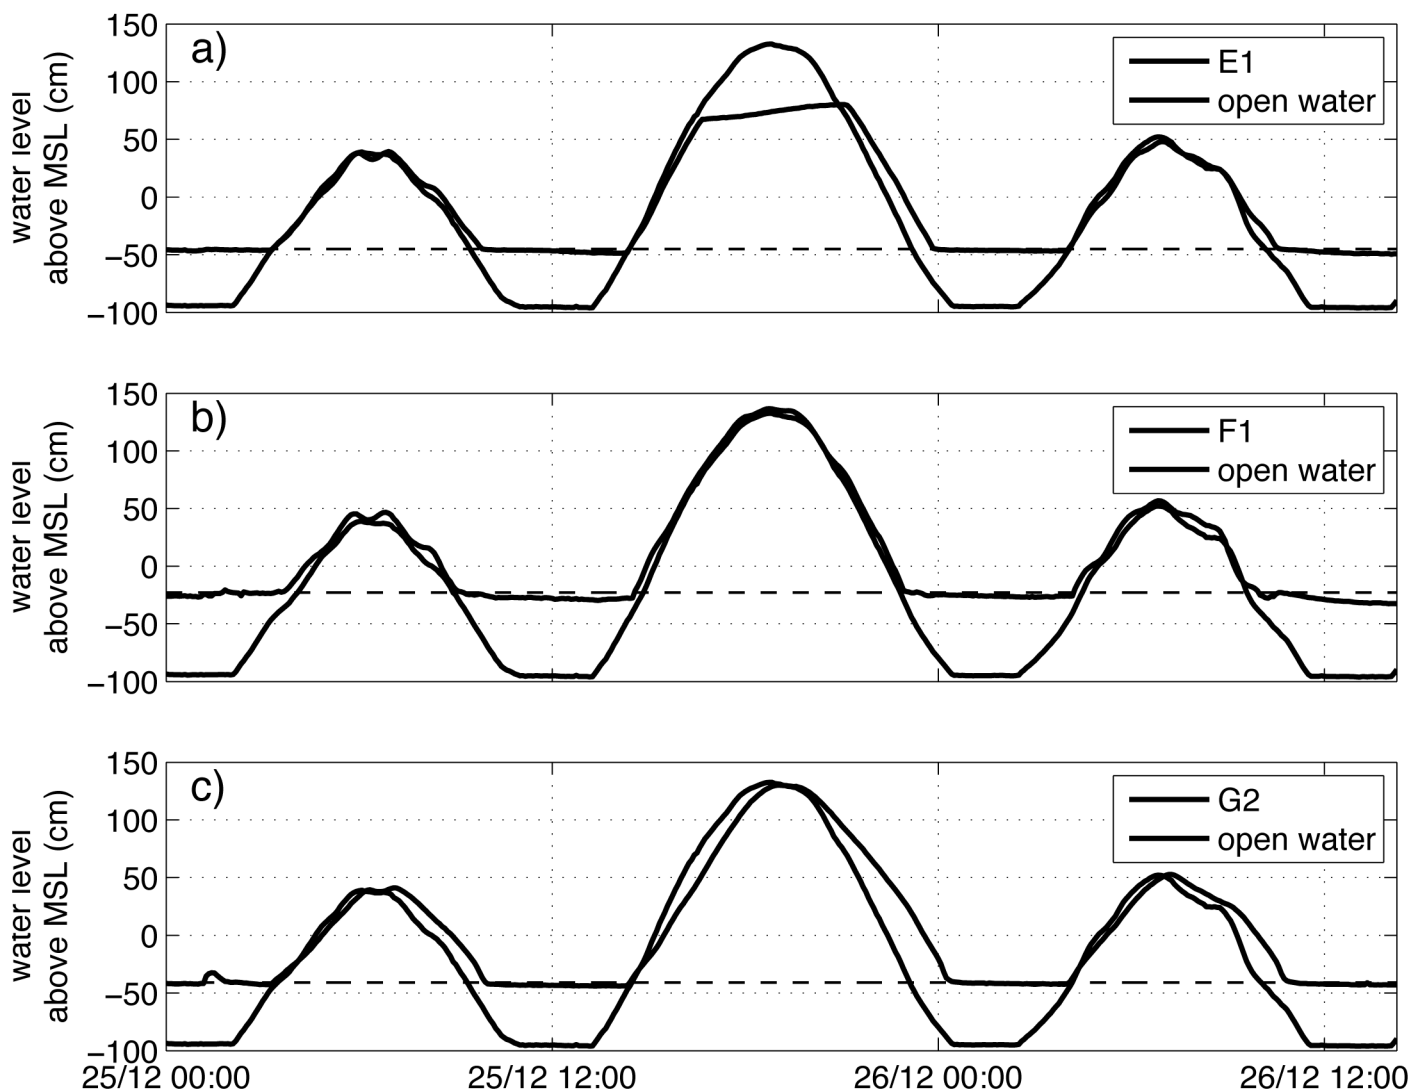
Fig 7. Time series of water levels in three hydrologically disturbed sites in Mahakam (E1, F1, G2) and their respective open water site.

To evaluate the reasons for certain hydrological and vegetation conditions and possible mismatches between them in the restoration sites, we studied water level time series of some selected sites (E1, F1 and G2) in more detail and compared them with open water levels ([Fig 7](#)).

At site E1, we see a clear capping at the higher high tides; water levels never reach above 80 cm, which is up to 50 cm lower than the tidal maximum for the measurement period. The reason for this capping is unclear, but might be related to obstruction of dikes. It does, however, not influence inundation duration. The obstruction of dikes also causes tailing (i.e. higher water levels than expected during ebb), which does result in longer inundations, on average 2.6% longer in *min per day* and 10% longer in *min per inundation* compared to a situation with free outflow ([Table 6](#)). This effect of tailing is reflected in the resulting class. Site E1 has a lower class in reality (i.e. wetter conditions) than expected from the open water levels ([Table 6](#)).

At site G2, tailing is obvious ([Fig 7](#)). During ebb, outflow is restricted, resulting in a longer duration of inundation. Inflow is also restricted at this site, but less than outflow. Without these restrictions, site G2 would have had shorter inundations, on average 23% shorter in *min per day* and 8.5% shorter in *min per inundation*, and a higher class, so drier conditions ([Table 6](#)).
