Behaviour of stainless steel beam-to-column joints - Part 1: Experimental investigation

Elflah, Mohamed; Theofanous, Marios; Dirar, Samir; Yuan, Huanxin

- The papers reports for the first time experimental results on full-scale stainless steel beam-to-column joints
- Stainless steel joints are shown to possess excellent ductility and high strength
- Current design standards are assessed and found overly conservative in the strength prediction of stainless steel joints
- Current design standards do not accurately predict the observed failure mode

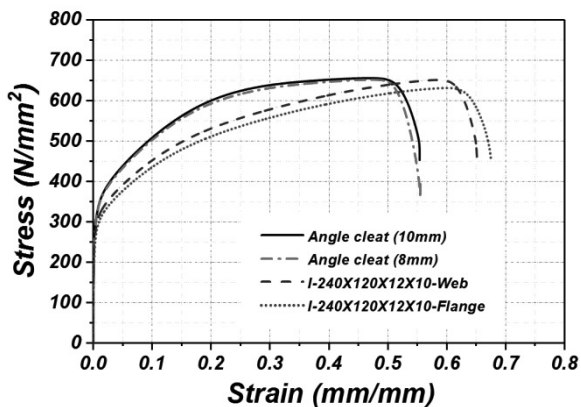
Fig.2 Typical stress strain curves of tested stainless steel tensile coupons.

Flat coupons were extracted from the flange and the web of the I-section, from the angle cleats and from the same material from which the end plates were cut. The coupons were tested under strain control with an applied strain rate of 0.007%/s up to the 0.2% proof stress $\sigma_{0.2}$ and then a strain rate of 0.025%/s was applied until fracture in accordance with [26]. Fig.2 shows some representative stress strain curves for the material coupons extracted from the I-section and the angles. In addition to the material coupons, bolts from the same batch as the ones used for the specimens were tested in tension and in double shear to obtain the basic material response and facilitate the analysis of the experimental results. Figs.3 and 4 illustrate the load-deflection curves and failure modes of stainless steel bolts in double shear and in tension respectively. Table 2 reports the key material properties obtained from the tensile tests. In all cases the proof stresses and ultimate tensile stresses reported in Table 2 are lower than the respective mill certificate values. This is attributed to possible differences in the orientation in which the coupons were tested, which coupled with stainless steels' anisotropy can have a significant effect on the obtained results. An additional reason for the observed discrepancy is the lower strain rate at which the material coupon tests were conducted in the lab compared to the strain rate used for the mill certificate tests. In the remainder of the paper and in the companion paper [23] the material properties reported

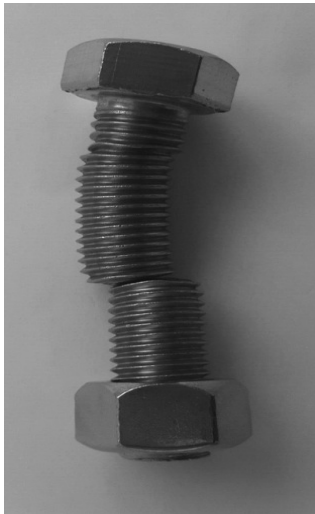
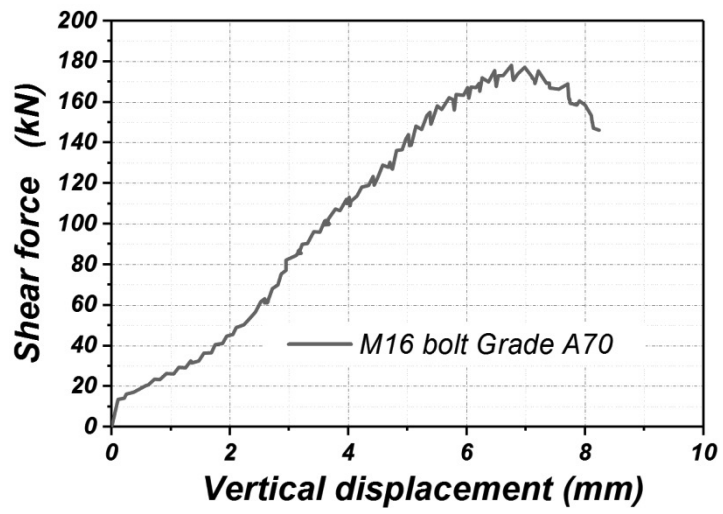
Fig.3 Load-deflection curve and failure mode of M16 bolt Grade A4-80 loaded in double shear.

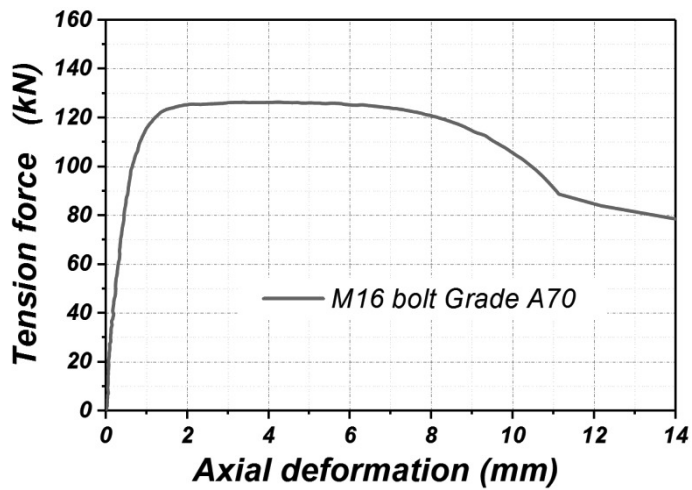
Fig.4 Load-elongation curve and failure mode of M16 bolt Grade A4-80 loaded in tension.

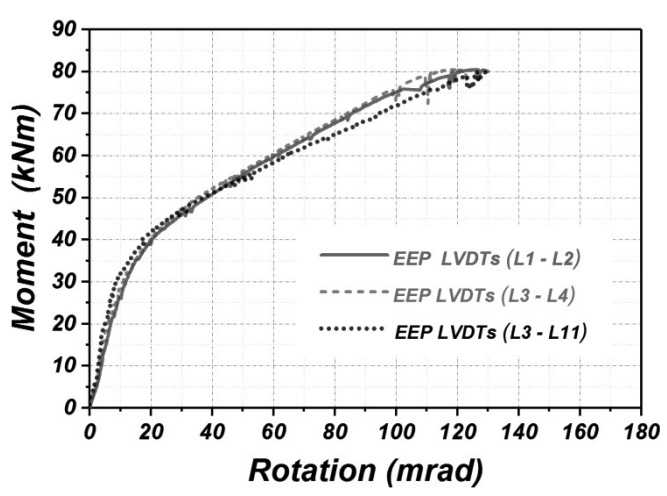
Fig.8 Moment rotation curves of EEP with different definitions of beam rotation Φ_b

In this section, the obtained results are discussed in detail. Emphasis is placed on the observed failure modes and the overall moment rotation response, which are discussed separately for each type of joint hereafter. The moment acting on the joint was determined by multiplying the force applied by the actuator by the distance of the actuator from the column face (1.47 m), whilst the joint rotation Φ was determined by subtracting the rotation of the column Φ_c from the rotation of the beam Φ_b . These rotation values were obtained from the relevant LVDT readings as previously mentioned. A typical moment-rotation curve is shown in Fig. 8, where the rotation is based on different LVDT readings. Very little difference can be observed between the beam rotation calculated by LVDTs L1-L2 and L3, L4 and L11, hence, only the beam rotation as determined by L1 and L2 is considered in the remainder of the paper.

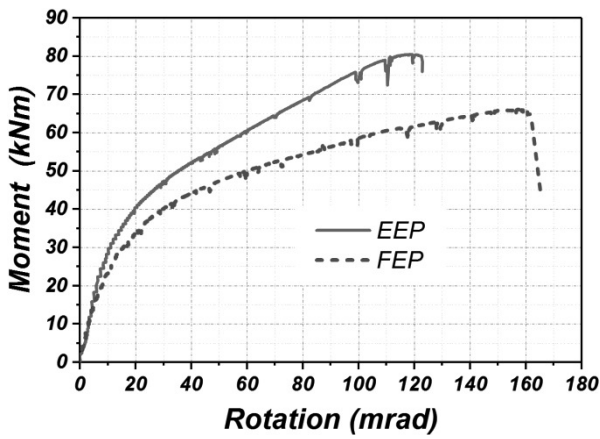
Fig.9 Moment-rotation response for FEP and EEP specimens

Fig.9 depicts the obtained moment-rotation response for the FEP and EEP specimens. Both graphs exhibit an initial linear elastic response until about a third of the maximum recorded moment, whereupon a gradual loss of stiffness occurs followed by another almost linear region, as indicated by the smooth transition between the two lines. The second linear part of the response curves sharply once the maximum moment $M_{j,u}$ is reached. The FEP specimen exhibits a sharp linear post-ultimate response following the attainment of the maximum load which coincides with the failure of the bolt and is terminated upon the fracture of the bolt. This post-ultimate response was not recorded for the EEP specimen as the test was terminated shortly after the maximum load was reached. As expected, EEP is characterized by a stiffer response and a higher moment resistance, since the bolts beyond the top flange of the beam are more effective in transmitting the bending moment. However, FEP has markedly higher ductility with a rotation at ultimate load $\Phi_{j,u}$ more than 150 mrad, whilst the corresponding value for the EEP specimen is 119 mrad. The excellent ductility and the sharp increase in the moment resistance with increasing strain exhibited by both specimens is arguably partly attributable to material characteristics of stainless steel.

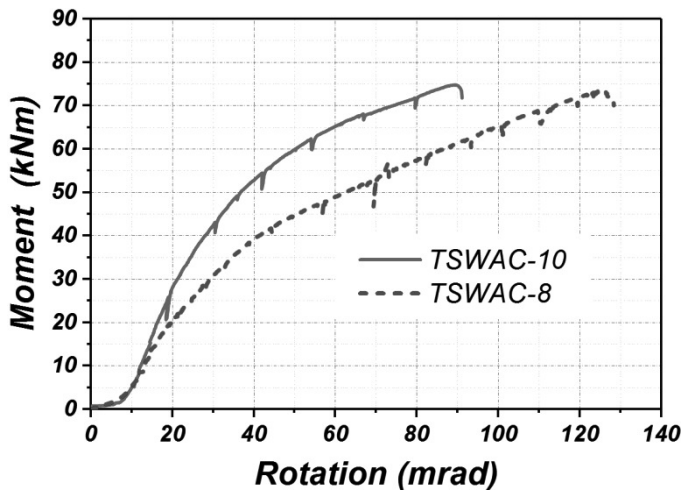
Fig.15 Moment-rotation response for TSWAC-8 and TSWAC-10 specimens

Fig.15 shows illustrates the recorded moment-rotation for the TSWAC-8 and TSWAC-10 joints. The response of both specimens is similar and exhibits the initial non-linear part of reduced stiffness due to lack of contact between the bolts and the clearance holes as discussed before. As expected, the TSWAC specimens are stiffer and stronger than their counterparts without the web cleats. Regarding the effect of the employed angle cleat thickness, there seems to be a marked effect on the initial stiffness and the rotation at maximum moment $\Phi_{j,u}$, however the maximum moment itself remains unaffected, as is the stiffness of the second linear branch of the moment-rotation curve.
