High speed imaging of biofilm removal from a dental implant model using ultrasonic cavitation

High Speed Imaging of Biofilm Removal from a Dental Implant Model using Ultrasonic Cavitation

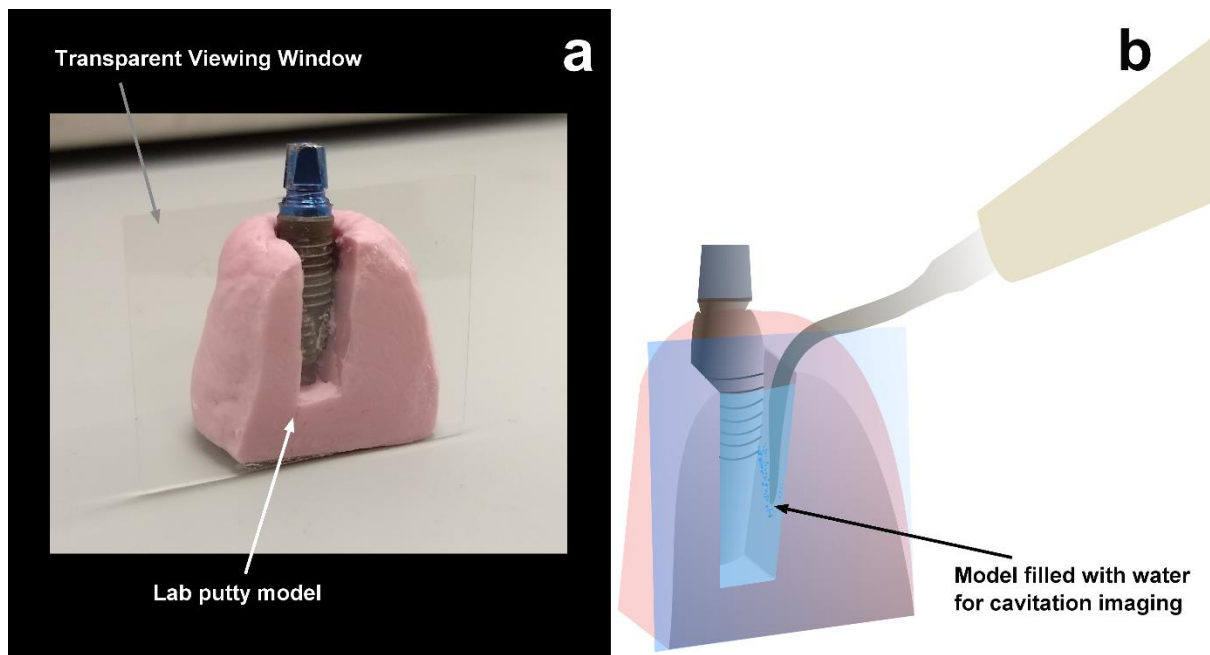
Figure 1 (a) Photograph of the restricted pocket model developed in this study to allow for high speed imaging of biofilm removal from a dental implant. (b) Schematic of the model in use for investigating cavitation from ultrasonic scalers

The implants used in this study were Xive S Plus D 4.5/L8-13 implants (supplied by Dentsply Friadent, Mannheim Germany (now Dentsply Sirona) with a surface resembling the 'Friadent plus' surface which is sand blasted and acid etched [21]. The implants have evenly spaced threads approximately 0.6 mm apart. A restricted pocket model was constructed (Figure 10) using lab putty by creating an impression of the implant in a block of activated lab putty and removing it before waiting for the lab putty to set. A section of the model was removed using a scalpel to make a vertical cut for the viewing window. A plastic coverslip (Thermanox™, 24 x 30mm, Nunc, ThermoFisher) was attached to the putty model to seal and form the viewing window for high speed imaging.

The restricted pocket model developed in this study for high speed imaging makes the experiment clinically relevant whilst still being able to image the cleaning process. It is cost-effective and easy to construct and could be used in other similar studies. It can also be easily adapted to investigate other periodontal therapy methods and also other geometries such as interproximal spaces or root furcations.

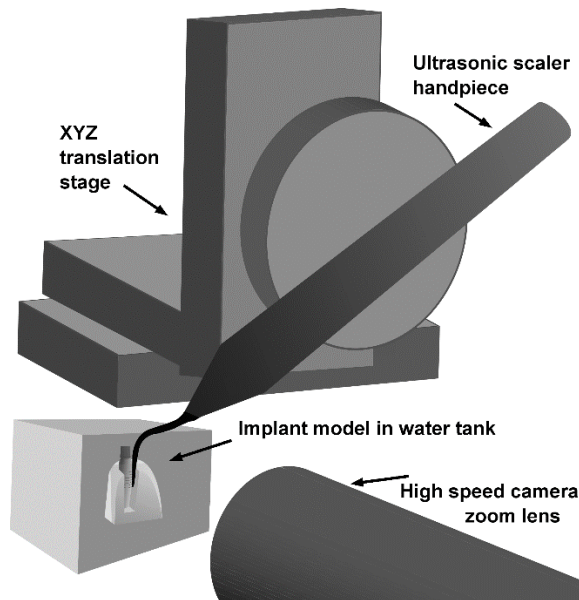
Figure 2 Schematic of the high speed imaging setup

High speed imaging was used to image biofilm removal from the different surfaces via cavitation (Figure 11). The implant was placed inside the restricted pocket model which was fixed vertically in a custom-made glass water tank filled with 180 ml reverse osmosis (RO) water. A P5 Newtron XS scaler (Satelec, Acteon, France) was used in conjunction with Tip 10P. The tip was immersed in the glass water tank and its position was fixed at 0.5 mm away from the implant by attaching it to a XYZ translation stage (PT3, Thorlabs Inc, NJ, USA) and a high-precision rotation mount (PRO1/M, Thorlabs Inc, NJ, USA). The axial rotation of the scaler tip was also maintained during each experiment. The sample was illuminated using an LED cold light source (Hayashi HDF7010, Japan) in reflectance mode. The biofilm removal was imaged using a high speed camera (Fastcam mini AX200, Photron, Japan). A long distance microscope zoom lens was attached to the camera (12x zoom lens system, Navitar, USA) with a 2x adapter. The scaler tip was operated at medium power (power 10) or high

power (power 20) for 2s. Five samples were imaged for each test condition. High speed imaging was done at 500 frames per second (fps), with a shutter speed of 1/1000 s, at a magnification of x0.8 or x4 giving a resolution of 12.5 $\mu\text{m}/\text{pixel}$ or 2.5 $\mu\text{m}/\text{pixel}$ respectively.

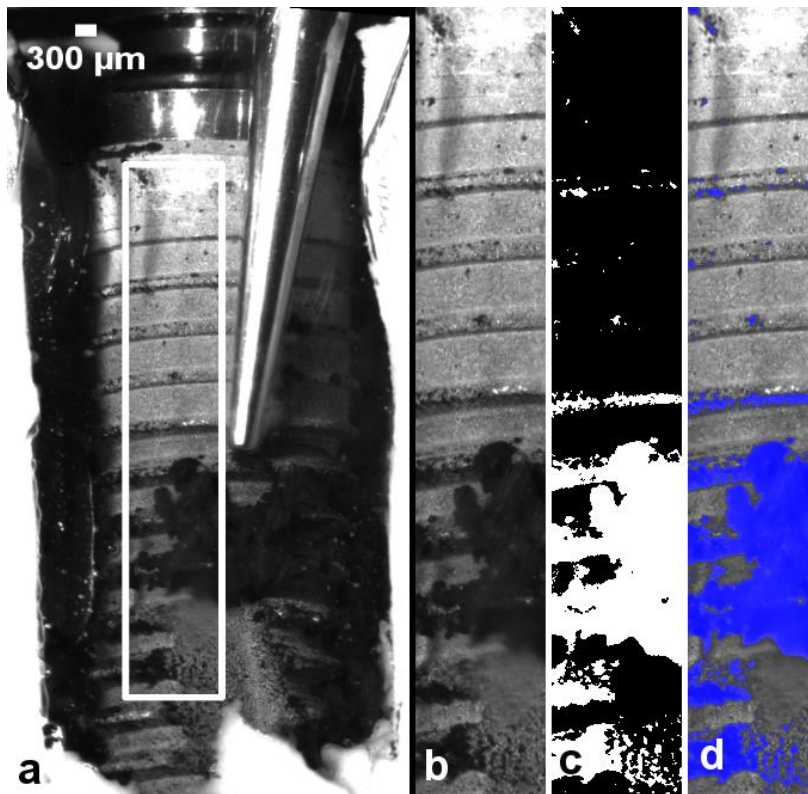
Figure 3 Image analysis steps on an example high speed image showing how the image was cropped (b) and thresholded (c). The blue overlay (d) of the thresholded image on the original image demonstrates the accuracy of the image segmentation

The biofilm removal on the implants was quantified by calculating the area of biofilm on the implants from the high speed images. A high speed image taken before the scaler was operated was compared to a high speed image taken after operating the scaler tip for 2s. The two images were cropped to a rectangle which showed an identical area before and after cleaning. Fiji [24] (ImageJ, U.S. National Institutes of Health, Bethesda, Maryland, USA) was used to segment the images to calculate the area of biofilm on the implant surface before and after cleaning. Image segmentation was done using manual thresholding (**Error! Reference source not found.**). The number of white pixels in the thresholded image corresponded to the biofilm area. The ratio of pixels in the before and after thresholded images was taken to calculate the percentage of biofilm remaining on the surface. This was done for 5 repeat experiments for each power setting investigated and the mean value was plotted using Sigmaplot. Statistical significance was tested in Sigmaplot

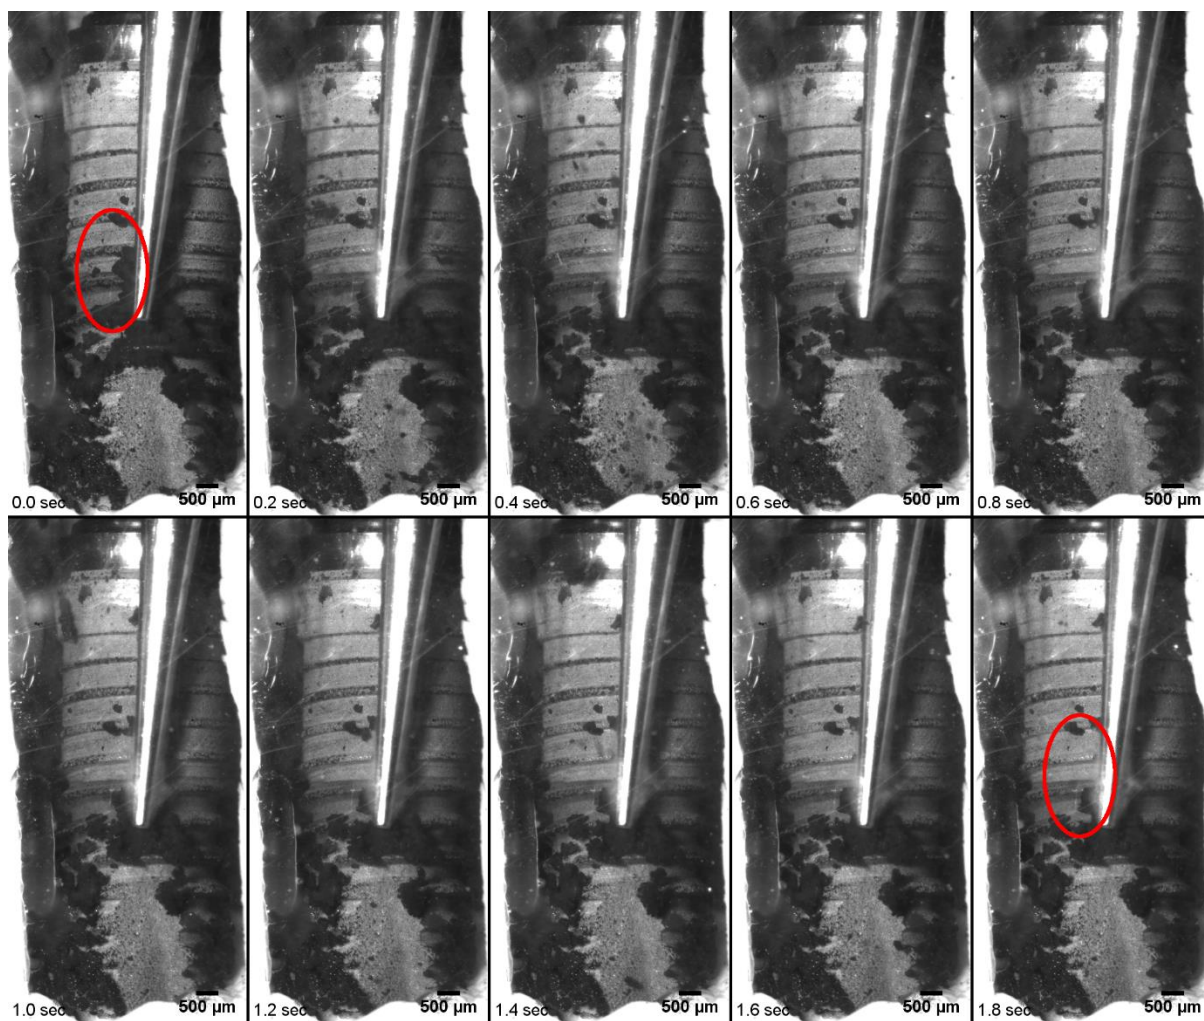
Figure 4 High speed image stills from cavitation applied at medium power, the red circles show areas of biofilm disruption.

Biofilm was removed from parts of the dental implants using cavitation from an ultrasonic scaler (Figure 13, Figure 14). High speed imaging showed that the majority of biofilm disruption occurred in the first 0.5 s (Figure 13, Figure 14). Cavitation bubbles were inertial, causing chaotic oscillations where the bubble collapsed and reformed continuously. Biofilm was removed from the implant threads by these oscillating cavitation bubbles (Figure 17). At

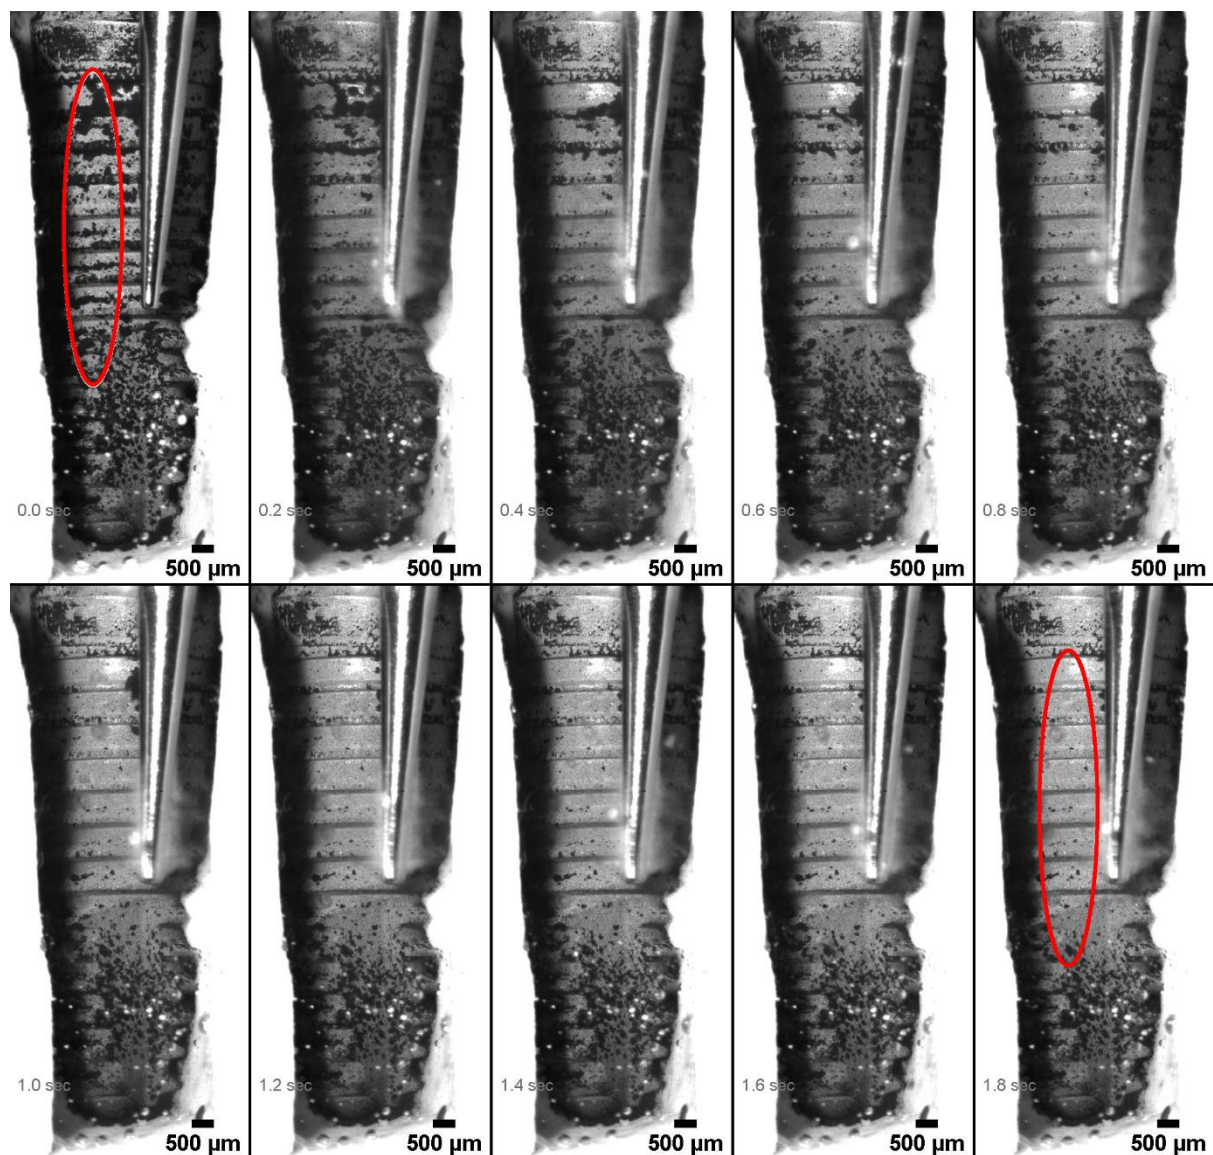
Figure 5 High speed image still from cavitation applied at maximum power, the red circles show areas of biofilm disruption.

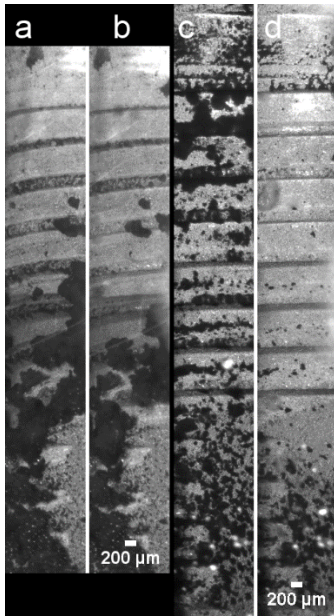
Figure 6 (a, b) implant before and after cleaning at medium power for 2 s. (c, d) implant after cleaning at high power for 2 s

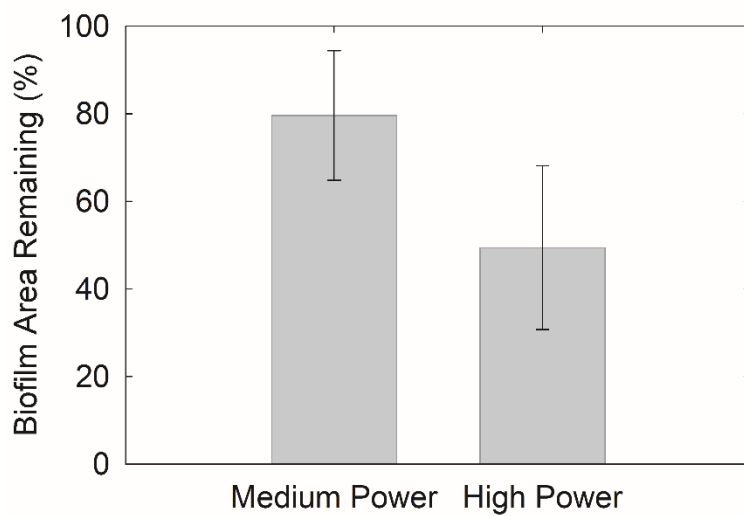
Figure 7 Biofilm surface area remaining on dental implants after 2s treatment with cavitation from an ultrasonic scaler n =5, $p < 0.02$ (t-test)

Image analysis showed that more biofilm was removed at high power (Figure 16). At high power the area of low acoustic pressure around the tip would be larger. This would enable the cavitation to be powerful enough at further distances which are not possible at medium power. High speed images showed that at high power the larger cavitation bubbles cleaned more of the biofilm between the implant threads (Figure 17). SEM images showed that the implant surface was completely intact, after cavitation at both power settings (Figure 18). SEM images also showed effective biofilm removal at both power settings (Figure 18). This suggests that small cavitation bubbles are just as effective at removing biofilm, but the larger bubbles moved quicker across the implant surface so could clean a bigger area in the same time span. This demonstrates that the power of the instrument is a major factor that affects biofilm removal. The instrument power is positively correlated with the vibration displacement of the ultrasonic scaler tip [18, 26]. As it is difficult for a clinician to hold the tip 0.5 mm away from the implant without making contact, this method is difficult to put into practise clinically because if the ultrasonic scaler tip contacts the implant it scratches the surface, which will increase biofilm accumulation and may cause problems with re-osseointegration [27], but further research can be done to enable ultrasonic scalers to be used in a non-contact mode.

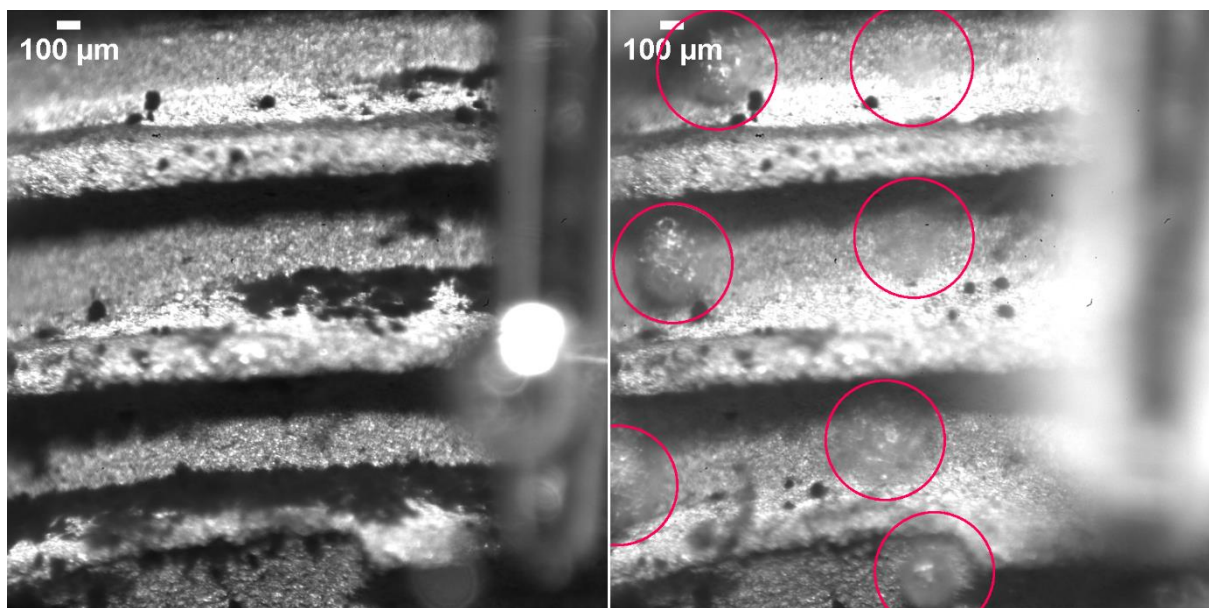
Figure 8 Stills from a high speed video showing a close up of the implant threads with stained biofilms (black) (left). (right) after 0.5 s most of the biofilm is removed. Cavitation bubble clusters can be seen in between the implant threads, circled in red. See supplementary video

At high power the diameter of the cavitation bubbles was similar to the width of the implant threads (Figure 17). The bubbles travelled horizontally inside the threads and caused most of the biofilm disruption. Biofilm streamers, which are loosely attached parts at the top of a biofilm cluster, were removed first. In some cases smaller biofilm structures which were closer to the implant surface were not removed even after the cavitation bubble clusters made contact with them multiple times. This was seen at both medium and high power.

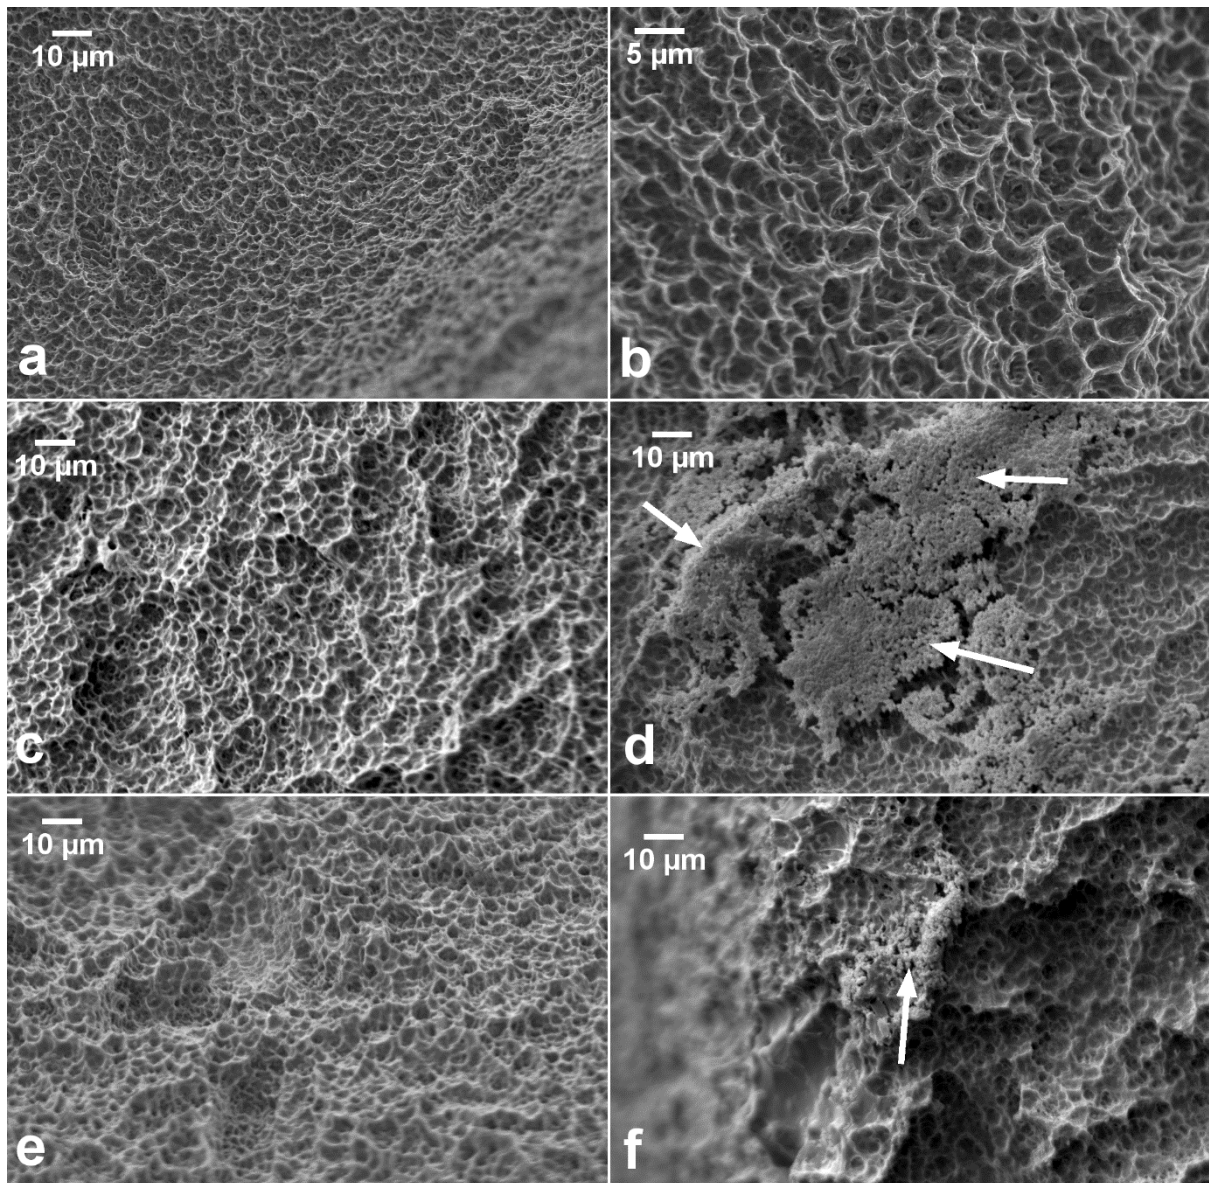
Figure 9 (a, b) The clean Friadent dental implant surface, before bacterial colonisation. (c) The implant surface closest to the free end of the ultrasonic scaler tip, after biofilm disruption using cavitation at medium power. (d) The implant surface towards the upper part of the dental implant after using cavitation at medium power, showing some biofilm clusters still attached (white arrows) (e) The implant surface closest to the free end of the ultrasonic scaler tip, after biofilm disruption using cavitation at high power. (f) The implant surface towards the upper part of the dental implant after using cavitation at high power, showing some biofilm clusters still attached (white arrow)

Scanning electron microscopy images showed that the implant surface was returned to its original condition at locations where the free end of the ultrasonic scaler tip was closest to the implant (Figure 18). This was the case when cavitation was used at both medium and high power. However small clusters of biofilm were found still attached to the implant surface towards the top of the implant, for both power settings, although more biofilm remained when medium power was used.

ultrasonic cavitation did not damage the implant surface (Figure 18). In addition, because only water was used, there was no residue left on the implants. Many previous studies *in vitro* were done using an artificial biofilm such as ink or a calcium phosphate coating [8, 12, 28-30], but this is not clinically accurate as ink and biofilm have different attachment and viscoelastic properties. Lasers were investigated using bacterial biofilm but they did not physically disrupt the biofilm, although they had an antimicrobial effect [27]. Another limitation of many of these studies is that the image analysis procedures used for calculating the amount of biofilm removed were not fully explained [8, 12, 28-30]. This does not allow accurate reproduction of the method and may increase bias in reporting of the results.
